GLAS 2020

Chris Southgate Conservation
Engineer with Southgate
Associates

**Typical structural
issues and possible
fixes!**

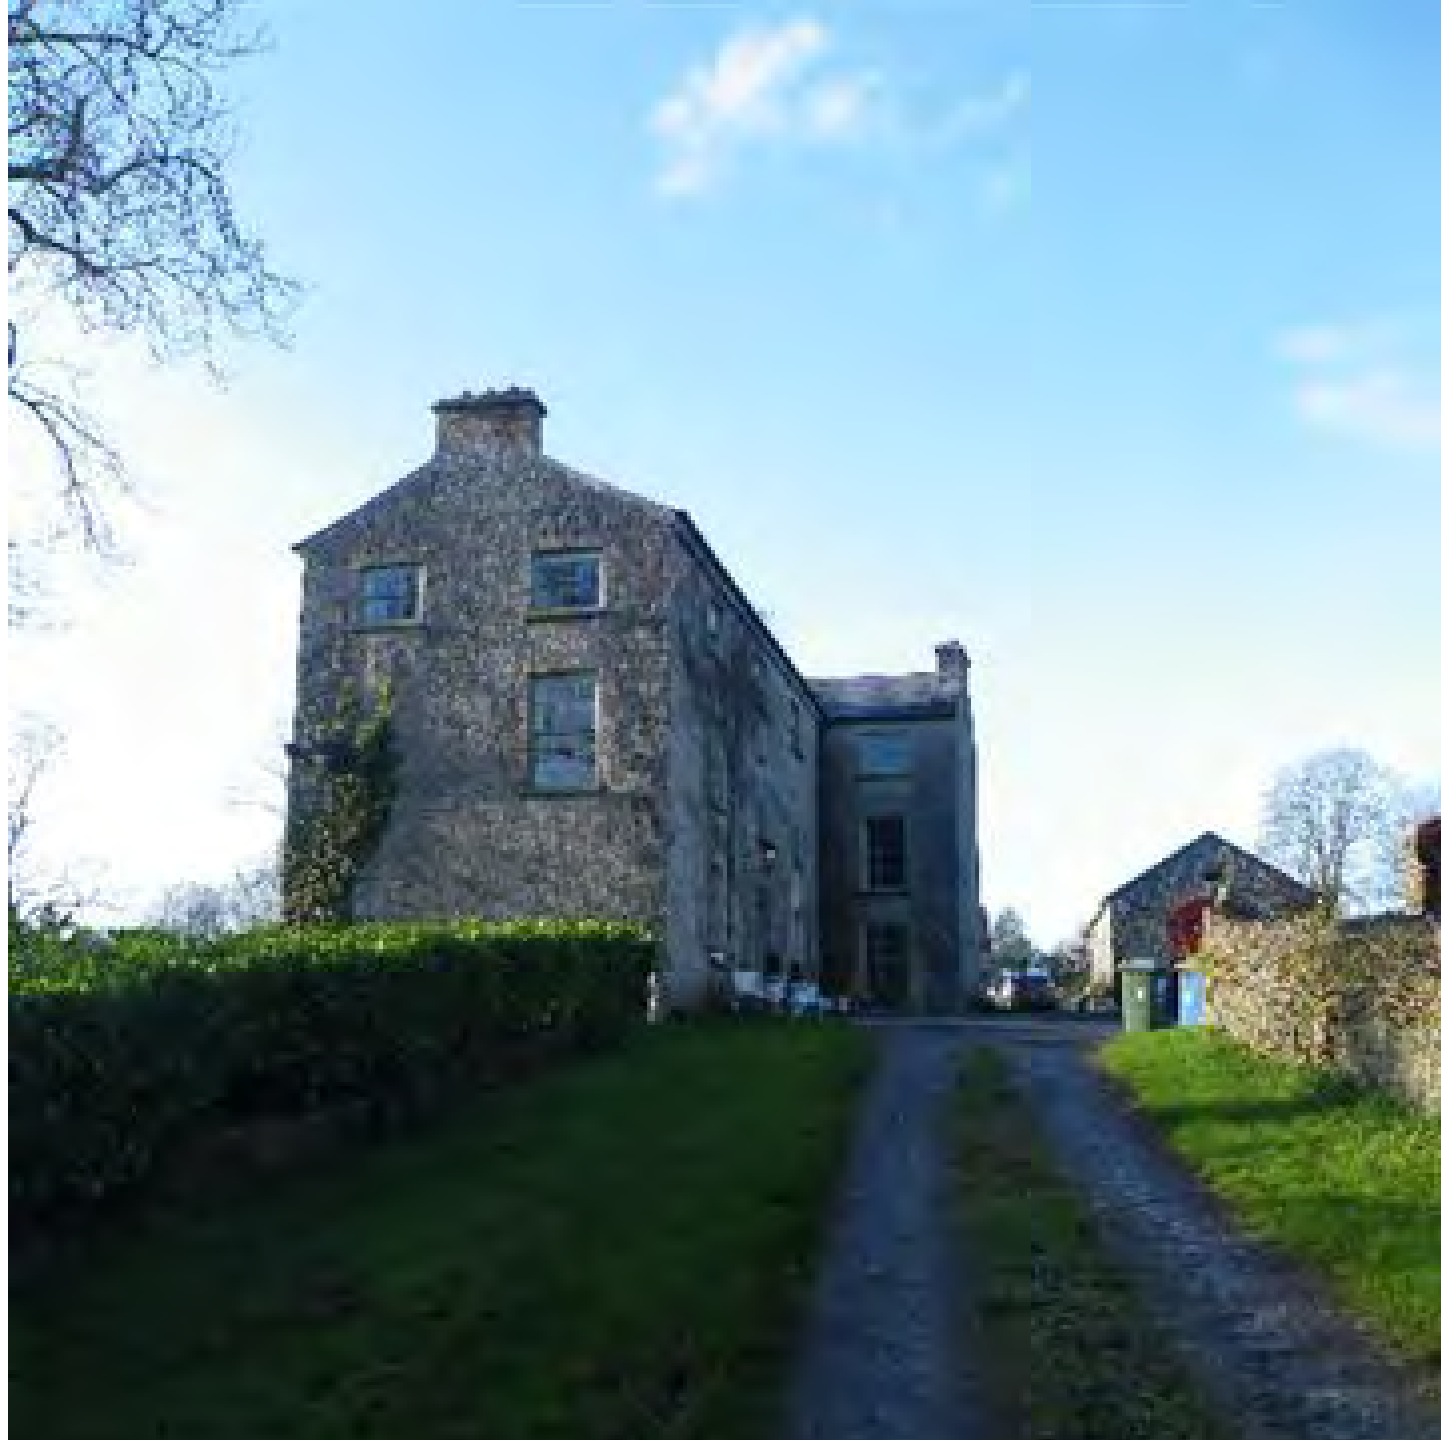
Walls to the 17th
century
outbuilding were
leaning out about
300mm

THIS WAS CAUSED BY ROOF
FAILURE IN THE COLLAR
TIES

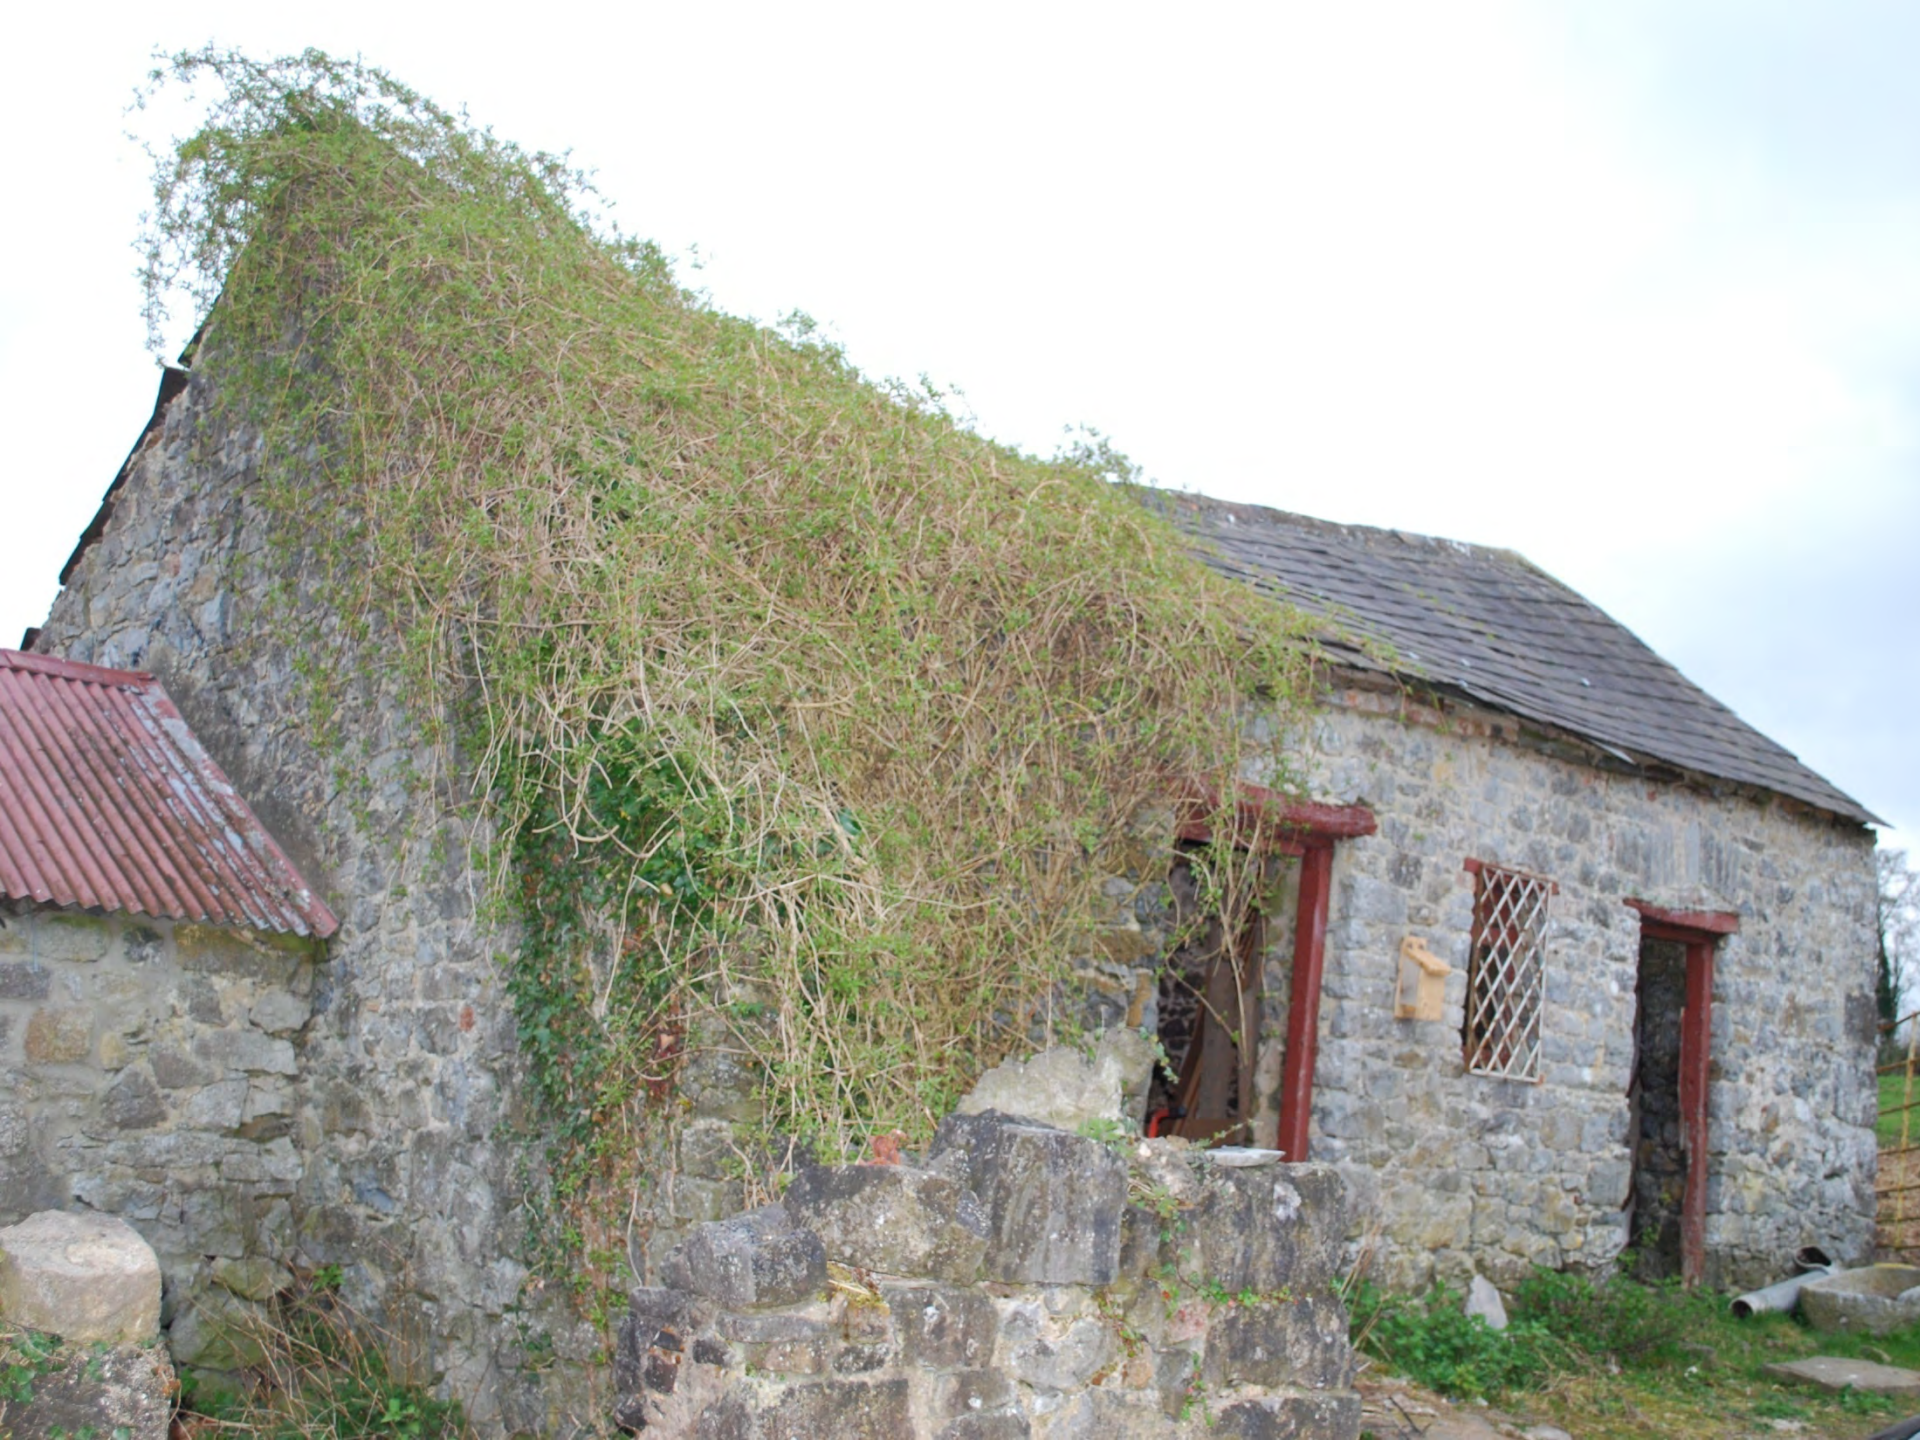
The roof had literally pushed walls outwards causing major cracks in the gable walls
