**June and Ken Bourke Farm Buildings Case Study,
Knappagh, Westport, Co. Mayo GLAS TFB 2016**

Áine Doyle MUBC Conservation Consultant

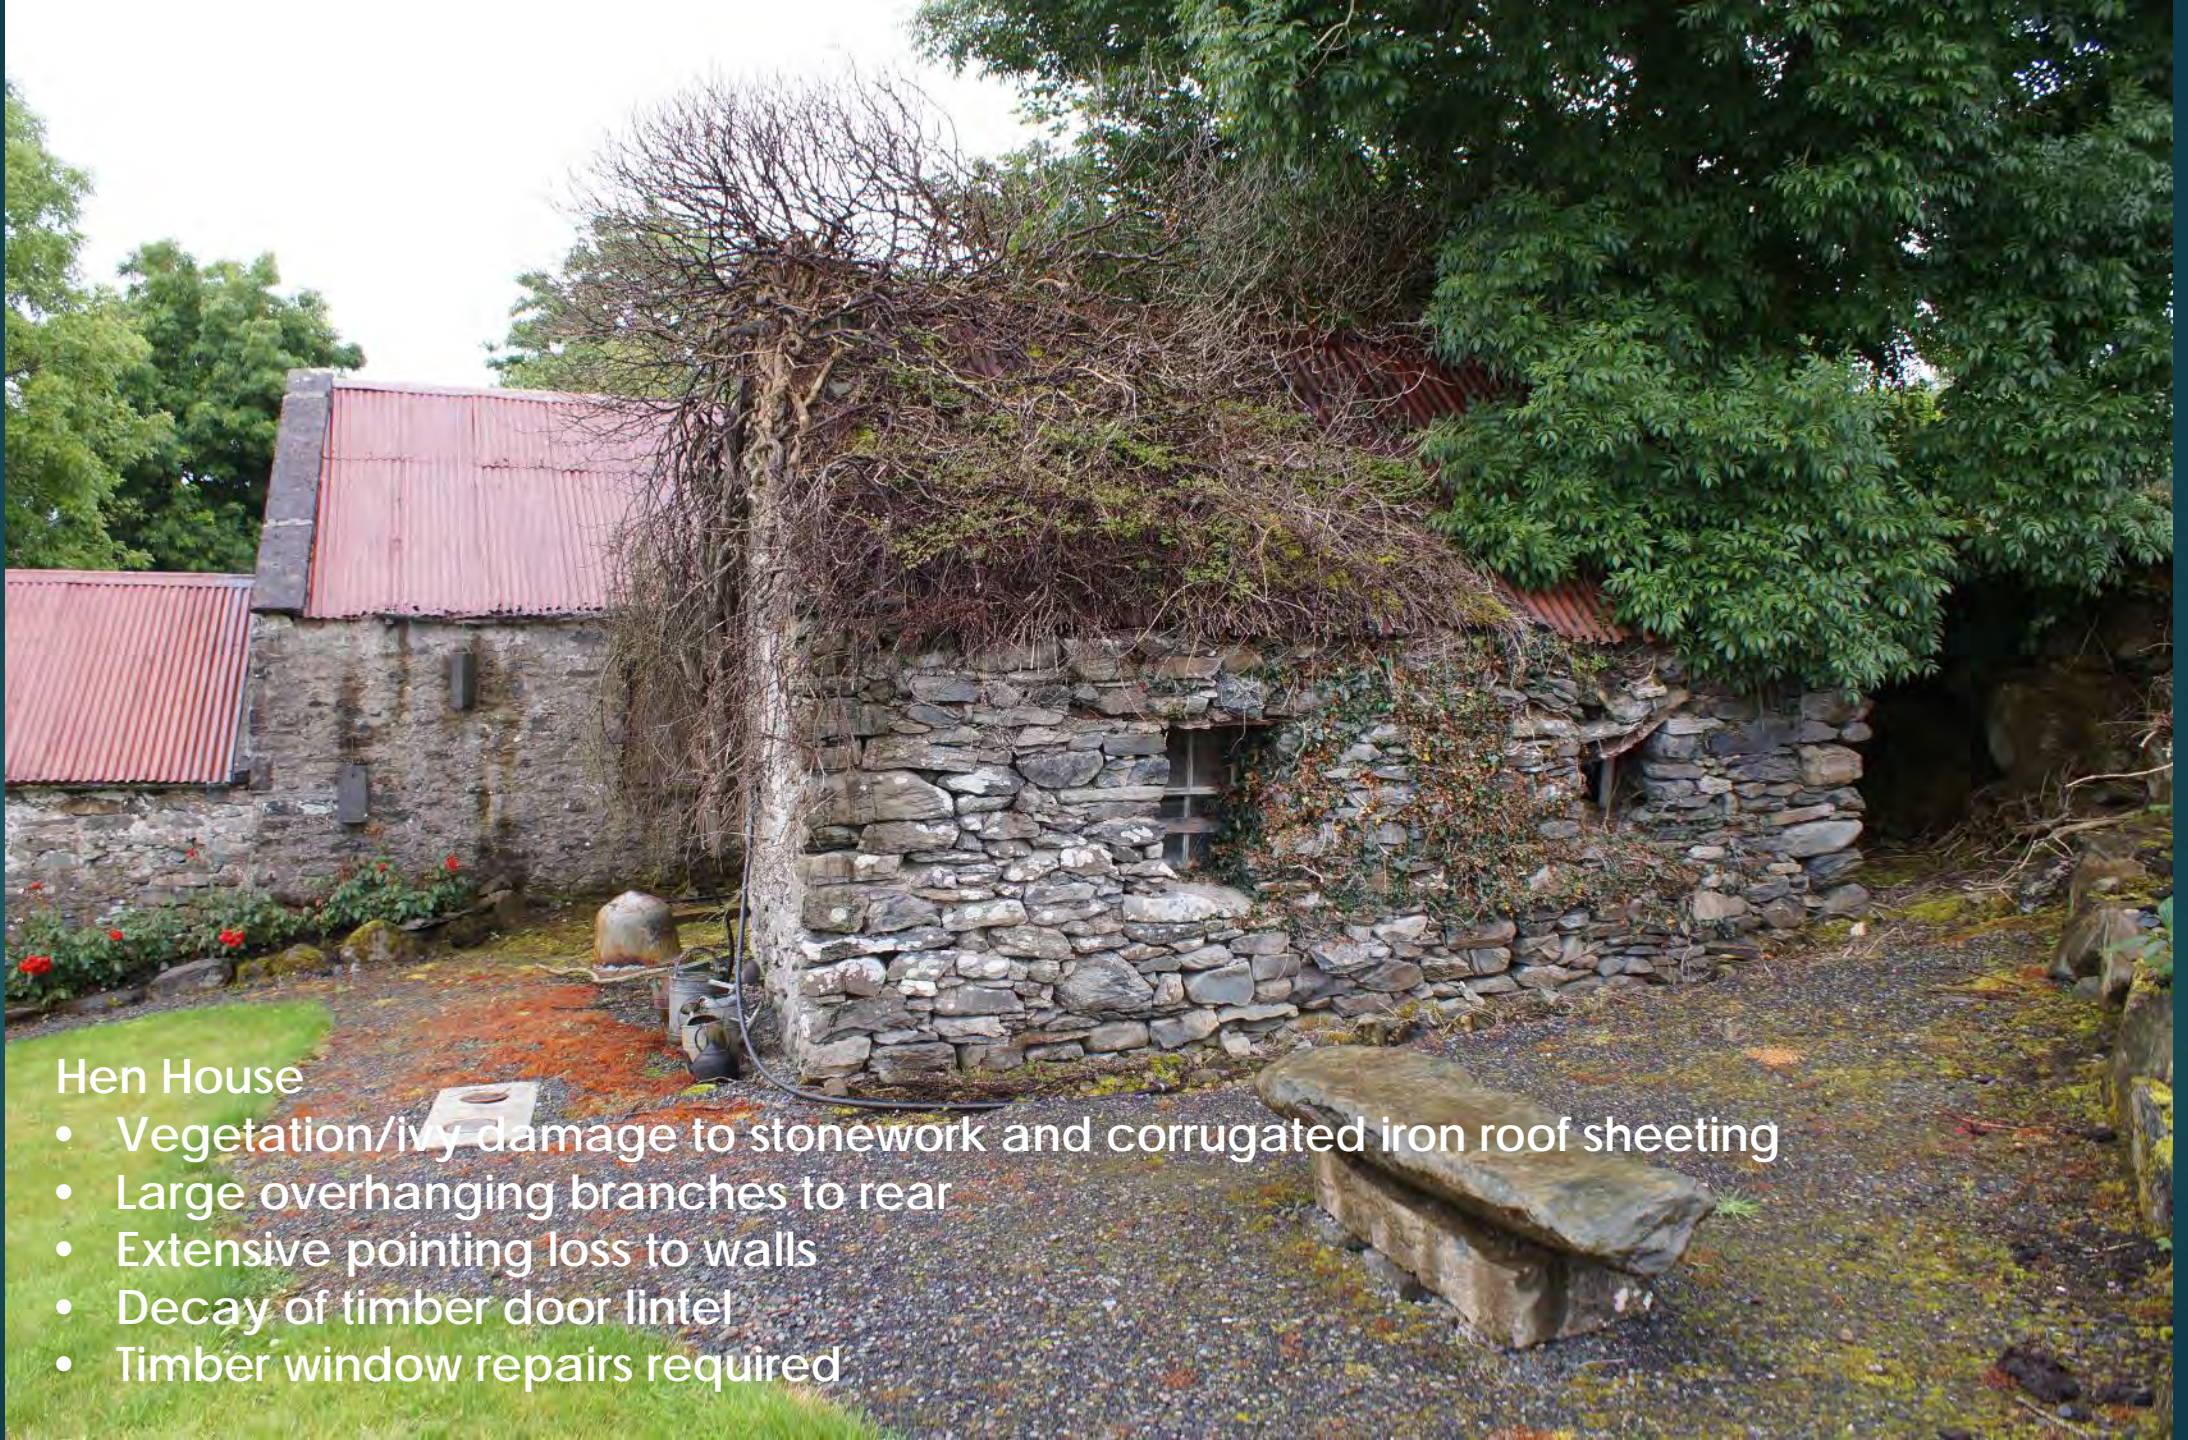
Hen House

- Vegetation/ivy damage to stonework and corrugated iron roof sheeting
- Large overhanging branches to rear
- Extensive pointing loss to walls
- Decay of timber door lintel
- Timber window repairs required

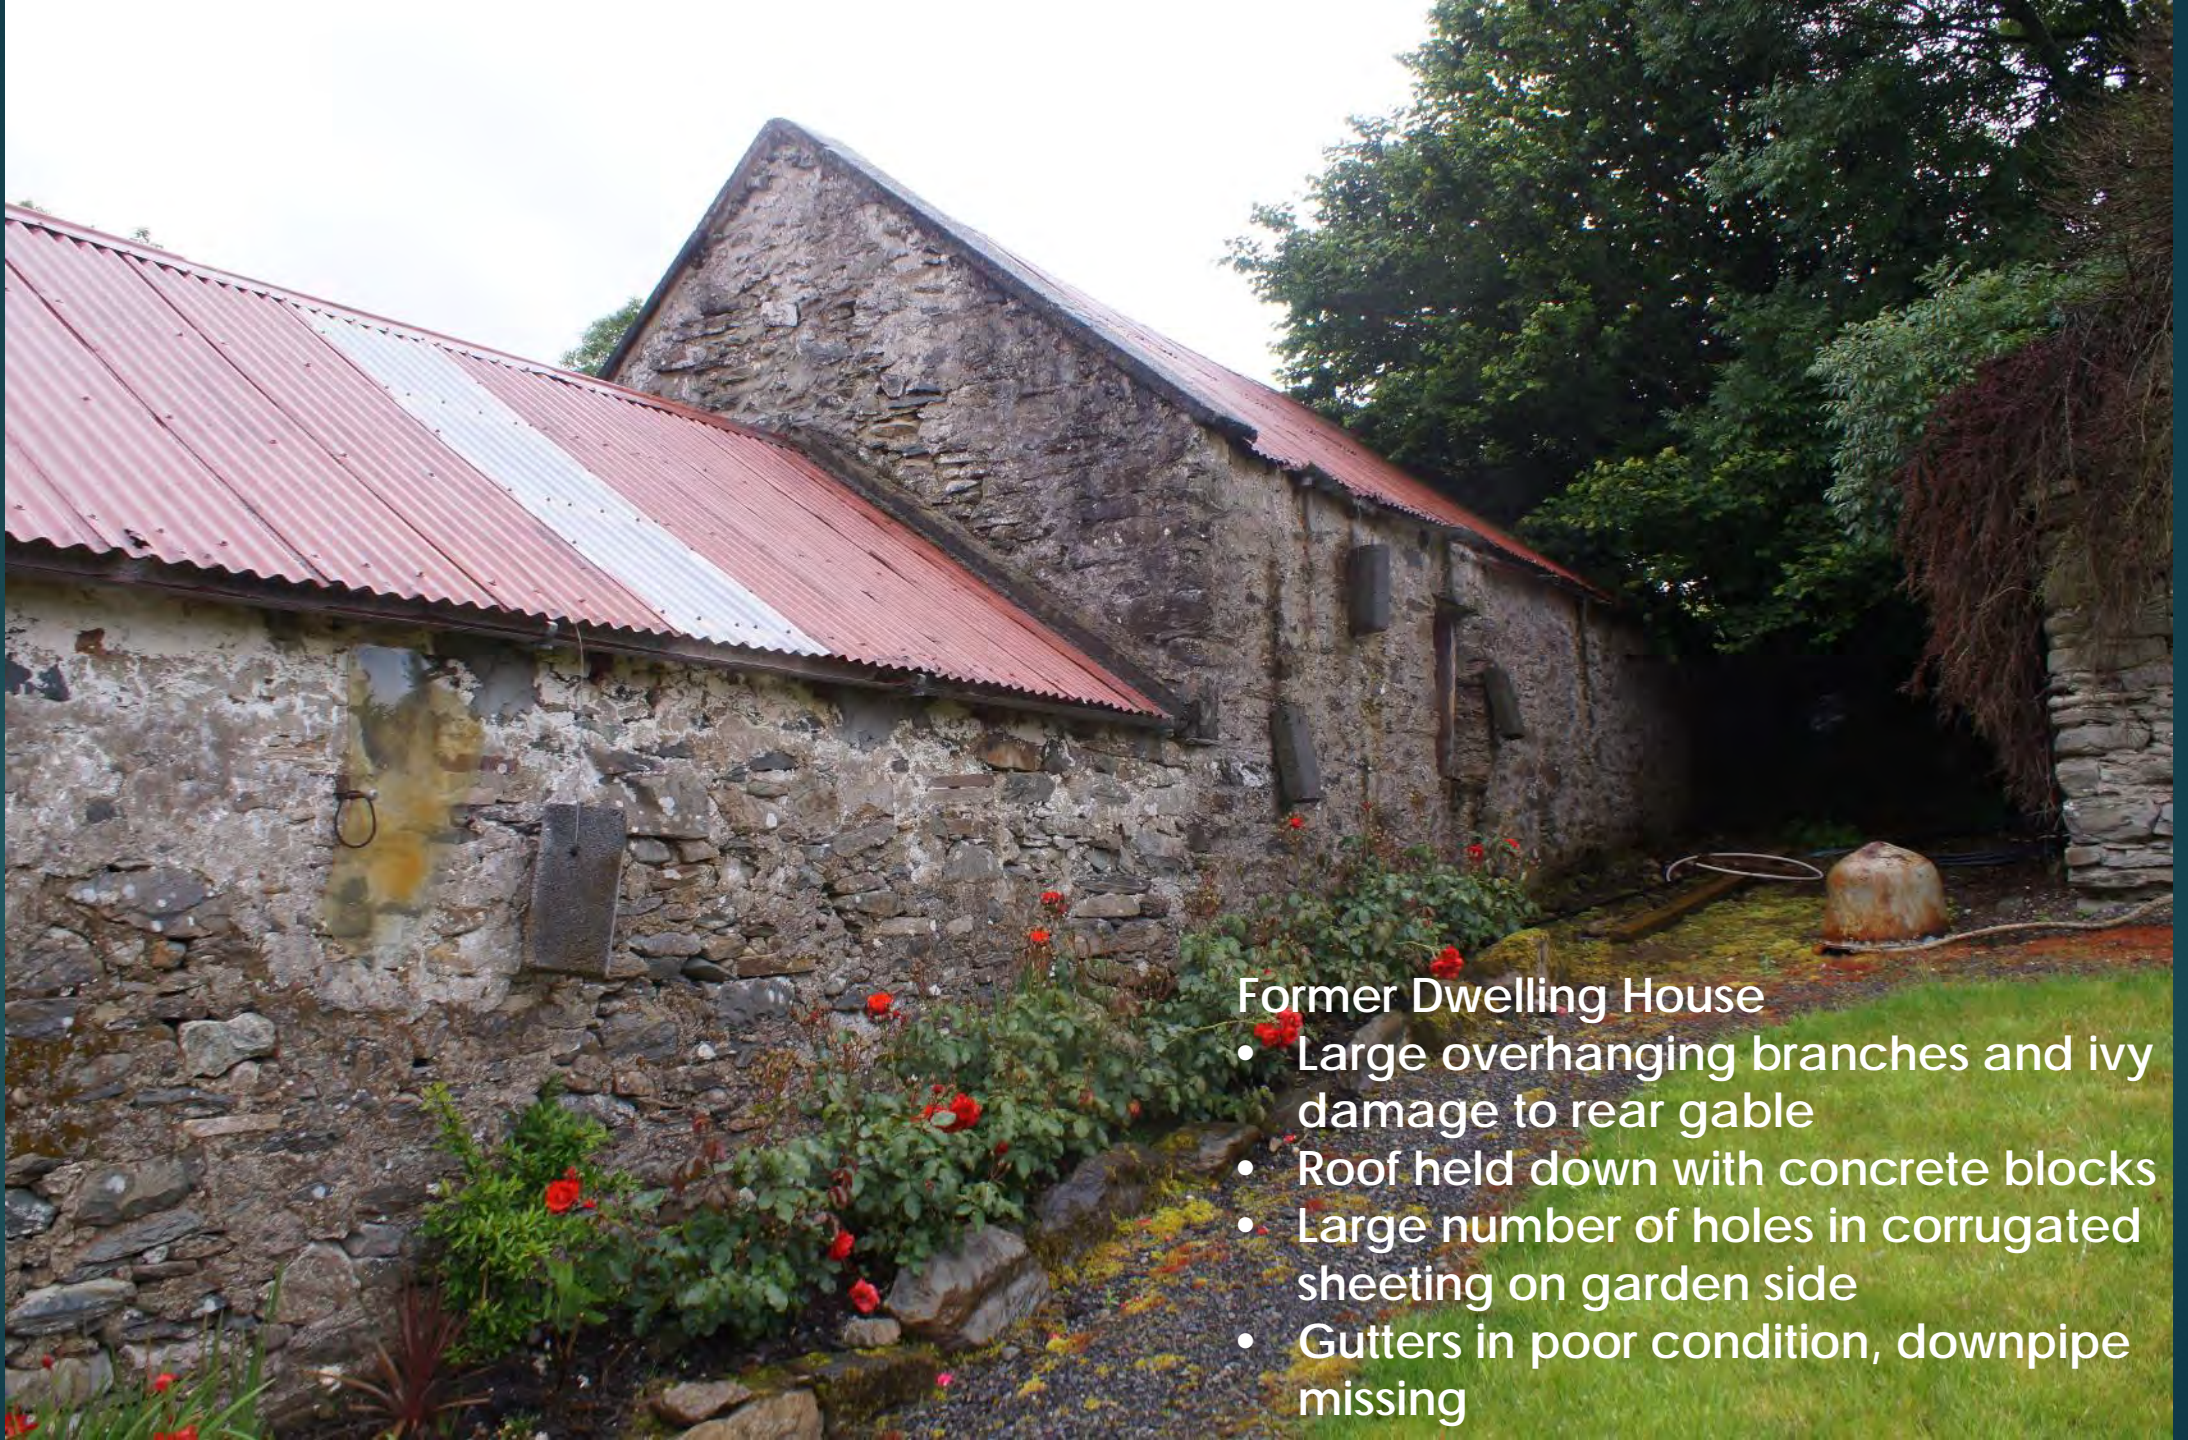
Former Dwelling House

- Large overhanging branches and ivy damage to rear gable
- Roof held down with concrete blocks
- Large number of holes in corrugated sheeting on garden side
- Gutters in poor condition, downpipe missing

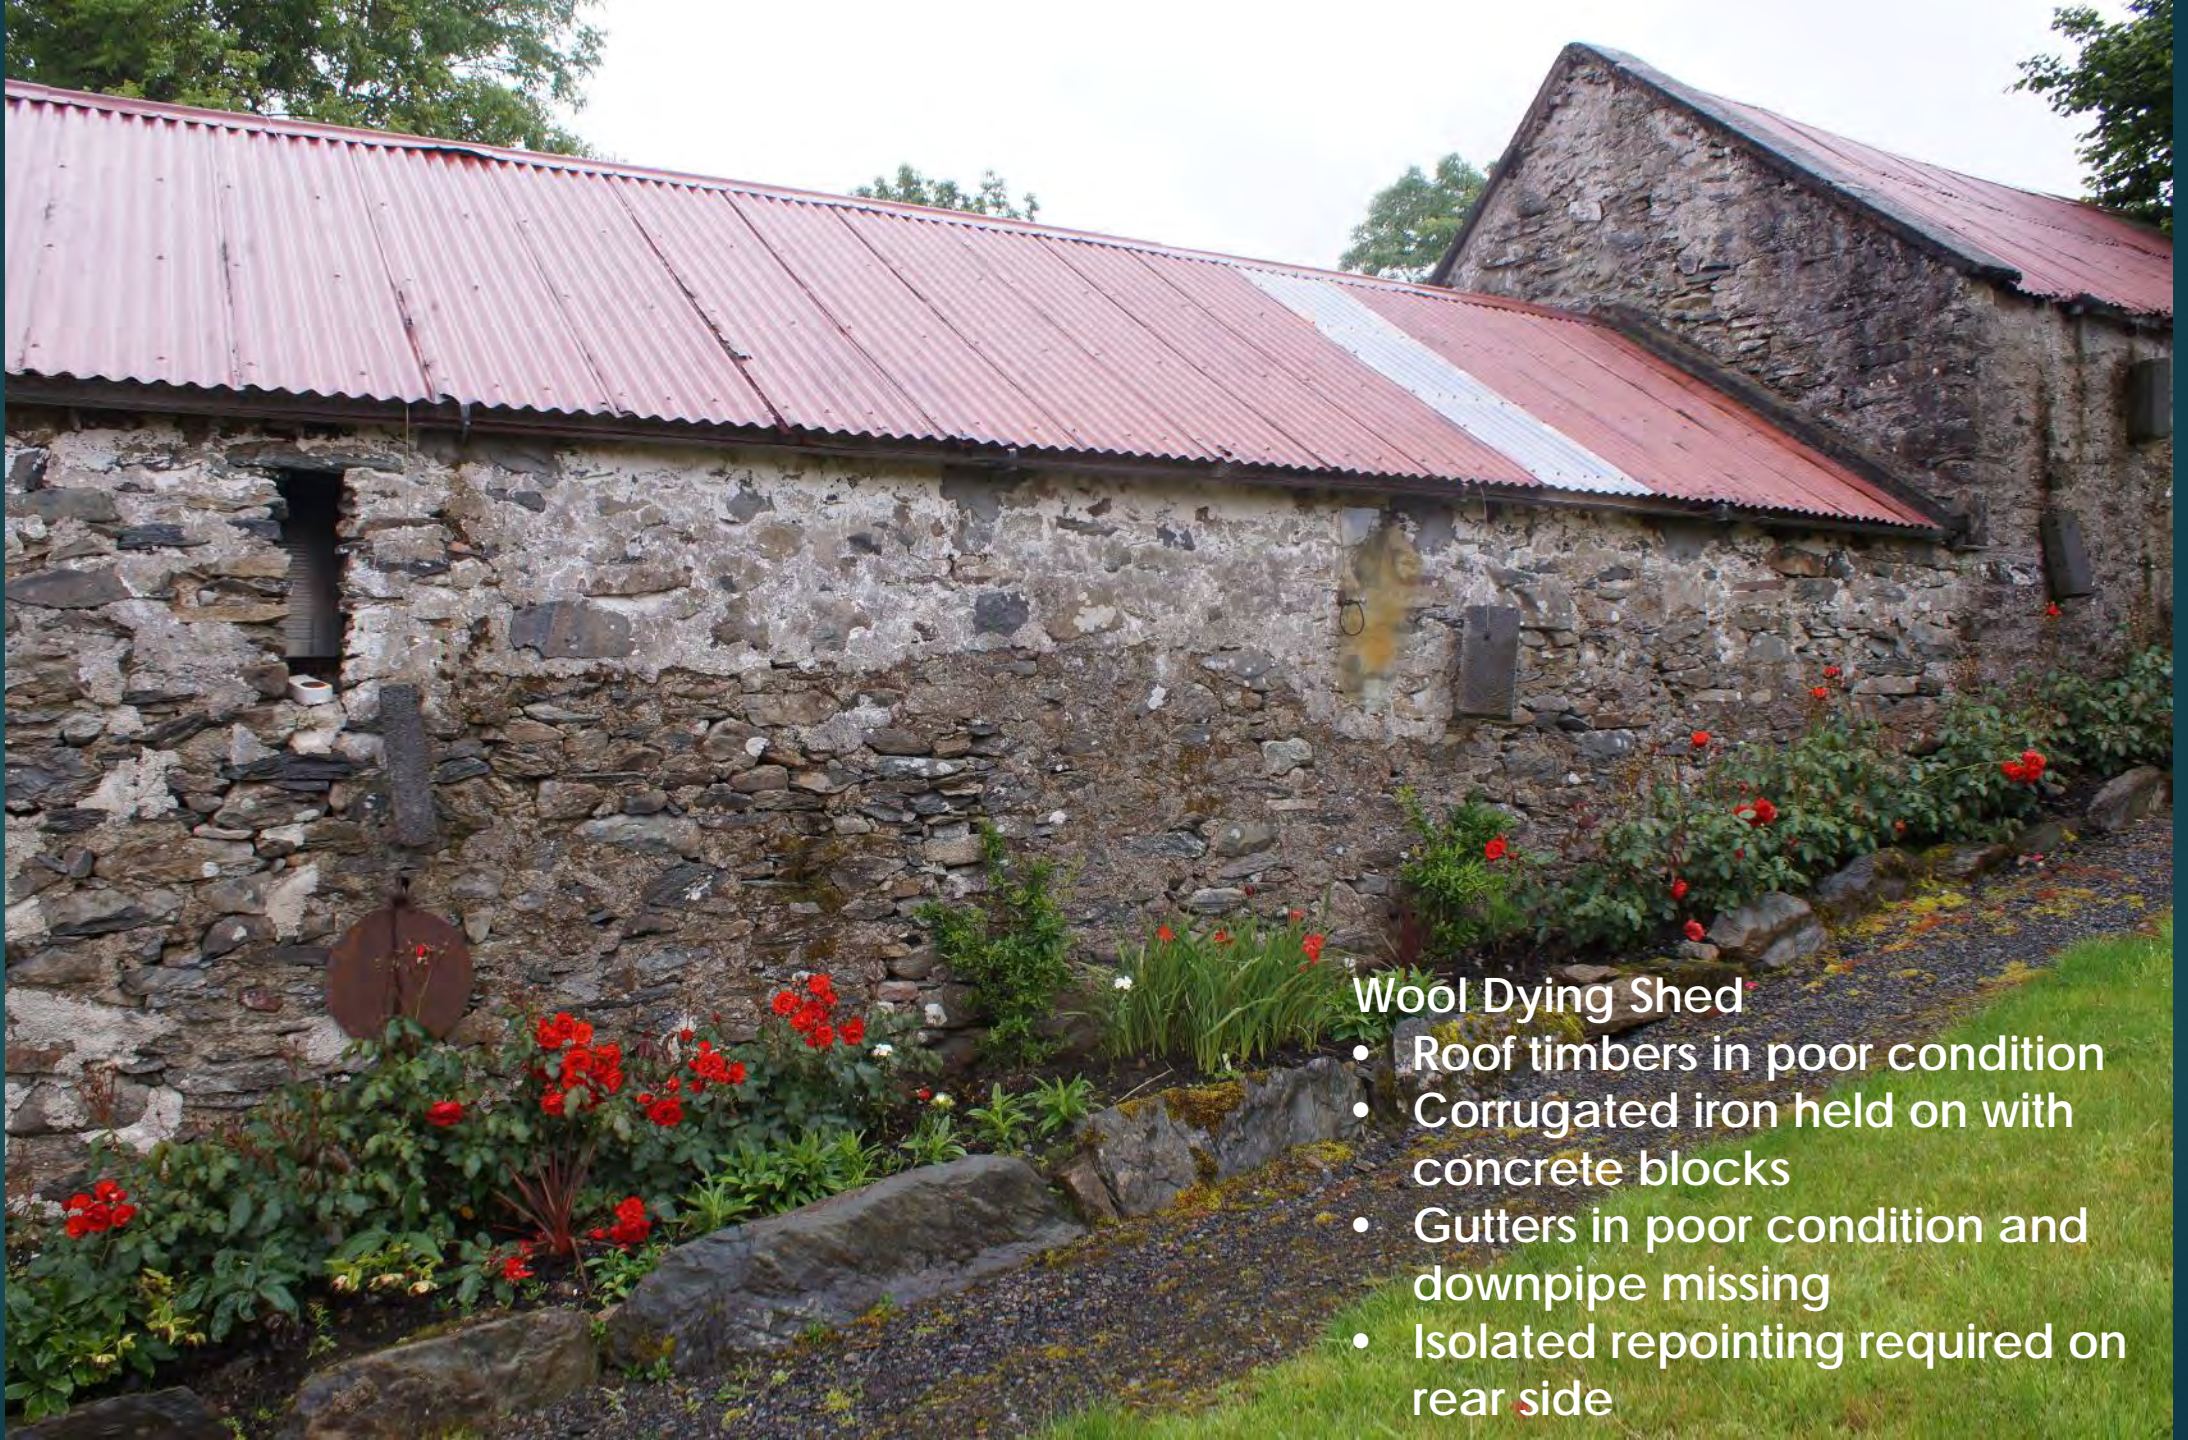
Wool Dying Shed

- Roof timbers in poor condition
- Corrugated iron held on with concrete blocks
- Gutters in poor condition and downpipe missing
- Isolated repointing required on rear side

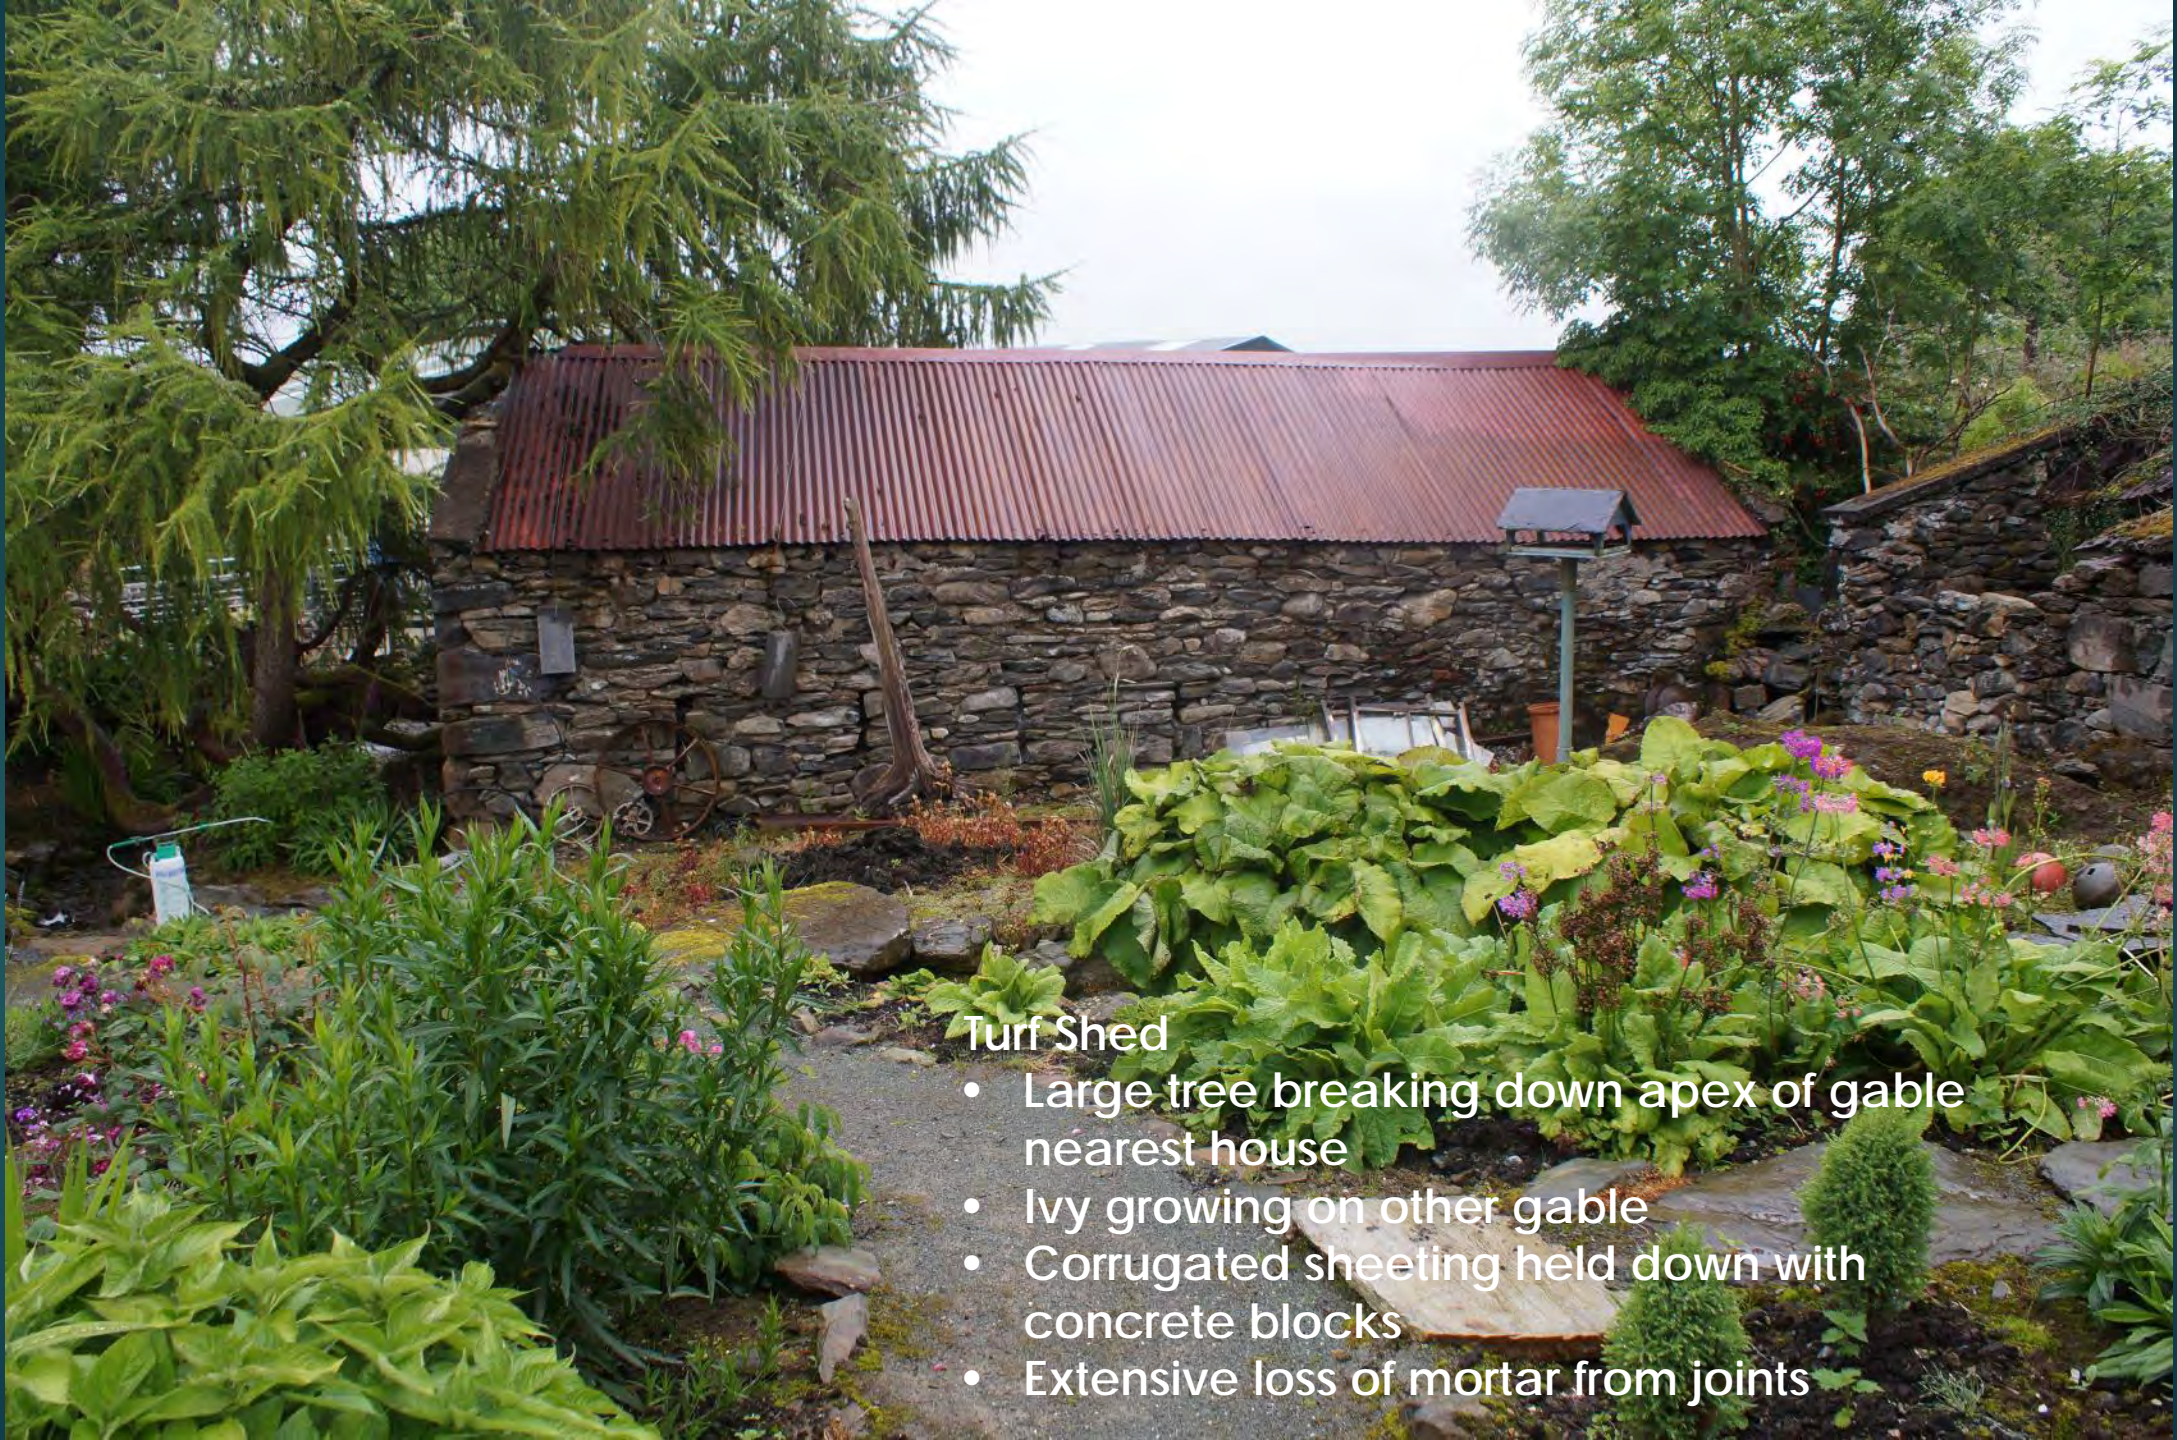
Turf Shed

- Large tree breaking down apex of gable nearest house
- Ivy growing on other gable
- Corrugated sheeting held down with concrete blocks
- Extensive loss of mortar from joints
