# YOUGHAL TOWN WALL

# Conservation and Management Plan

The Integrated Conservation Group,  
The David Kelly Partnership  
and John Cronin & Associates, Planning Consultants

18th May 2008

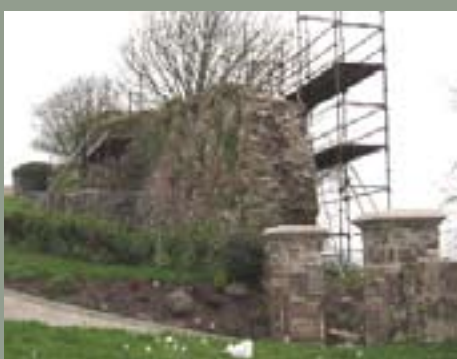
Plate 33. Section M – repairs to original fabric and new gate crossing line of wall

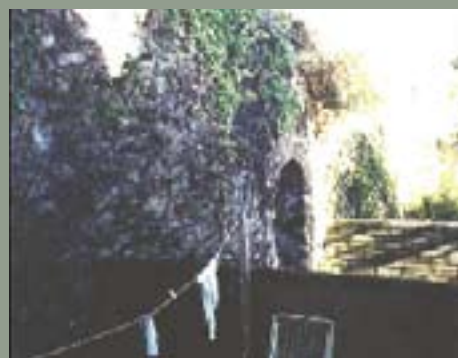
Plate 44. Opening along external face of Section Q (after Kelly 2000)

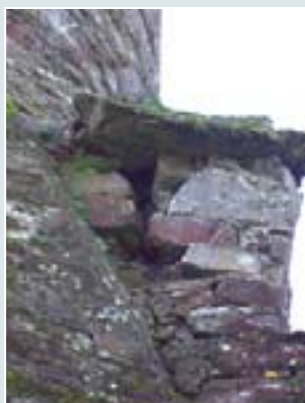
Movement related cracking is noted at section I. Here demolition of the fever hospital, (which stood at section H) may have resulted in movement of the adjacent wall - pressure fracturing of the surrounding stone is noted in this area. Elsewhere a loss of pointing material and the erosion of fabric are likely to have lead to unstitching of the wall and in places, collapse. Bowing of the wall is noted in the external face of section J - it is likely that the significant loss of stone to the internal face of this section relates to the structural failings expressed on the external face. Further structurally instability is noted at section D where the upper courses of this section of the wall appear to be in danger of collapse. Significant failure is noted to the tower at section K where careless backfilling following archaeological investigation has lead to listing of this structure. Movement at sections I and J has lead to unstitching of the wall walk from the outer face with partial collapse of the wall-walk at section J exposing the core of this section to the elements.

*Structural cracking of internal face of section I adjacent breach in the wall.*

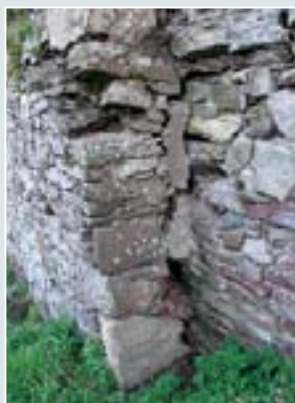
*Detaching external face to section J, note the bowing of masonry.*

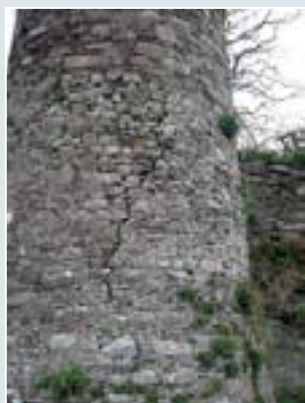
*Structural cracking of external face of tower to section K.*

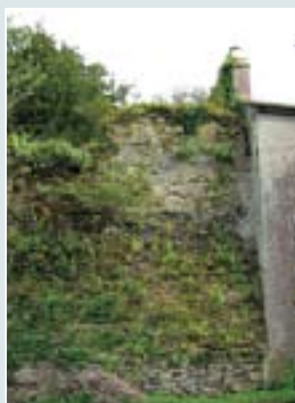
*Structurally unstable material at section D.*

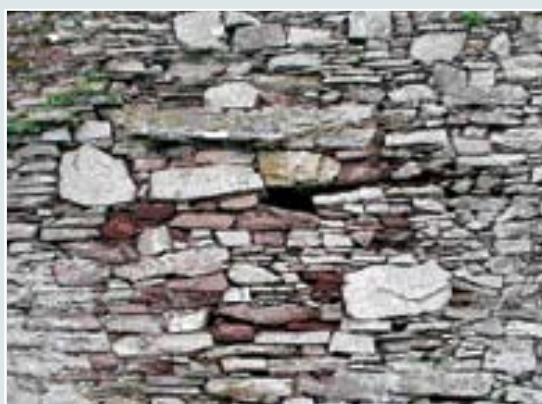
*The continued action of rainwater has lead to the disintegration of pointing mortar to the external face of section J. Note plant life to adjacent areas.*

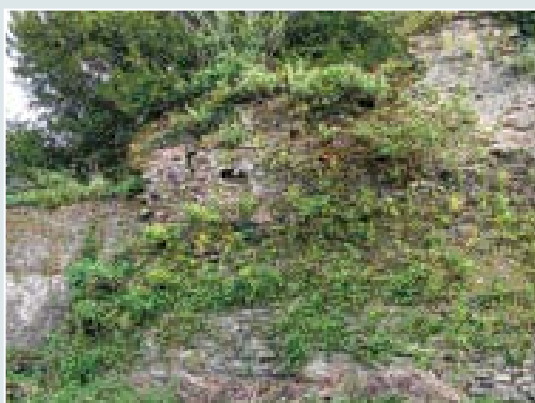
Large areas of open-joints at sections C through G are heavily colonised with plant life and mature vegetation. Here, mechanical damage caused by root systems is likely to lead to a further loss of pointing material. It should be noted that some attempts have been made in the recent past to re-point sections of the wall.

*Open joints colonised by plant life to section C.*

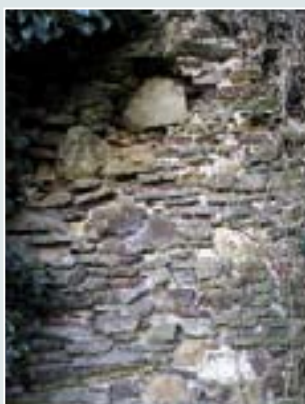
*Voids to external face of section G, note the open joints to surrounding area*

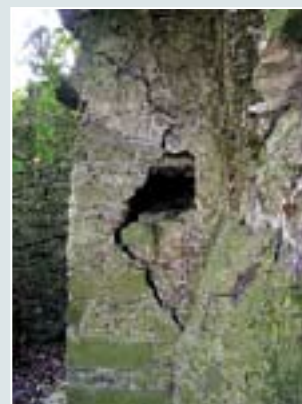
*Substantial crack and void to internal face of section E*

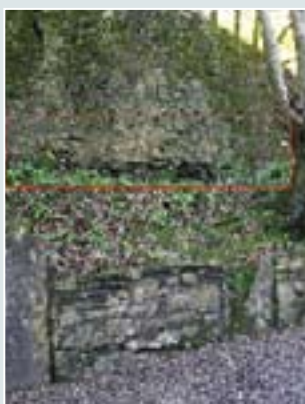
*Missing stones to base of internal face of section F, note the heavy moss growth to sheltered areas.*

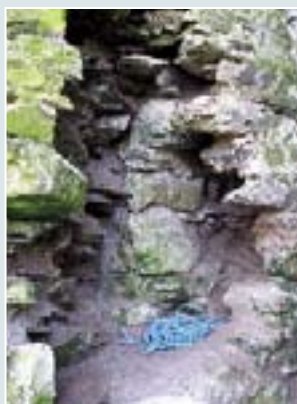
*Large void to internal face of section J.*

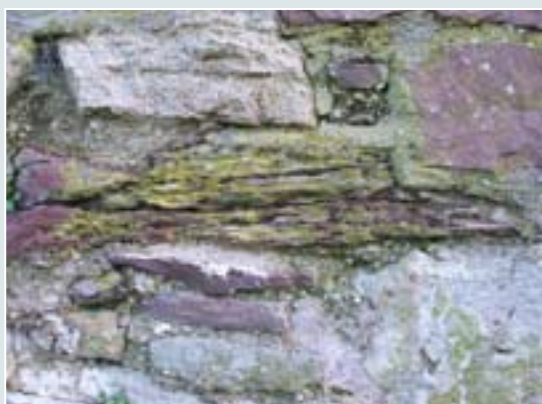
*Cracking along bedding planes of stone to external face of section I.*

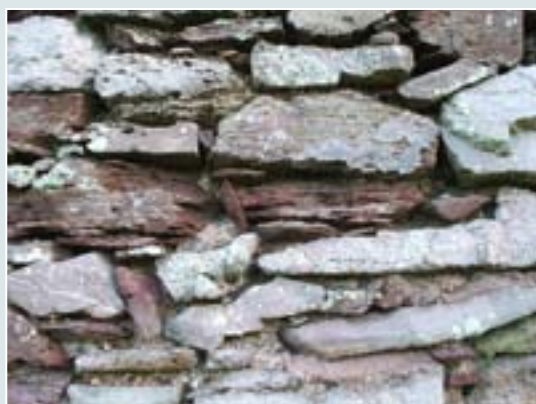
*Cracking along bedding planes of stone to external face of section J, note the loss of pointing mortar to surrounding areas.*

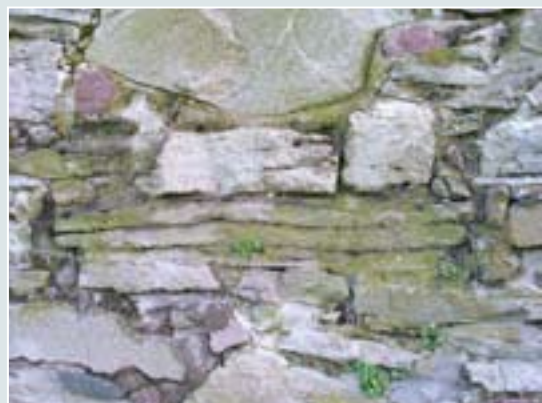
*Cracking along bedding planes of stone to external face of section I.*

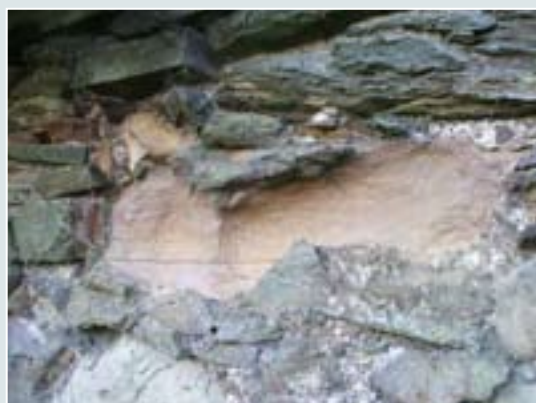
Differential weathering is noted to the poor quality rubble stone throughout the monument. The deep purple stone is likely to be a mudstone from the Ballytranza formation of which at least two local sources exist upriver from Youghal. This mudstone has a large granular structure and is characterised by a very weak binder, making it susceptible to deterioration, particularly in more exposed locations such as the external face of Sections I and J. The more red coloured stone is likely to be Old Red Sandstone, the local variety is highly stratified leading to the type of preferential weathering noted when end bedded. Further geological and petrographic analysis is required in order to determine the exact provenance and physical characteristics of the stone. The cracks and fissures expose the stone to both increased water penetration and the potential for weathering due to the freeze-thaw cycle damage. Some limited dissolution of sandstone is recorded with a significant example of this phenomenon to the external face of section G.

*Significant dissolution of stone to external face of section G.*

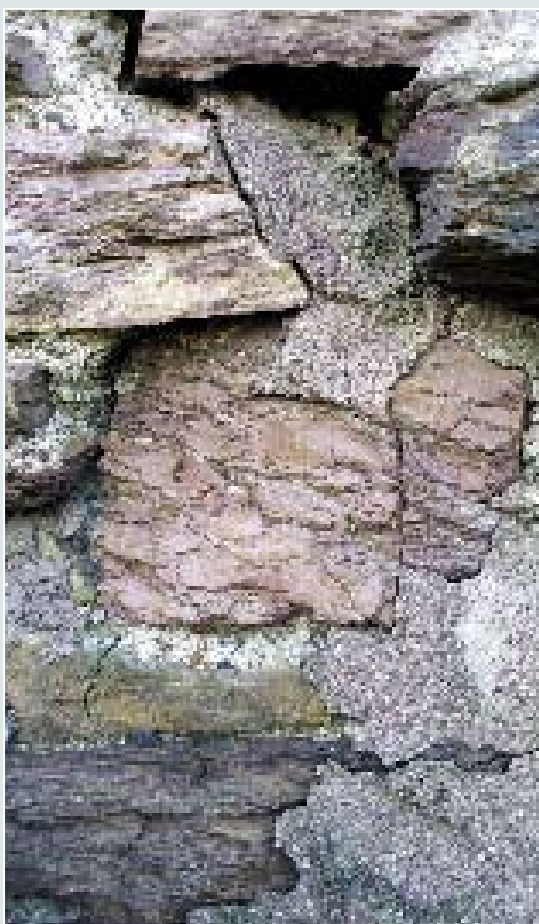
Pressure fractures in the stone are noted to sections I and J. Here, movement within the wall has created differential stress on the stone, causing this to fracture along fault lines. It is plausible to suggest that the demolition of the fever hospital at section H has lead to movement in the adjacent wall at section I where fracturing of stone is concentrated. Expansion of these fractures during freezing will cause further damage to the stone.

*Fracturing of stone to external face of section I*

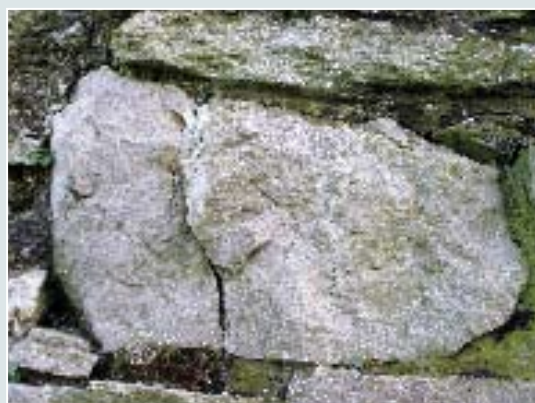
*Fracturing of stone to external face of section I*

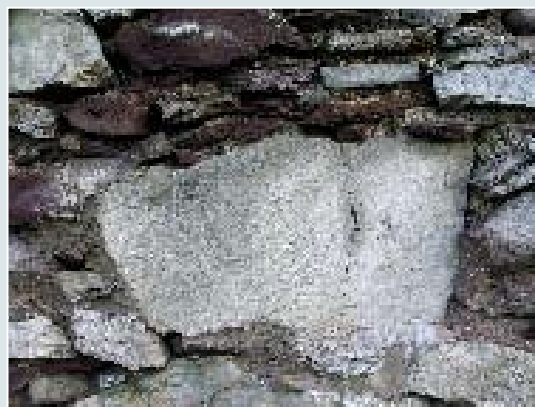
*Fracturing of stone to external face of section J*

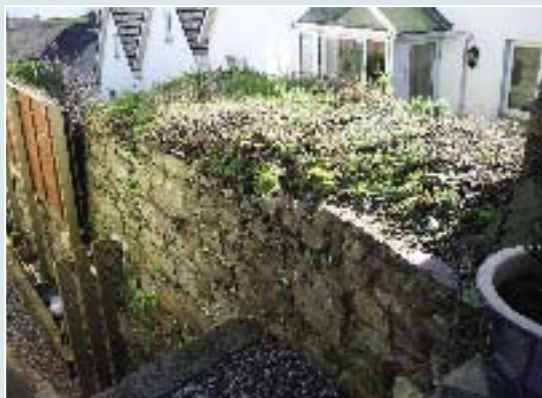
Access to wall heads was restricted however it would appear that there is a lack of coping to skyward surfaces where the wall has been reduced in height. Inadequate coping details facilitate water ingress within the monument accelerating the loss of pointing material and encourage the colonisation of plant life which may lead to further degradation of the historic fabric. At sections L, I and J a cementitious capping has been provided affording some protection, albeit inappropriate by its nature.

*Plant life to cap of Section Q, note structures built up to wall.*

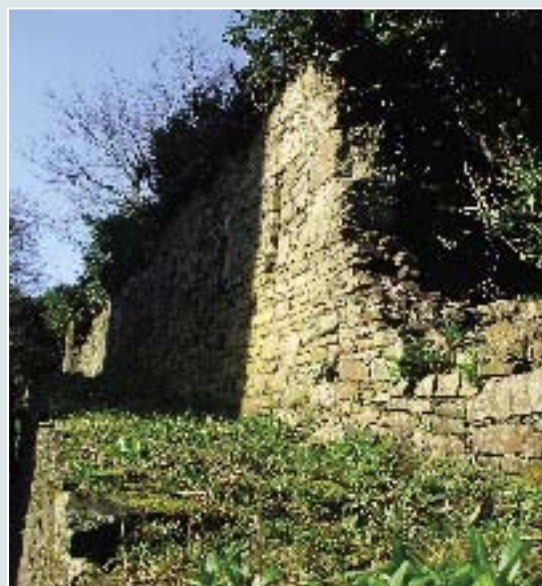
*Plant life to wall walk of Section F.*

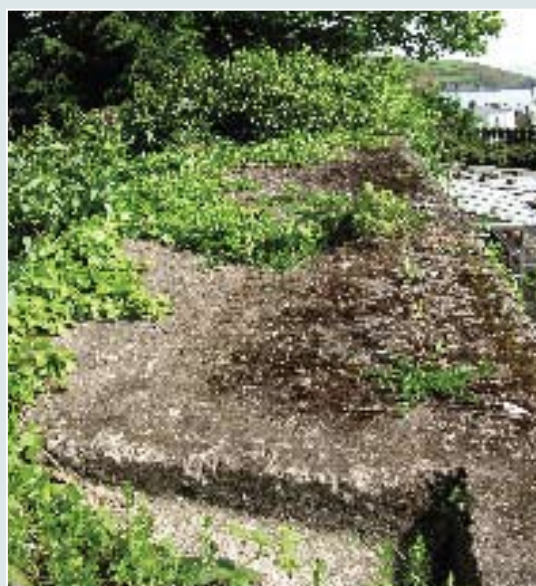
*Cement capping to head of Section L.*

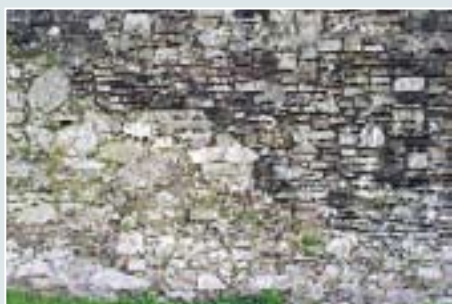
A number of early and recent repairs are noted throughout. Entire sections of the wall have been rebuilt at Section I, J, and M. A membrane to section I defines the perimeter of the rebuild in this section. In general areas of reconstruction do not match the adjacent sections of historic wall; this is particularly apparent as sections I and J where the reconstructed parapet is based on conjecture. Some repair has been carried out using a cementitious render, inappropriate for use on an historic structure. Cement is of such a hard nature that it can trap moisture, furthering damage to the substrate behind. Some current repair work is noted to section M, though it would appear that this relates to localised re-pointing of this section rather than any substantial rebuild. Surviving material at Section R is hoarded from accidental damage while work is being carried out on the adjacent courthouse building.

*Junction of historic fabric and repair to external face of Section I, note the membrane lining to distinguish phases.*

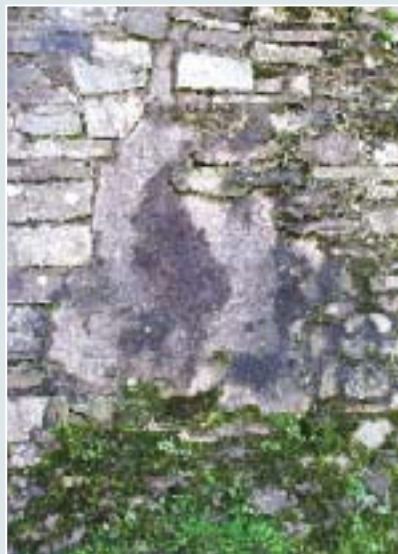
*Cement repair of internal face of section I.*

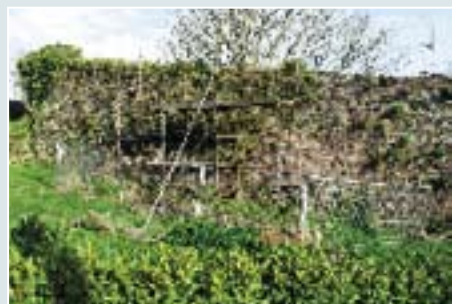
*Current repair of external face of section M.*

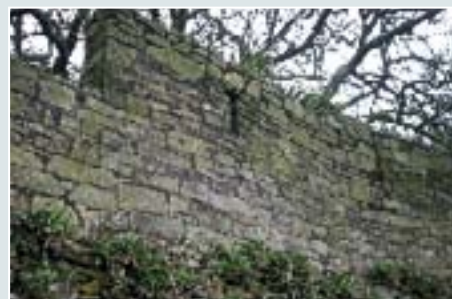
*Repair of internal face of section J.*

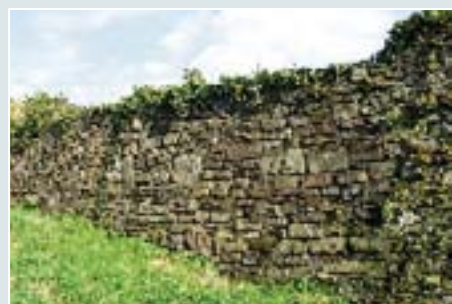
*Poor repair of wall to section M*

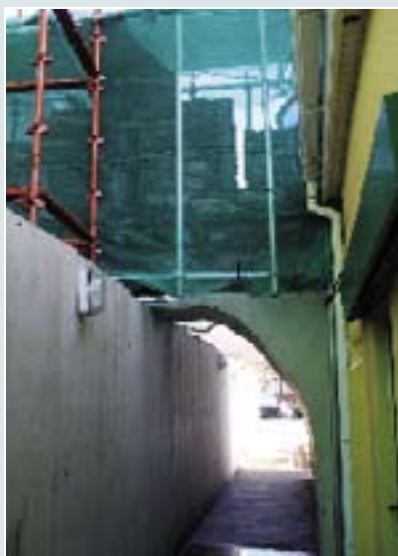
*Hoarding protection to section R during works to adjacent court house.*

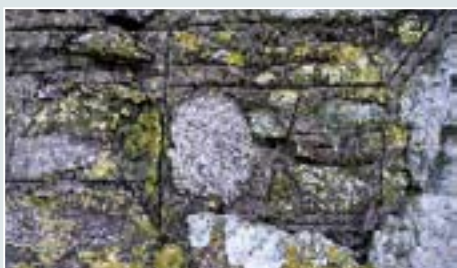
Areas of stonework to the external face of sections J and K have been re-pointed in a cementitious material. This mortar is harder and more impermeable to moisture than the stone thus increasing water movement within the masonry and the risk of subsequent frost related damage. A number of various incorrect pointing methods have been adopted throughout the years. Proud-standing and incorrectly applied pointing mortar detracts from the aesthetics of the wall, changing its overall appearance and allows moisture to accumulate at joints increasing the likelihood of water penetration within the structure.

*Cementitious pointing to external face of section J, note the poor pointing technique.*

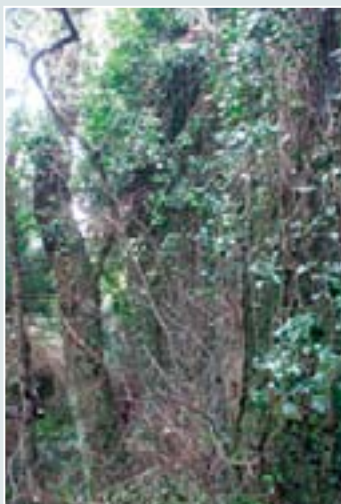
Advanced plant life is noted throughout with substantial blankets of ivy growth to sections C through G, sections L and M and part of the internal face of section J. The colonisation of open-joints by vigorous root systems is likely to lead to further erosion of pointing mortar and dislodgment of stone in these areas. A number of mature trees are noted, rooted in the face of section J and E. Here, areas of the wall will have been undermined where roots have been allowed to grow to an extreme level of maturity. Falling limbs from trees standing in close proximity to the wall present a significant risk to the historic fabric with limbs and in one case an entire trunk resting on the wall head at sections E and K, respectively. Some attempt has been made to remove vegetation from the internal face of Sections E, F, G and H. Here, a number of tree stumps remain rooted within the wall. Though the internal face of section E and to a lesser extent the external face of section I are relatively free from vegetation, unchecked growth to the corresponding faces has in places scaled the wall colonising these sections from the top down.

*Plant life to external face of Section F.*

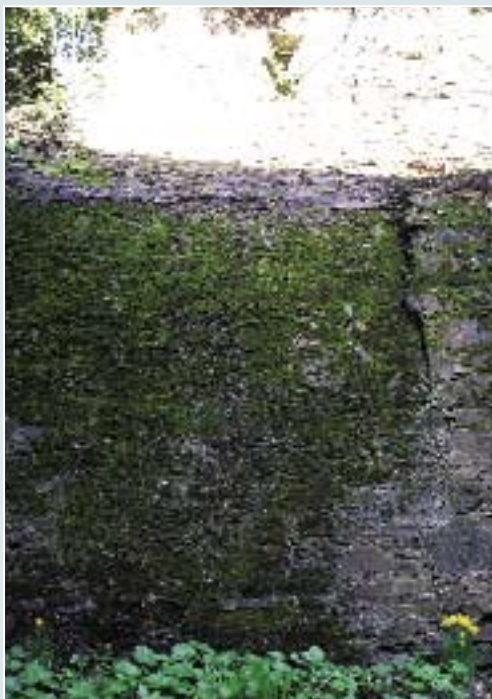
Mosses are noted to sheltered areas throughout, though areas of blanket coverage are concentrated to the internal face of sections F, I and J. These areas receive little direct sunlight and are moisture rich, being below the ground level of the corresponding face. White lichen is common throughout with an area of orange lichen noted to the internal face of section I. Both mosses and lichen increase the amount and duration of moisture held on the stone surface while providing nutrients for higher-order plants and facilitating possible mineral alternation of the stone surface.

*Heavy moss growth to sheltered internal face of Section F.*

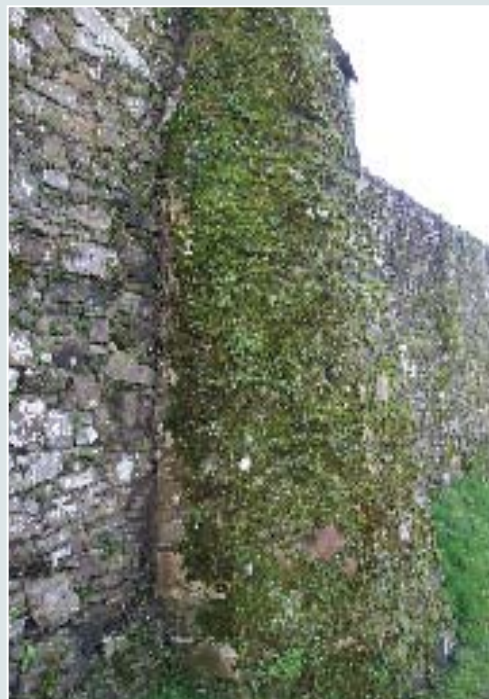
*Heavy moss growth to battered internal face of Section I.*

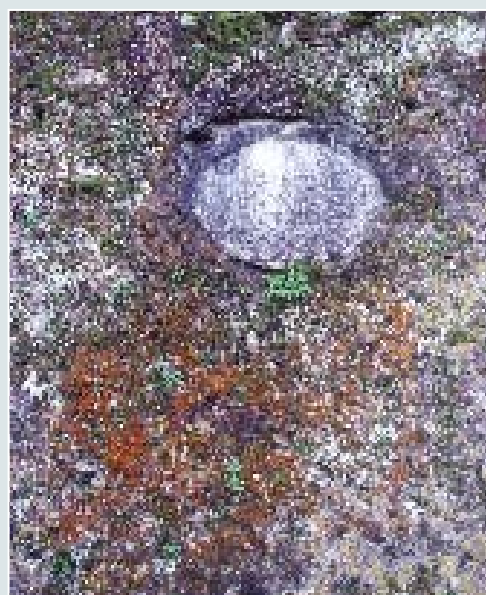
*Lichen to stonework on internal face of section I, note the plaque to wall.*

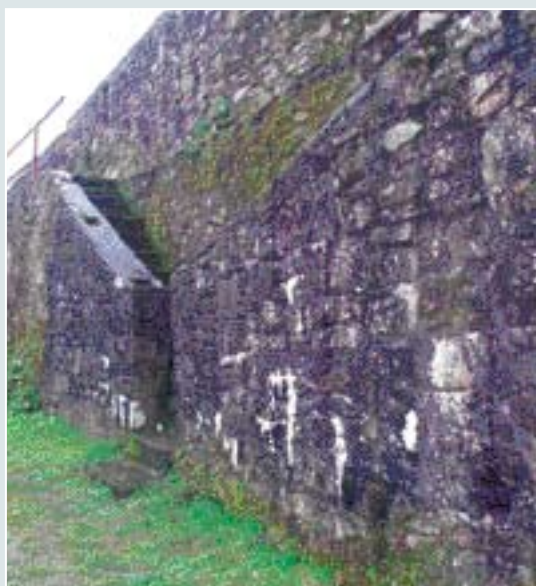
Missing sections of wall-walk railings are noted to the access steps at Section I and to the wall-walk at Section J. Access is unrestricted and as such presents a significant health and safety concern. The remaining sections of railings are unsightly and display areas of failed paintwork and corrosion. Open sockets in the wall provide ideal locations for plant-life to take hold as well as facilitating the ingress of rainwater within the monument.

*Missing railing to Section I.*

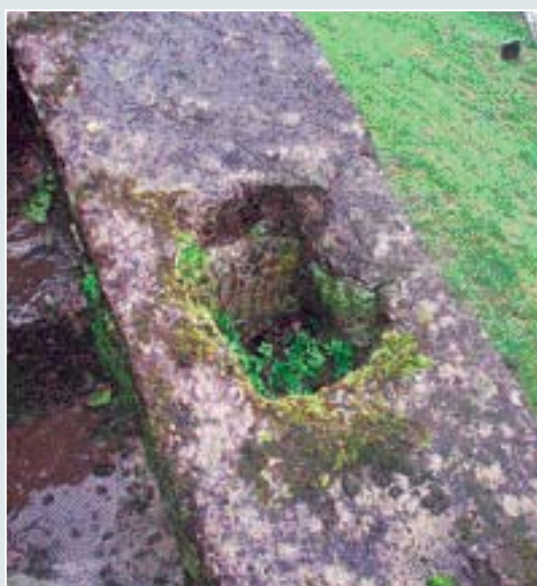
*Socket from former railing to Section I, note plant growth to socket.*

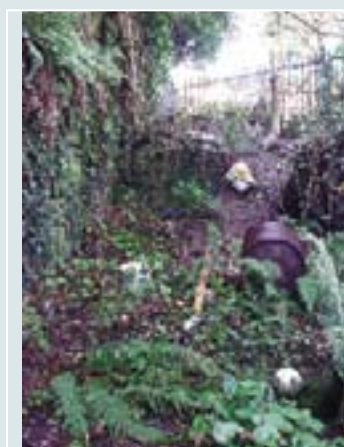
Unsightly dumping of rubbish is noted to the secluded areas, at section F and G. Grass cuttings have been dumped at the base of the tower at section K. Although mainly unsightly, the presence of waste or litter in areas of the wall can encourage further dumping in these areas.

*Dumping adjacent to external face of Section F.*

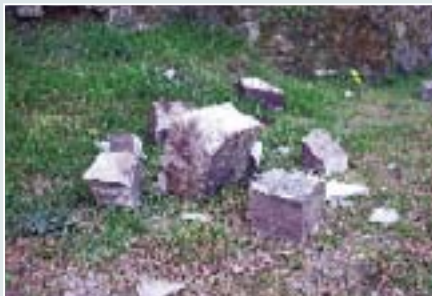
Graffiti and vandalism are noted to secluded areas of the monument with spray paint and etched stonework recorded to the internal face of section I where youths are known to congregate. On one site visit stone dislodged from Drew's tower was found strewn on the ground below. Such destructive acts of vandalism not only present a risk to the monument but a considerable health and safety risk to passers-by.

*Dislodged stone from Drew's tower thrown to the ground below.*

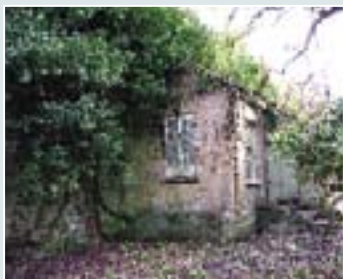
*Single-storey building abutting the external face of D and C..*

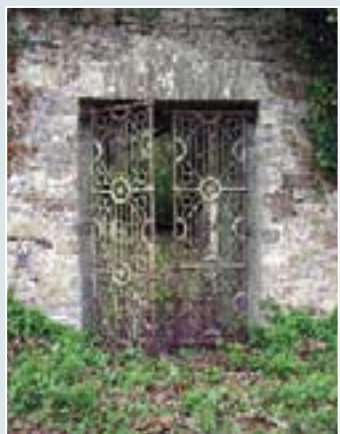
*Opening at section C*
