# Paul Osborne Architects

GLAS information/training seminar for 2019

Case Study 2- Glas-Traditional Farm Buildings Scheme: The Stables, Anneville, Co. Laois

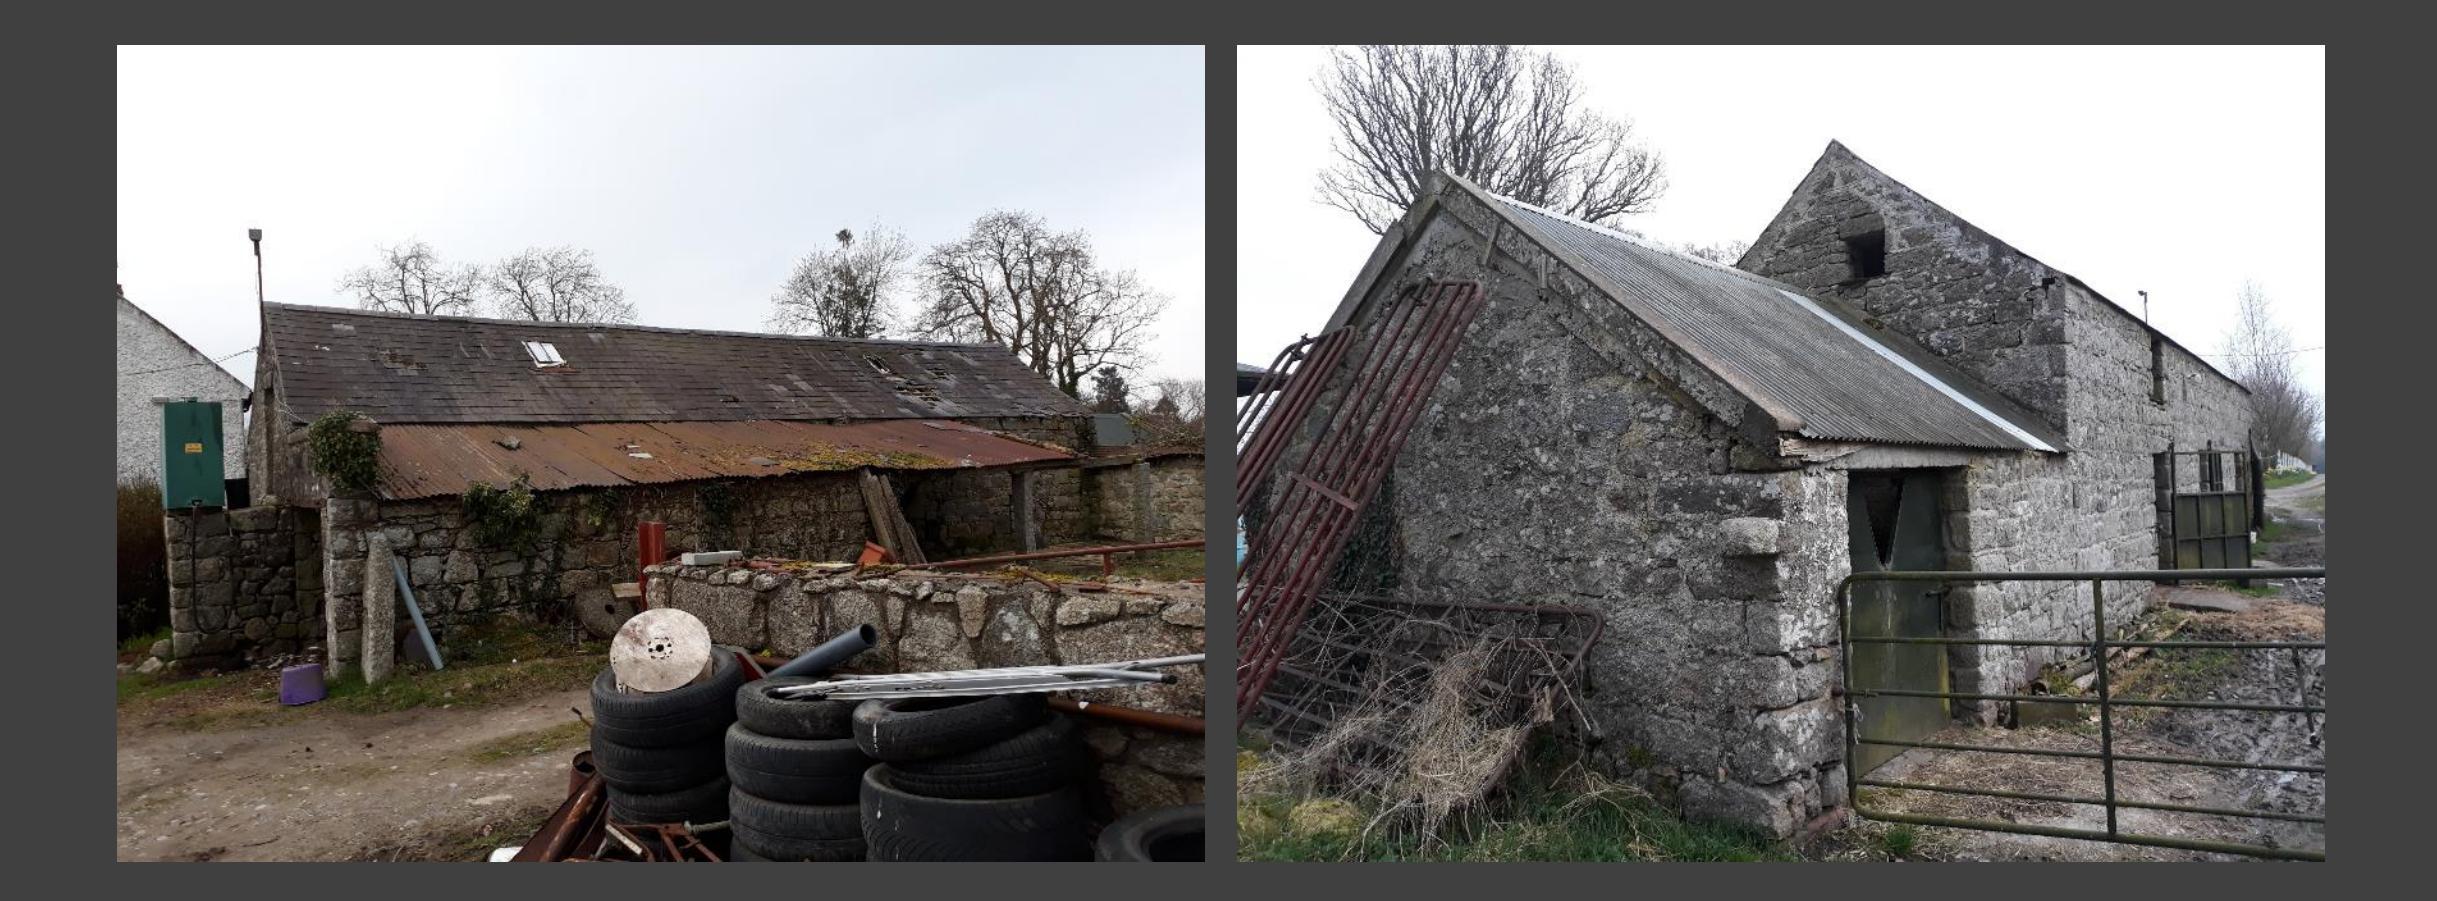
From the scaffolding it was determined that the 'one third rule' in relation to slipped slates applied to both sides of the roof, i.e. full re-slating was required

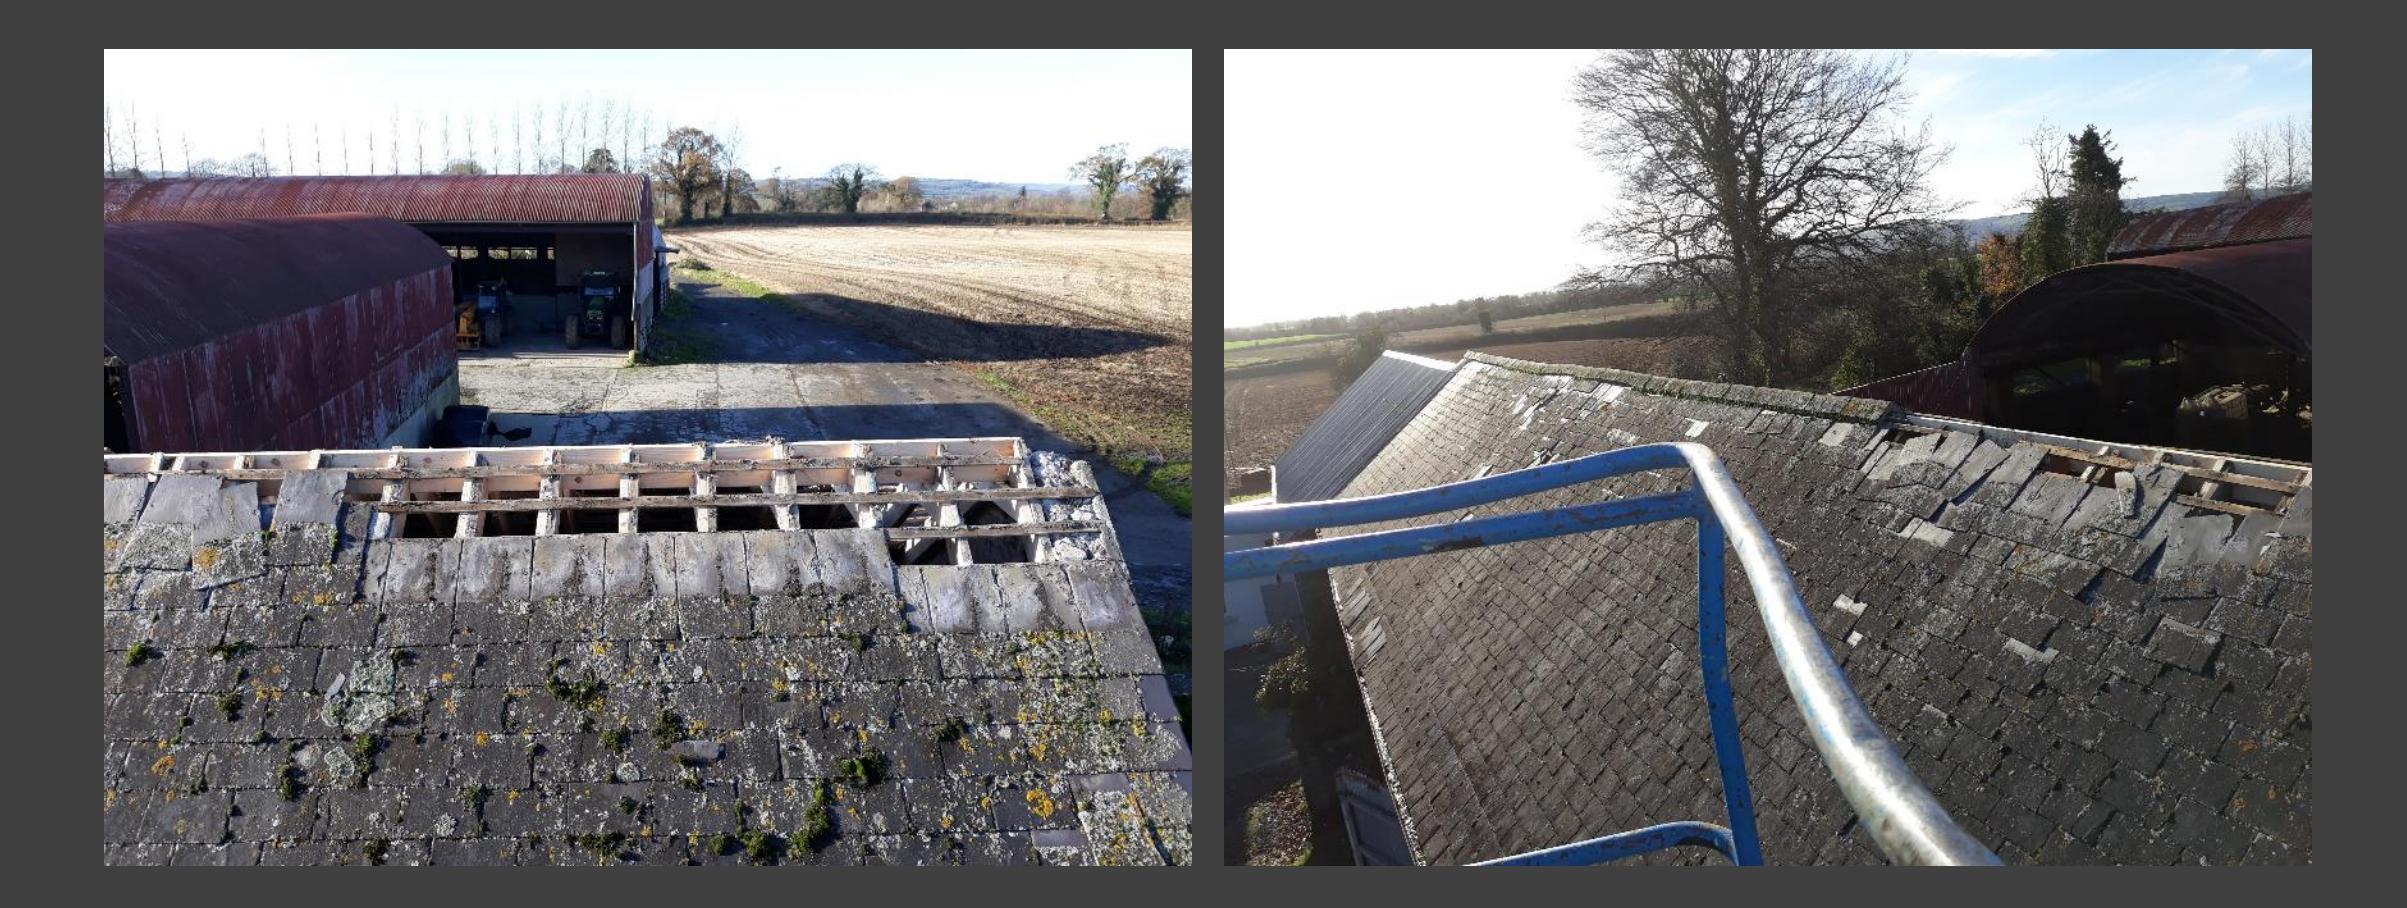
From the cherry picker it was determined that the 'one third rule' in relation to slipped slates did not apply, i.e. full re-slating was not required. There were isolated areas of slipped slate but the vast majority were secure. The top five rows of slates at the ridge were where most of the slippage had occurred and this was due to the failure of the ridge boards.

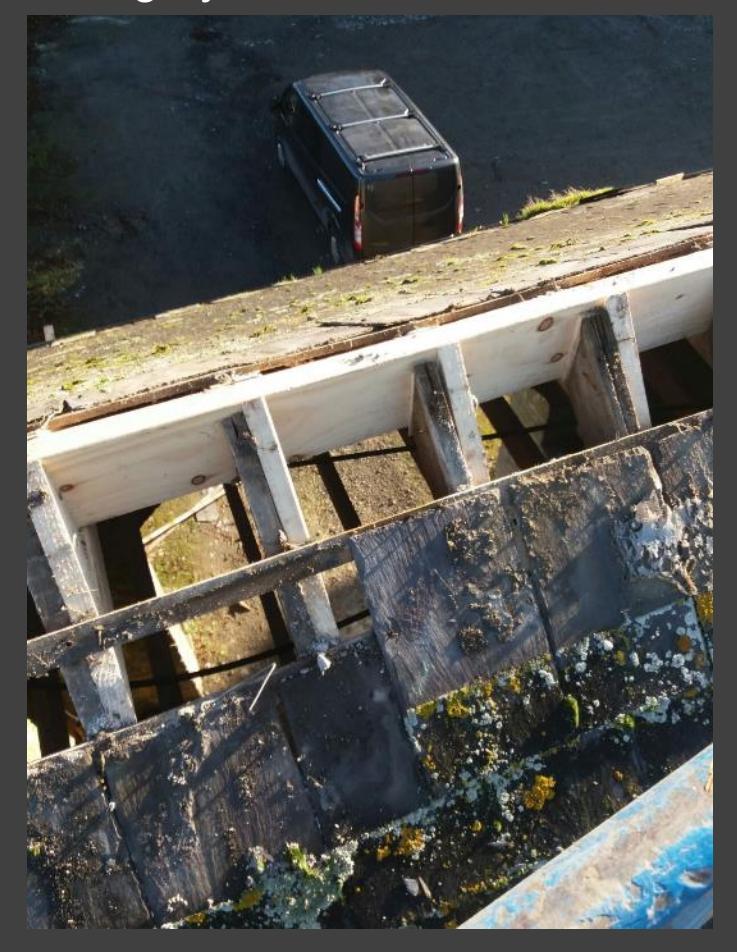
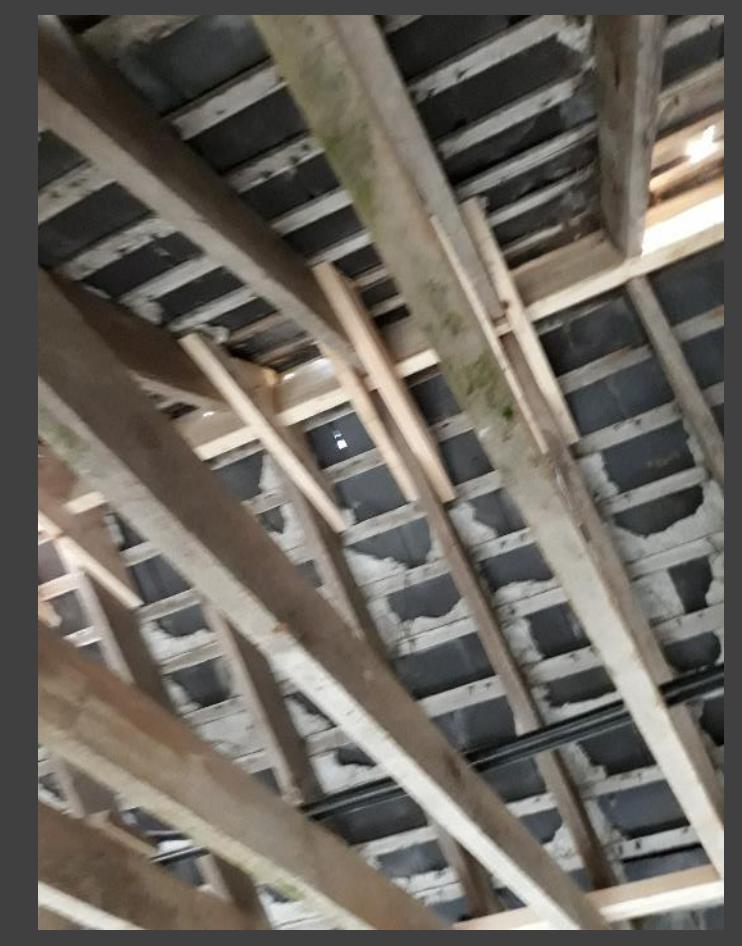
When the scaffolding was erected internally it was possible to make a full appraisal of the roof structure. One section of the roof which comprised of six rafters each side of the roof had failed. This was due to the ridge board dropping below the rafters, in essence they had separated. The contractor had to prop the roof over this section and insert a new ridge board. The decision was made to provide collars to the underside of the ridge board to stitch the rafters and the ridge board and provide greater structural integrity.

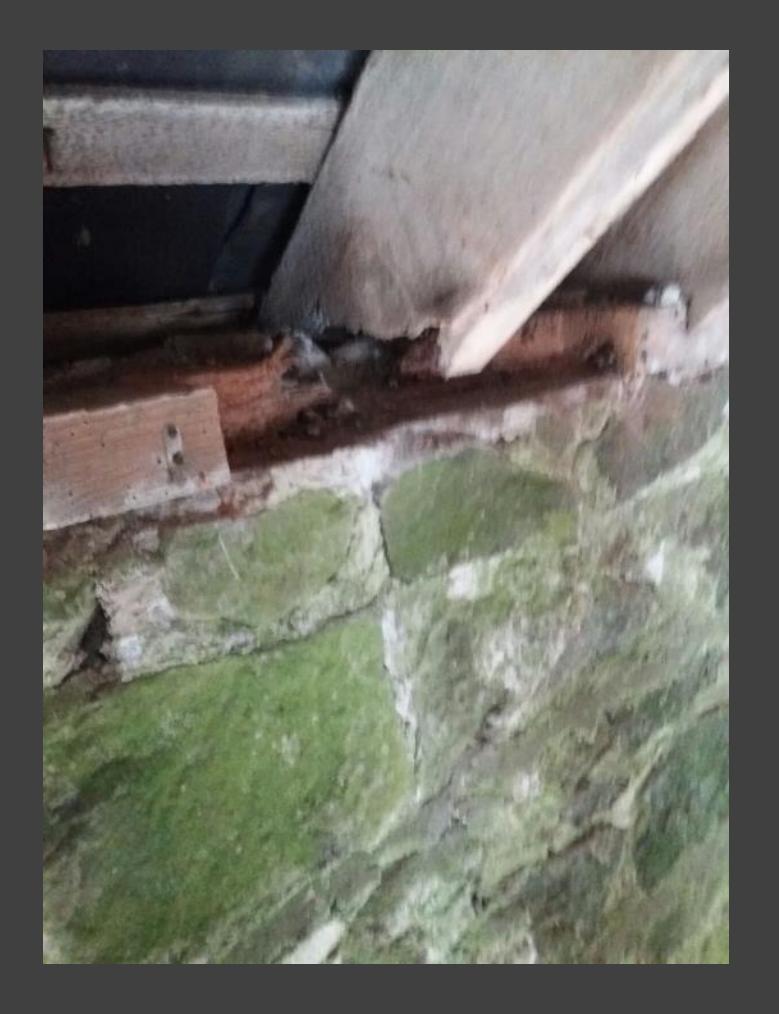
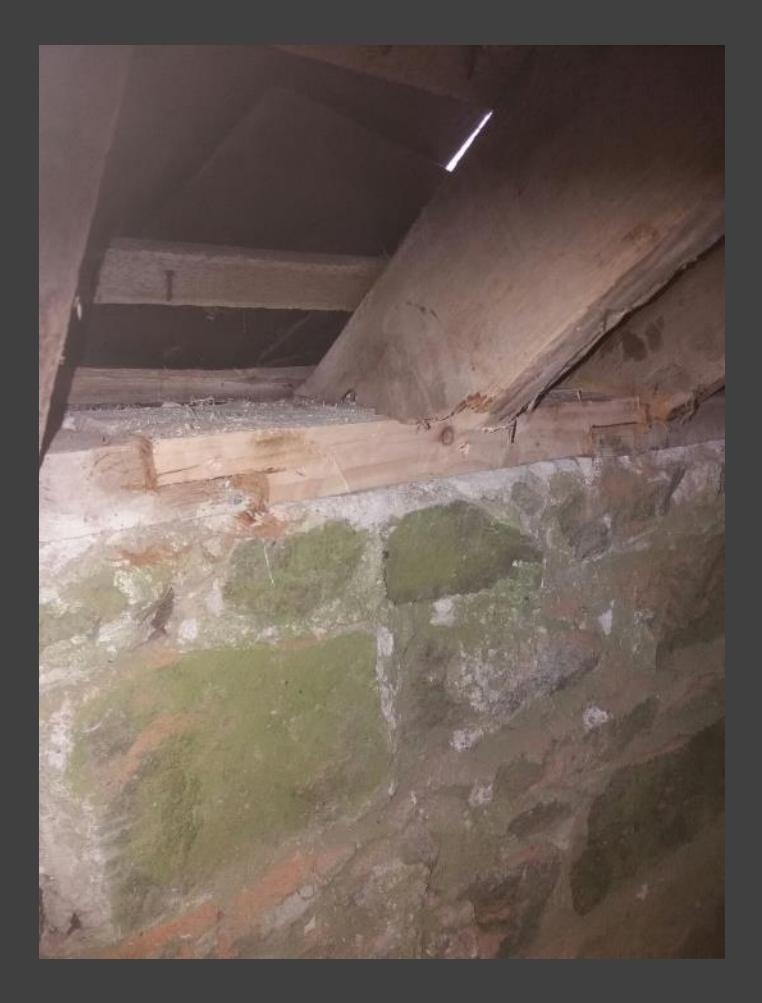
Woodworm and rot are evident in isolated areas of the roof structure. The wall plate is in excellent condition generally but an isolated case is highlighted below as well as the repair. The rot in this instance was due to a slipped slate going unnoticed for a period of time. This is a good example of minimum intervention and repairing a damaged element rather than a full replacement

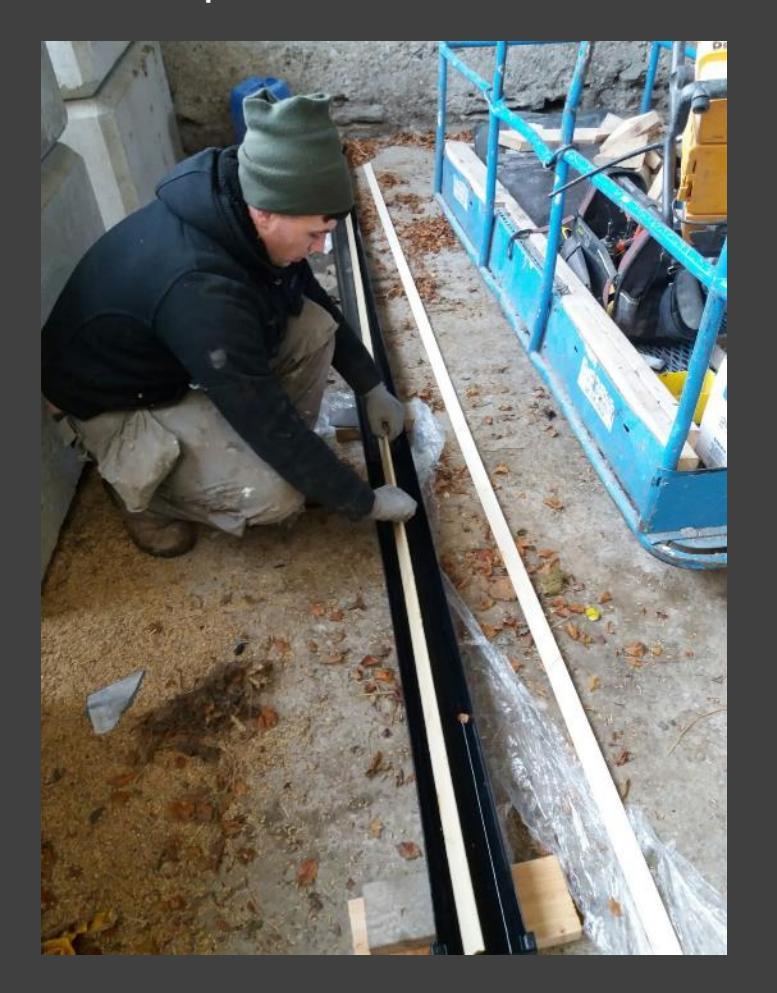
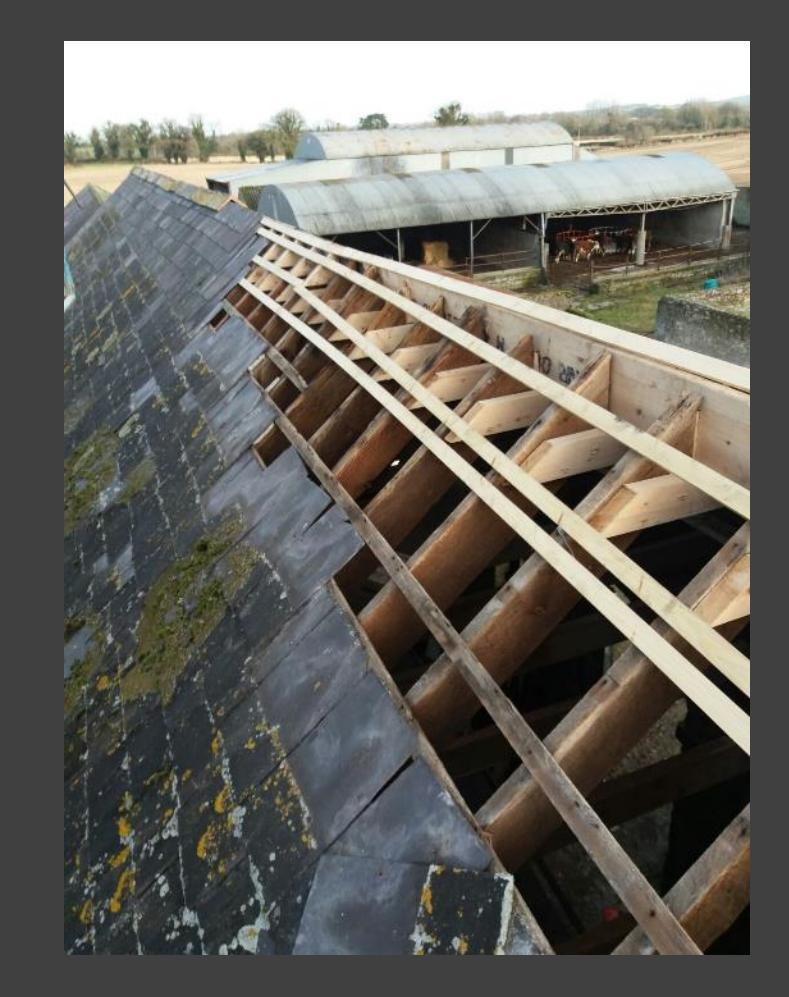
The vast majority of the rafters and collars are in excellent condition, a small number show signs of woodworm attack. In reference to the bat survey carried out by the ecological consultant, a Boron compound based product for the treatment of timber was used. New specially sourced thin battens were installed where needed and the slates and ridge tiles replaced once the repairs to the ridge board were completed.
