# 2019 GLAS Traditional Farm Buildings Grant Scheme Seminar

Hodson Bay Hotel, Athlone. Co. Roscommon 14<sup>th</sup> March 2019

Typical Structural Issues and Possible Solutions

Austin Dennany Chartered Engineer

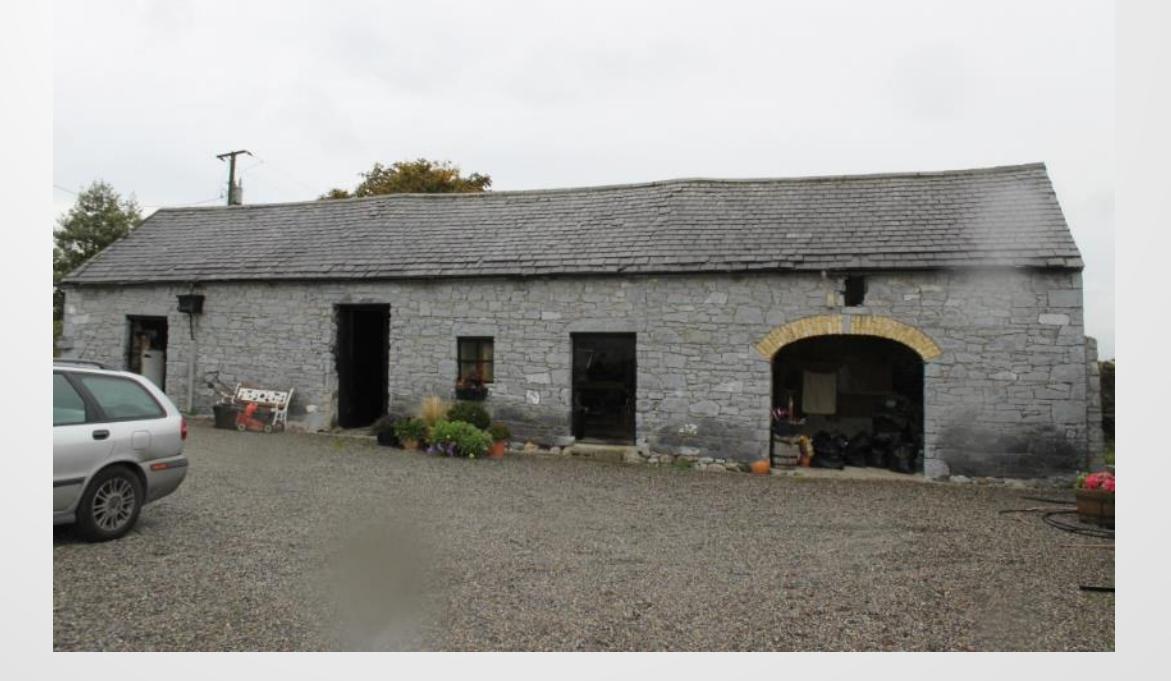
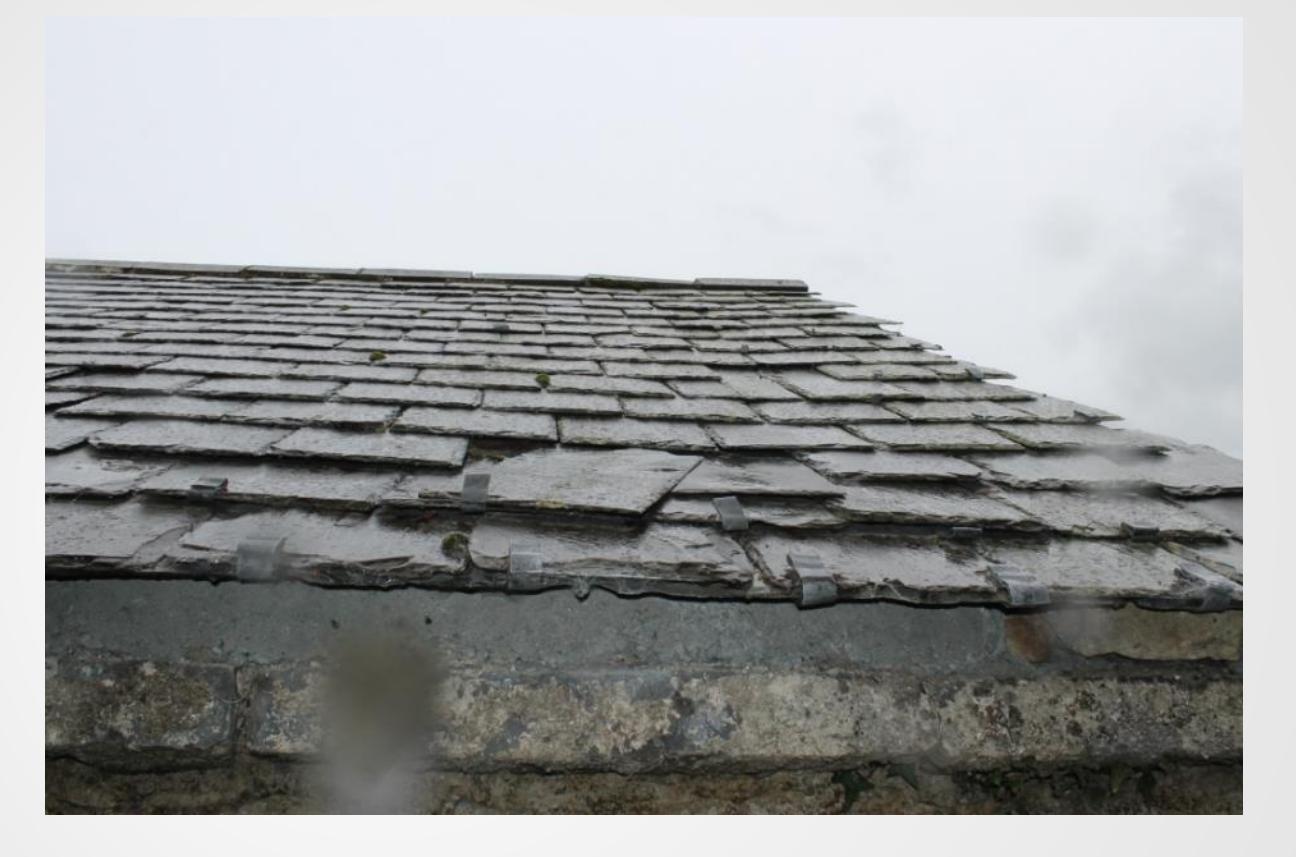
- Typical Issues/Repairs:
  - Slipped slates usually due to corrosion of nails and/or rot of battens rather than problem with slate.
  - Slipped slates can be repaired by installing lead clips or stainless steel hooks.

• When 25% - 30% of slates have slipped you should consider full re-slate of roof.

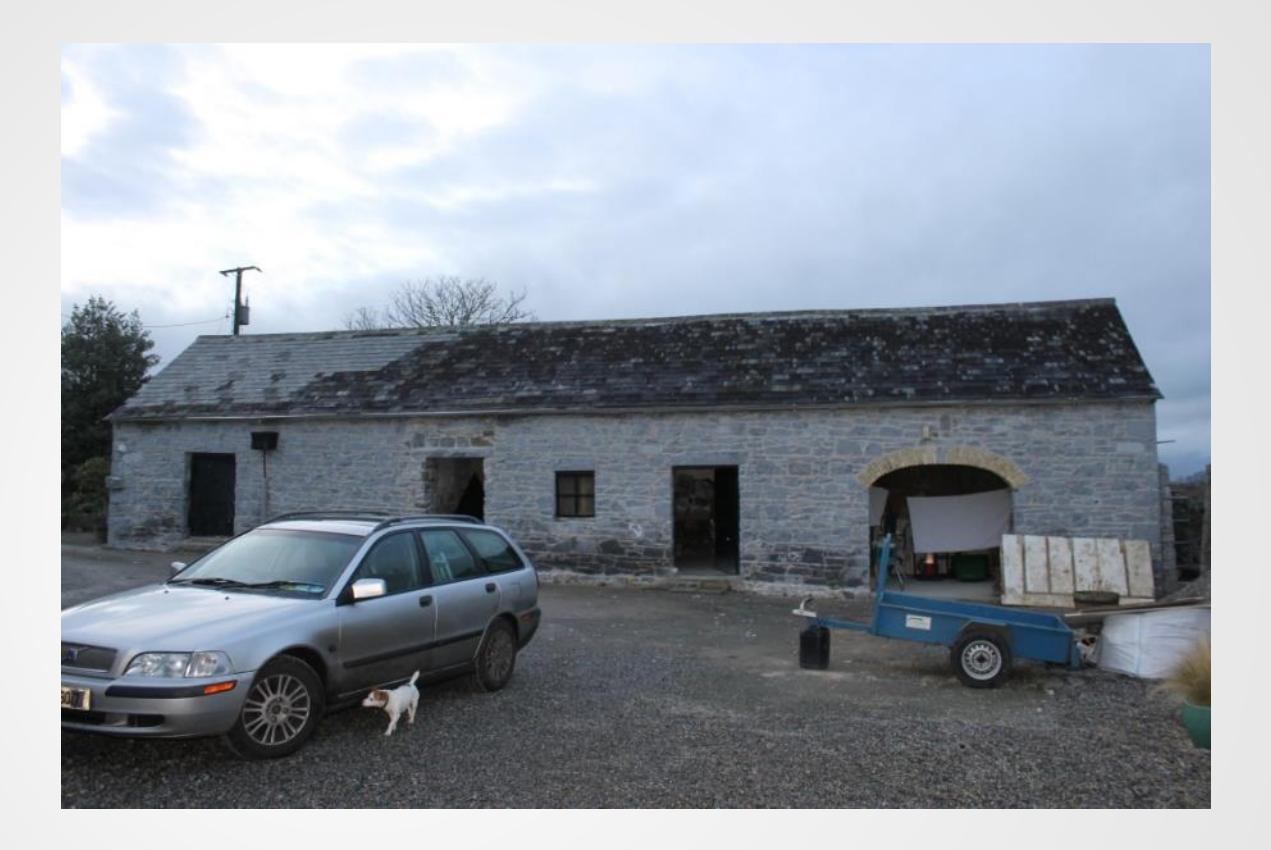
• Mix slate where possible to avoid large areas of a different colour.

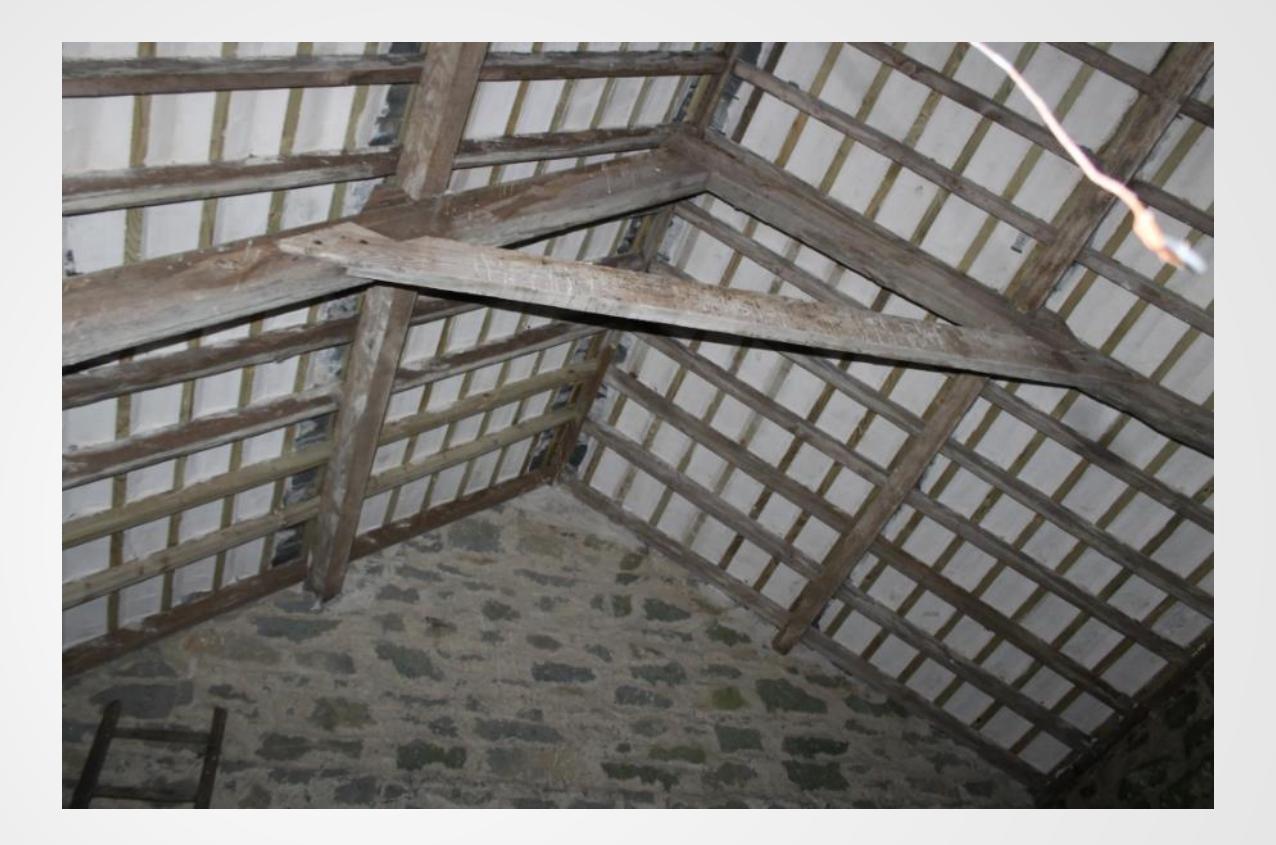
Provide lime parging to underside of slates. This provides additional protection water ingress and also resistance to wind suction.

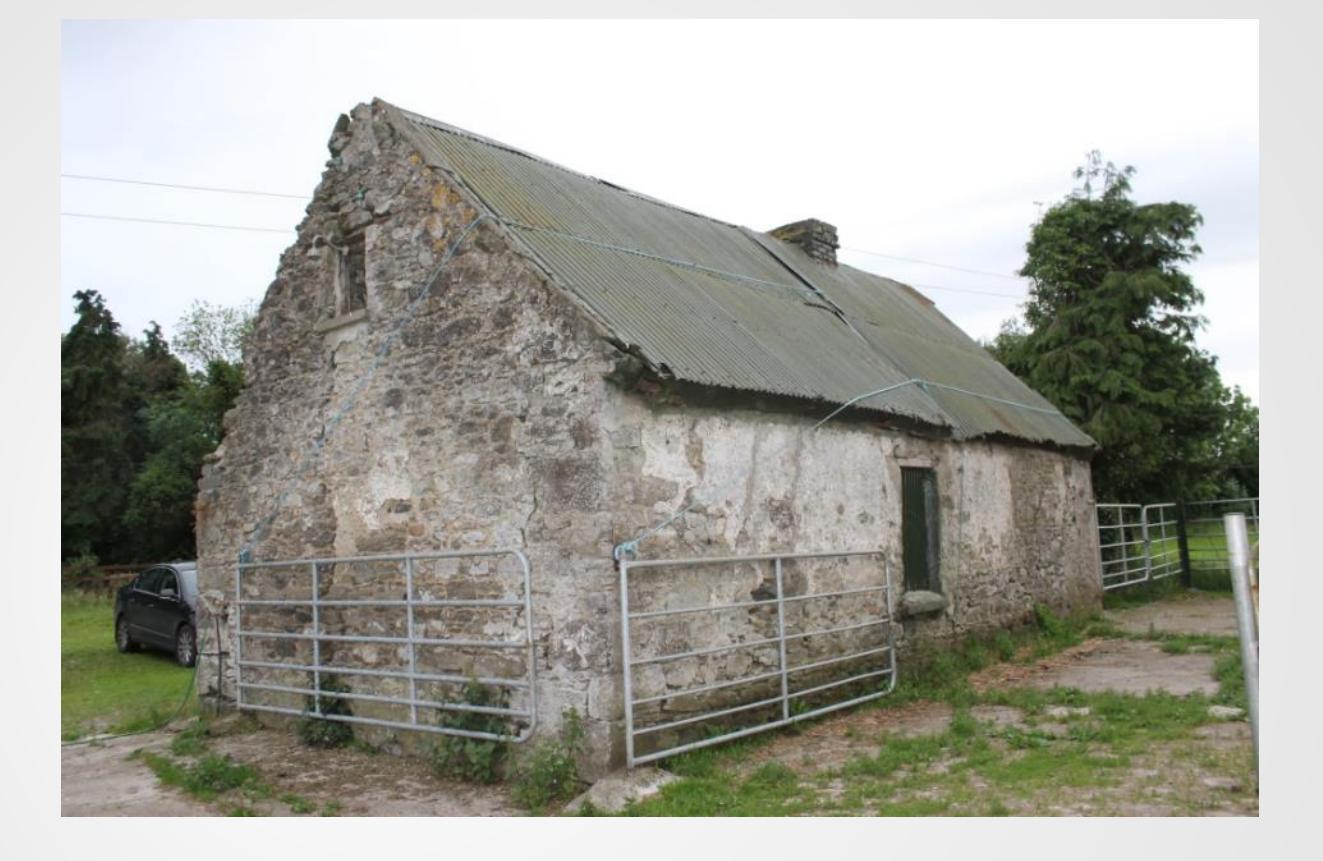
• When roof sheeting is excessively corroded, the only solution is to replace.

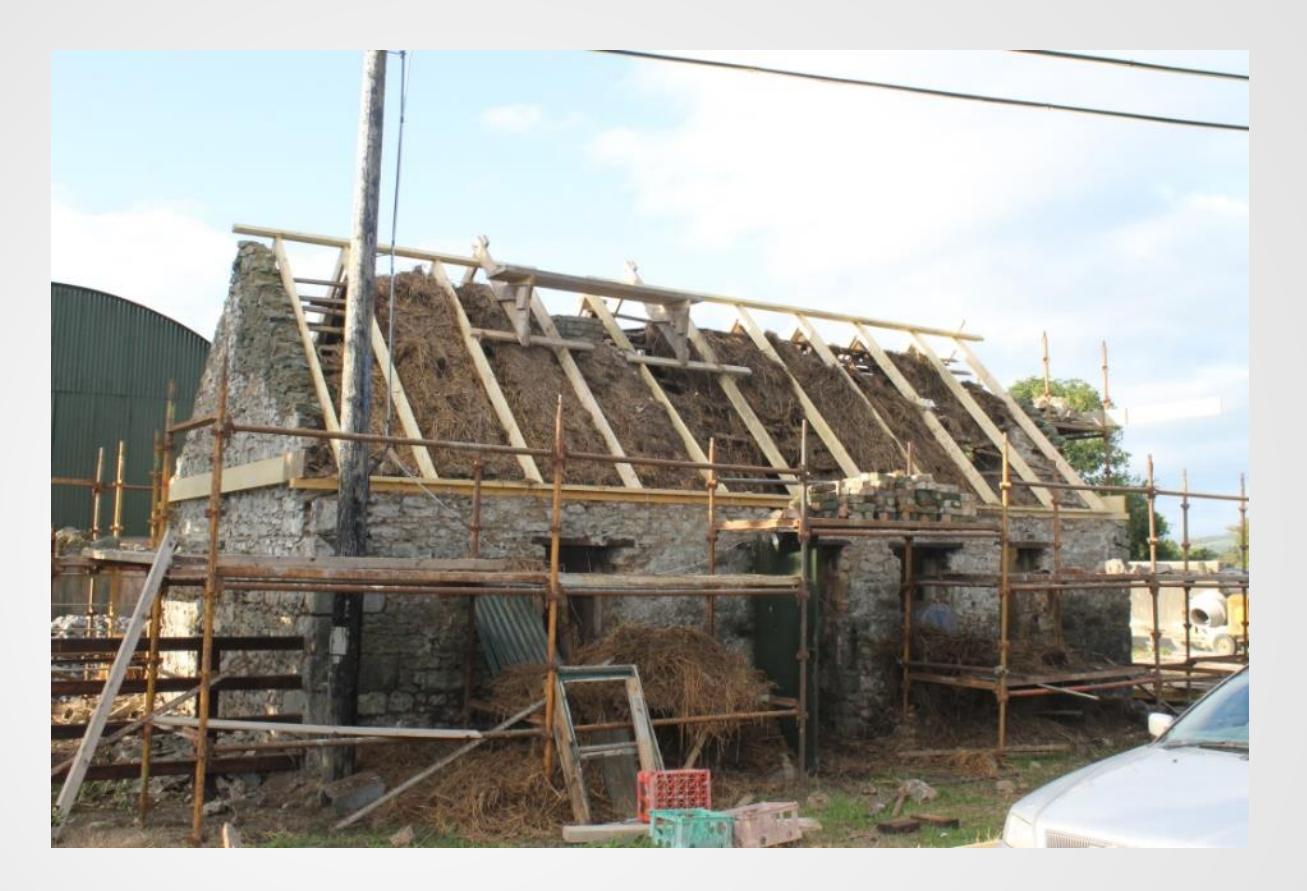
New Timbers constructed over existing so that ceiling could be maintained.

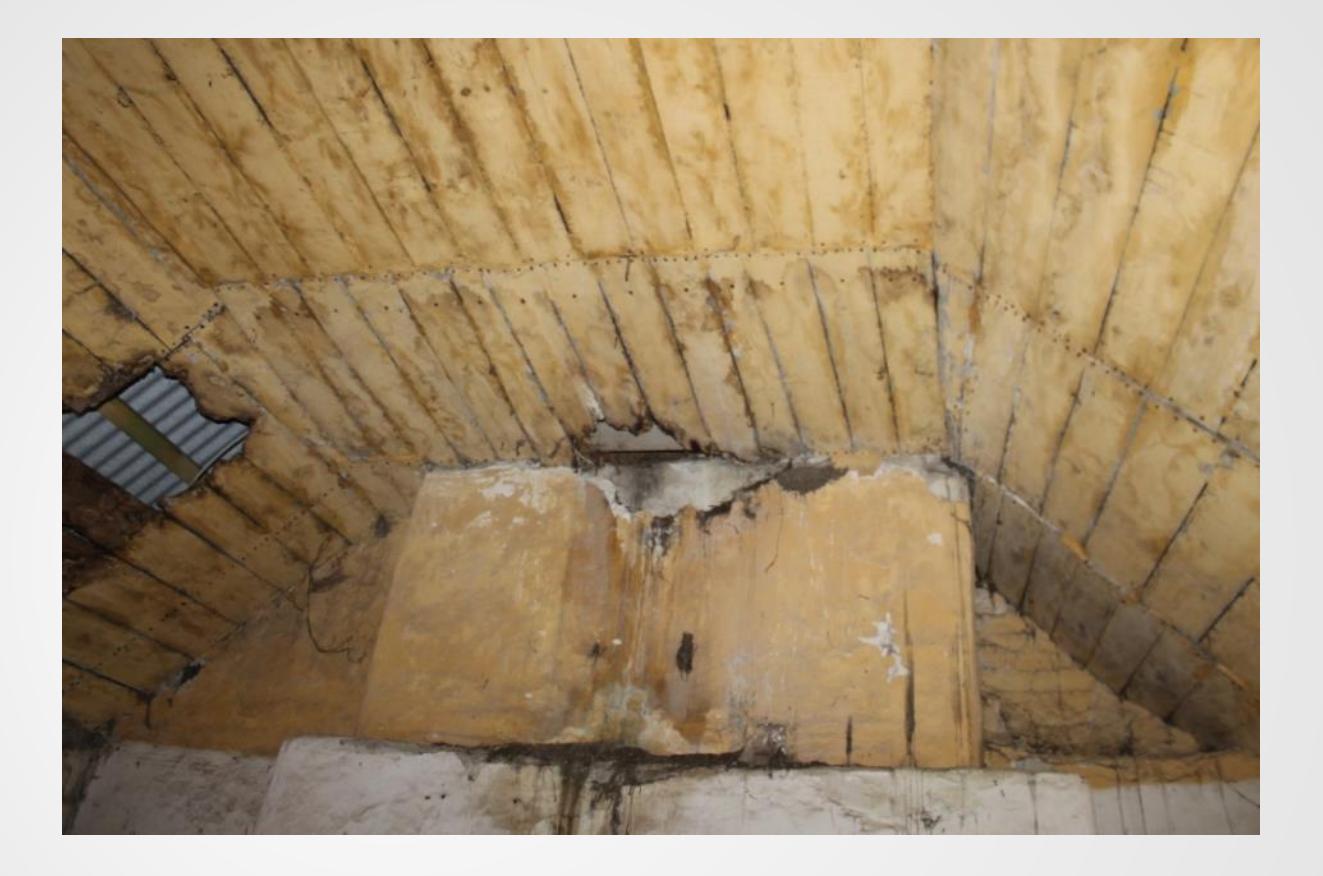
• Original Ceiling maintained internally.

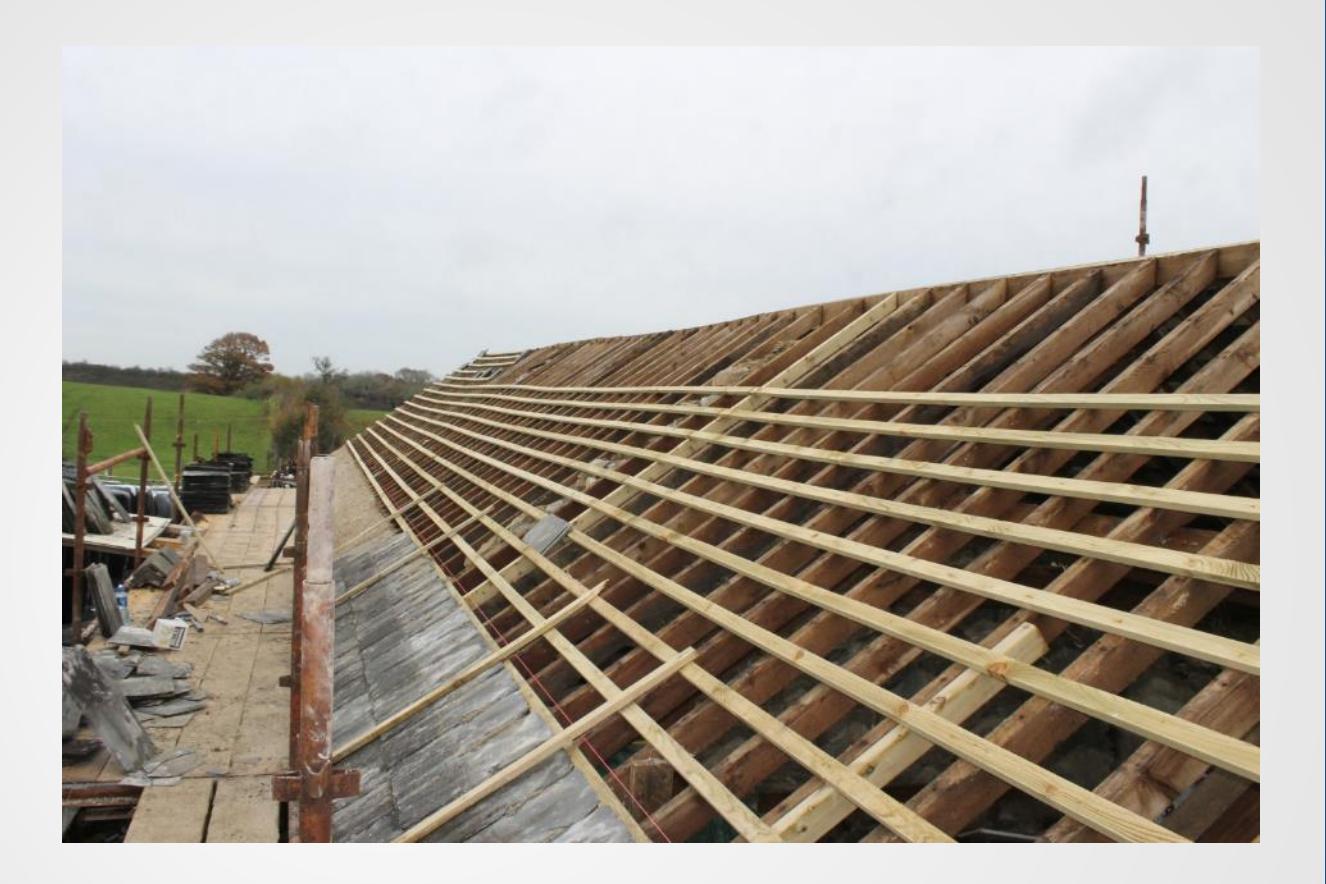
New battens on existing timbers. Some timbers spliced.

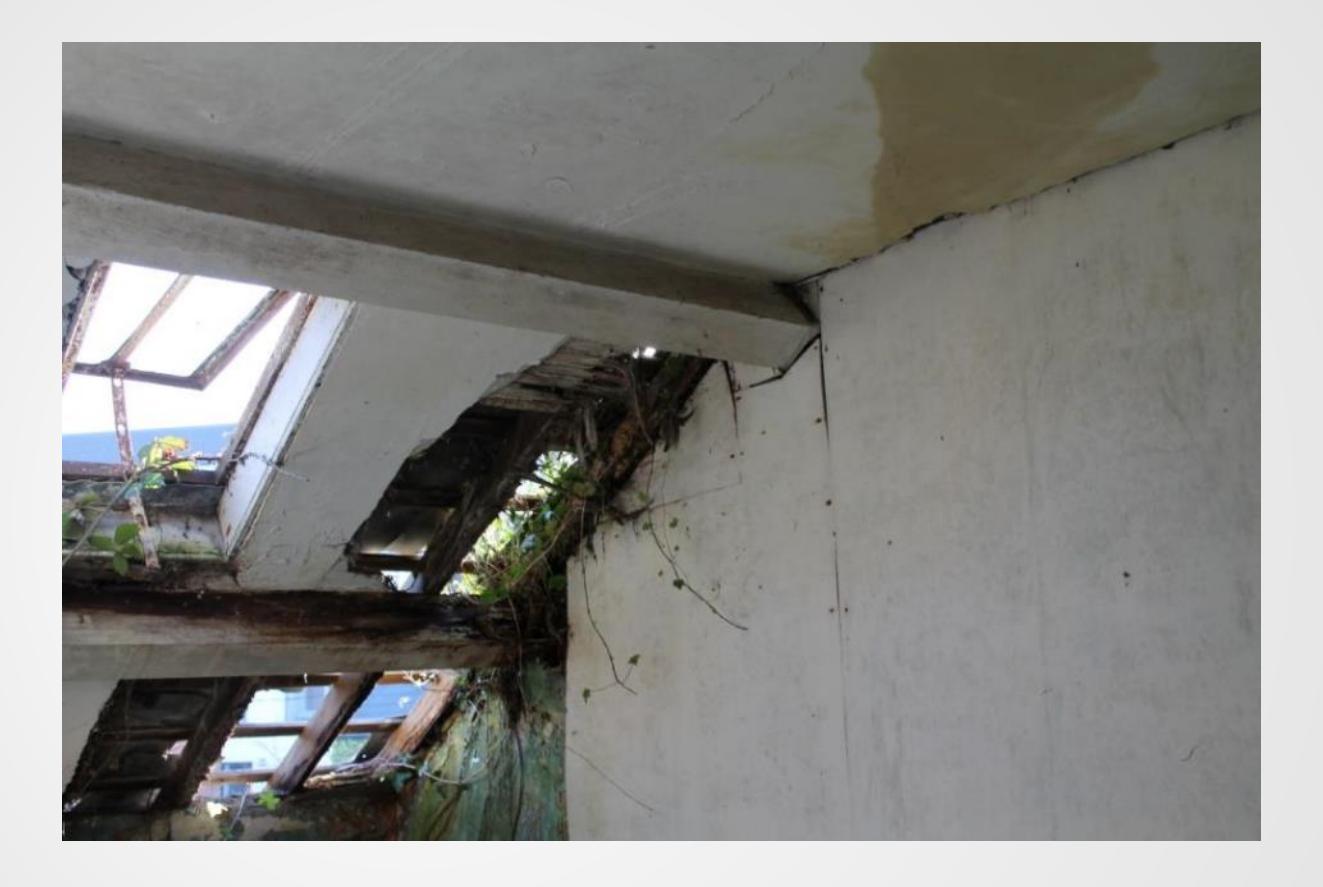
• Existing timber purlins and rafters rotten due to water ingress

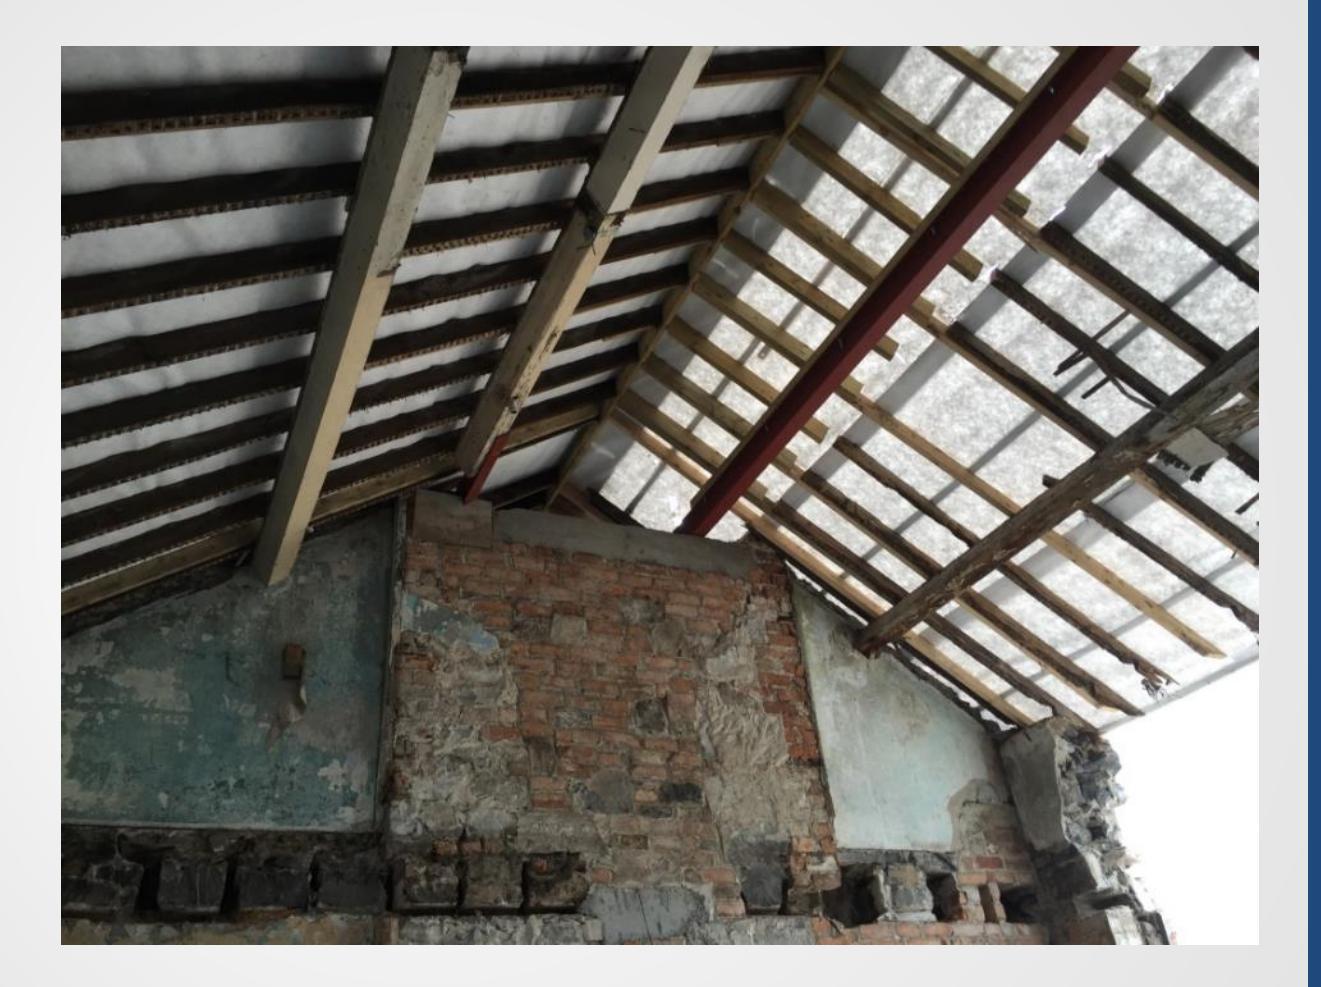
Existing purlins and rafters retained where possible. Rotten ends cut out and spliced. (Note felt used as weather shield, removed as works progressed)

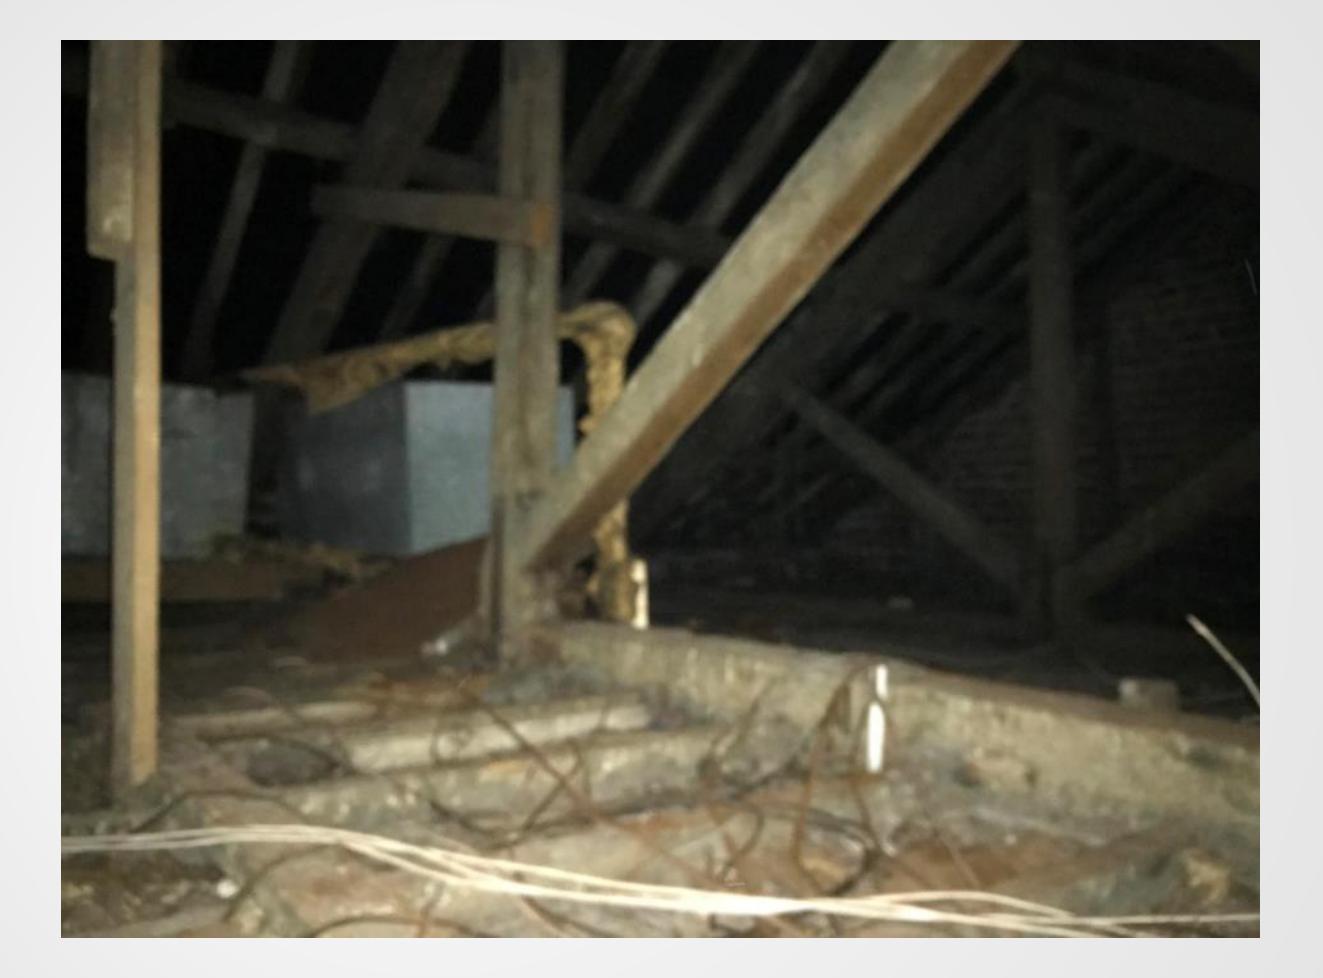
Diagonal strut cut out to accommodate water tank.

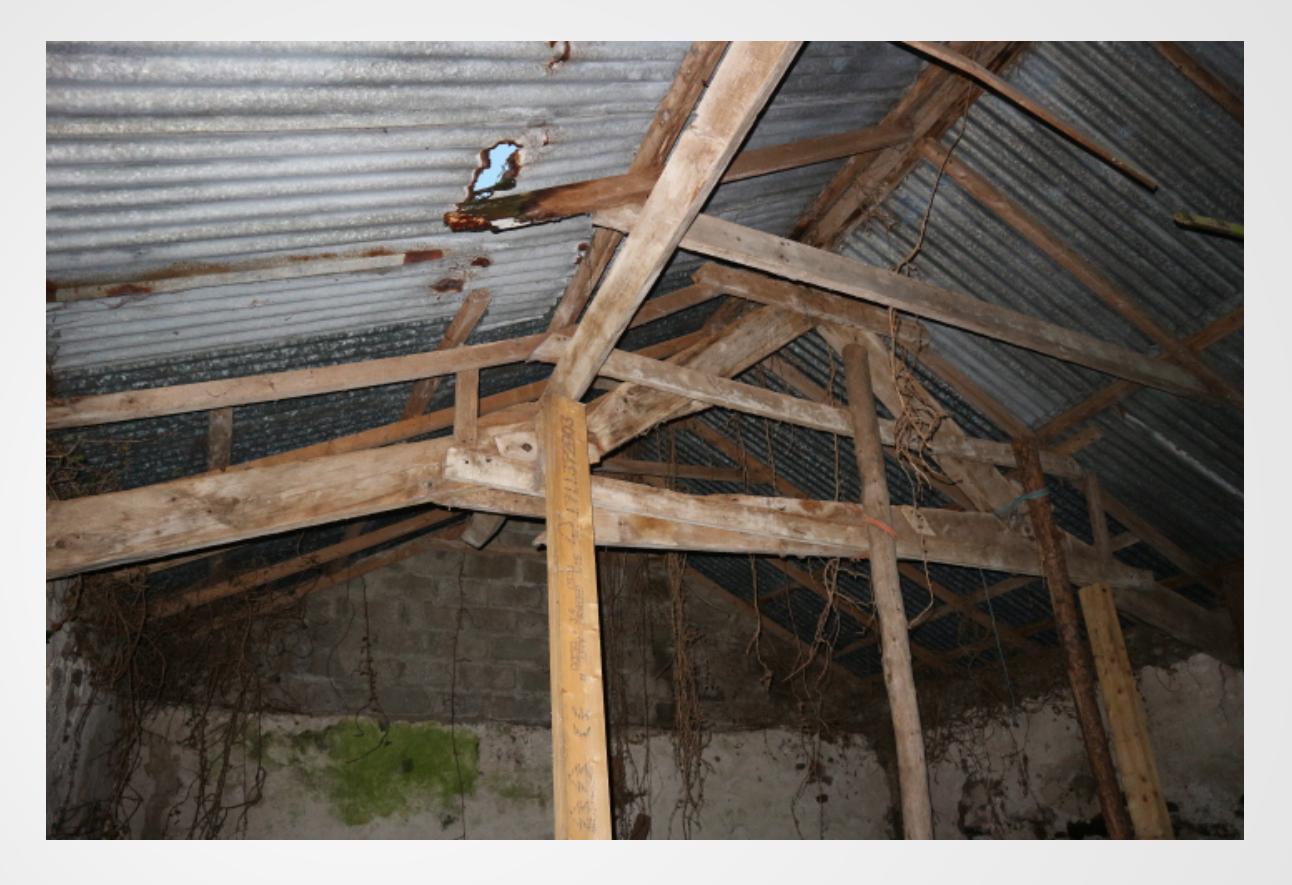
• If it looks dangerous, prevent access and seek advice.

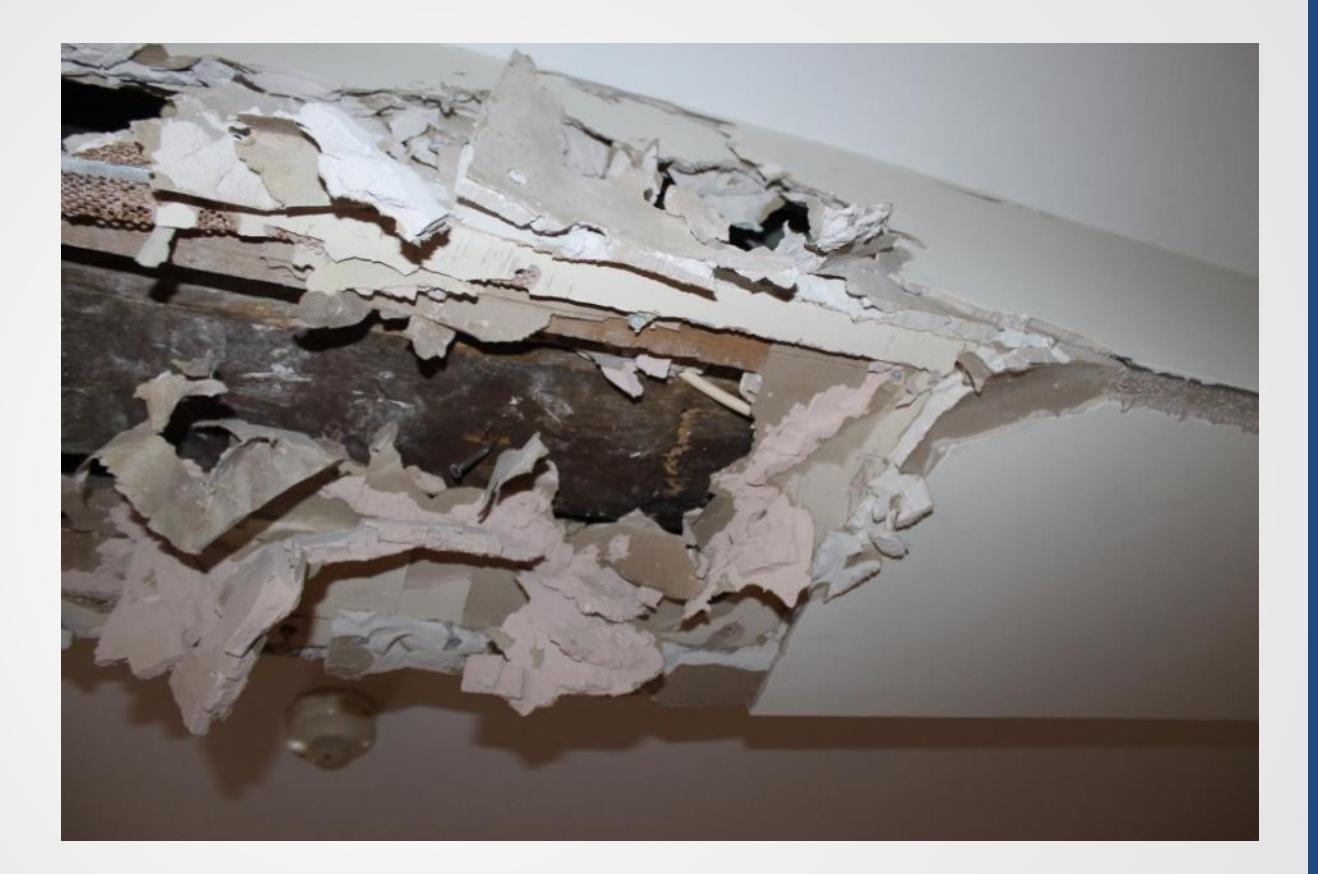
• Cracking in down-stand beam reported. Opening up identified cracking perpendicular to grain.

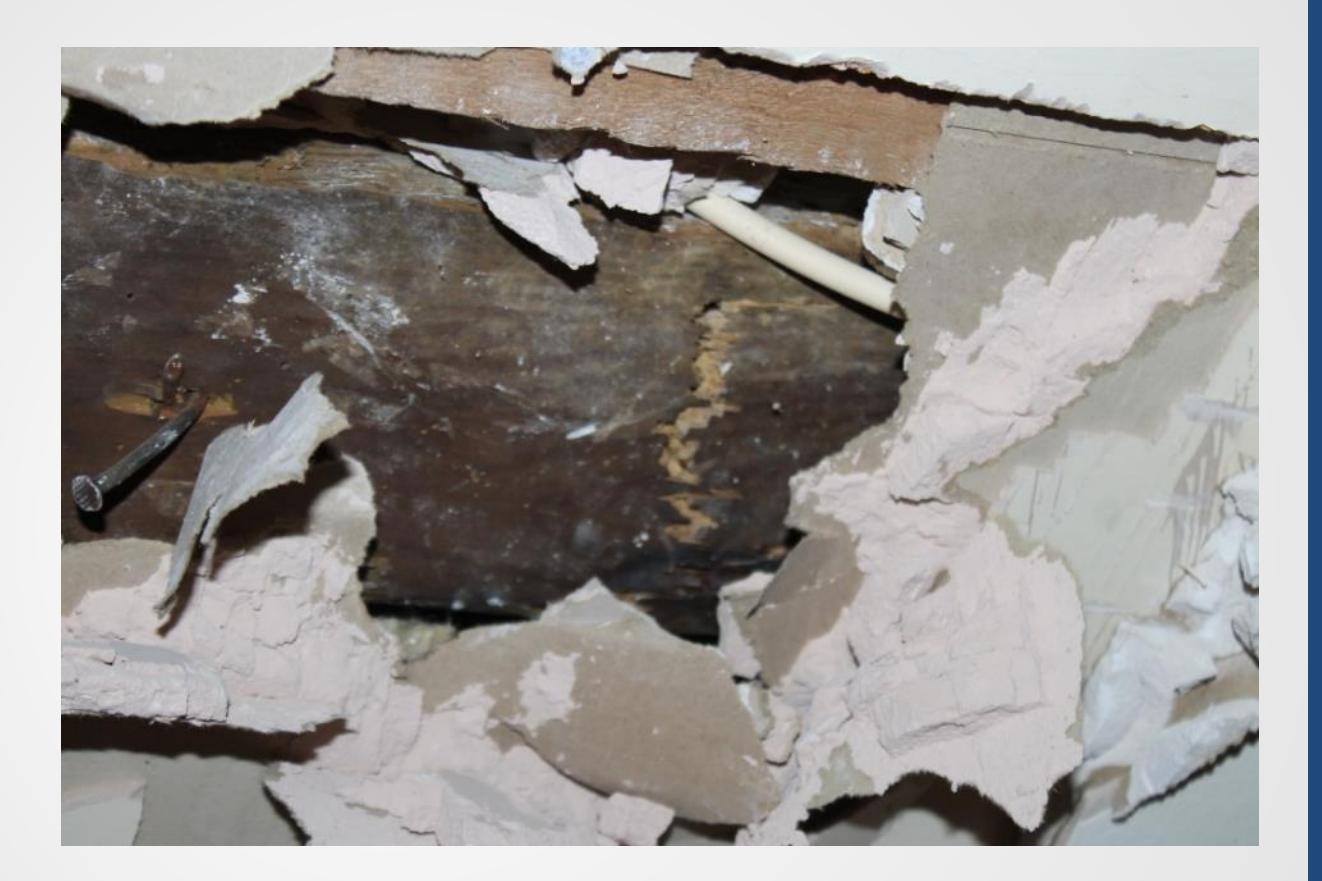
Crack in bottom of timber beam perpendicular to grain

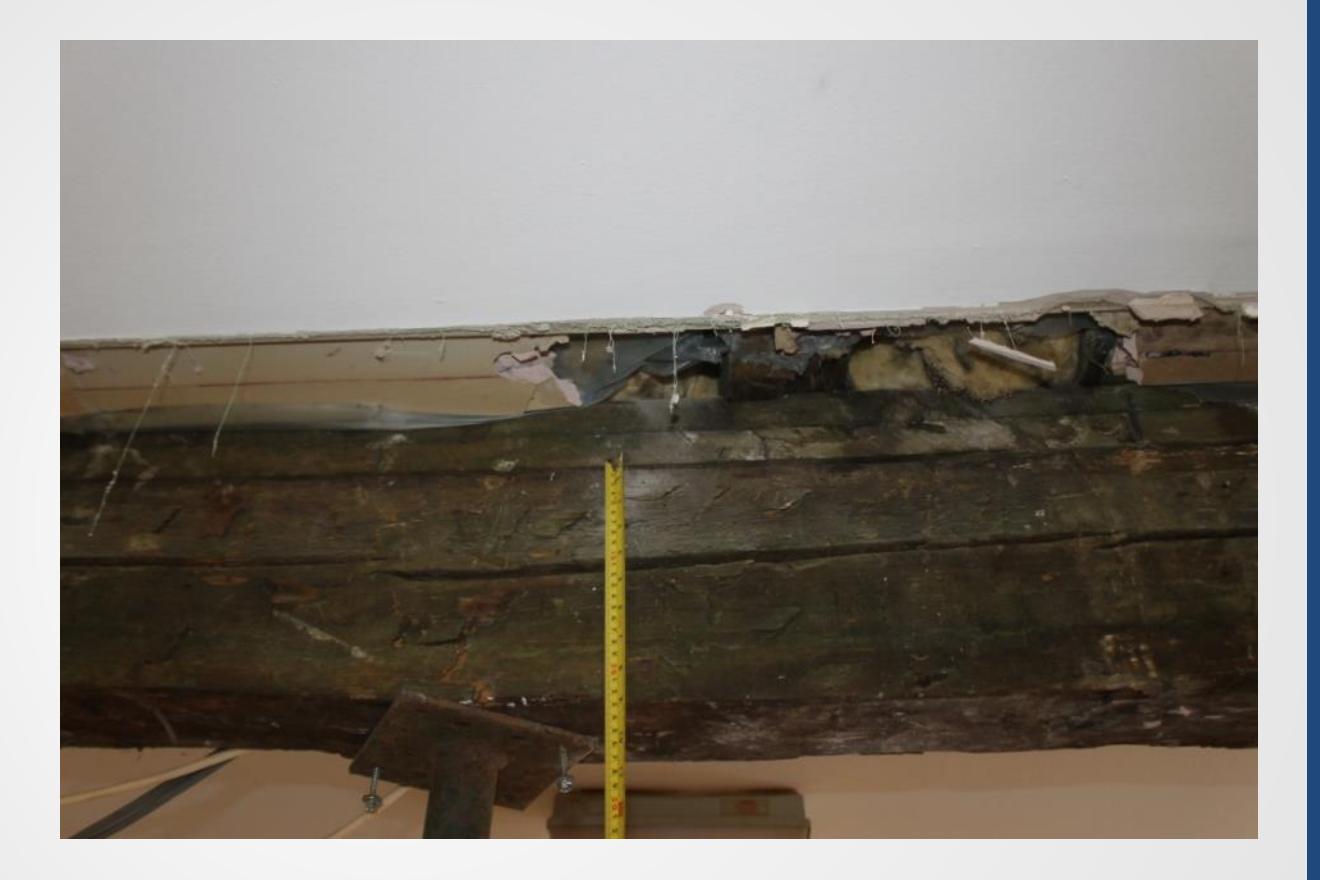
• Timber beam failed in bending.

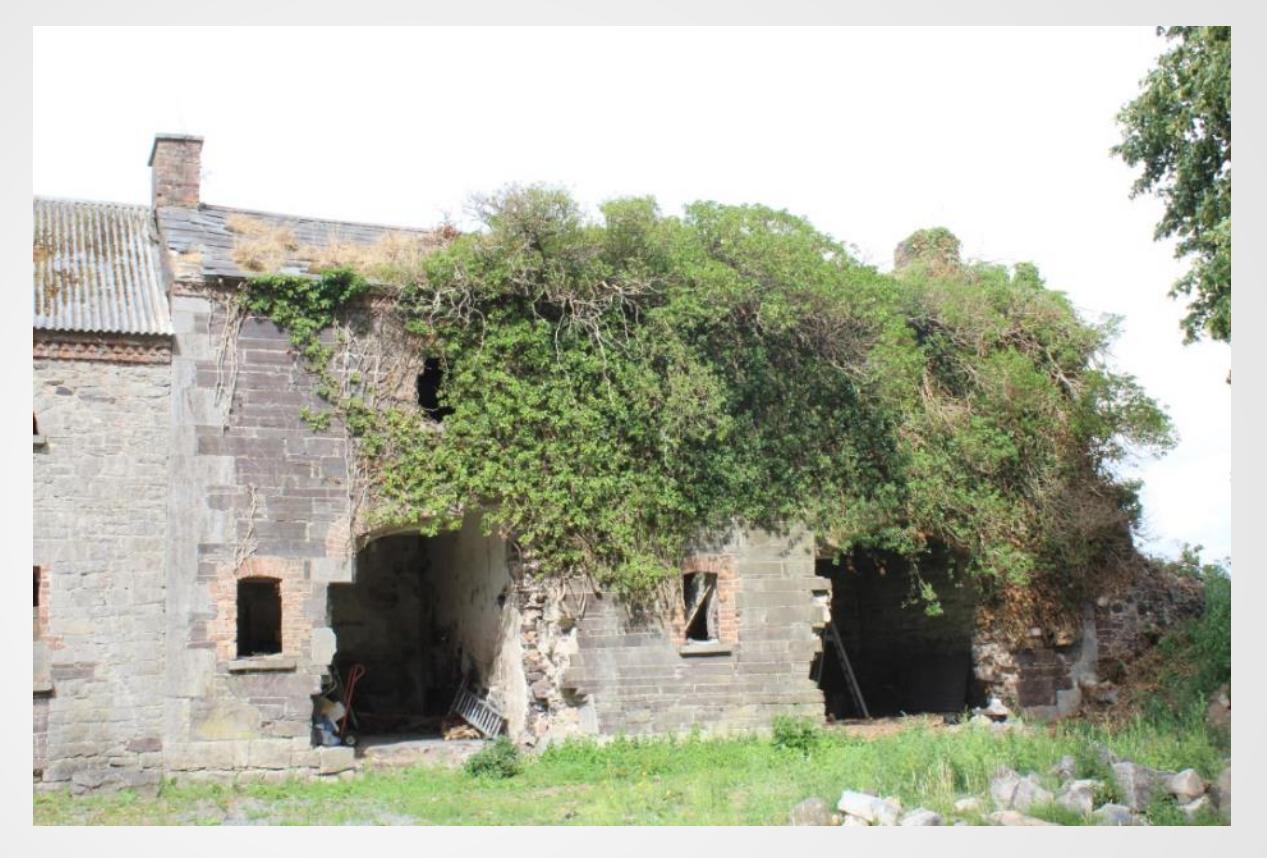
Arches need to be temporarily propped until they can be re-built.

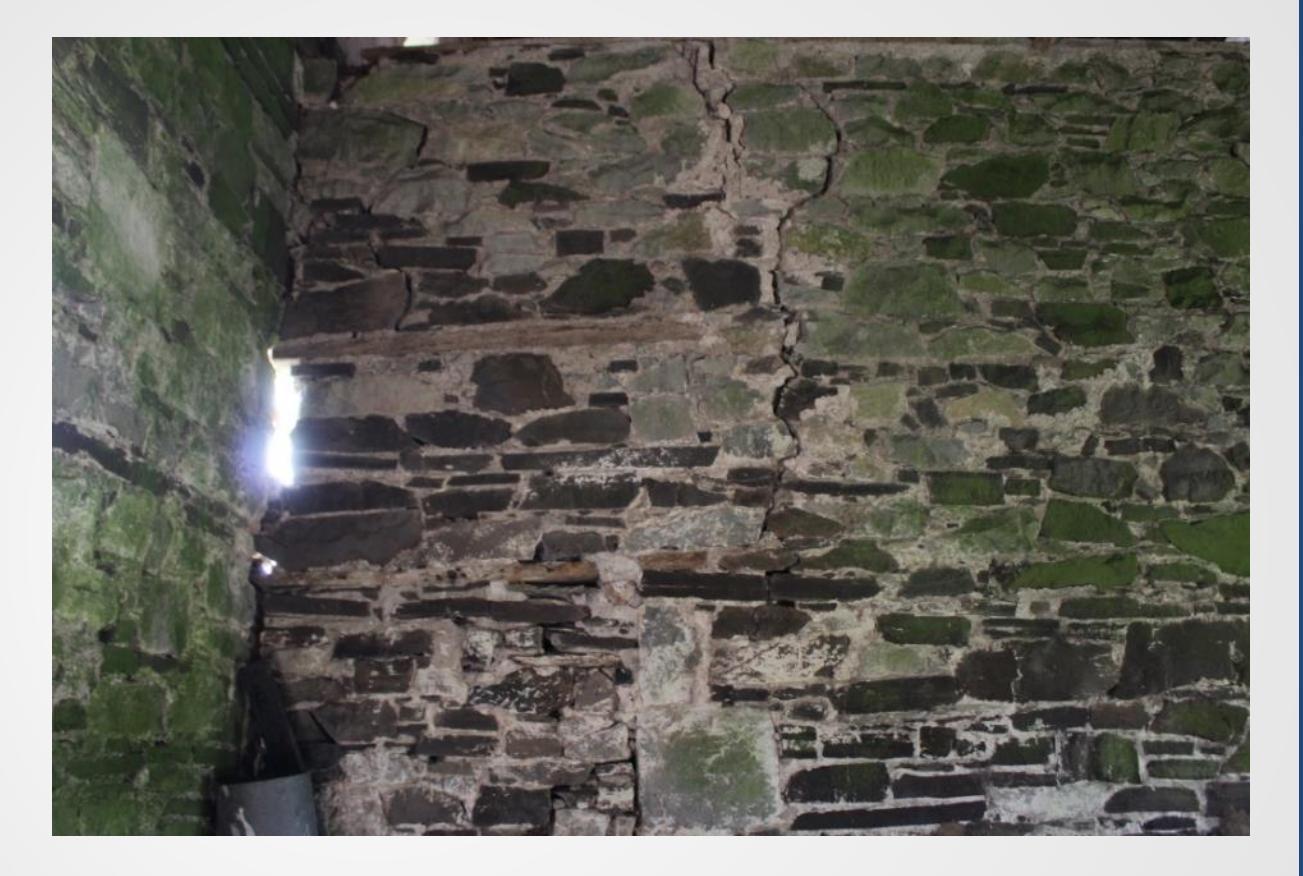
Cracking in return walls caused by rotting of timbers imbedded in wall

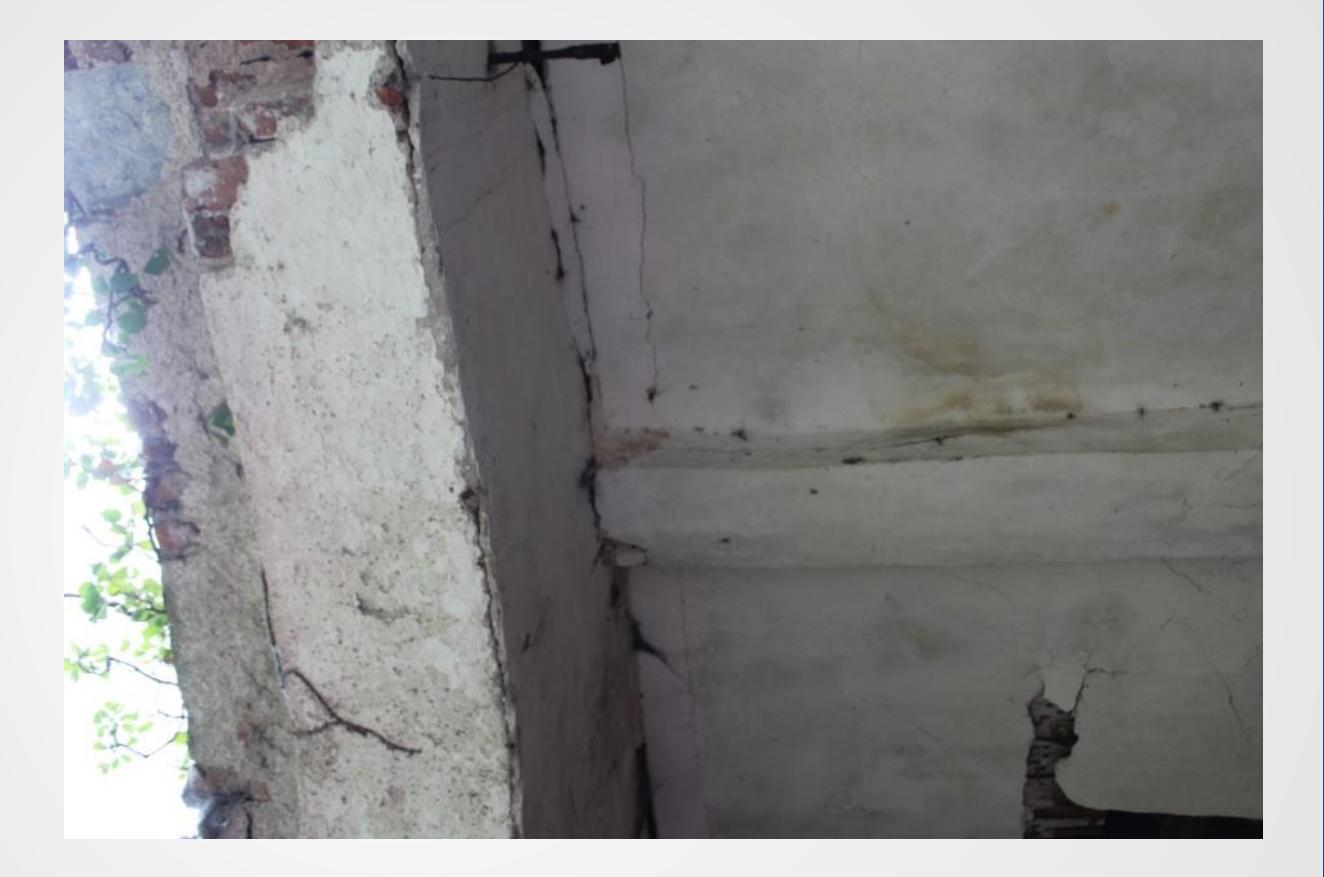
Paint on beams, etc bearing into wall can be good indicator of movement of walls. When was beam last painted or cracks filled?

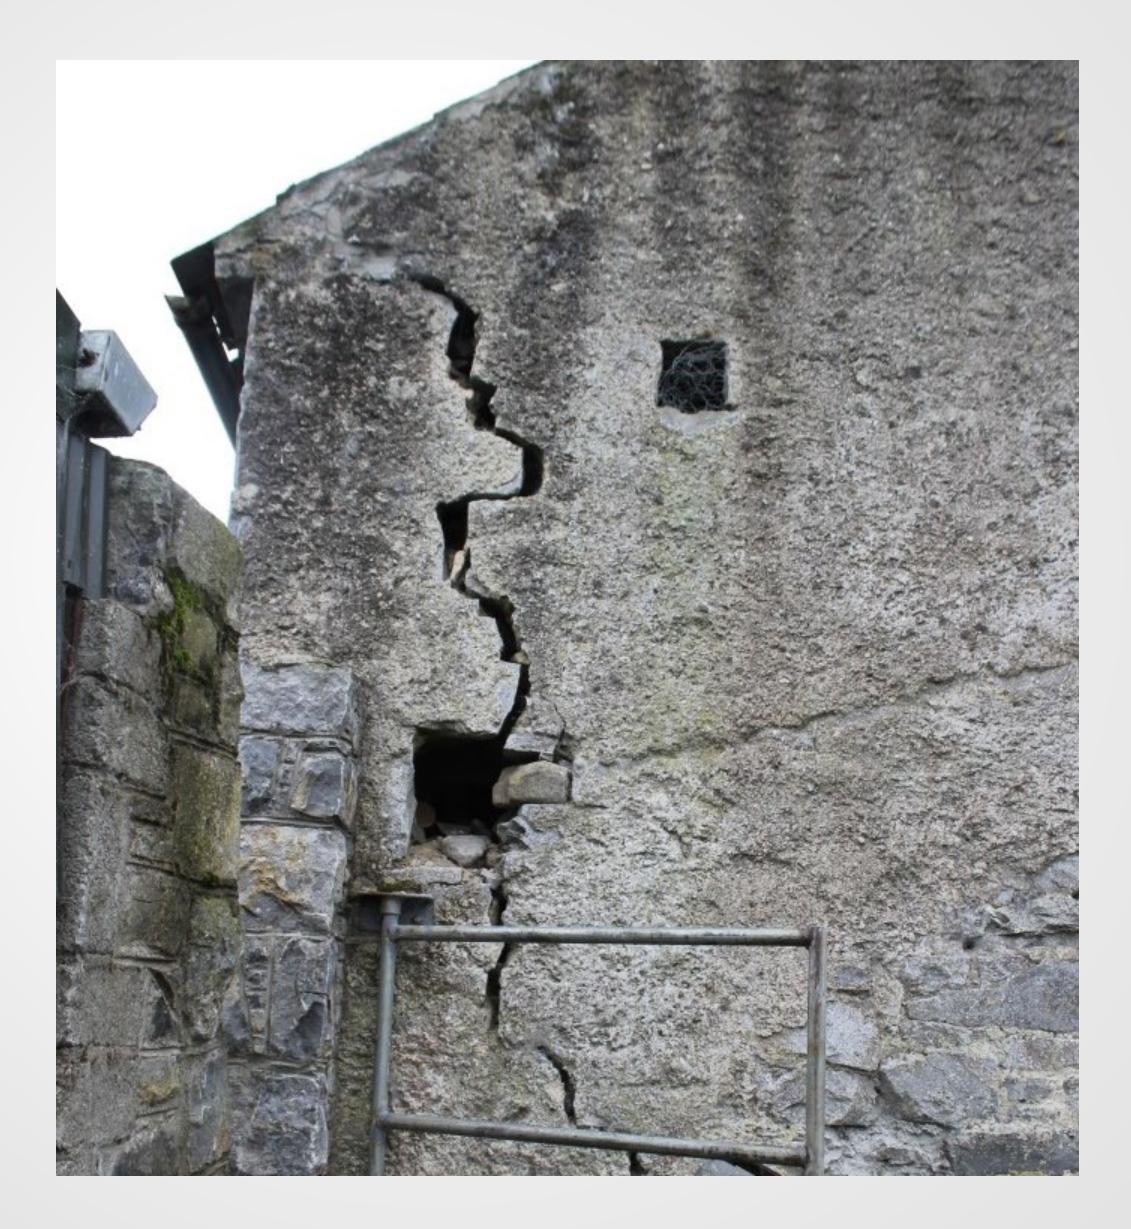
Cracking in gable wall as result of movement of front wall
