# 2019 GLAS Traditional Farm Buildings Grant Scheme Seminar

Hodson Bay Hotel, Athlone. Co. Roscommon 14<sup>th</sup> March 2019

Typical Structural Issues and Possible Solutions

Austin Dennany Chartered Engineer

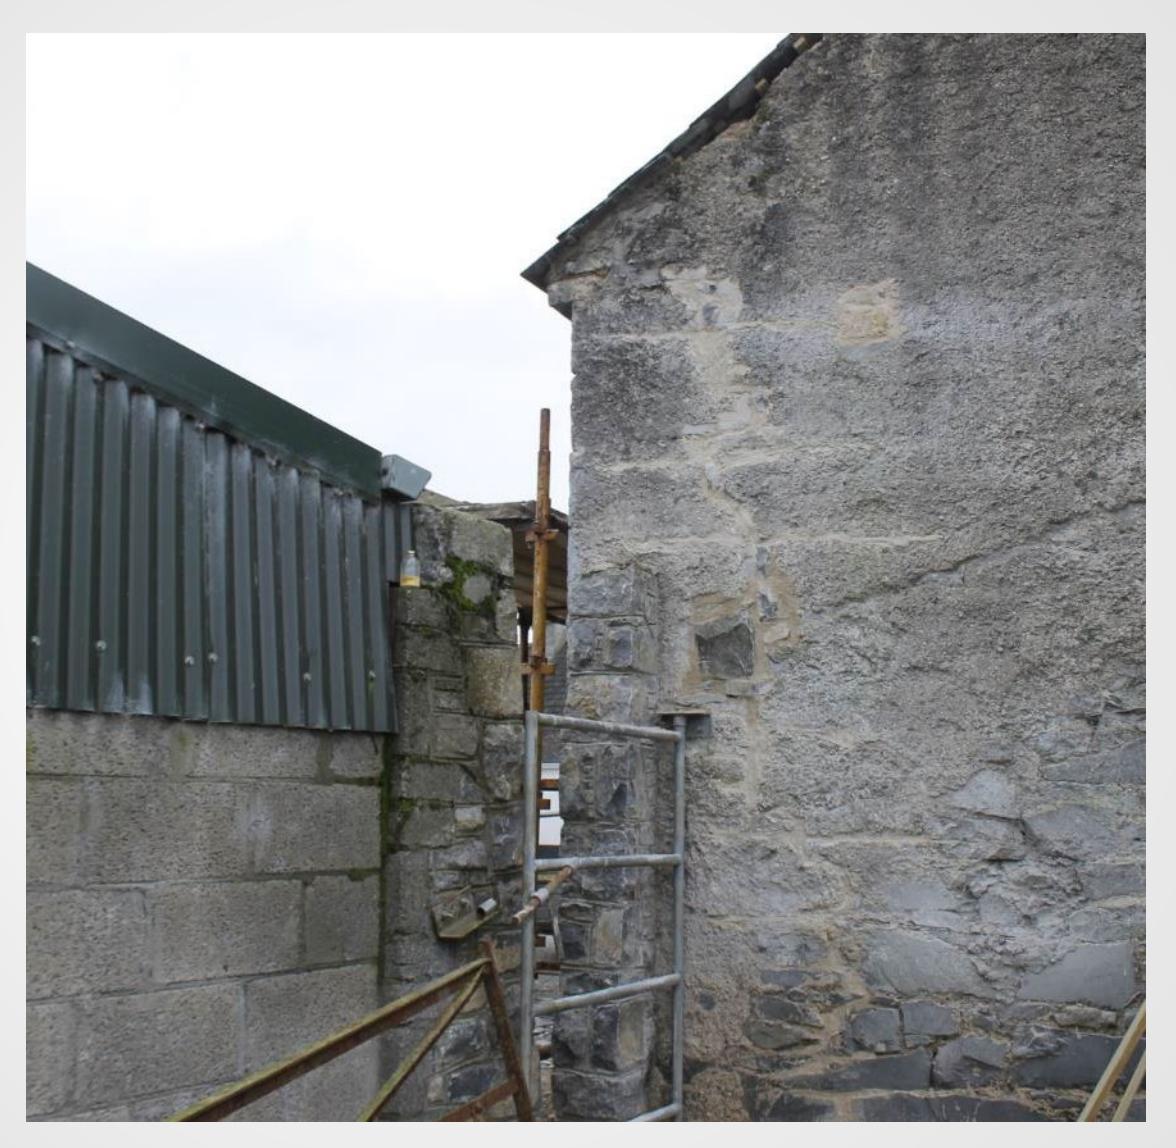
Stitching of crack using stainless steel twisted rods and chemical grout.

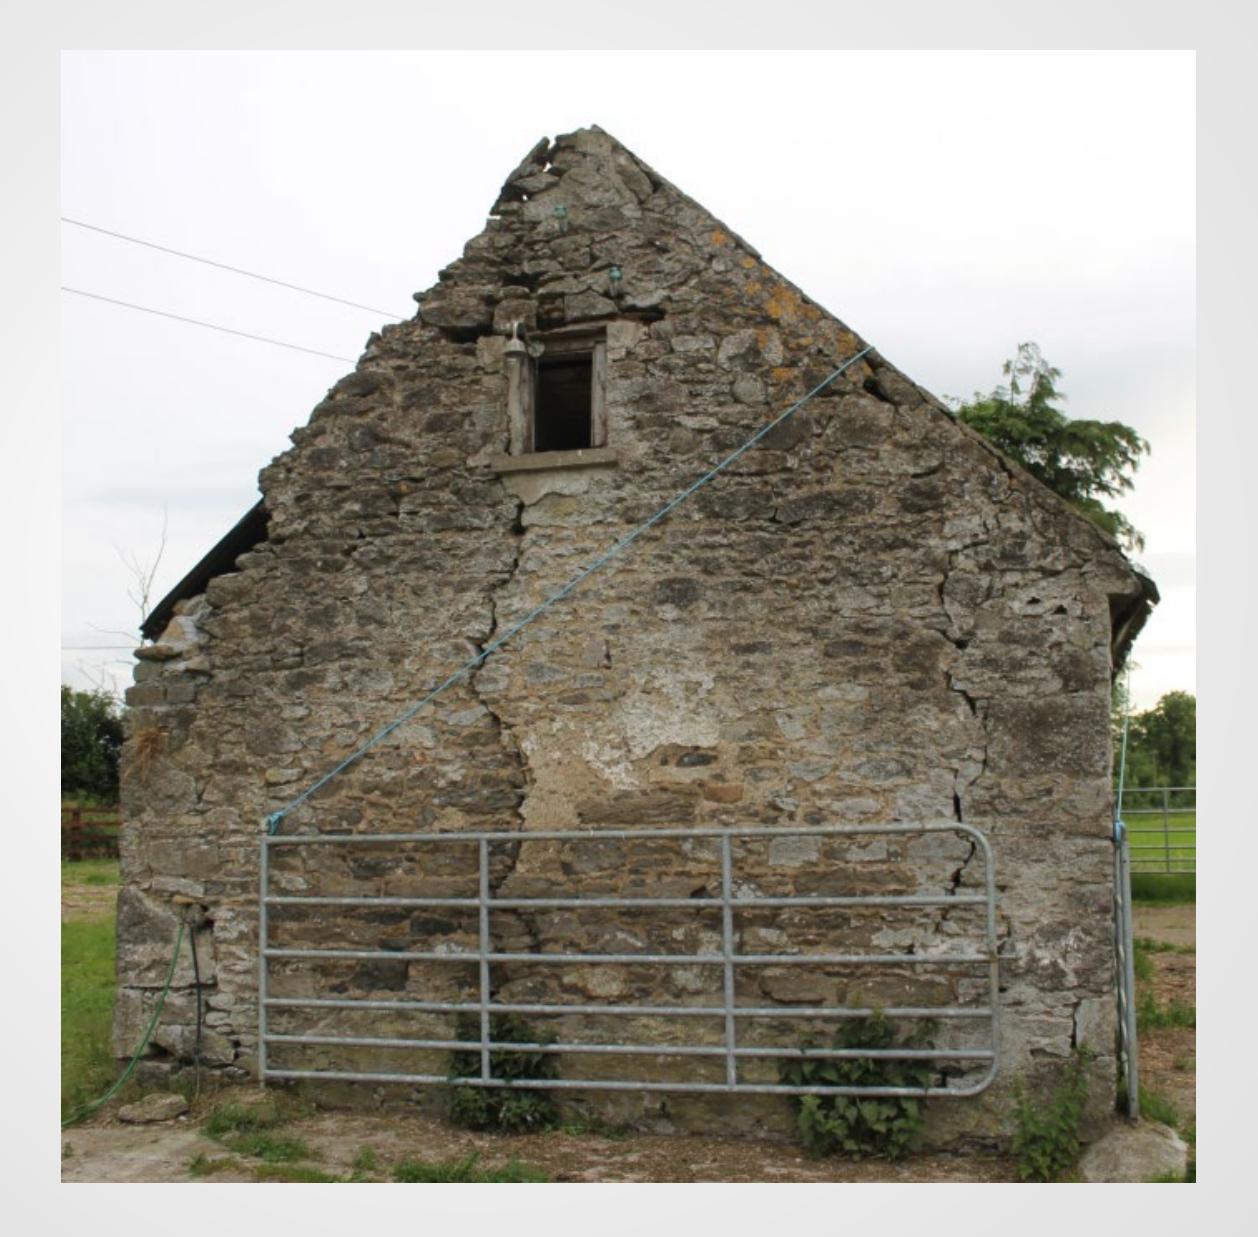
Cracks may no longer be opening up and can be stitched and filled.

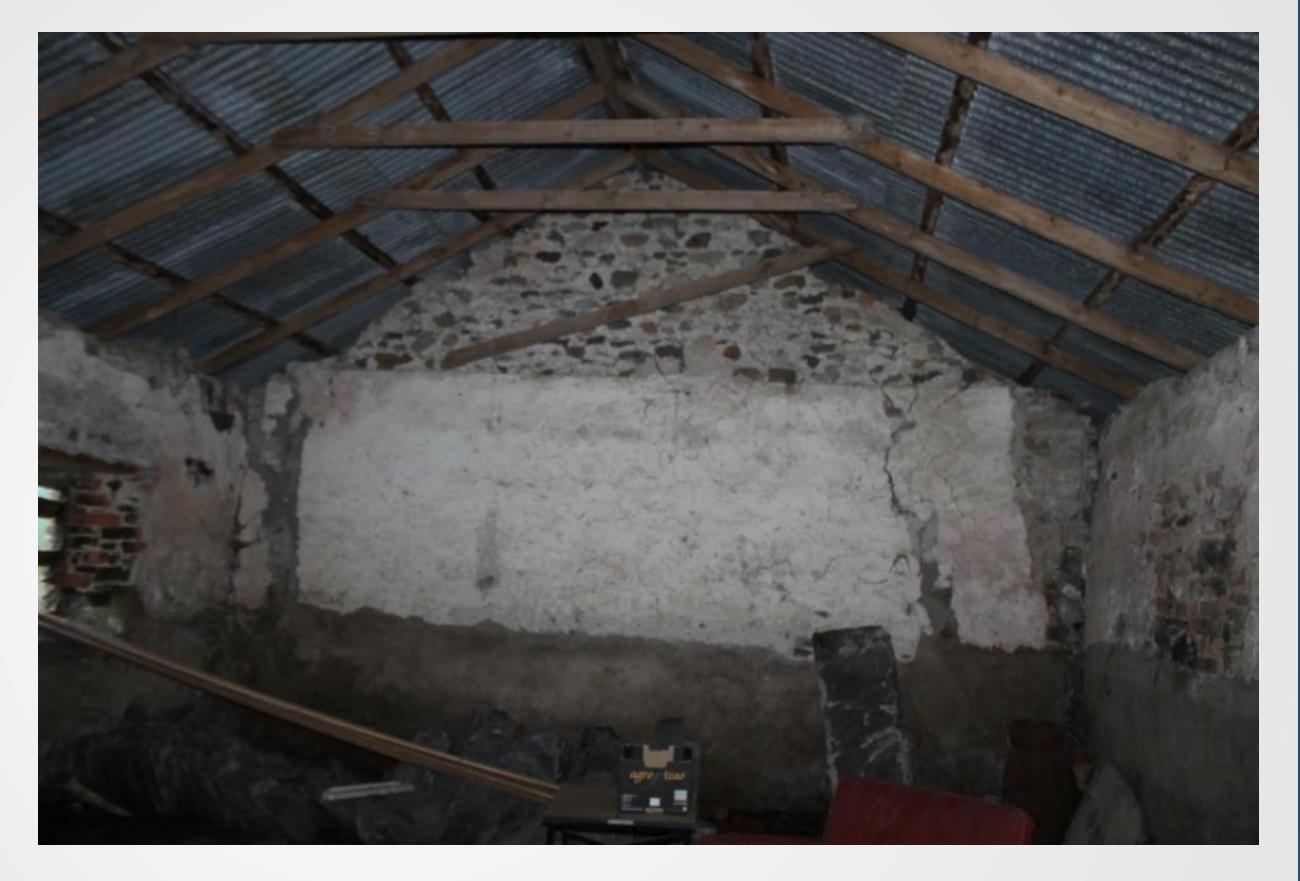
Undersized rafters and lack of adequate horizontal tie shall contribute to rotation of the walls.

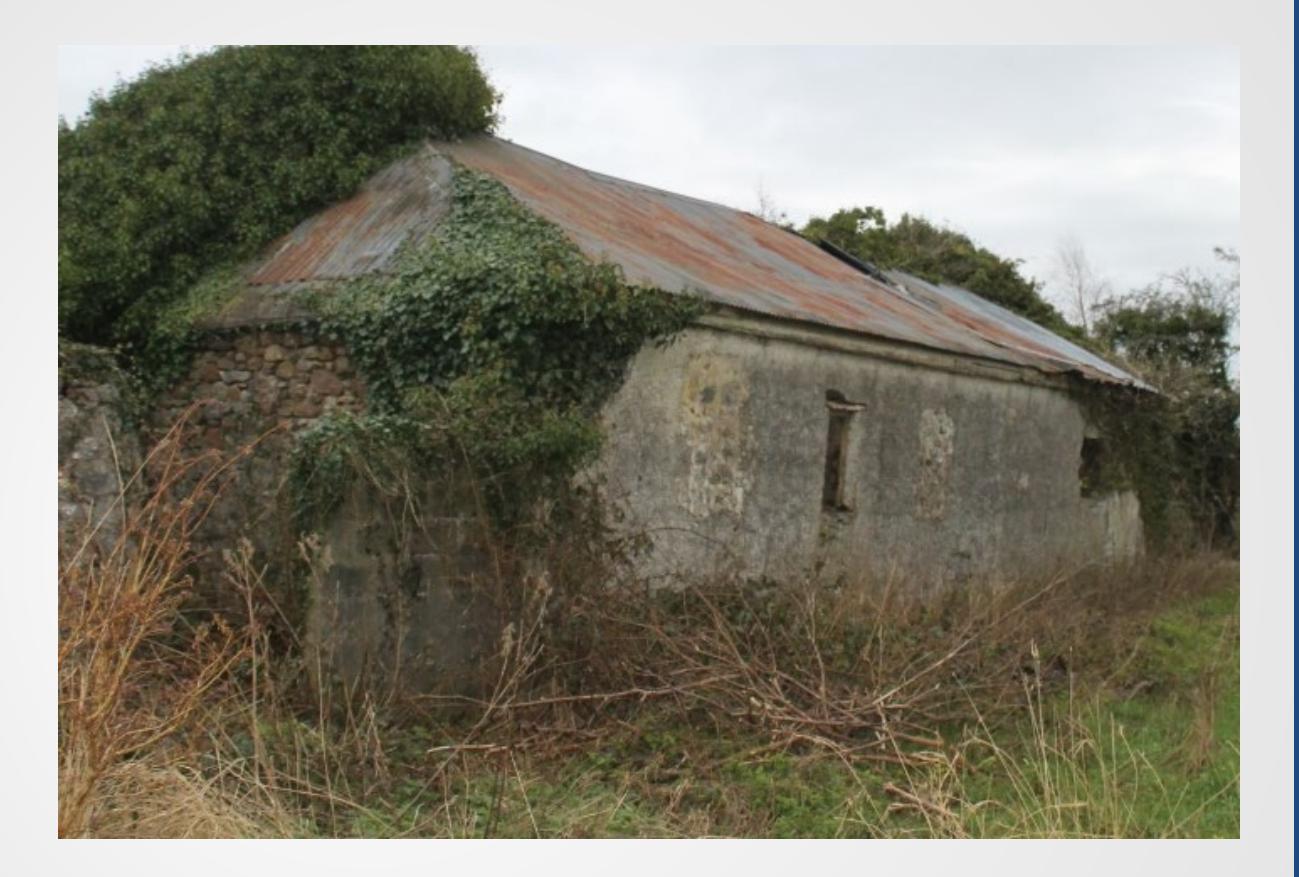
Significant rotation of rear wall. Ground conditions very poor in close proximity to Shannon River

- Solutions considered:
  - Insufficient internal walls to 'stitch' back to.
  - Pattress plates and steel ties would render internal of shed unusable.
  - Conservation officer was amenable to construction of concrete buttresses to halt rotation of wall. (not a GLAS project)

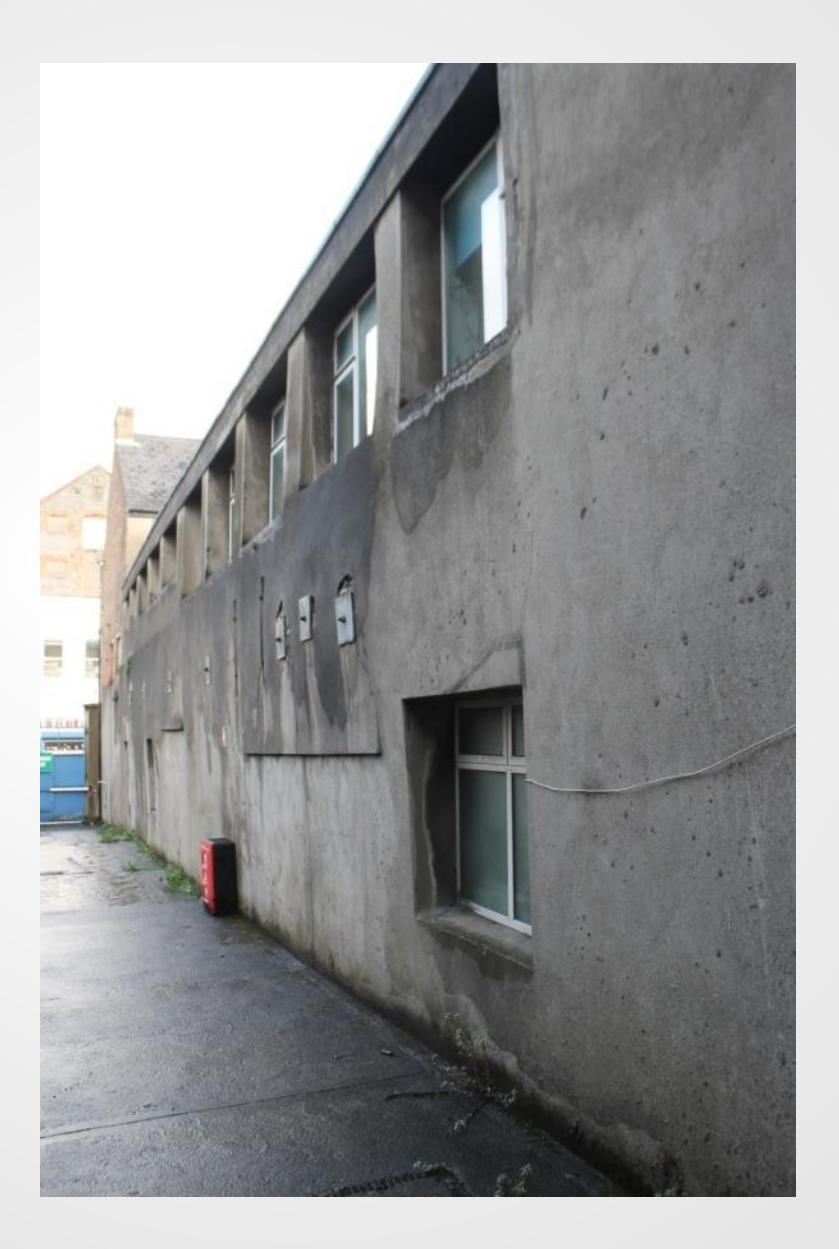
Bulge in wall and previously installed pattress plates.

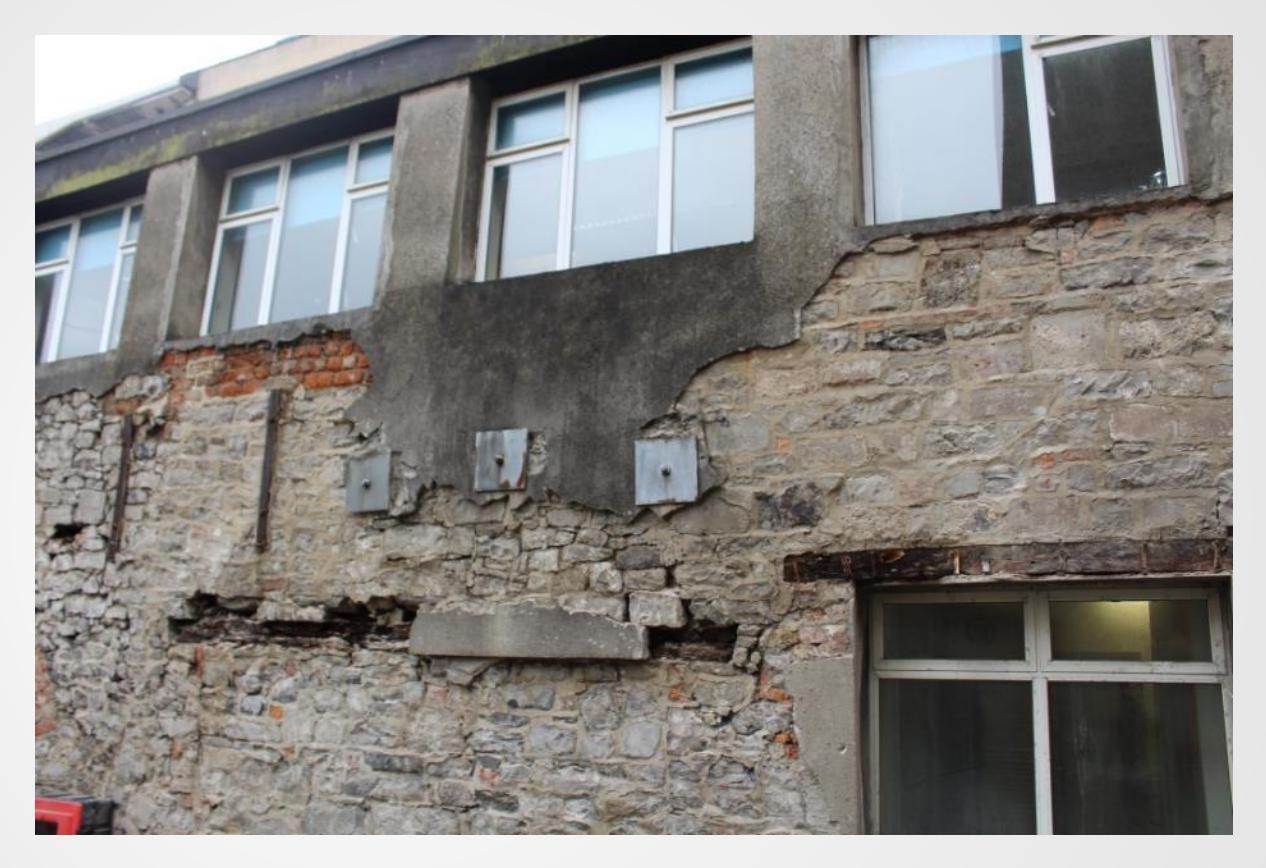
Cement based render removed to reveal large sections of timber embedded in wall. Pattress plates would never solve the problem.
