# 2018 GLAS Traditional Farm Buildings Grant Scheme Seminar

## Typical Structural Issues and Possible Solutions

Austin Dennany  
Chartered Engineer

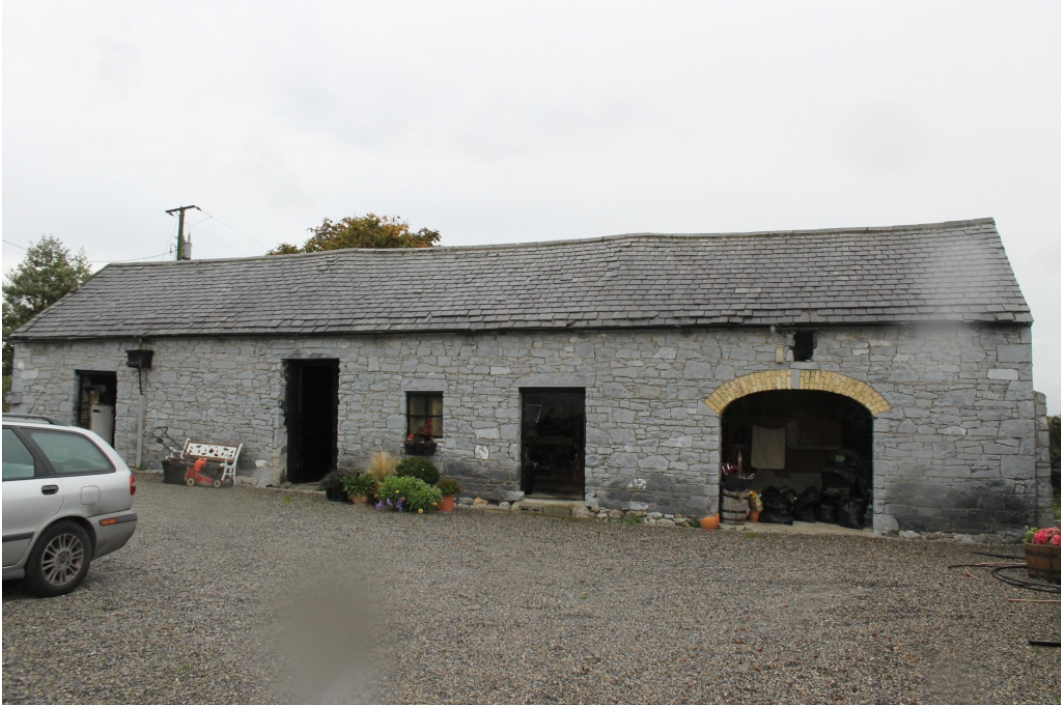
- Typical Issues/Repairs:
  - Slipped slates – usually due to corrosion of nails and/or rot of battens rather than problem with slate.
  - Slipped slates can be repaired by installing lead clips or stainless steel hooks.

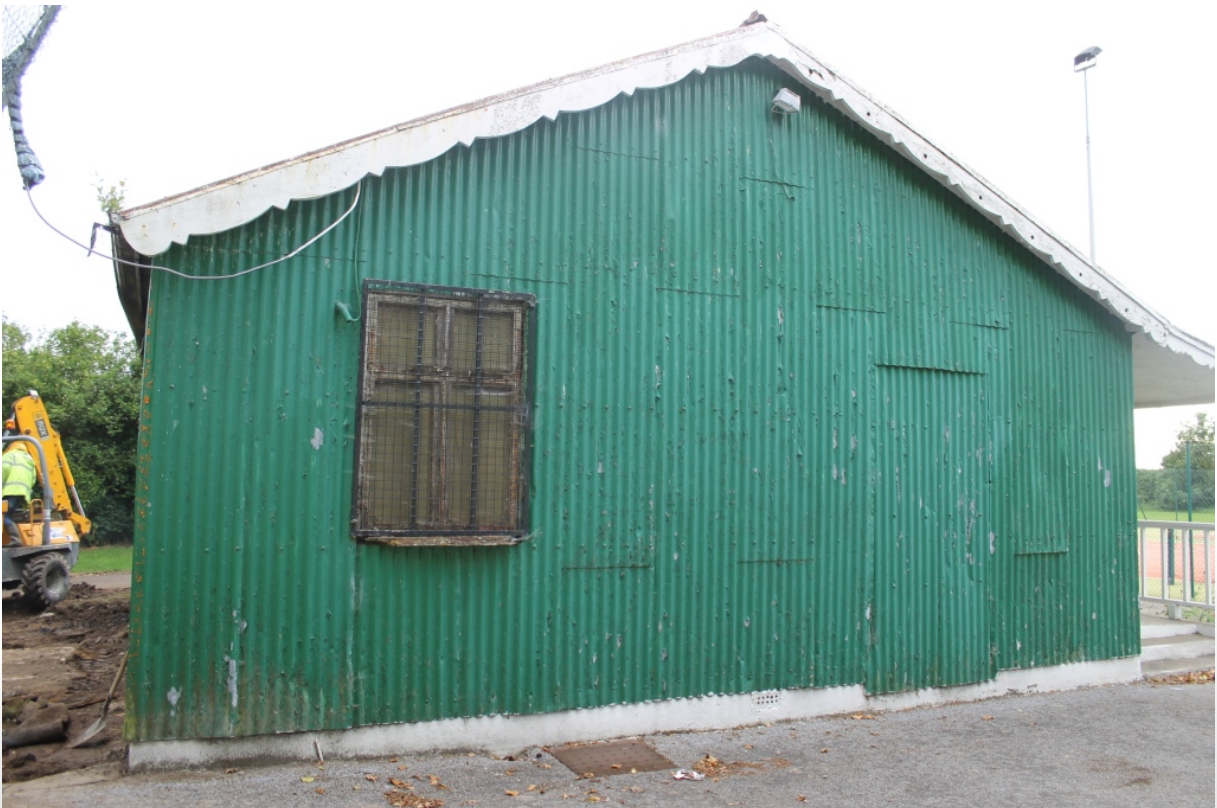
- Typical Issues/Repairs
  - Corrosion of fixings – If replacing fixings, use galvanised mild steel with weather proofing washers. Take care not to damage corrugated sheets when using nail bar or hammer to remove fixings.
  - Corrosion of corrugated sheets – It is possible to significantly extend the lifespan of the corrugated sheets by cleaning, removing rust and painting with a corrosion resistant paint.

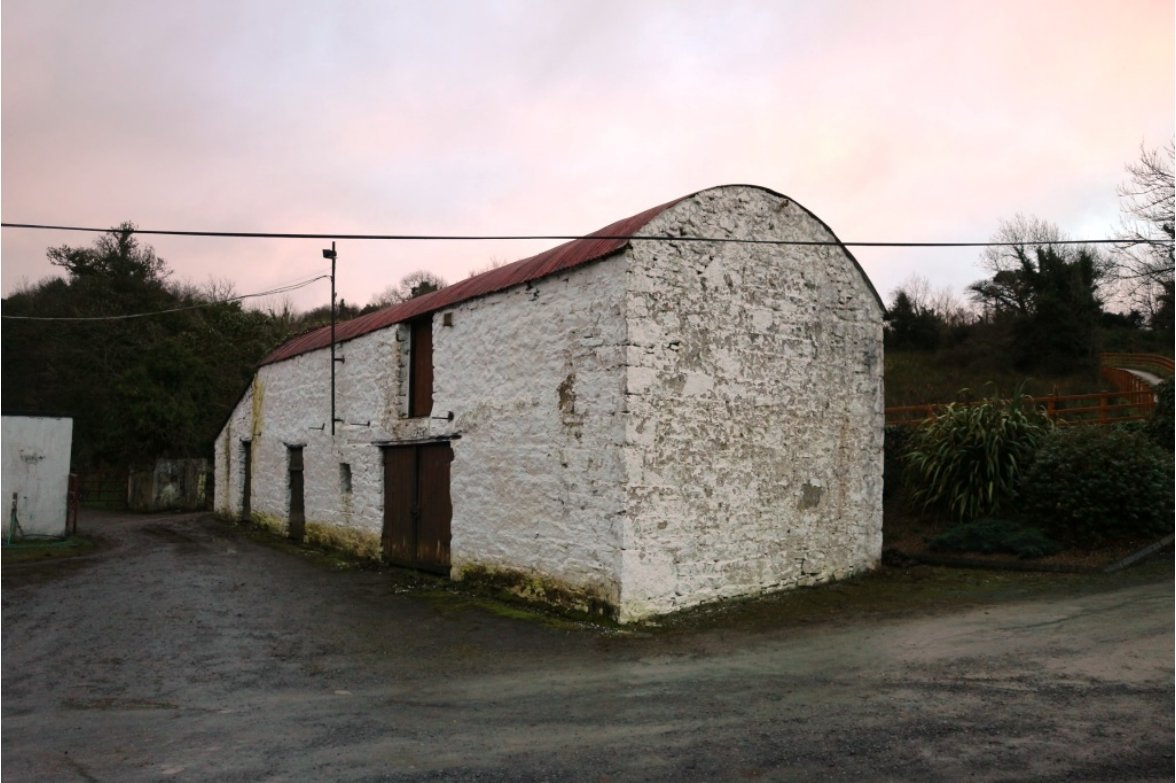
- Rotation of front wall caused by constant drip of water from roof softening ground at foundation/wall base.
- Walls can be restrained by using stainless steel ties to tie back to internal return walls and also to floor joists. Another method is to run a tension bar through the building and fix pattress plates on threaded ends on outside of front and rear walls.

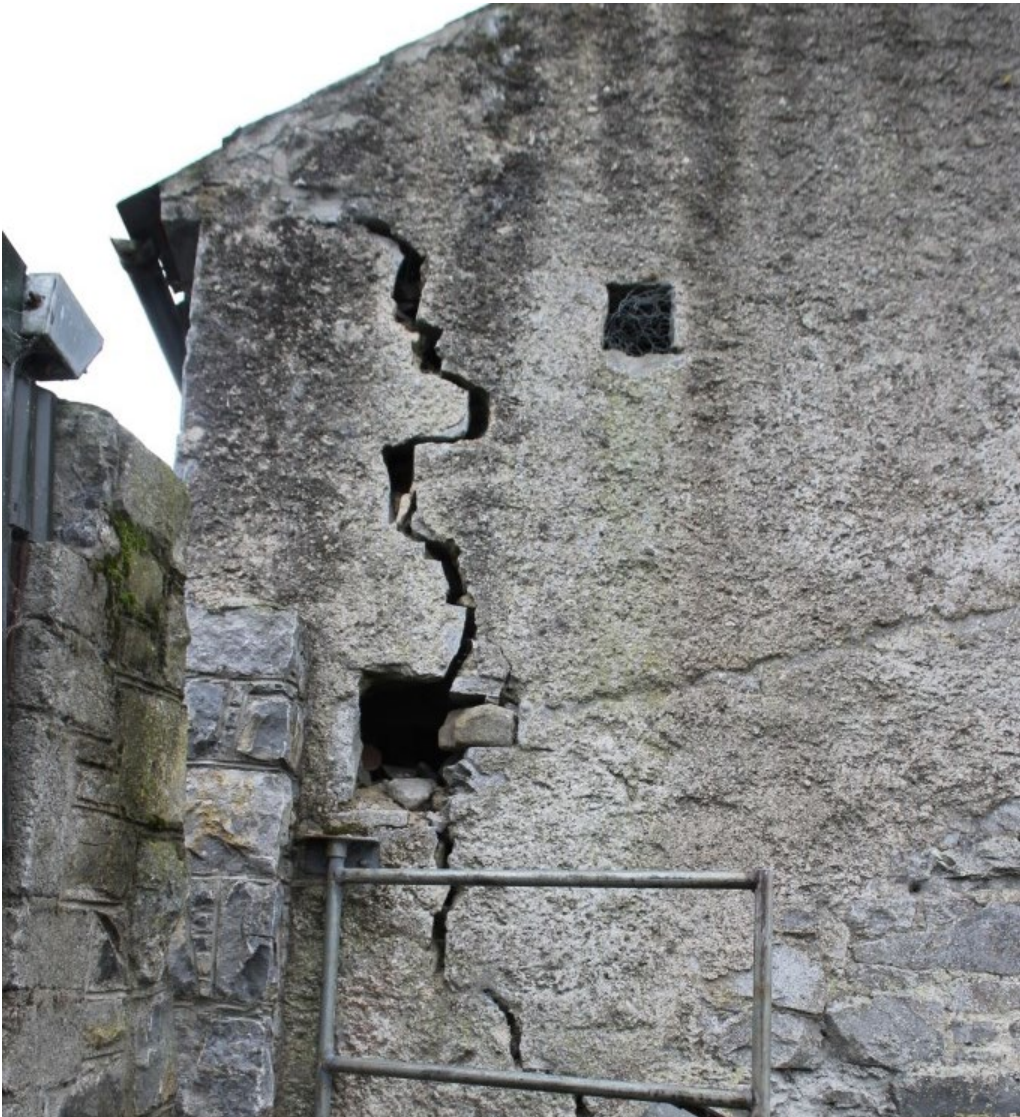
- Cracking in gable wall as result of movement of front wall

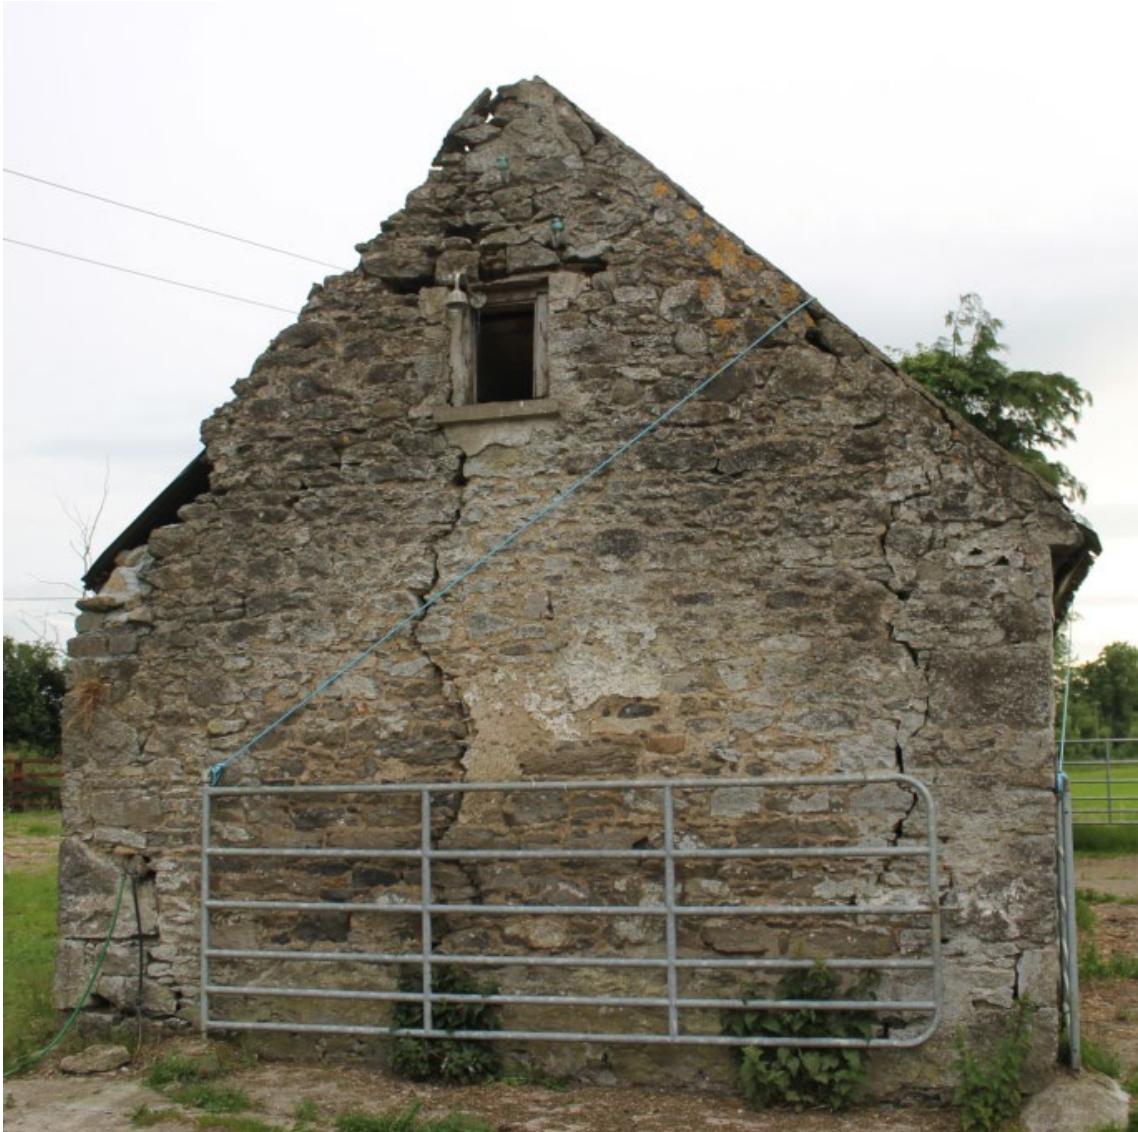
- Cracks may no longer be opening up and can be stitched and filled.

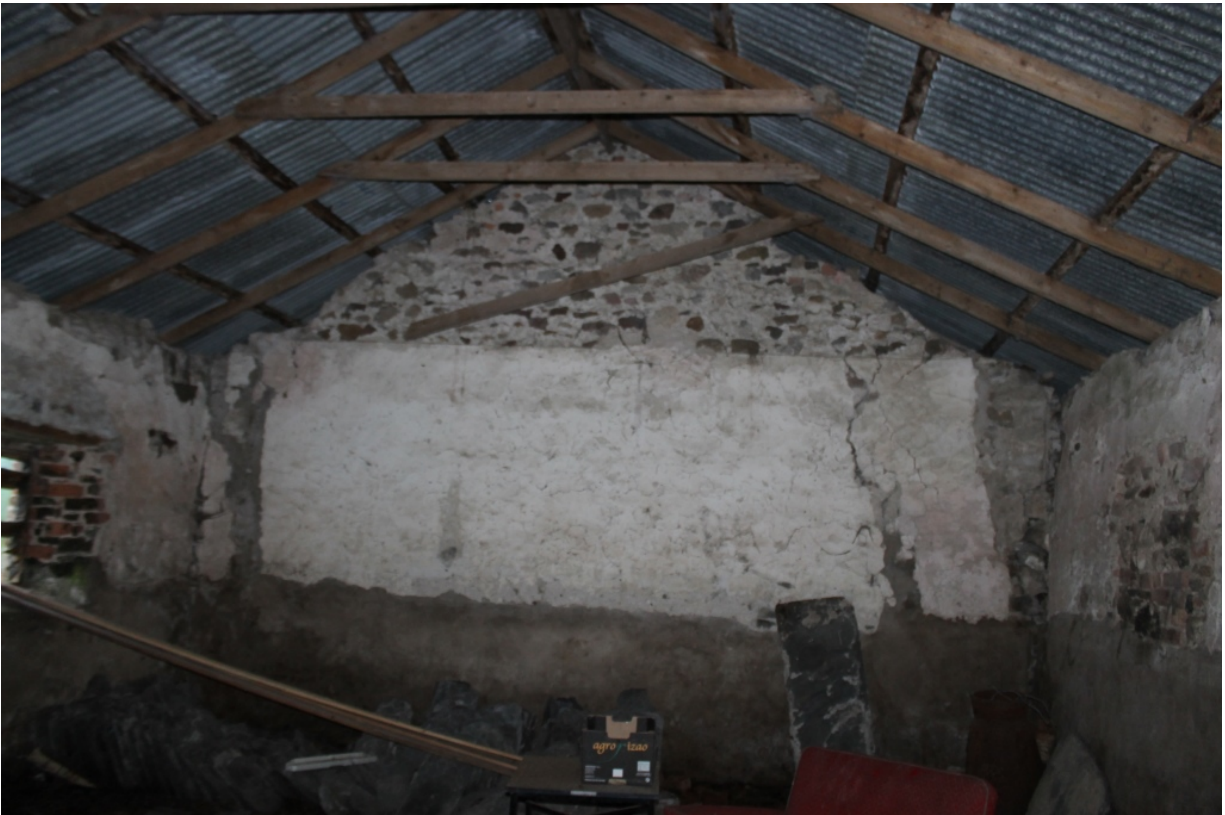
- Undersized rafters and lack of adequate horizontal tie shall contribute to rotation of the walls.

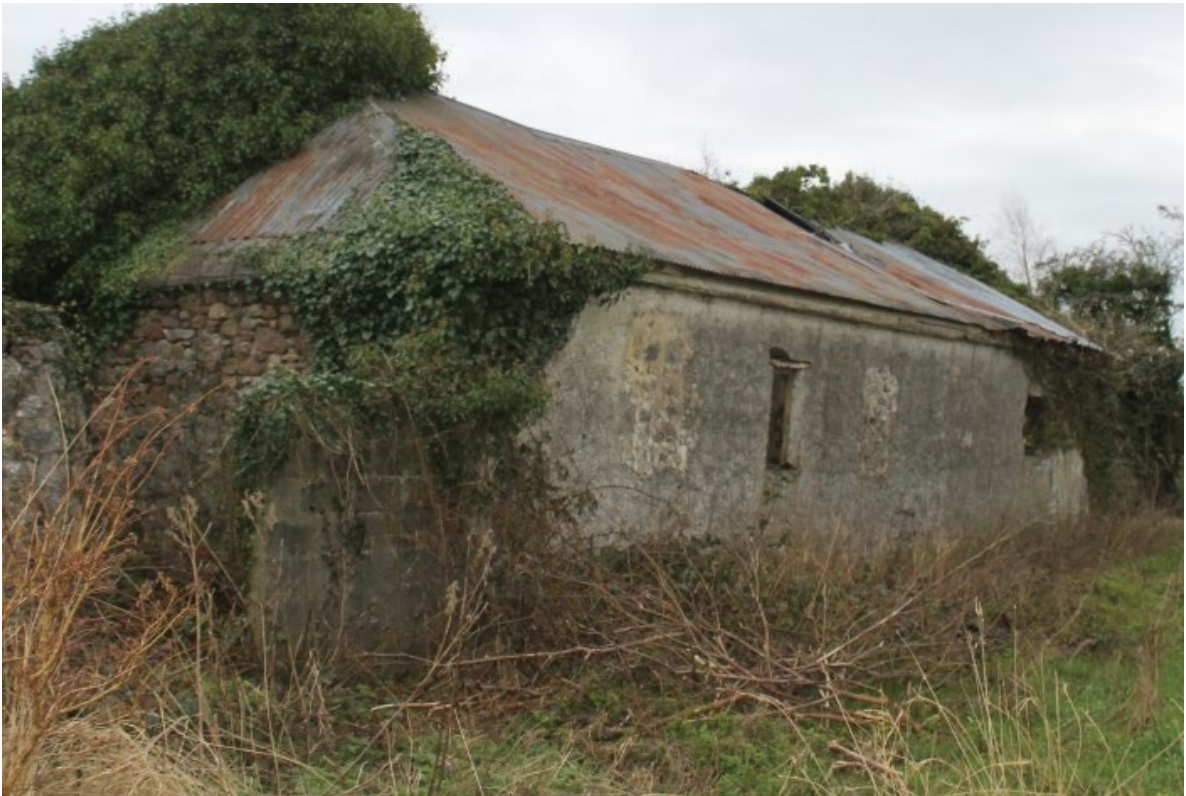
- Significant rotation of rear wall. Ground conditions very poor in close proximity to Shannon River
