Kilmallock Town Walls Conservation and Management Plan

KILMALLOCK TOWN WALLS
CONSERVATION AND MANAGEMENT PLAN

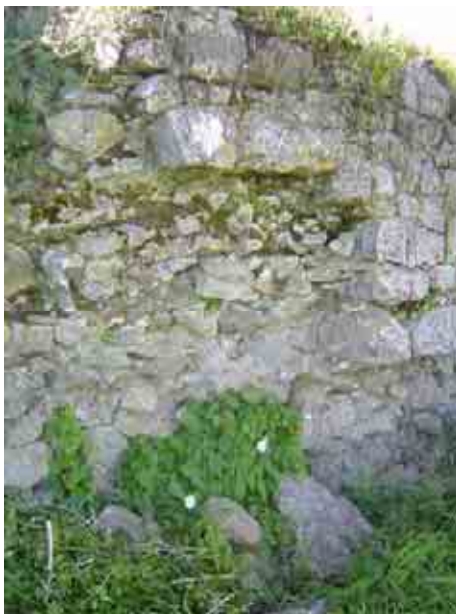
Plate 6: Loss of facing stones

Rubble filled cores to medieval walls like those at Kilmallock are extremely vulnerable to attack from water and freeze-thaw activity. If water is allowed to drain uncontrolled into a rubble core and no allowance is made for dissipating such water, then the results can be catastrophic. Not only will the water wash away the fines and materials within the mortar mix resulting in a breakdown in the bond between the rubblework, it will also, if allowed to build up and be subjected to freeze thaw activity, result in the blowing off of the facing stonework.

This has occurred at a number of locations along the length of the wall where the facing stonework has collapsed exposing the softer core within (Plate 7). Further damage to the core has occurred through the direct action of weathering. If no action is taken in the short term, the loss of further material is almost certain. The loss of a face makes the wall more slender, and the possibility of overall instability and eventual collapse increases.

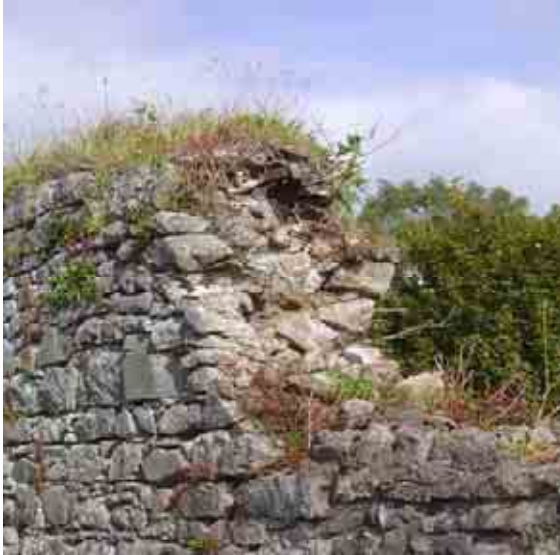
Plate 8: Unprotected wall top

The vigorous action of roots from plants which adorn the Town Walls and grow along the top of the walls is contributing significantly to much of the structural damage observed during the inspection. The unhindered action of the roots of these plants within the stone joints is resulting in numerous small sections of stonework becoming detached and falling away from the bulk of the wall off which they are supported. The damage to capping stonework along the length of the wall and subsequent loss in areas is resulting in further water penetration into the rubble core within the wall construction (Plate 8). If the capping is not reinstated, water will continue to flow into the rubble core washing out the fines from within the matrix of the core and breaking down the bond between the core and the facing stonework on the external elevations. In time, this will eventually result in facing stonework falling away.

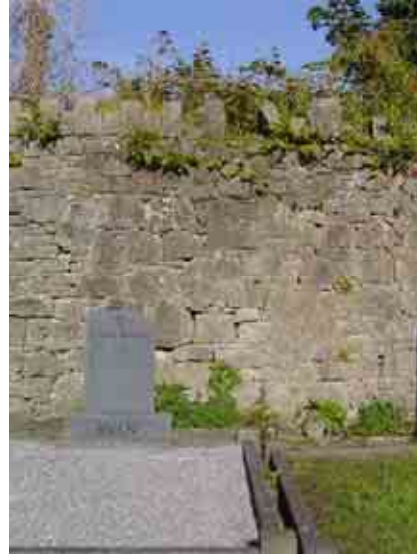
Plate 9: Plant overgrowth

Much of the plant overgrowth on the walls comprises ivy – which tends to affect the wall top (Plate 9), but there is evidence for it growing from the face. The thick stems of the ivy indicate that this is not a new problem and that the root systems must be very extensive within the wall core. Such root systems can contribute significantly to structural damage – the growth at the wall top loosens any previous protection and hastens water ingress. Furthermore, where the ivy grows from the wall top it tends to grow predominantly in one direction, thereby increasing the eccentric loading on the wall as well as increasing the area affected by wind pressure and so reducing the overall stability of the wall. Where the facing joints have weathered back vegetation is growing in the joints – at present much of this vegetation is minor and could be picked off/treated without damage to the wall.

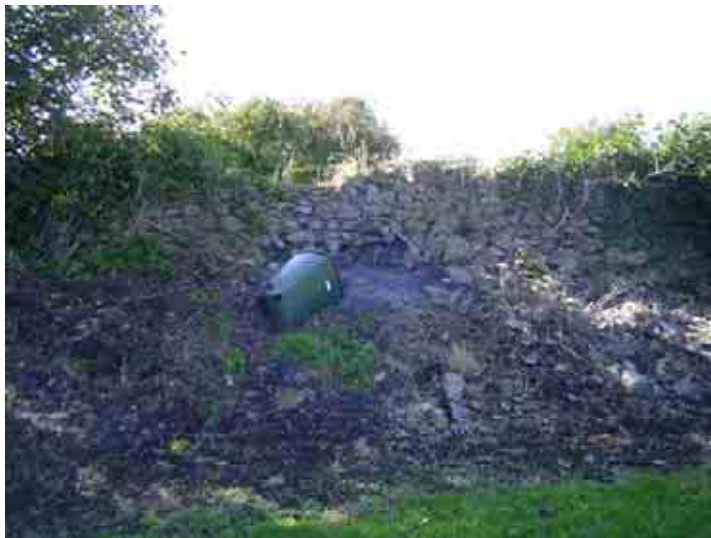
Plate 10: Build up along internal wall face

Evidence of the fosse and rampart that formed part of the defences of the town survives along the west wall (Figure 3). How the external face of the Town Walls met the fosse could be accurately determined through archaeological excavation. It is possible that part of the build up of material along the internal face of the walls is as a result of not just deposition of material over time but the excavation of material for the fosse and wall foundations that was then not removed. It is also possible that the wall is revetted against an earlier bank.

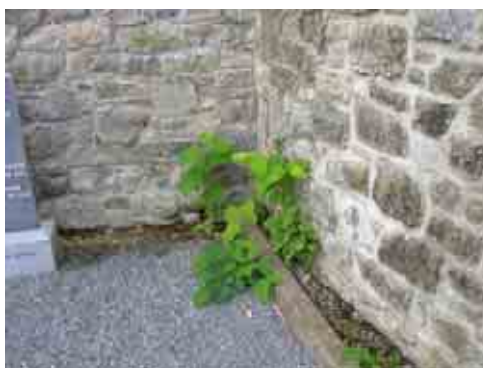
Plate 15: Stand of Japanese knotweed

A small stand of Japanese knotweed (*Fallopia japonica*) was noted growing on and close to the walls within the cemetery of the Collegiate Church (Plate 15). This species is extremely invasive and can result in decreased biodiversity as it out competes native plants and is not a natural habitat for Irish fauna (such as invertebrates). Japanese knotweed is also capable of structural damage as it is capable of growing through mortar and tarmac. The habitat of the walls is considered to be classed as 'stone walls and other stonework' and 'buildings and artificial surfaces' when compared to the habitat guidelines for Ireland (Fossitt, 2000).

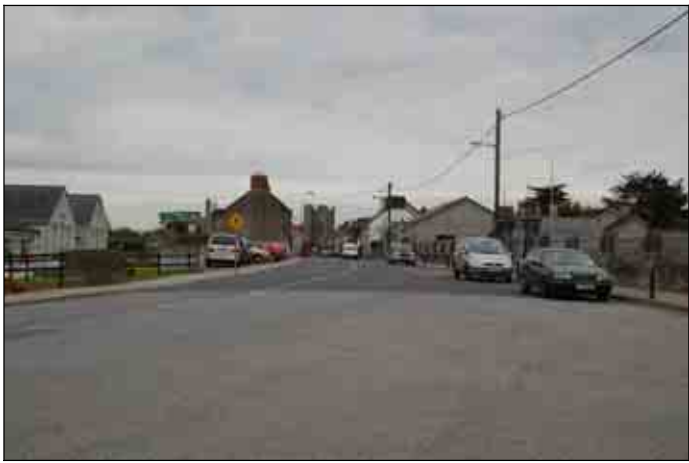
<p>Feature Name: St. John's Gate (site of)</p>

<p>Phase/Construction Date(s): Construction - Phase 4-5: 14th – 16th century Alteration - Phase 4: 16th century or Phase 5: 17th century Demolition – Phase 6: 19th century</p> <p>Background and Description: There are no remains of St. John's Gate existing above ground, but traces of the structure may survive below-ground.</p> <p>The gate was added as part of the medieval extension to the town. There is a reference to the gate from 1410 (Westropp 1904-5, 421), which may indicate the presence of a gated north suburb to the town, or that the town had extended north by this time. The standing remains of Kilmallock are thought to date from 14th -15th centuries (Bradley <i>et al</i> 1989, 155).</p> <p>Joanes's map, c.1600, shows the gate as double-towered with a pitched roof and crenellated parapets, possibly two storeys, with a wide, pointed archway.</p> <p>Nicholson's 1822 engraving shows the exterior side of the gate, with an angular north-east stair tower, a first and second floor and a parapetted roof. This structure is notably different to that shown in Joanes' map and it is possible that the arched central section remained, while the wings to either side were removed / modified. These alterations may have occurred during the 16th-17th centuries.</p> <p>Thomas (1992, 134) notes that St. John's Gate survived until 1840 (reference in Lewis, 1837) but it was absent by 1889 (no reference in O'Dowd 1889, 133ff).</p> <p>The first edition OS map of 1829-41 may show the gate, although it is not clear amongst the buildings to either side of the road and the dotted townland boundary and it is not labelled. The second edition OS map (1897 -1913) shows the end of the road had been widened, with the removal of the buildings that had lined the west side and their replacement by the 1889 church and grounds. This formed the widest section of the central street of Kilmallock, which survives as such today.</p> <p>A test excavation was carried out on Sheares Street as part of the Urban Renewal Scheme in 1998 (S. McCutcheon, 98E0538). At the site of the Gate, a cobbled surface was found, together with evidence of modern disturbance, but no remains of the gate or wall</p>	<p style="text-align: center;"><i>Site of St John's Gate, looking south</i></p>

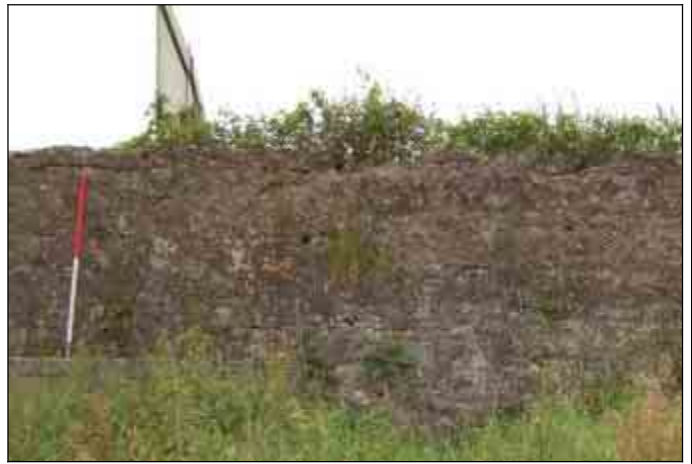
The area c.4m from the wall face, has been largely affected by landscaping, dumping and vegetation growth, masking evidence for the fosse. Further out from the wall, the ground has been landscaped to provide a recreation area for the secondary school.

Section of Town Wall along school boundary, looking south

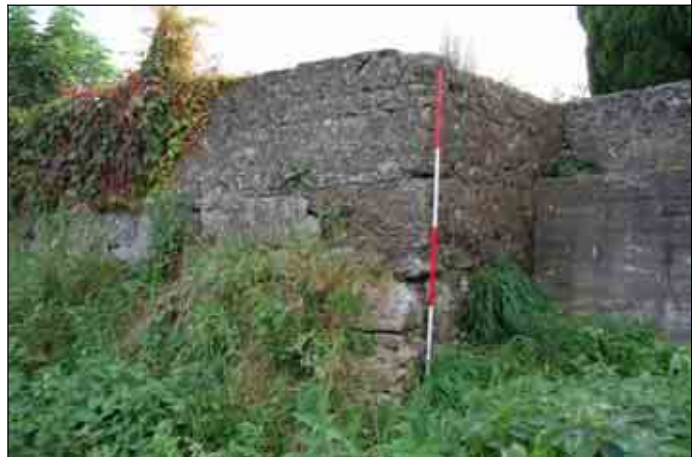
Statutory Protection	National Monument; RMP LI047-022 Kilmallock Town; RPS M(47)M60-Town Wall.
Condition	<ul style="list-style-type: none"> • Modern application of concrete panelling may allow water to be trapped behind it, encouraging freeze-thaw damage. The panelling might pull material away from the wall, due to the strength of its bonding, encouraging collapse of the original material. • Vegetation has been allowed to take hold of the wall, causing loosening of the stones. • The build-up of soil against the internal surface of the wall encourages ground water to penetrate, which could add to freeze-thaw damage. • Some sections of the wall towards the north end have been entirely replaced.
Historical Significance	<ul style="list-style-type: none"> • The north-east section of the Town Wall marks part of the extension to the north end of medieval Kilmallock. • The battered section may be the remains of a defensive feature or opening, now lost.

Vulnerability	<ul style="list-style-type: none"> • The concrete panelling is unsympathetic and may add to the deterioration of the wall. • Vegetation growth needs to be controlled, superficial hand removal and removal of larger growth is required, together with repair work. • No consent should be given to intrusive works in the environs of the town wall. The majority of this section of wall forms boundaries of individual private properties inside the wall, which can create lead to an inconsistency in maintenance work.
Guidance Notes	<ul style="list-style-type: none"> • Planning conditions should be applied to development proposals of intrusive works, in case of the presence of below-ground remains within the 15 - 20m buffer zone (<i>Kilmallock Local Area Plan</i> 2002, 45) surrounding the wall. This may include repairs to the wall, provision of services, alterations to properties on the interior of the wall. • This section of the Town Wall forms part of the National Monument of Kilmallock and mitigation should include preservation <i>in situ</i> and recording works and visual representation of results through published or displayed sources. • A combined effort of monitoring of the condition of the wall and vegetation growth should be used to highlight sections requiring repairs and maintenance as quickly as possible. Where appropriate, more sympathetic materials should be applied to replace the concrete applications. • The protection of the Town Wall in the <i>Kilmallock Local Area Plan</i> includes a margin of 20m to either side of the Town Wall for proposed buildings and 15m for other developments (2002, 45) and the undeveloped nature of the exterior of the wall should be preserved.

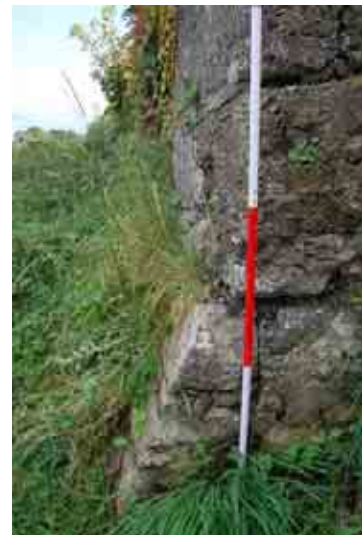
Battered step in alignment of Town Wall, looking south-east

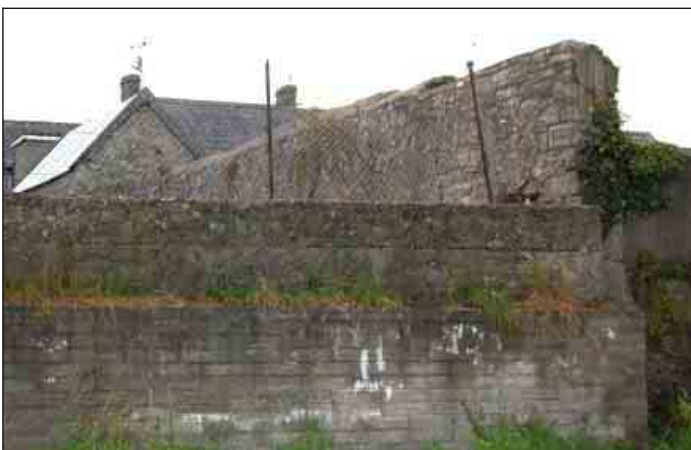
Dressed stones at corner of batter, looking south

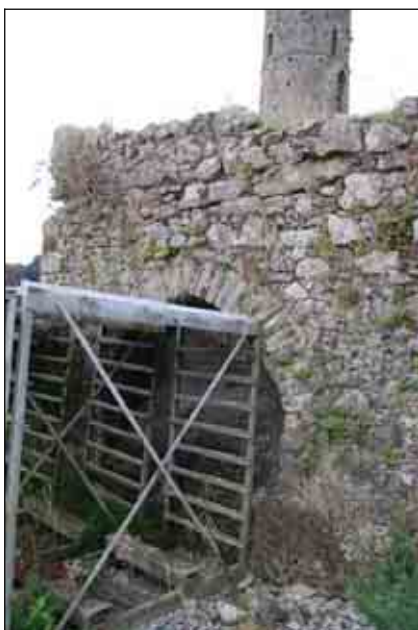
Exterior side of arch, looking south-east

Statutory Protection	National Monument; RMP LI047-022 Kilmallock Town; RPS M(47)M60-Town Wall.
Condition	The archway appears to be intact, although the concrete panelling may be trapping water that could result in freeze-thaw damage.
Historical Significance	A possible entrance in the boundary wall of the church, leading to an extra-mural route to the Priory.
Vulnerability	<ul style="list-style-type: none"> • The concrete blocking of the archway and its conversion into a shrine limits the understanding of the purpose of the opening. • The application of the concrete blocking to the archway may trap water, encouraging freeze-thaw damage. • Landfill is located on the exterior of the archway.
Guidance Notes	<ul style="list-style-type: none"> • Planning conditions should be applied to development proposals of intrusive works in the vicinity of the wall and archway. • The archway forms part of a National Monument and mitigation should include preservation <i>in situ</i> and recording works and visual representation of results through published sources. • The condition of the wall and vegetation growth should be monitored.

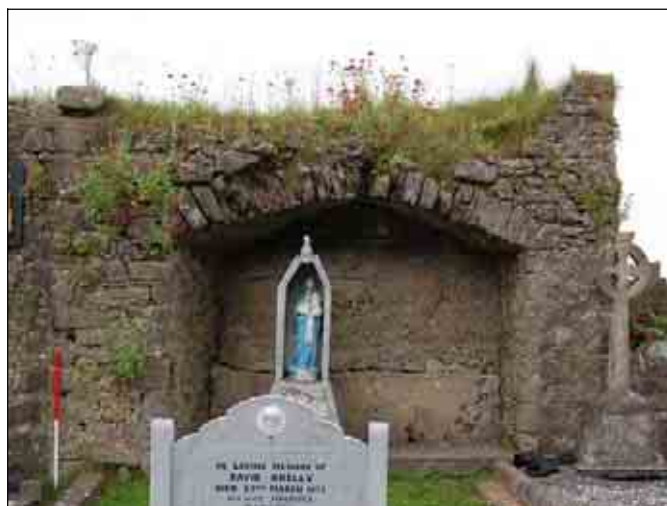
Archway in north boundary wall of Collegiate Church, looking north-west

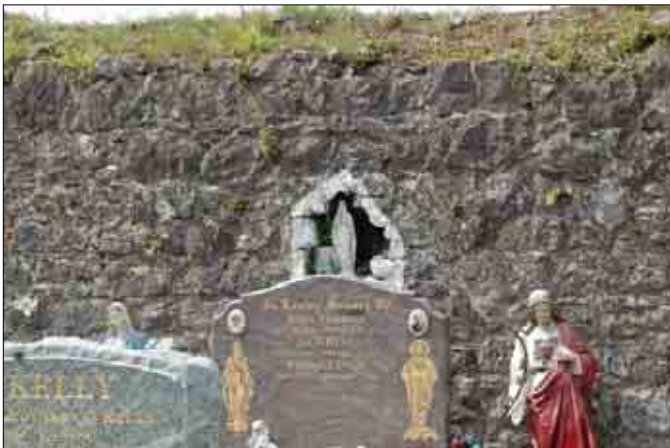
The interior face of the Town Wall contains a second shrine, created out of the removal of stones and highlighted with white paint. This may have been created out of a falling in the interior face, or deliberately. The ground level is higher on the interior and stones have become loosened at the base.

Shrine on interior side of north boundary wall, looking north

Protection	
Condition	<ul style="list-style-type: none"> • The exterior of the wall appears to have been repointed at the bottom in some places, while other sections have become very loose and cracked in others. • From c.1.5m above ground level and higher, the wall appears to have been consolidated in the past, with larger shaped blocks set in random courses and repointed with mortar. • Stones have been set in concrete capping along a low section of the wall, less than 2m high, forming crenellations of 19th century date. • The exterior face has fallen away in two areas, revealing the vulnerable rubble core of the wall. In between these areas, ivy has taken hold and may be hiding or causing a third area of loosened stones. • The majority of the wall is capped by grass growing along the top surface and large areas of ivy growth in places. The grass may be adding some protection to the wall, but could encourage more substantial plant growth. • Towards the east end, concrete render has been applied to the face of the wall, behind a grave statue. The height of the wall diminishes to the east end, where it returns to the south and is very overgrown • The previous repairs to the wall have resulted in a change of its character in places. Where cement-based mortars and concrete renders have been applied, the wall has become damaged through freeze-thaw action and facing stones have fallen out, exposing the vulnerable rubble core. • Vegetation has taken hold of sections of the wall and has been left to grow un-checked. • Shrines have been created in the internal face of the wall and from the archway structure.

Historical Significance	<ul style="list-style-type: none"> • Part of the Town Wall and remains of the boundary wall of the Collegiate Church. • Remains of an archway that may have marked one end of an extra-mural route to the Priory.
Vulnerability	<ul style="list-style-type: none"> • The creation of a shrine adds a weakness point to the wall. • Sections of the exterior are in urgent need of consolidation and repair where the facing stones have fallen away and the wall has become thinner. • Vegetation has been allowed to grow along the top of the wall and entirely covering it in places. • Later additions of concrete repointing and crenellations have been made.
Guidance Notes	<ul style="list-style-type: none"> • The exterior is currently under pasture and the field provides the setting for the Town Wall, the church and the nearby Priory and should be zoned appropriately. • The wall is part of a National Monument and mitigation should include preservation <i>in situ</i>, recording works and visual representation of results through published sources. • Consolidation works are needed to stabilise the wall. • Vegetation needs to be carefully removed and cut back for the works to be completed. • The wall should be monitored to address any structural problems as soon as possible and to control vegetation growth. • The creation of new niches or shrines in the wall should be forbidden and the existing niche should be examined for stability and if possible, filled.

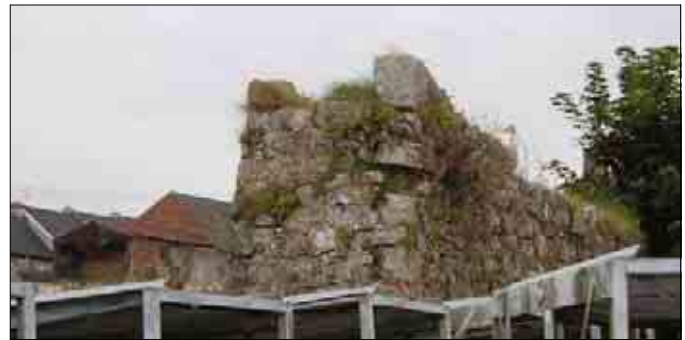
Exterior face of wall above archway, looking west

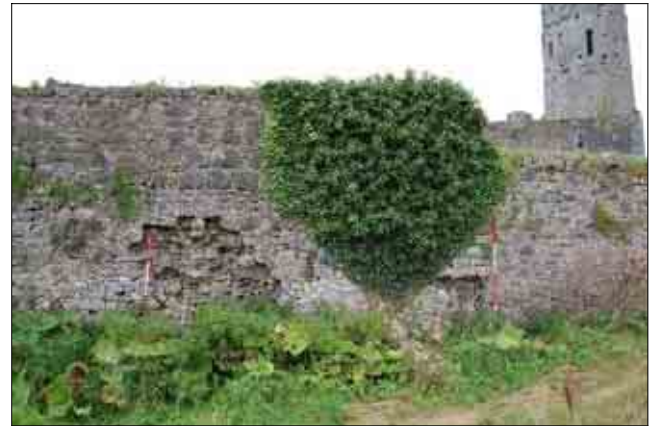
Exterior face of north boundary wall, looking south

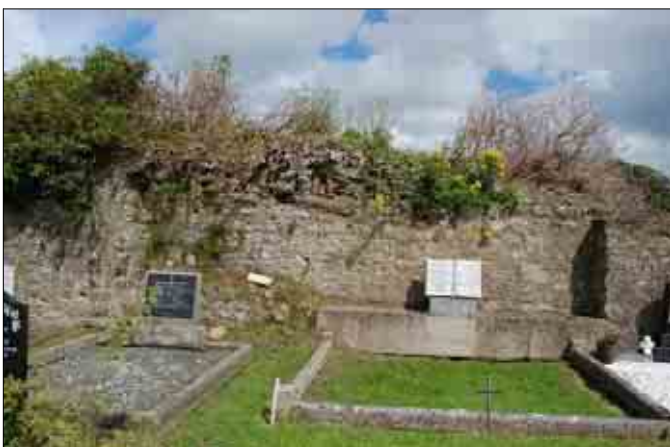
Interior side of east boundary wall, north end, looking east

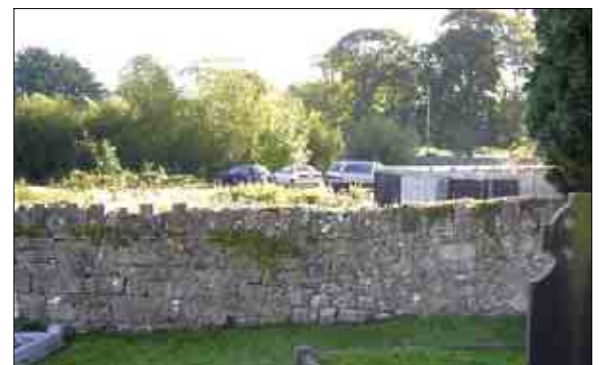
Repaired section of east boundary wall towards south end, looking east

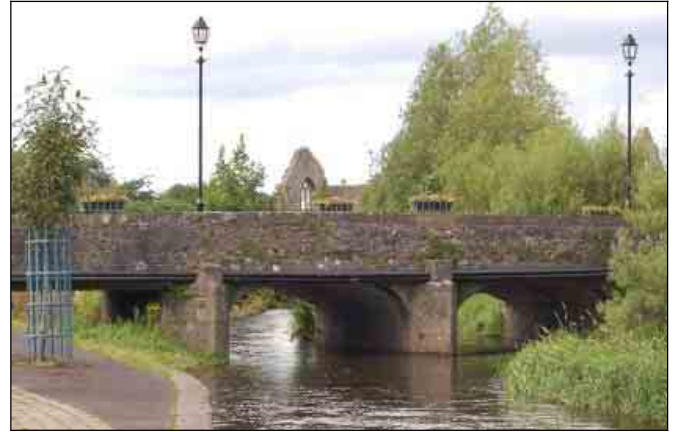
South face of bridge, looking north

Statutory Protection	RMP LI047-022 Kilmallock Town; RPS M(47)39i-vi - composition of Wolfe Tone Street and bridge.
Condition	<ul style="list-style-type: none"> • The cutwaters have been capped with concrete to hold modern pipes, which could put stress on them and the concrete may trap water, leading to freeze-thaw damage. • The concrete lintel slabs replacing the arches of the west end may trap water between them and the superstructure, causing freeze-thaw damage.
Historical Significance	<ul style="list-style-type: none"> • This bridge exists as the main river crossing into the east of Kilmallock. • Potential viewpoint of the East Wall, Collegiate Church, and Dominican Priory
Vulnerability	<ul style="list-style-type: none"> • Elements of the bridge may survive from its original construction, although other features have been added for modern purposes, altering the character of the bridge. • The relationship between the Water Gate, the Town Wall and the bridge has been lost. • The location of a car repair garage to the north of the site has resulted in increased traffic and parking.

Guidance Notes	<ul style="list-style-type: none"> • Planning conditions should be applied to development proposals of any intrusive works in the vicinity of the bridge. • Mitigation should include preservation <i>in situ</i>, recording works and visual representation of results through published sources. • A display board may be appropriate in this location, to explain the importance of the Water Gate, the bridge and the street as the east entrance to the town.

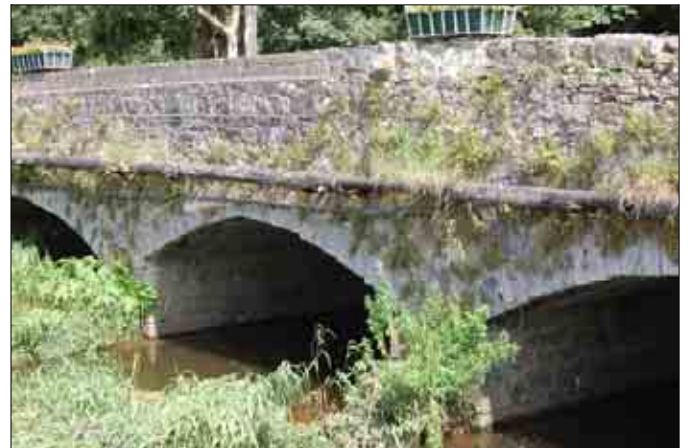
Arches of north face of bridge, looking south-east

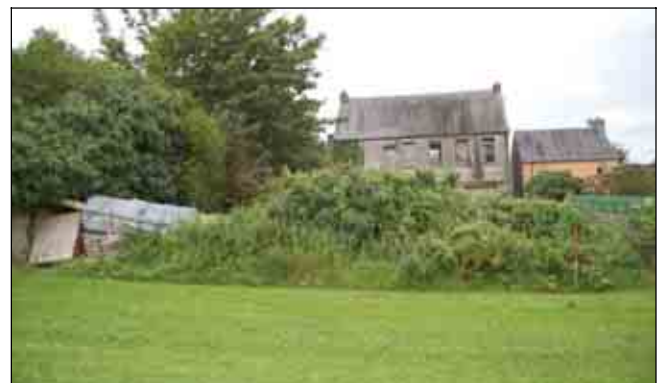
North-east end of wall, overgrown, looking north-west

Statutory Protection	National Monument; RMP LI047-022 Kilmallock Town; RPS M(47)M60-Town Wall.
Condition	<ul style="list-style-type: none"> • Facing stones have fallen out, exposing the vulnerable rubble core. • Vegetation has taken substantial hold of sections of the wall and the build-up of flora debris against the exterior face may encourage water ingress. • The wall has been repointed in places, which may result in water being trapped inside and causing freeze-thaw damage. • Sections of the wall have been incorporated into houses, which may add protection to the external face but the treatment of the internal face is not known.
Historical Significance	This section of wall forms part of the south defences of Kilmallock and is incorporated into the town buildings.
Vulnerability	<ul style="list-style-type: none"> • At the west end the wall forms part of actual buildings located along its internal and external faces and have been repaired with cement-based mortar and concrete render in the past. • The internal faces may be vulnerable to unmonitored works. • The remains of the wall that survive may be further impacted during intrusive development, or removal of the adjoining buildings, should that occur.

Guidance Notes	<ul style="list-style-type: none"> • Planning conditions should be applied to proposals of any intrusive works near the line of the wall. • The wall is part of a National Monument and mitigation should include preservation <i>in situ</i>, recording works and visual representation of results through published sources. • The creation of further breaks in the Town Wall should not be allowed.
References	<p>McCutcheon, S. 2003 'Orr Street / Wolfe Tone Street, Kilmallock' in I. Bennett (ed.) <i>Excavations 2001</i>, 234, Bray.</p> <p>O'Callaghan, N. 2007 'Kilmallock' in I. Bennett (ed.) <i>Excavations 2004</i>, 244, Bray.</p> <p>O'Connor, J. 2002a 'Abbeyfarm, Kilmallock' in I. Bennett (ed.) <i>Excavations 2000</i>, 192, Bray.</p> <p>O'Donovan, E. 1998 'Wolfe Tone Street, Kilmallock' in I. Bennett (ed.) <i>Excavations 1997</i>, 115-6, Bray.</p> <p>O'Donovan, E. 1998a 'Wolfe Tone Street, Kilmallock' in I. Bennett (ed.) <i>Excavations 1997</i>, 116, Bray.</p> <p>Wiggins, K. 2004 'Lord Edward Street, Kilmallock' in I. Bennett (ed.) <i>Excavations 2002</i>, 327, Bray.</p> <p>Wiggins, K. 2004 'Lord Edward Street, Kilmallock' in I. Bennett (ed.) <i>Excavations 2002</i>, 327-328, Bray.</p>

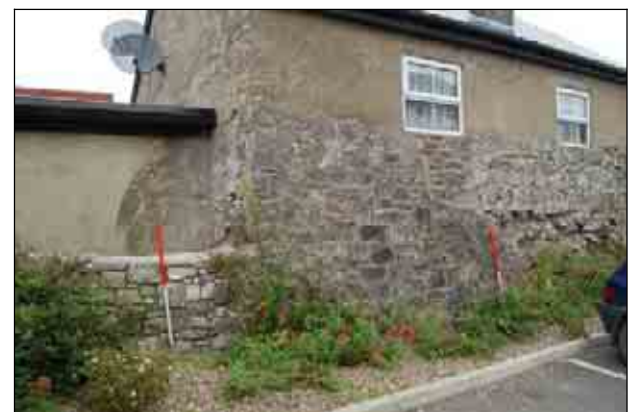
Exterior face of wall by house, looking north

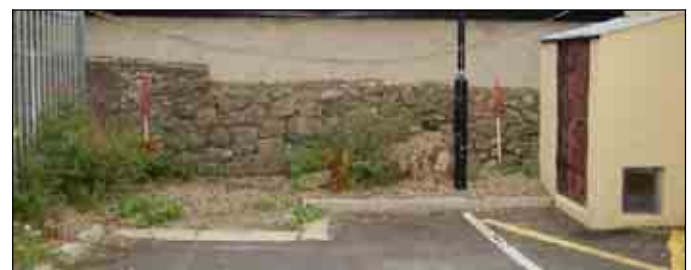
South-west end of wall, looking north-west

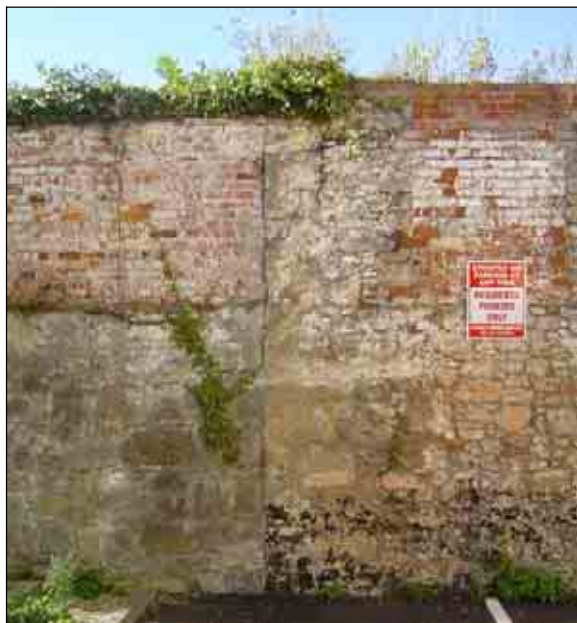
Exterior face of wall, looking north-west

Statutory Protection	National Monument; RMP LI047-022 Kilmallock Town; RPS M(47)M6-Town Wall.
Condition	Elements of the original wall may survive, incorporated in the existing structure which contains 19 th and 20 th century brick and repointing.
Historical Significance	This section of the wall formed the south boundary of Kilmallock.
Vulnerability	<ul style="list-style-type: none"> • The upstanding wall maintains the line of the original Town Wall, which may be more complete below-ground. • The interior face is largely neglected and overgrown.
Guidance Notes	<ul style="list-style-type: none"> • The wall is part of a National Monument and mitigation of further works in the locality should include preservation <i>in situ</i>, recording works and visual representation of results through published sources. • Vegetation should be removed or cut back from the interior face of the wall and consolidation works carried out. • A scheme of monitoring the condition of the wall and vegetation growth should be implemented.

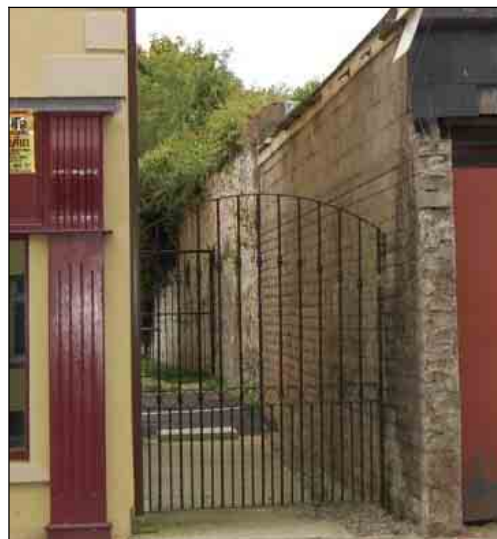
Line of Town Wall, looking west

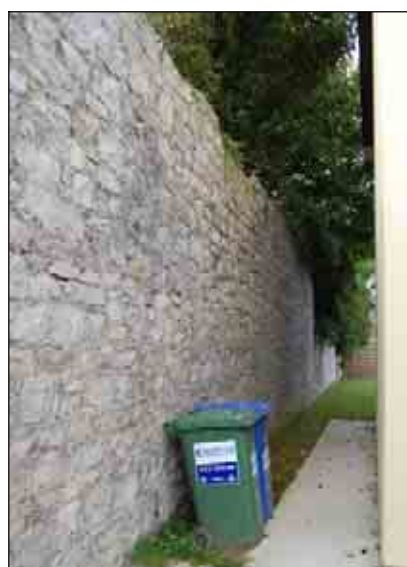
West end of Town Wall, looking north-west

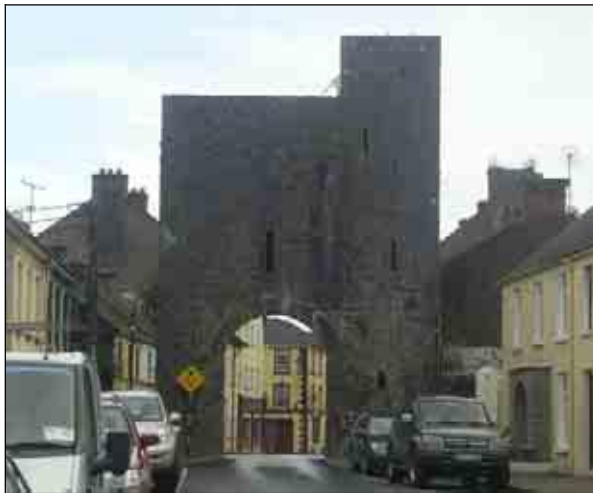
External face of Blossom Gate, looking east

Statutory Protection	National Monument – Blossom Gate (under ownership of Limerick County Council); RMP LI047-022 Kilmallock Town; RPS M(47)31 – Blossom Gate.
Condition	The gate has been repointed in places and a 20 th century roof has been applied, thereby reducing water ingress and aiding the longevity of the building.
Historical Significance	<ul style="list-style-type: none"> • Blossom Gate formed the west entrance into the town and the connection with the Town Wall survives, although fragmented. • Blossom Gate is the only gate still standing.
Vulnerability	<ul style="list-style-type: none"> • The gate has recently been consolidated, leading to its longevity. • Traffic passing through the gate may cause damage through potential impact or fumes. The road is continuously busy and viewing the gate is hazardous. • The exposed ends of the Town Wall and the adjoining stones on the north face of the gate are vulnerable to degradation and over time could reduce the visible relation between the two structures.

Guidance Notes	<ul style="list-style-type: none"> • Planning conditions should be applied to development proposals of any intrusive works in close proximity to the gate or the line of the adjoining Town Wall or for any alterations to the standing structures. • The gate is part of a National Monument and mitigation of further works in the locality should include preservation <i>in situ</i>, recording works and visual representation of results through published sources. • The views towards the gate should be protected as it forms one of the main landmarks of the town.
References	O'Connor, J. 2002a 'Abbeyfarm, Kilmallock' in I. Bennett (ed.) <i>Excavations 2000</i> , 192, Bray. Thomas, A. 1982 <i>Walled Towns of Ireland volume 2</i> . Dublin.

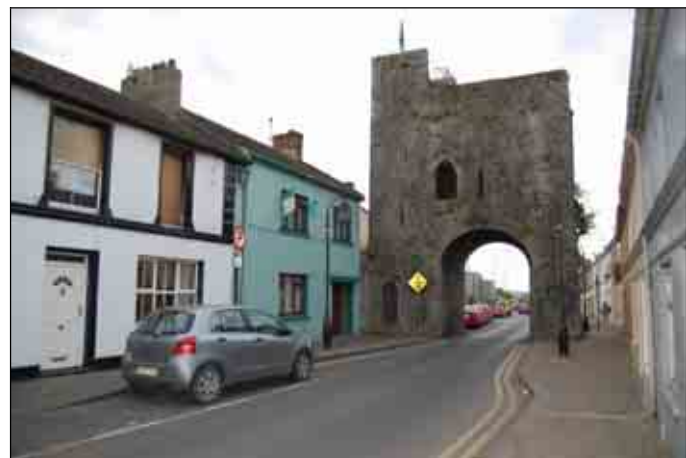
Internal face of Blossom Gate, looking south-west

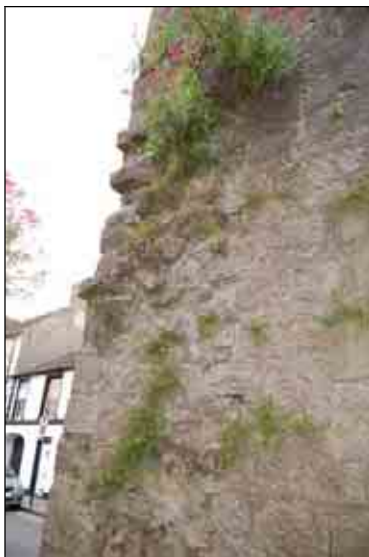
North face of Blossom Gate, showing scar of Town Wall, looking south-east

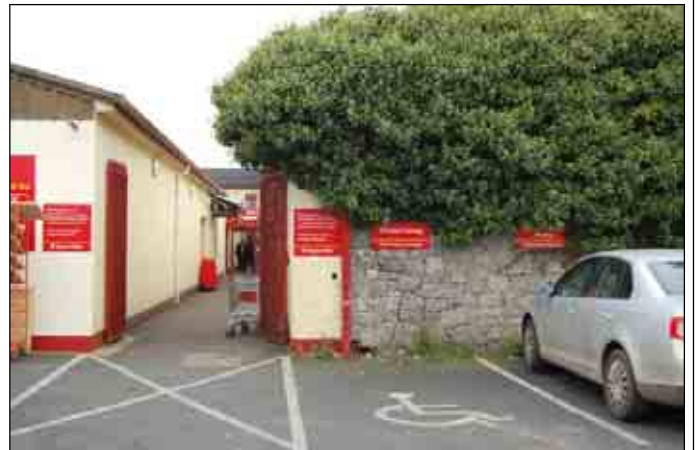
Supermarket entry in south end of Town Wall, looking east

Statutory Protection	National Monument; RMP LI047-022 Kilmallock Town; RPS M(47)M60-Town Wall.
Condition	The Town Wall has become damaged over time, including the loss of facing stones exposing the vulnerable rubble core. Vegetation has taken hold of the wall. Its removal has caused major collapse in places. Holes have been created in the wall, where stones have fallen out, endangering the stability of the surrounding stones and the rubble core of the wall. The wall has been repointed in places with cement-based mortar that may result in trapped water and freeze-thaw action. Fallen stones, vegetation debris and other materials have collected around the base of the exterior face, while the ground level has risen considerably on the interior of the wall, possibly adding stress on the structure.
Historical Significance	This section of the Town Wall forms the original west boundary of Kilmallock.

Vulnerability	<ul style="list-style-type: none"> • The exterior of the wall borders rough pasture that is not accessible to the general public. • The wall is very fragmented in places and is in risk of collapse. • A section of the wall by the supermarket has been removed, thereby breaking the continuity of the structure. • The careless removal of vegetation and neglect for failing sections of the facework has caused collapse of areas of the wall.
Guidance Notes	<ul style="list-style-type: none"> • The wall is in urgent need of consolidation works, following careful removal and trimming of vegetation on both sides. Vegetation growth and the state of the wall should be monitored to address any immediate problems. • The ground surface of this area has been radically altered since 1999. Three excavations have already plotted the line of the ditch. • A topographic survey should be completed on the exterior of the wall to record the fosse and any other related features. • The stables which abut the exterior face of the wall should be removed. • Planning conditions should be applied to development proposals of any intrusive works in close proximity to the Town Wall and development should not be permitted within 15-20m of either side. • The wall is part of a National Monument and mitigation of further works in the locality should include preservation <i>in situ</i>, recording works and visual representation of results through published sources.

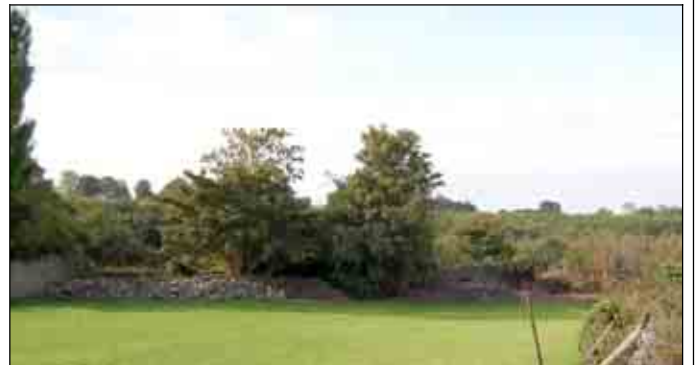
Internal face of Town Wall, north of the stables, looking west

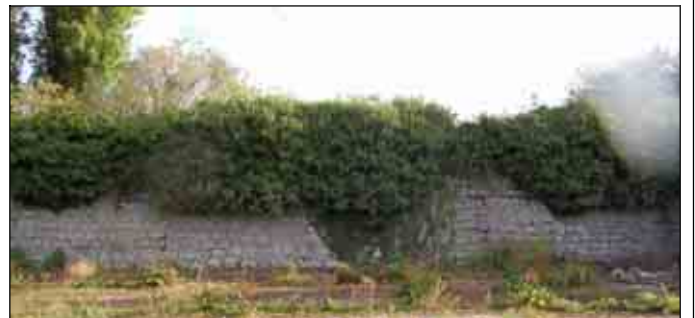
Section of Town Wall to the north of stables, looking east

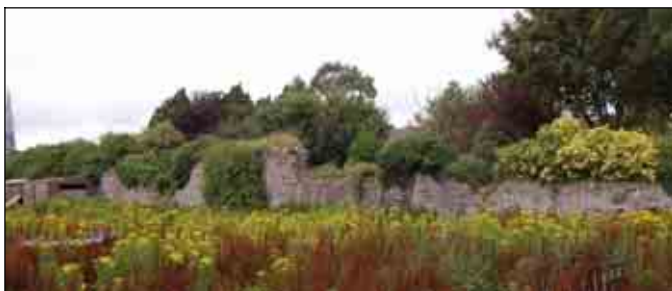
Section of Town Wall, north of supermarket to stables, looking north-east

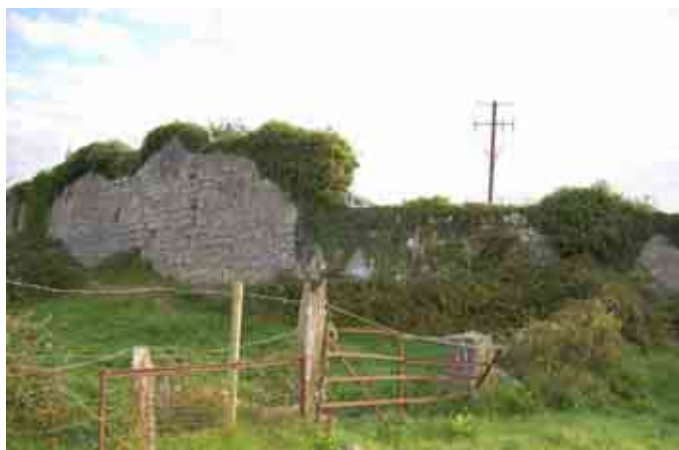
Exterior face of angle in Town Wall, looking east

Statutory Protection	National Monument; RMP LI047-022 Kilmallock Town; RPS M(47)M60-Town Wall.
Condition	<ul style="list-style-type: none"> • The wall has become damaged over time, where facing stones have fallen out, exposing the vulnerable rubble core. • Vegetation has taken hold of sections of the wall, causing major collapse in places. • A build-up of land on the interior of the wall may encourage ground water to seep into the structure. • Loss of facing stones from the exterior face has exposed the footings of the wall, making it vulnerable to weather action and possibly reducing stability.
Historical Significance	This section of wall forms the junction with the ditch that marks the original northern extension to Kilmallock.
Vulnerability	<ul style="list-style-type: none"> • The wall is fragmented in places, causing instability. The failing sections of the facework and vegetation growth adds to the instability of this section of wall. • The presence of water-logged ground on the exterior may cause instability of the wall.

Guidance Notes	<ul style="list-style-type: none"> • The wall is in urgent need of consolidation works, following careful removal and trimming of vegetation. • The Town Wall should be monitored to address any new areas of instability. • Planning conditions should be applied to development proposals for any intrusive works in proximity to the Town Wall. • The wall is part of a National Monument and mitigation of further works in the locality should include preservation <i>in situ</i>, recording works and visual representation of results

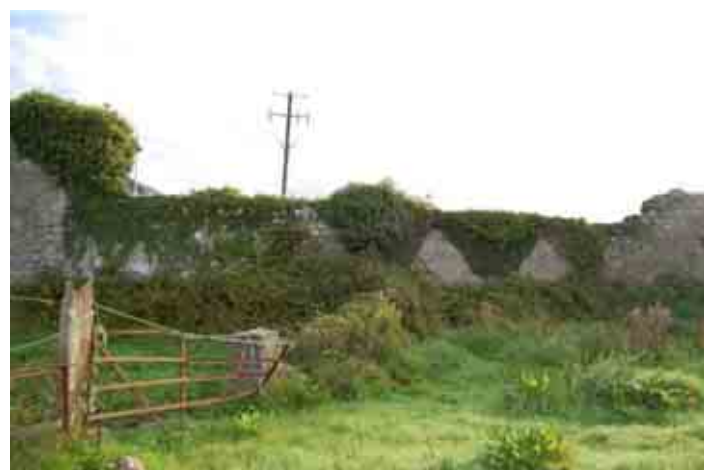
Lower section of Town Wall to south of angle, looking east

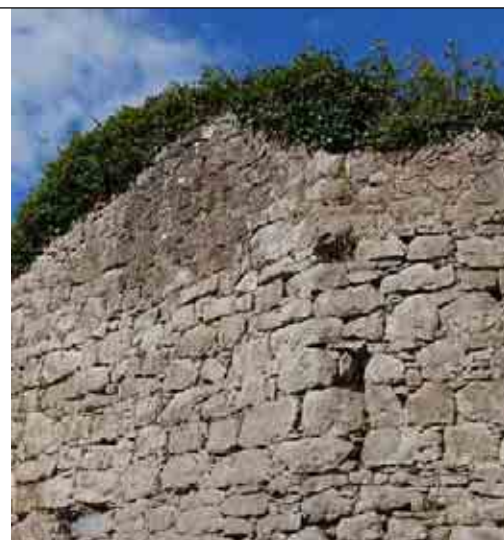
Angled facing stones at corner, with two faces, above smaller stones marking top of construction stage, looking east

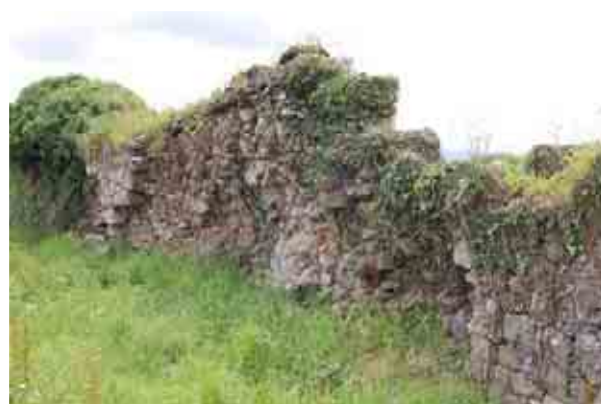
Interior face of Town Wall, with exposed rubble core, looking south-west

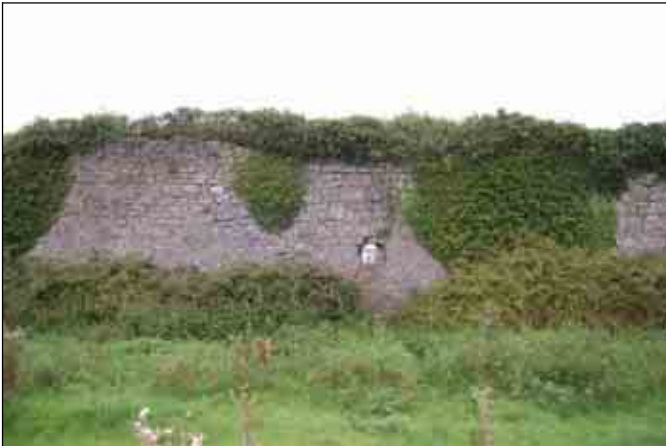
Background and Description:
The wall continues north at a height of over 4m on the exterior, with footing stones protruding from the base. Sections of the exterior and interior faces have become degraded, exposing the rubble core. A hole has formed in the wall, which may have initially been an opening, due to what appears to be a dressed stone in the exterior face and a splay to the interior. However, stones have fallen out from the opening, making the hole larger and potentially weakening the structure around it. The hole is 1.3 x 1m and c.2.3m from the top of the exterior face.

Hole in exterior of wall, looking east

Statutory Protection	National Monument; RMP LI047-022 Kilmallock Town; RPS M(47)M60-Town Wall.
Condition	<ul style="list-style-type: none"> • The wall has become damaged over time, where facing stones have fallen out, exposing the vulnerable rubble core. • The wall has been rebuilt in places with cement-based mortar, which alters the entire character of the structure. • The north end section of the wall has been entirely removed although remains may survive below-ground. • The fosse is evident from the angle to south of the bastion.
Historical Significance	<ul style="list-style-type: none"> • This section of the Town Wall forms part of the northern extension to Kilmallock. • Sections of parapet are preserved as evidence of a narrow wall-walk. • The fosse to the exterior may be part of the northern extension of the town or may represent the defences of a northern area of the town that was not formalised until the building of a stone wall.

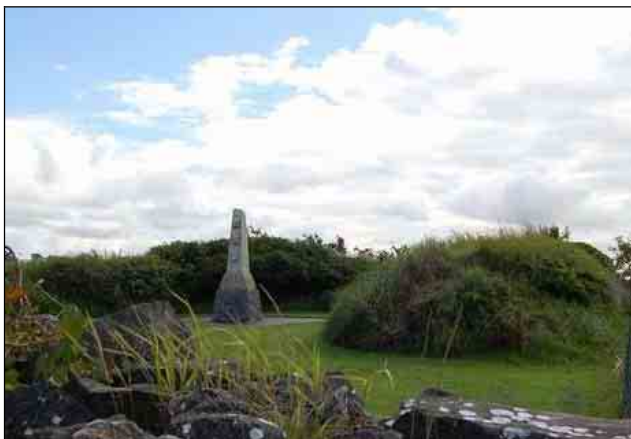
Bastion on exterior of Town Wall, looking west

Statutory Protection	National Monument; RMP LI047-022 Kilmallock Town; RPS M(47)M60-Town Wall.
Condition	The bastion appears to be stable and the vegetation adds support and protection.
Historical Significance	The bastion forms part of the defences for the north-west corner of Kilmallock added in the 17 th century.
Vulnerability	<ul style="list-style-type: none"> • The bastion is accessible to be walked on, which may lead to wear, if not monitored. The vegetation helps protect it, but could mask its shape and penetrating roots may now be integrated throughout the structure. • A number of wire mesh fences with concrete poles are situated between the bastion, the Town Wall and the school, which have become degraded.
Guidance Notes	<ul style="list-style-type: none"> • Planning conditions should be applied to any development proposals of intrusive work within the vicinity of the bastion. • The bastion is part of a National Monument and mitigation of further works in the locality should include preservation <i>in situ</i>, recording works and visual representation of results through published sources. • Vegetation should be monitored to minimise destabilisation of the bastion through root growth or the masking of its shape. The degraded wire mesh fences should be removed and replaced by new and more effective boundary markers.

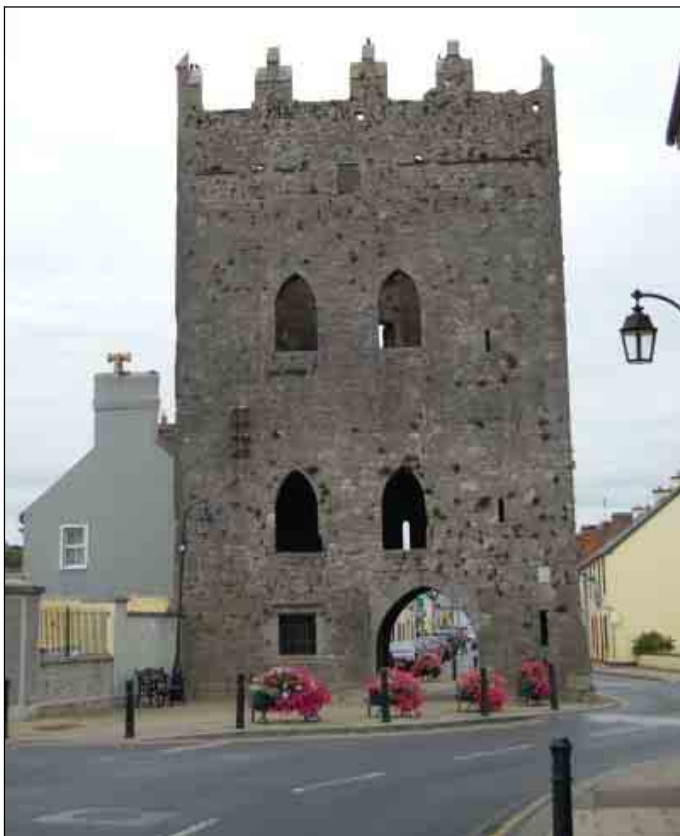
The building is also shown on the first and second edition OS maps (1829-41 and 1897-1913). Petrie's engraving of 1825 shows the south face of King's Castle, at the north end of Sarsfield Street and Mulvaney's painting of 1829 shows the same viewpoint.

King's Castle, looking north

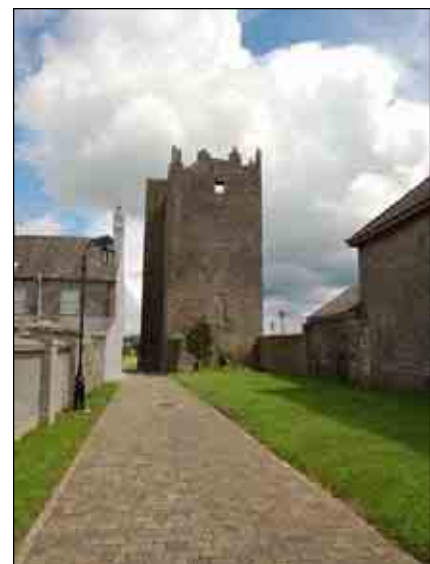
King's Castle, looking east

Statutory Protection	National Monument no. 173 – King's Castle (under ownership of National Monuments Service and managed by OPW); RMP LI047-022 Kilmallock Town; RPS M(47)30 – King's Castle.
Condition	<ul style="list-style-type: none"> • The tower is solidly built but has been repointed with cement-based mortar in places, which may trap water, encourage freeze-thaw action. • The roofing inside the tower needs to be repaired to minimise water ingress.
Historical Significance	<ul style="list-style-type: none"> • The site of King's Castle marks the original north entrance of Kilmallock, prior to the extension of the town and defences. • The tower was continuously used throughout the post-medieval history of the town and dominates the main street.
Vulnerability	<ul style="list-style-type: none"> • The tower is in need of consolidation works, to minimise water ingress and pigeon habitation. • The traffic has been diverted around the east side and bollards have been placed to

protect it and pedestrians from impact.
Guidance Notes	<ul style="list-style-type: none"> • Consolidation works should be completed on the King's Castle, including archaeological recording of exposed features and phases of construction. • Planning conditions should be applied to development proposals of any intrusive works in close proximity to the castle or for alteration works to the structure itself. • Mitigation should include preservation <i>in situ</i> and recording works and visual representation of results through published or display sources. • There are display panels by the memorial cross to the east which should be updated to include information about the King's Castle and the significance of its setting, in light of recent archaeological discoveries.

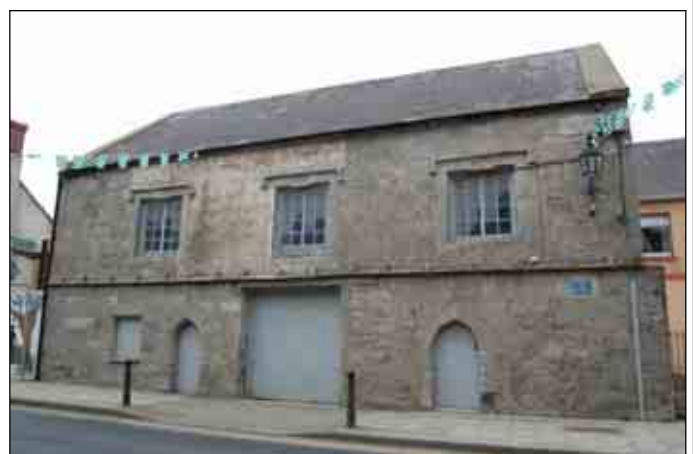
Medieval Mansion, looking south-west

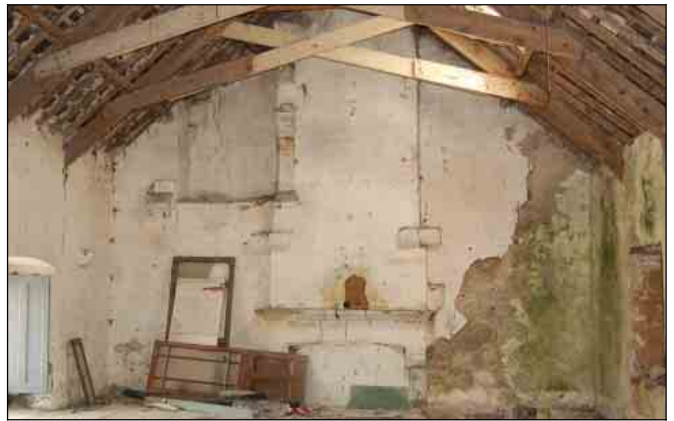
Interior of mansion, south end of first floor, looking south

Statutory Protection	National Monument no. 680 (in ownership of National Monuments Service); RMP LI047-022 Kilmallock Town; RPS M(47)36 – South of King's Castle on west side of road, a stone two storey house.
Condition	The mansion is in a degraded condition, due to previous water ingress and neglect. The internal wooden elements such as the stairs and floorboards have degraded, due to water ingress. The OPW, however, have recently weather-proofed the building.
Historical Significance	The mansion is one of the most complete, last remaining stone-built houses on the high street that illustrate the prosperity of the 16 th century town.
Vulnerability	The mansion is vulnerable to further degradation, particularly to the rear.
Guidance Notes	<ul style="list-style-type: none"> • The mansion should be brought into a sustainable use. • A historic building recording should be undertaken, to record the current condition of the building and to compare it with the surviving elements of Sarsfield House and those recorded by Arthur Hill (Leask, 1941).

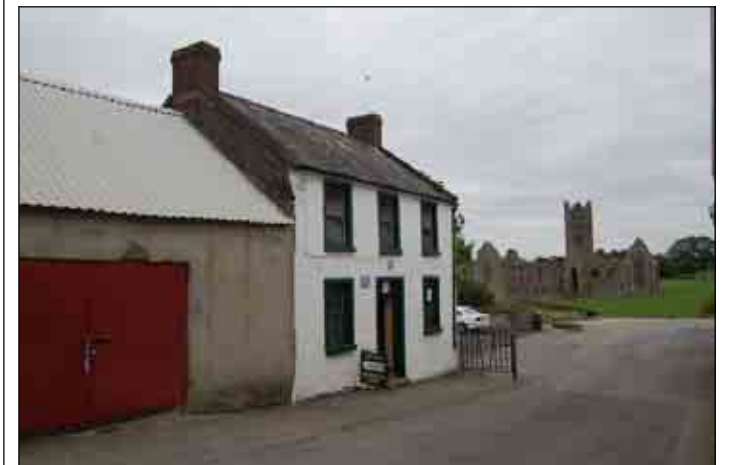
The Museum, looking north-east

Statutory Protection	RMP LI047-022 Kilmallock Town
Condition	The museum appears to be in good condition and is used and maintained. The adjoining barn could cause damp problems for the museum, if it is not in use or maintained.
Historical Significance	The museum is an historic preserved cottage and contains an assortment of artefacts that record elements of the history of Kilmallock.
Vulnerability	<ul style="list-style-type: none"> • The museum contents are possibly not catalogued and further objects are stored in the loft, which might include some valuable connections to Kilmallock's past. • The museum is staffed by an attendant provided to the Kilmallock Historical Society by Ballyhoura Fáilte.
Guidance Notes	<ul style="list-style-type: none"> • The museum should be examined for the need of consolidation works. • The display should be re-organised to rotate the collection and show the items more clearly. Lighting would enhance the viewing of the collection. • Varied opening hours might cater for more visitors.

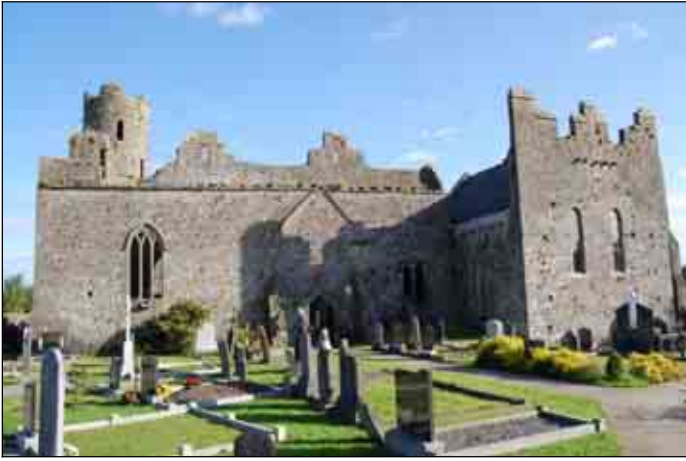
South face of Collegiate Church, looking north

Statutory Protection	National Monument no. 408 – Collegiate Church of Saints Peter and Paul (under ownership of National Monuments Service); RMP LI047-022 Kilmallock Town; RPS M(47)38 – Collegiate Church.
Condition	<ul style="list-style-type: none"> • The Church is solidly built and has been repointed in places, some of which may be cementitious mortar. • The south transept is roofed and sealed from the weather, adding to its longevity, while the remainder of the Church is open to the elements.
Historical Significance	The Church contains remains of pre- Anglo-Norman architecture.
Vulnerability	The Church is maintained at present, which ensures that the exposed sections do not deteriorate.
Guidance Notes	Larger family monuments should be subject to planning permission.
References	Bradley, J., Halpin, A. and King, H.A. 1989 <i>The Urban Archaeology Survey: Part 17 (iii) County Limerick</i> . OPW, unpublished.
