Kilmallock Town Walls Conservation and Management Plan

KILMALLOCK TOWN WALLS
CONSERVATION AND MANAGEMENT PLAN

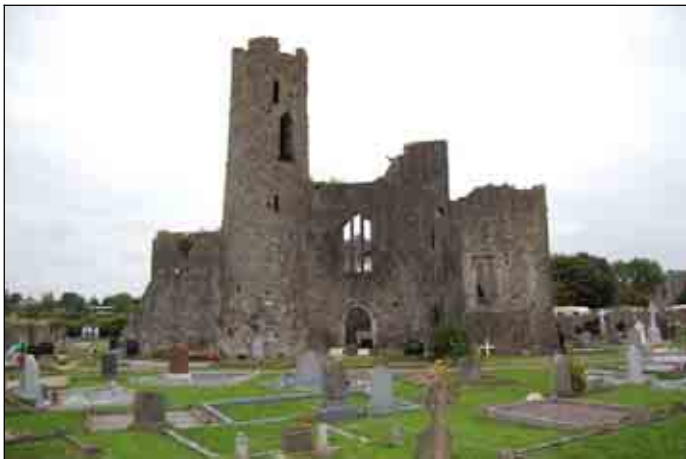
West face of Collegiate church, looking east

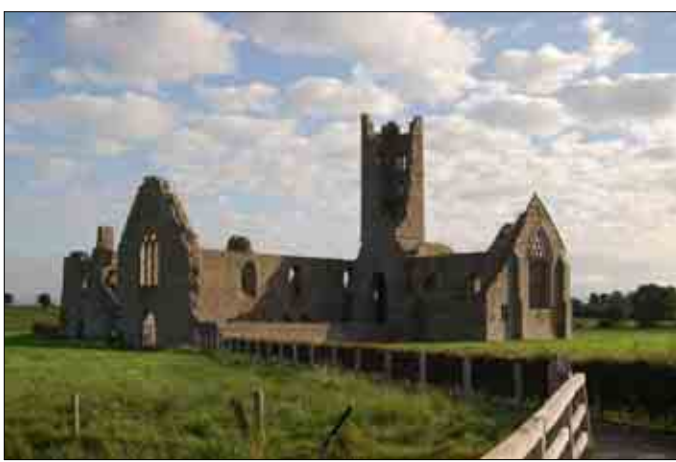
Priory, looking north-east

Statutory Protection	National Monument no. 212 – Dominican Priory (under ownership of National Monuments Service, DoEHLG, maintained and managed by the OPW); RMP LI047-022 Kilmallock Town; RPS M(47)25 – Dominican Abbey.
Condition	<ul style="list-style-type: none"> • The Priory is solidly built and has been repointed in places, some of which is 19th century cement-rich lime mortar and 21st century lime mortar. • The Priory is open to the elements and requires monitoring for degradation.
Historical Significance	<ul style="list-style-type: none"> • The Priory was one of the Anglo-Norman additions to Kilmallock and dominates the east riverbank. • The Priory is visible from many points around the town.
Vulnerability	<ul style="list-style-type: none"> • The Priory is maintained and its condition is monitored. • The surrounding field may contain below-ground remains that might add to the knowledge of the Priory.

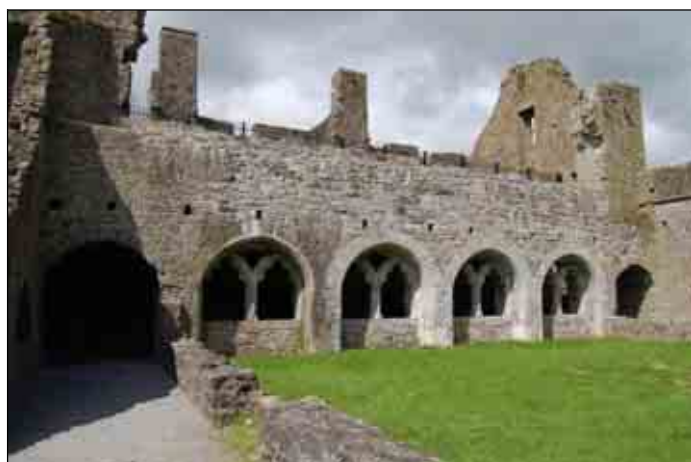
Detail of cloisters, looking north-east

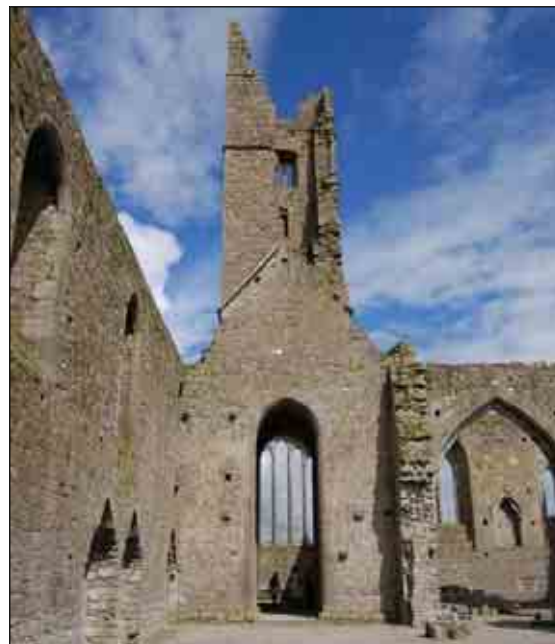
Nave and chancel of Priory, looking east

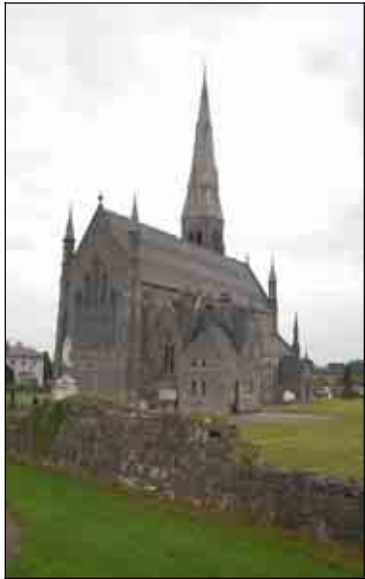
Church of SS Peter and Paul, looking north-east

Statutory Protection	RMP LI047-022 Kilmallock Town; RPS M(47)13 – Catholic Church.
Condition	The church appears to be in good condition and is in constant use and maintained.
Historical Significance	The church is part of the 19 th century additions to Kilmallock.
Vulnerability	<ul style="list-style-type: none"> • The removal of the Town Wall around the west and north boundaries of the church grounds have led to a break in connection between the west and east sections of the Town Wall. • Remains of the Town Wall may survive below-ground.
Guidance Notes	<ul style="list-style-type: none"> • Planning conditions should be applied to development proposals for any intrusive works along the line of the wall by the churchyard. • Mitigation should include preservation <i>in situ</i> and recording works and visual representation of results through published or display sources.

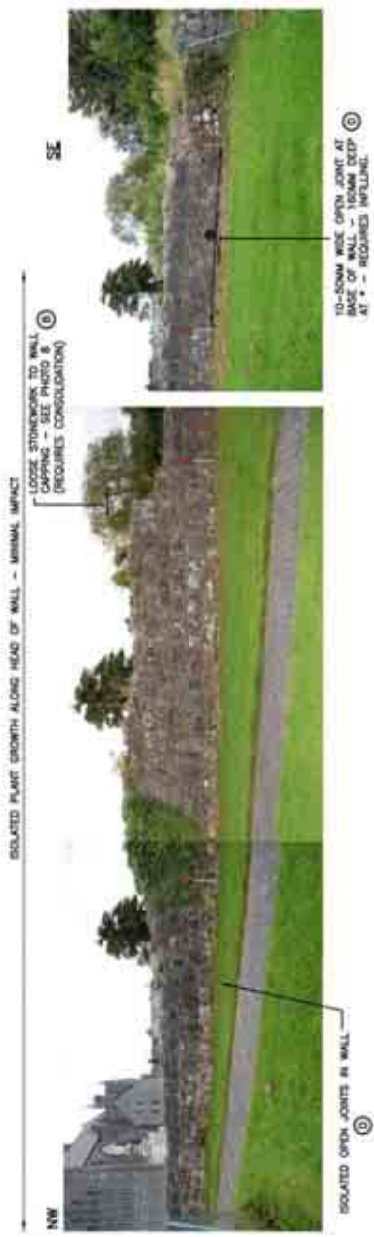
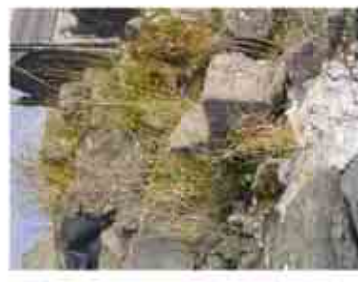
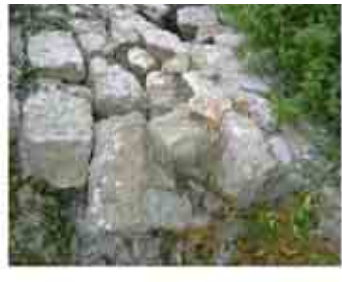
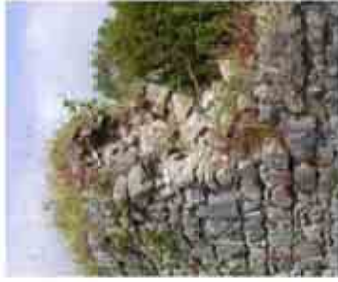
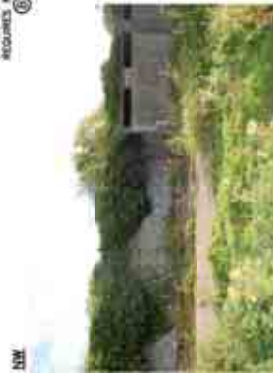
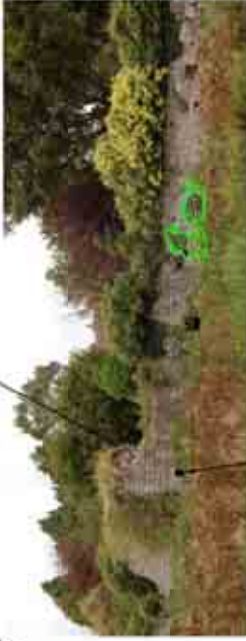
EXTERNAL ELEVATION 5

EXCESSIVE LOSS OF STONE AND POINTING AREA BEGINNING TO WEAR TO RESIST LATERAL SOIL PRESSURE. SEE PHOTO 15. AREA 5M REQUIRES RESETTING AND BEDDING. SEE PHOTOS 16,17,18 & 19.

0.5M LOSS OF FACING STONE.

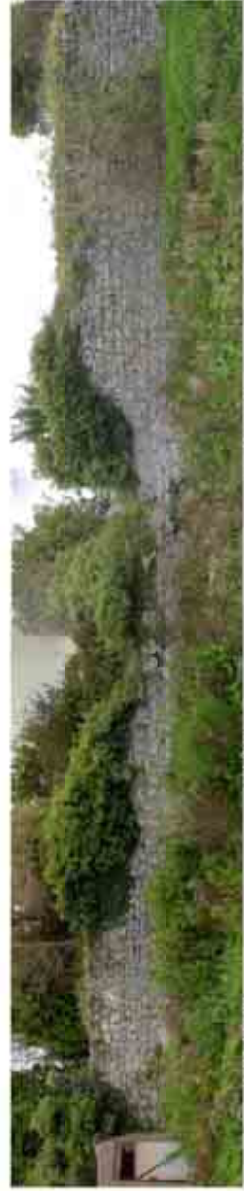
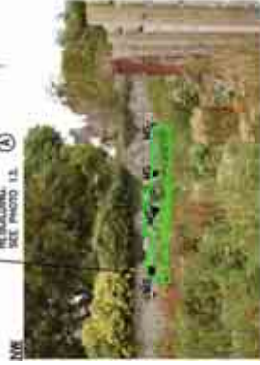
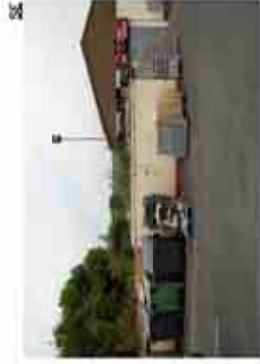
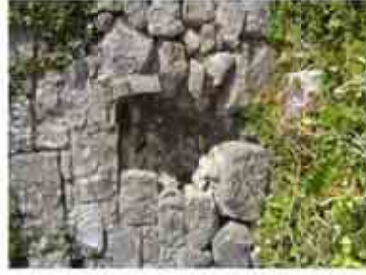
EXTERNAL ELEVATION 7

OPENING TO WALL RELATIVELY SOUND.
EXCESSIVE LOSS OF MASONRY
APPROXIMATELY 3M - REQUIRES
REPAIRING. SEE PHOTO 11.

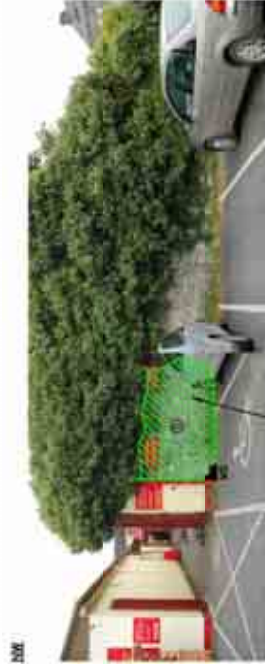
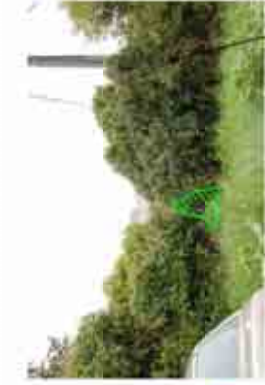
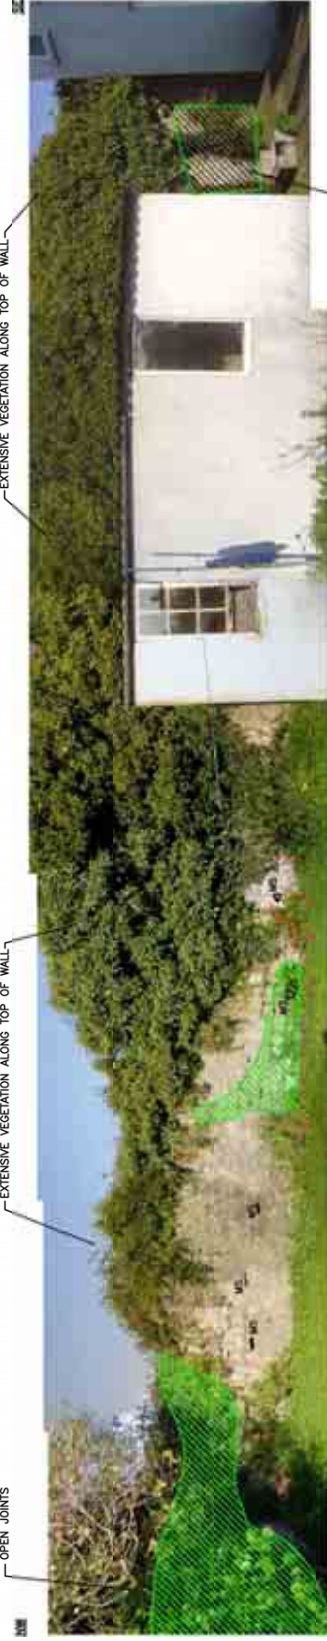
EXTERNAL ELEVATION 8

EXTENSIVE VEGETATION IN FRONT OF WALL -
NO INSPECTION POSSIBLE APART FROM
ISOLATED AREA

OPEN JOINTS AND ISOLATED LOSS OF INFILL STONE (C)

OPEN JOINTS

EXTENSIVE VEGETATION ALONG TOP OF WALL

ISOLATED OPEN JOINTS

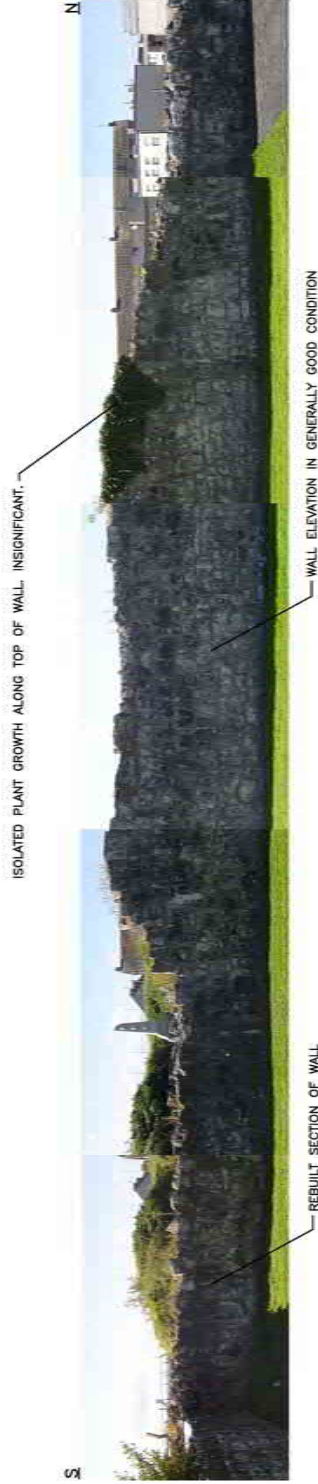
SECTION 1 SHOWN. GOOD CONDITION.
 SECTION 2 GENERALLY OVERGROWN AS VIEWED FROM CHURCH. A FEW ISOLATED MISSING STONES NOTED.
 SECTION 3 SHOWN.

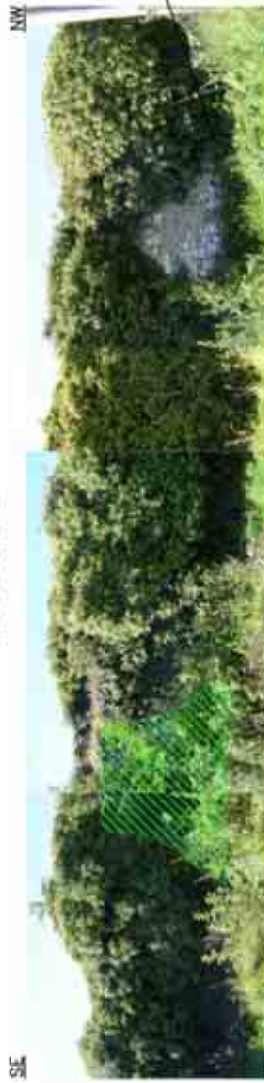
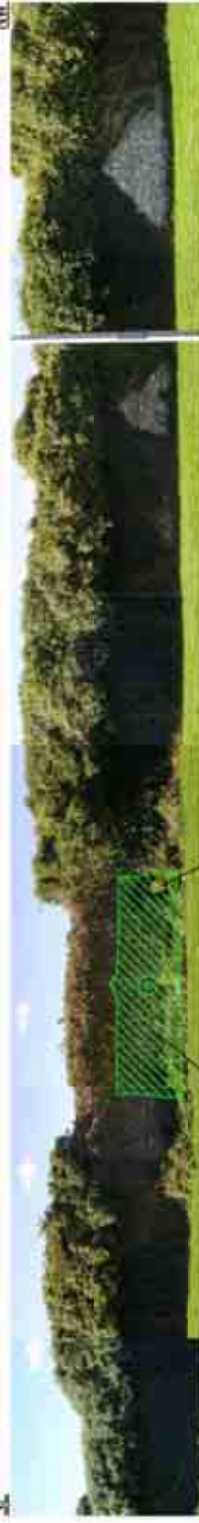
NOTE:
 WALL ELEVATION CURRENTLY ACTING AS A RETAINING WALL. APPROX 2M OF RETAINED SOIL INTERNALLY.
 SECTION 4 NOT ACCESSED
 SECTION 5 SHOWS ISOLATED MISSING STONES. GENERALLY GOOD CONDITION
 SECTION 6 SHOWS GENERALLY GOOD CONDITION
 SECTION 7 SHOWS EXCESSIVE LOSS OF POINTING, REQUIRES REPAIR
 SECTION 8 SHOWS EXCESSIVE NY GROWTH ALONG HEAD OF WALL TO BE CUT BACK.

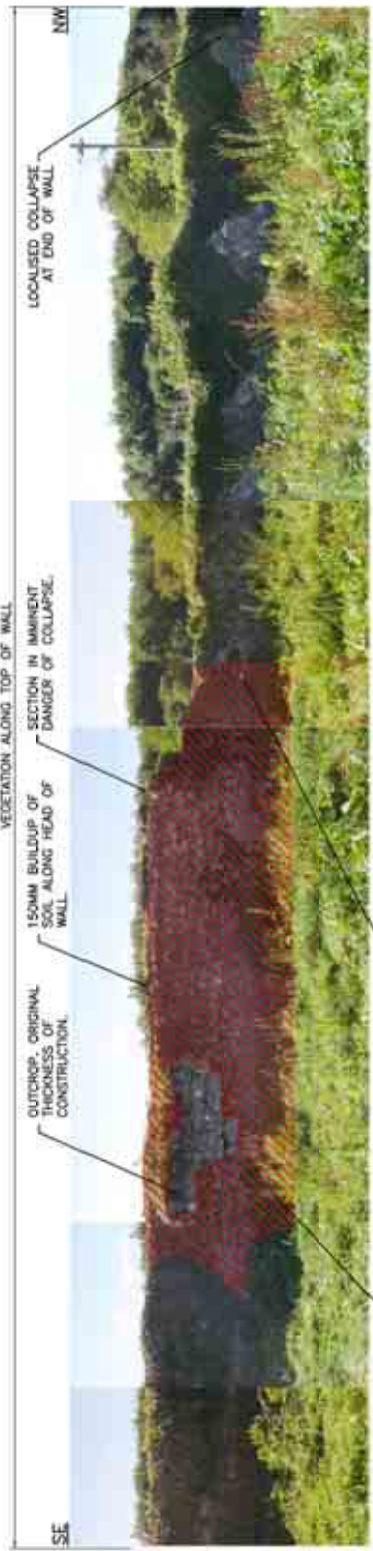
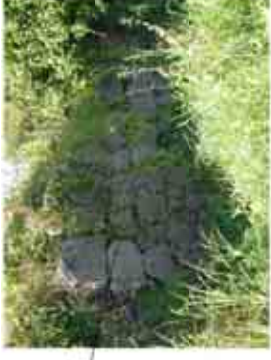
WALL SECTION 9 CONT.

PHOTO 64 & 65. LOSS OF FACEWORK UP TO 350 THICKNESS LOST. CORE REVEALED. URGENT CONSOLIDATION REQUIRED.

VEGETATION GROWTH ALONG WALL TOP. EXTENSIVE LOSS TO INFILL STONE AND POINTING. (B)

NOTE:
 WALL ELEVATION CURRENTLY ACTING AS A RETAINING WALL APPROX 1.5M OF RETAINED SOIL INTERNALLY. SECTION 9 SHOWN. MAJOR LOSS OF FACING STONEWORK. IVY TO BE CUT BACK AND WALL CONSOLIDATED AND REPOINTED.
 SECTION 10 SHOWN. OVERGROWN WITH SOME STONE VISIBLE. SIGNIFICANT LOSS OF INFILL STONE AND POINTING. HEAVILY OVERGROWN ALONG HEAD. REQUIRES URGENT CONSOLIDATION.

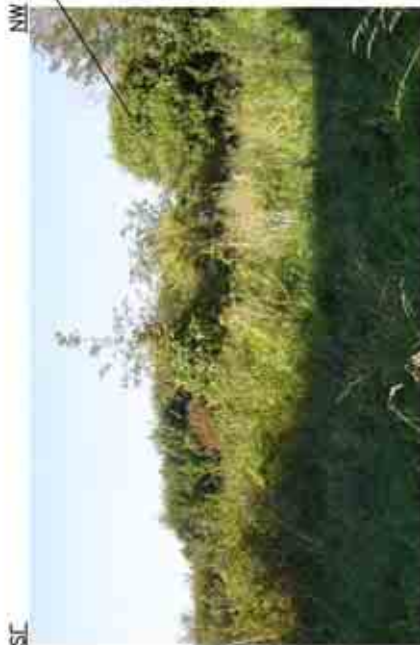
WALL SECTION 11
(WALL SECTION 9 SIMILAR)

NOT POSSIBLE TO VIEW WALL DUE TO VEGETATION GROWTH IN FRONT.

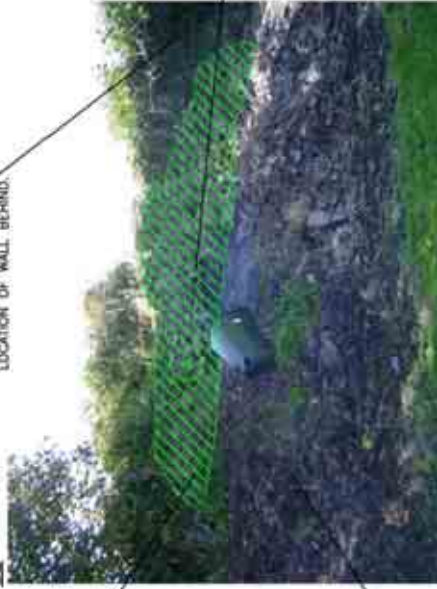
PARTIALLY COLLAPSED SECTION OF WALL. SIGNIFICANT LOSS OF STONE AND POINTING. URGENT REPAIR REQUIRED.

SIGNIFICANT GROUND BUILD UP IN FRONT OF WALL.

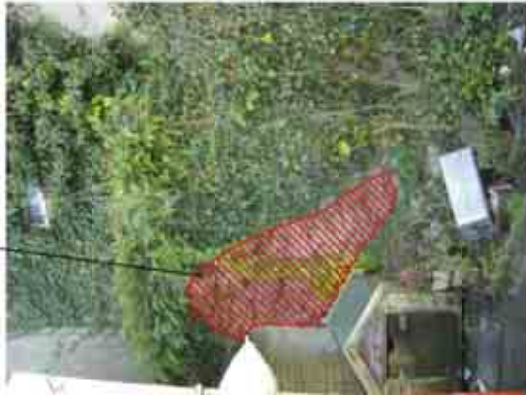
FACEWORK LOST, REPOINTED CORE

NOTE:
 SECTION 15 NOT ACCESSED BUT VIEWED FROM 14. WALL OVERGROWN.
 SECTION 16 NOT ACCESSED.
 SECTION 17, 18, 19 ACCESSED BUT OVERGROWN.
 SECTION 20 NOT ACCESSED.
 SECTION 21 NOT ACCESSED.
 SECTION 22 SHOWN.
 SECTION 23 SHOWN.
 SECTION 24 SHOWN. VEGETATION CONCEALING MUCH OF WALL.

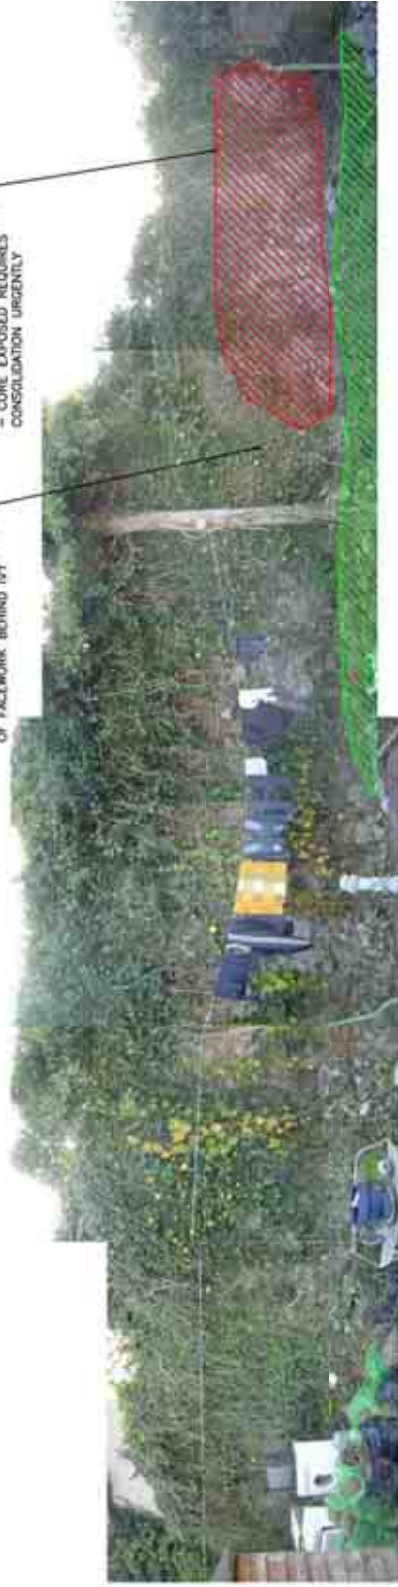
EVIDENCE OF SIGNIFICANT LOSS OF FACEWORK BEHIND IVY

SIGNIFICANT LOSS OF FACEWORK - CORE EXPOSED REQUIRES CONSOLIDATION URGENTLY

NUMEROUS STONES LYING ON GROUND

ELEVATION REQUIRES URGENT CONSOLIDATION TO PREVENT FURTHER LOSS OF STONE

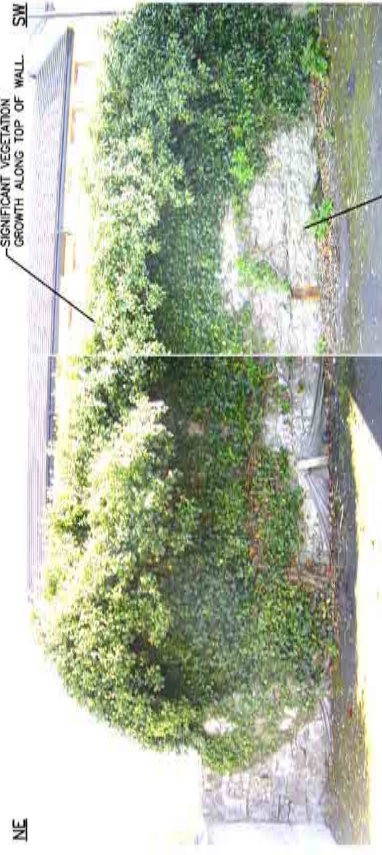
INTERNAL ELEVATION 8

SIGNIFICANT VEGETATION GROWTH ALONG TOP OF WALL

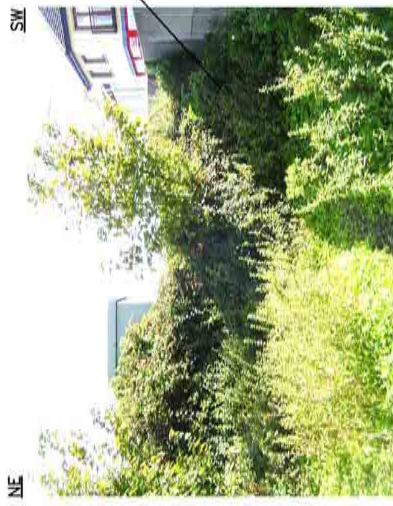
WALL SECTION 39

LOCALISED LOSS OF INFILL STONE AROUND BASE OF WALL (C)

NOTE:
SECTION 36-38 NOT POSSIBLE TO INSPECT.
SECTION 39 SHOWN. NO OBVIOUS DEFECTS.
SECTION 40 SHOWN. CONCEALED BY VEGETATION.

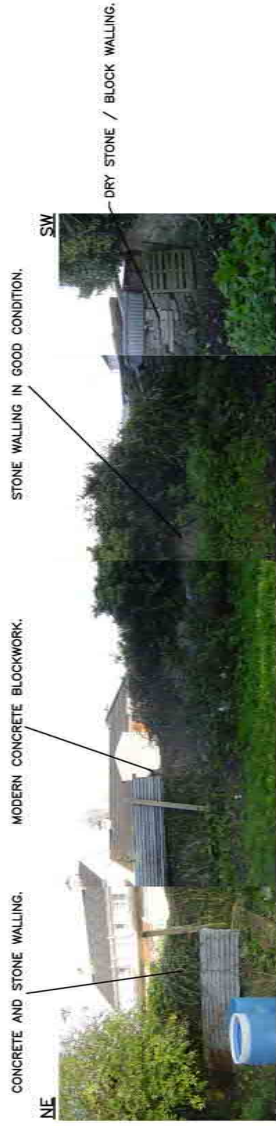
INTERNAL ELEVATION 10

NOTE:
 SECTION 42 SHOWN.
 SECTION 43 NO WALL. POSSIBLE EVIDENCE OF ORIGINAL WALL ON LEFT HAND SIDE.
 SECTION 44 NO WALL VISABLE.
