RINN DÚIN CONSERVATION AND MANAGEMENT PLAN

Blackwood Associates Architects

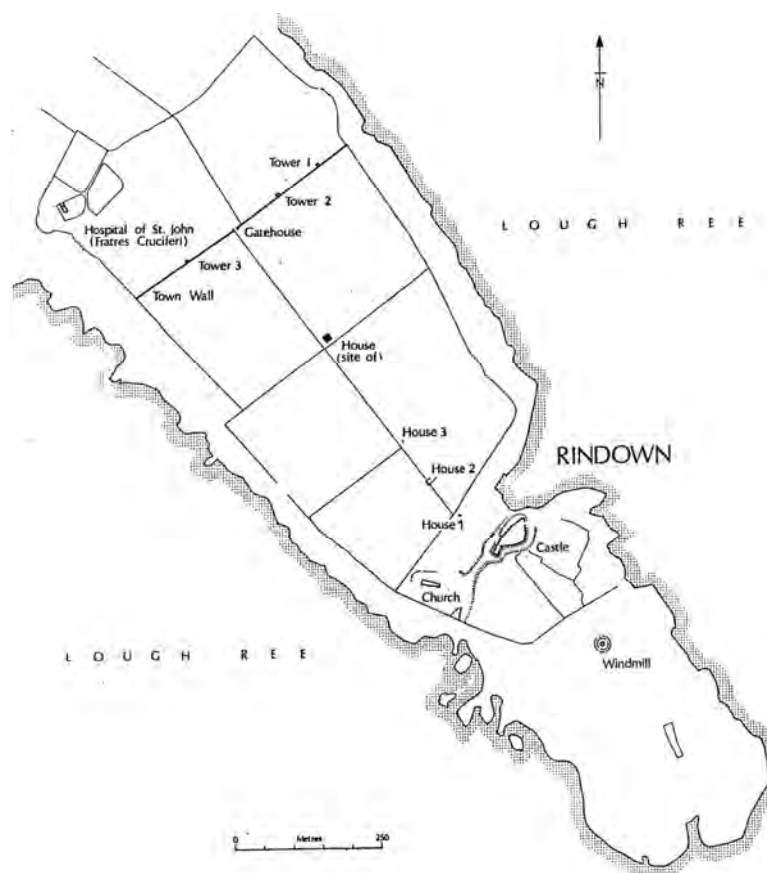
Figure 2.01

Rindown: Outline Plan showing Principal archaeological Monuments and Field boundaries

The site of the Medieval town of Rinn Dúin lies in the fields which are now used for grazing between the castle and the town wall (Figure 2.01). The street pattern was almost certainly linear, running from the gatehouse on the town wall to the entrance to the castle. The surviving house foundations lie along this line.

The remains of this building are situated about 200m NW of the town wall (see Figure 2.01). Only the church, which is oriented almost due south, survives. It is a rectangular structure with an unusual buttressed addition at the north end.

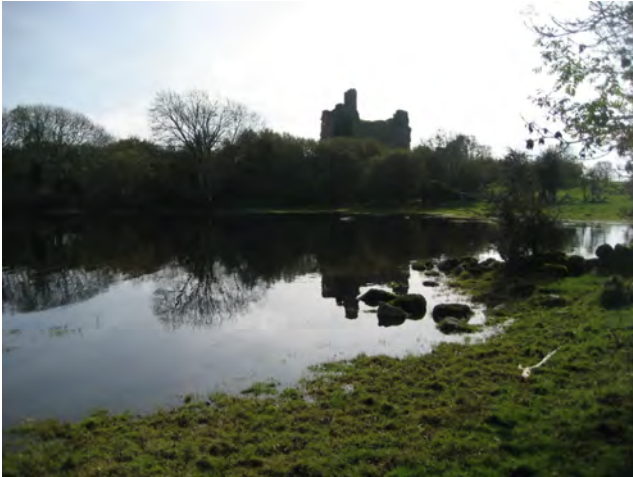
Figure 2.06 Safe Harbour:
The shores reveal remains of the medieval quays and slipway

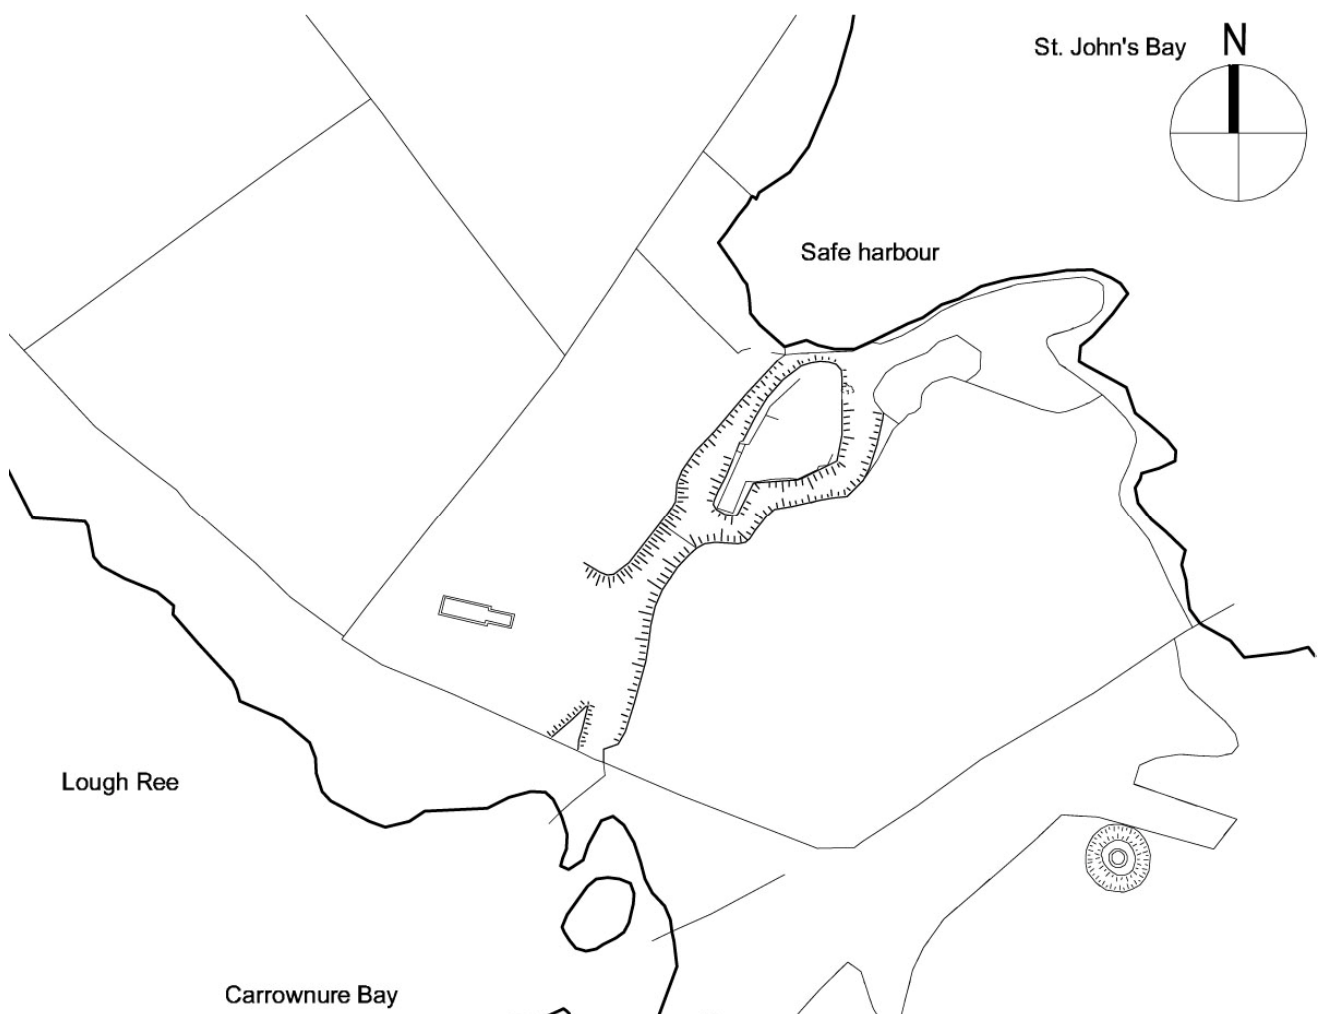
Figure 2.14

Map of the Bank and Ditch Systems that cross the peninsula adjacent the Castle and Parish Church

A NE-SW orientated bank-and-ditch system extends across the peninsula's waist just west of the castle, cutting off the tip. (See Figure 2.14) It consists of two inner banks, a broad ditch, and an outer bank. Interpretation would suggest that it was originally a promontory fort, re-cut at the north-east end to form a surround for the curtain wall of the castle. The date of the fort is unclear, but the place-name indicates that it has a pre-Norman origin. It may have been built in the twelfth century by Toirdelbach Ó Conchobhair or, indeed, it may even be the site of the fortress constructed by the Vikings of Lough Ree in the mid-ninth century.

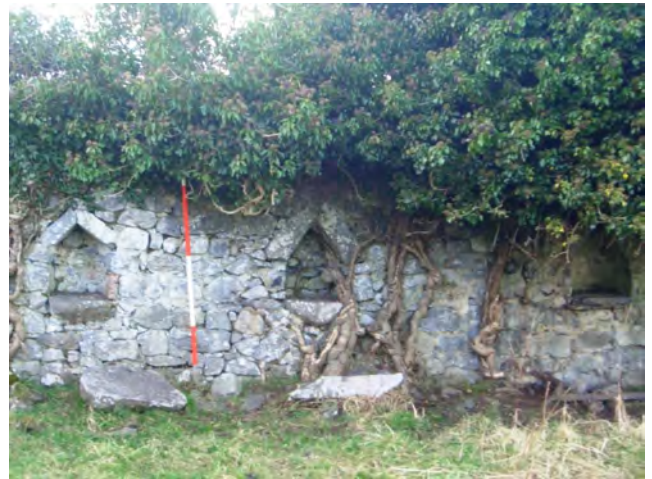
Figure 2.16

Bee-boles

To the north west of the Hospital and Graveyard is a walled garden with three bee boles. The latter are in the form of pointed stone niches located in the north west wall, into which the skeps (woven baskets containing the bee colony) would have been placed. The niches gave some protection to the bees, which would have been kept not only for their honey, but also as pollinators of the fruit trees in the garden. These bee boles are thought to date from around 1700, when the Hodsons owned the land.

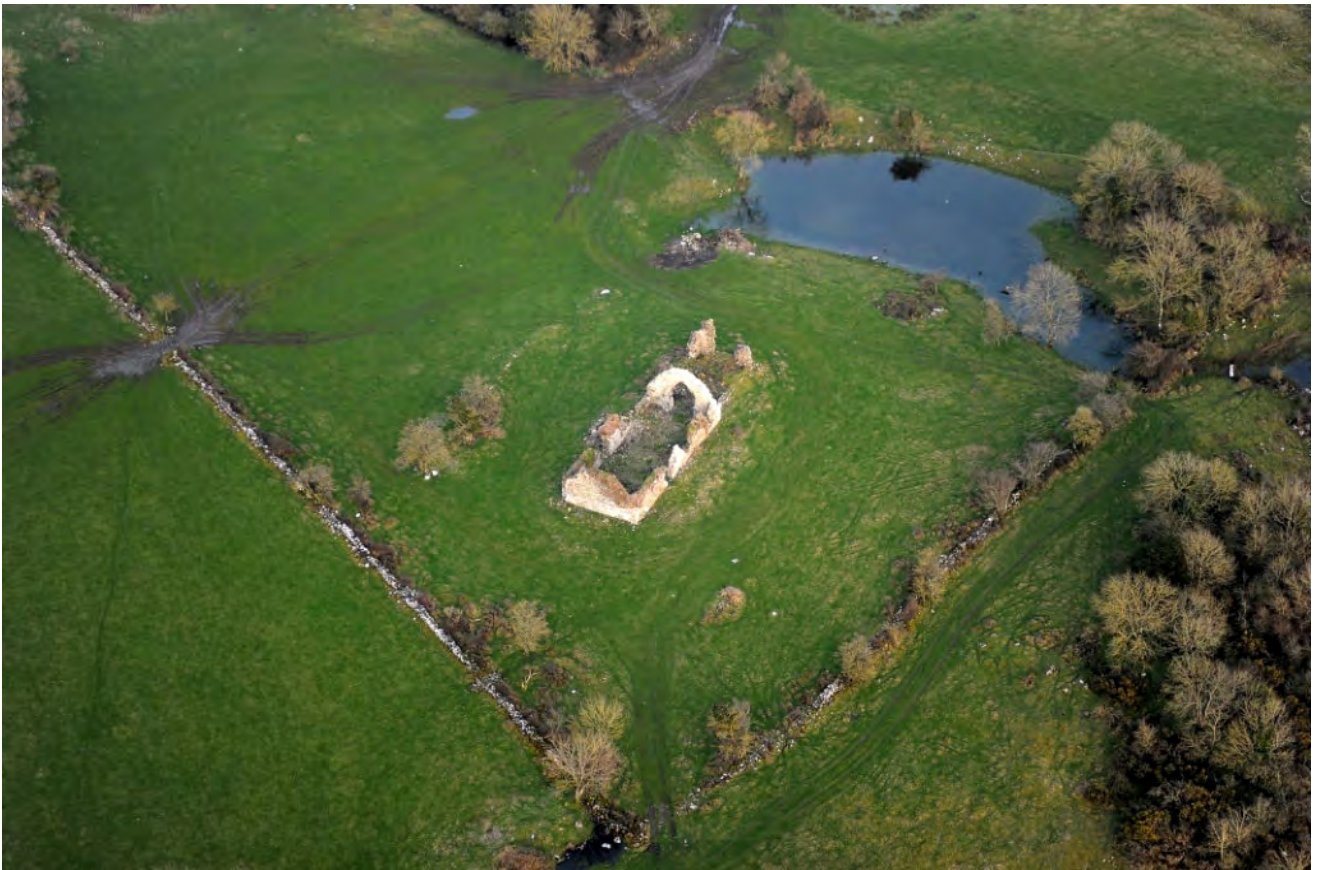
Figure 2.15

Fish Pond with the Parish Church (prior to recent conservation works) in the foreground

The flooded area, to the south east of the parish church, visible in Figure 2.15, below, has been identified as a fish-pond, dating from the medieval settlement of the peninsular. Its boundaries are related to the banks and ditches described above.

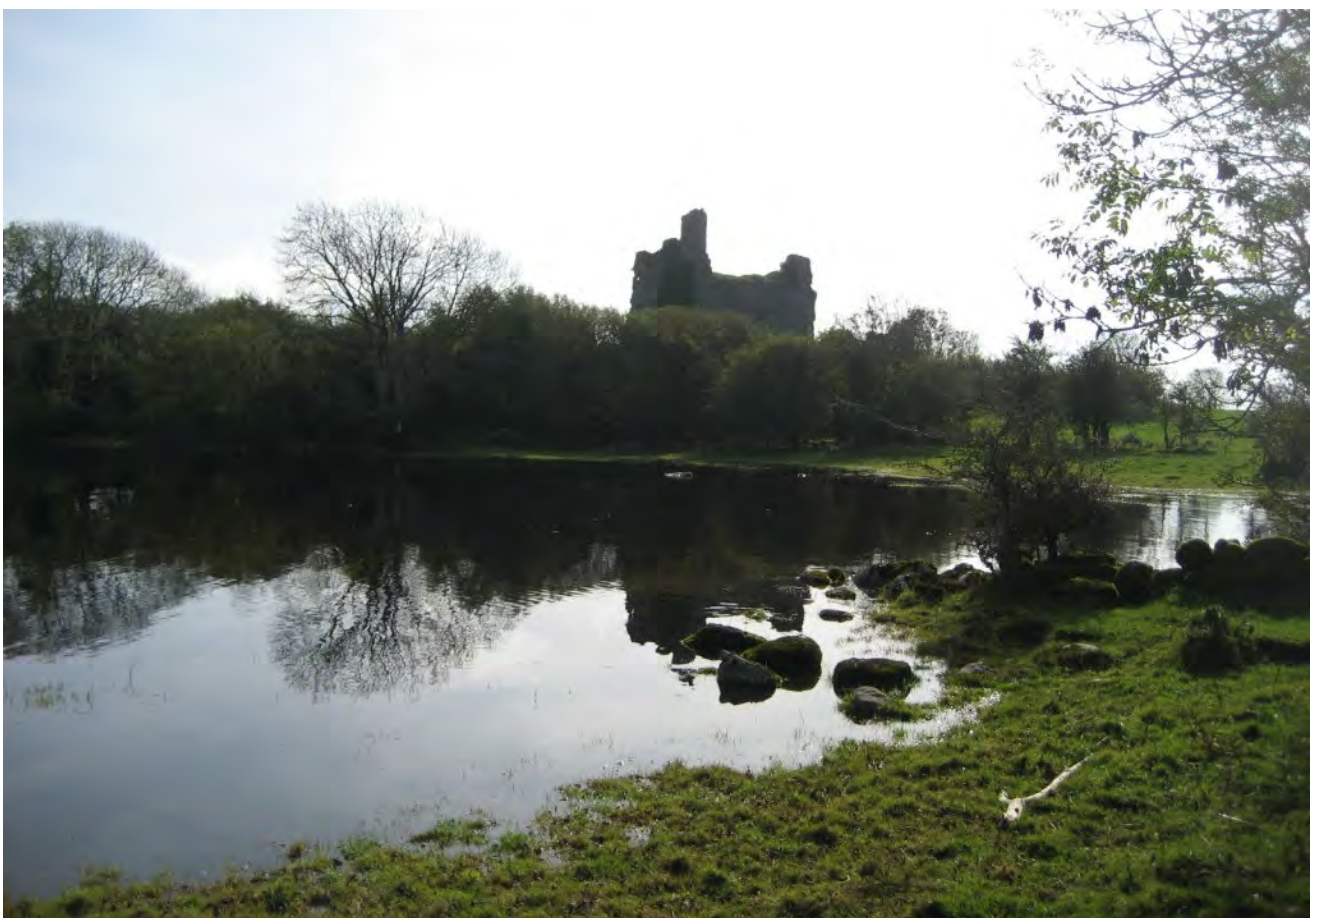
Figure 3.02

Safe Harbour

Safe Harbour is located on the northern shore of the promontory of Rinn Dúin (Fig. 2.01). It is a good sheltered inlet open only to the north east. This protects the inside of the harbour from the predominant south westerlies which can affect boat traffic adversely. The inlet is ideally suited as the landing place and anchorage for the promontory and seems to have been used as such during the site's occupation.

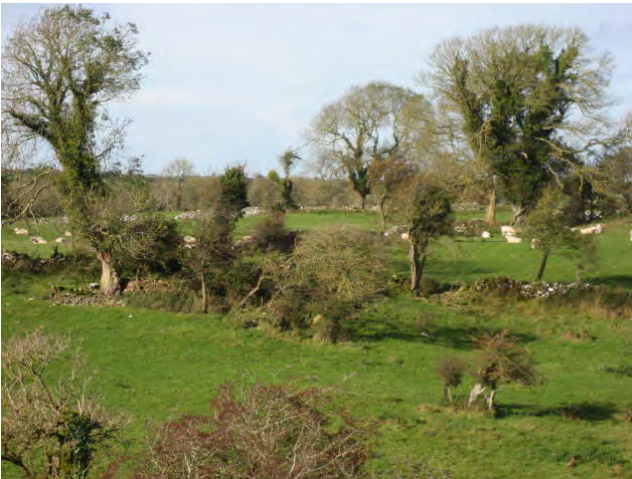
Figure 4.04 Site of House 1

The houses are chiefly vulnerable in that so little is understood of either their age, or original form and function. The scantiness of the remains, in the case of House 3, and the level of collapse in the case of Houses 1 and 2 make all sites vulnerable to further loss of standing masonry, dislodged by unwary livestock, farm machinery or feet.

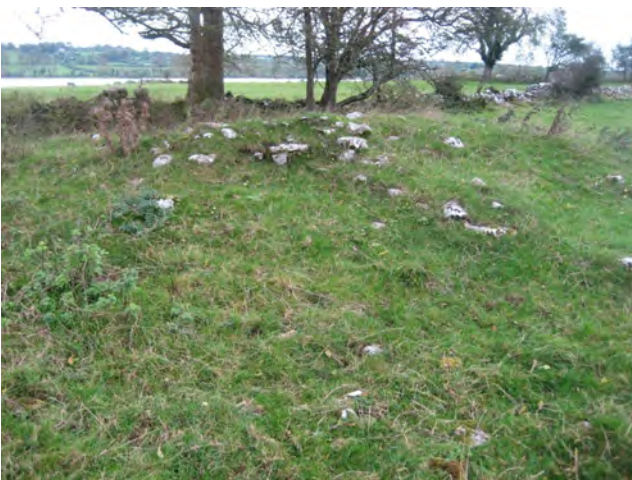
Figure 4.05 Site of House 2

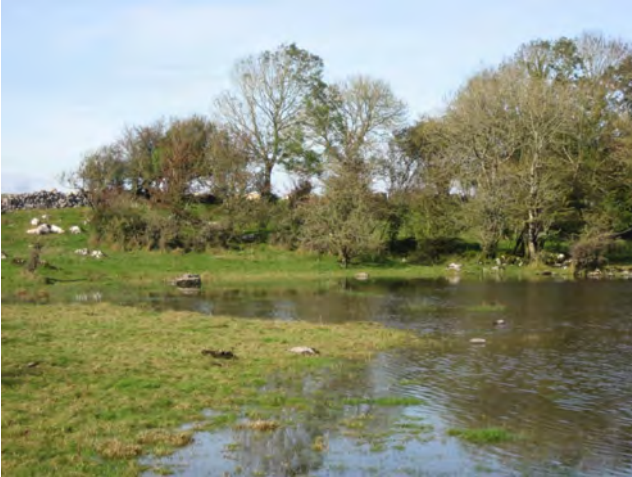
Figure 4.06 Trees indicate the line of the slipway descending the hill

The most easily visible feature is the slipway, which is illustrated in photographs 4.06 - 4.08. This feature, around 4m in width extends up the hillside to a level area at the top. It has been retained and added to as a field boundary, and the stone walls are heavily colonised by trees, which, while clearly marking its location, may also be undermining its structure. The underwater remains of quays and jetties described in Part 3. are harder to identify for the amateur observer, and some require entering the water to see clearly. There is need for further archaeological investigation.

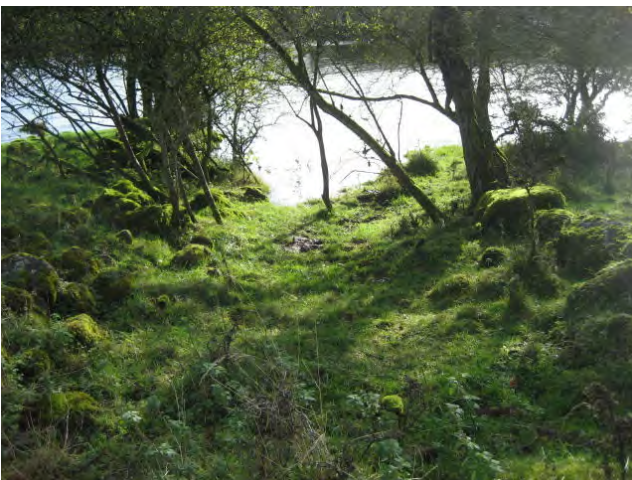
Figure 4.07 The Slipway

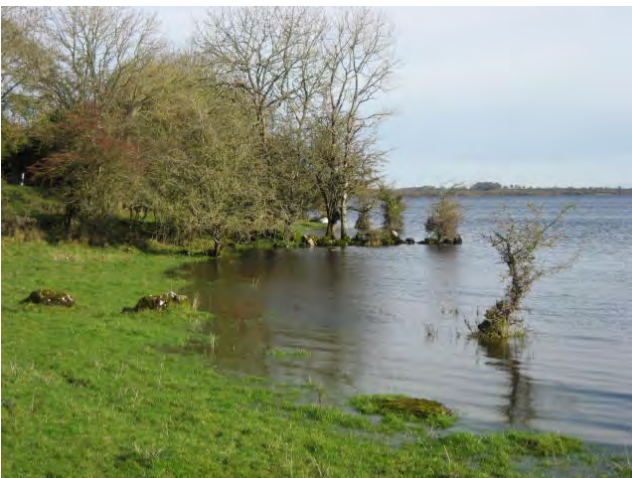
Figure 4.08 The end of the slipway entering the lake.

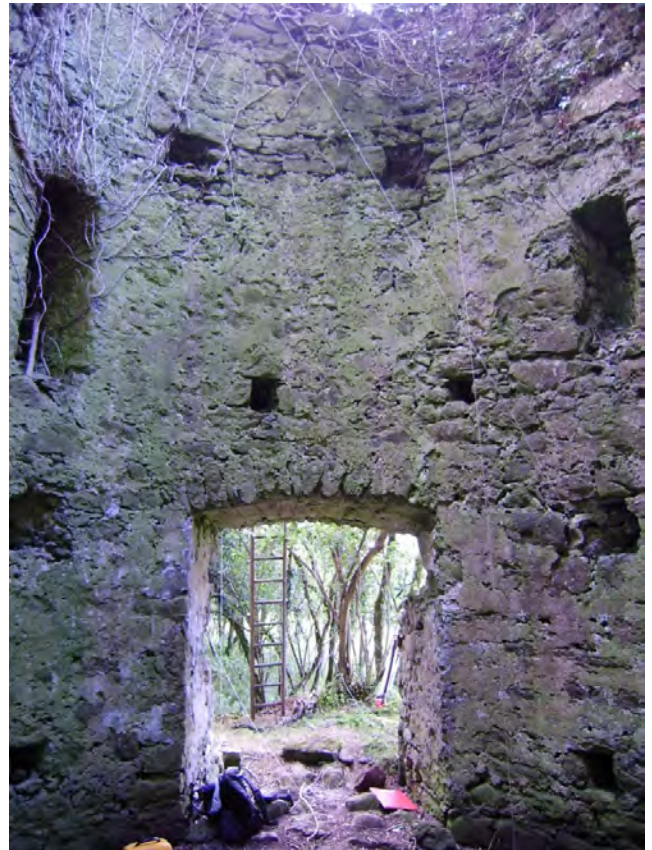
Figure 4.11 Masonry recesses and surviving plaster in the interior

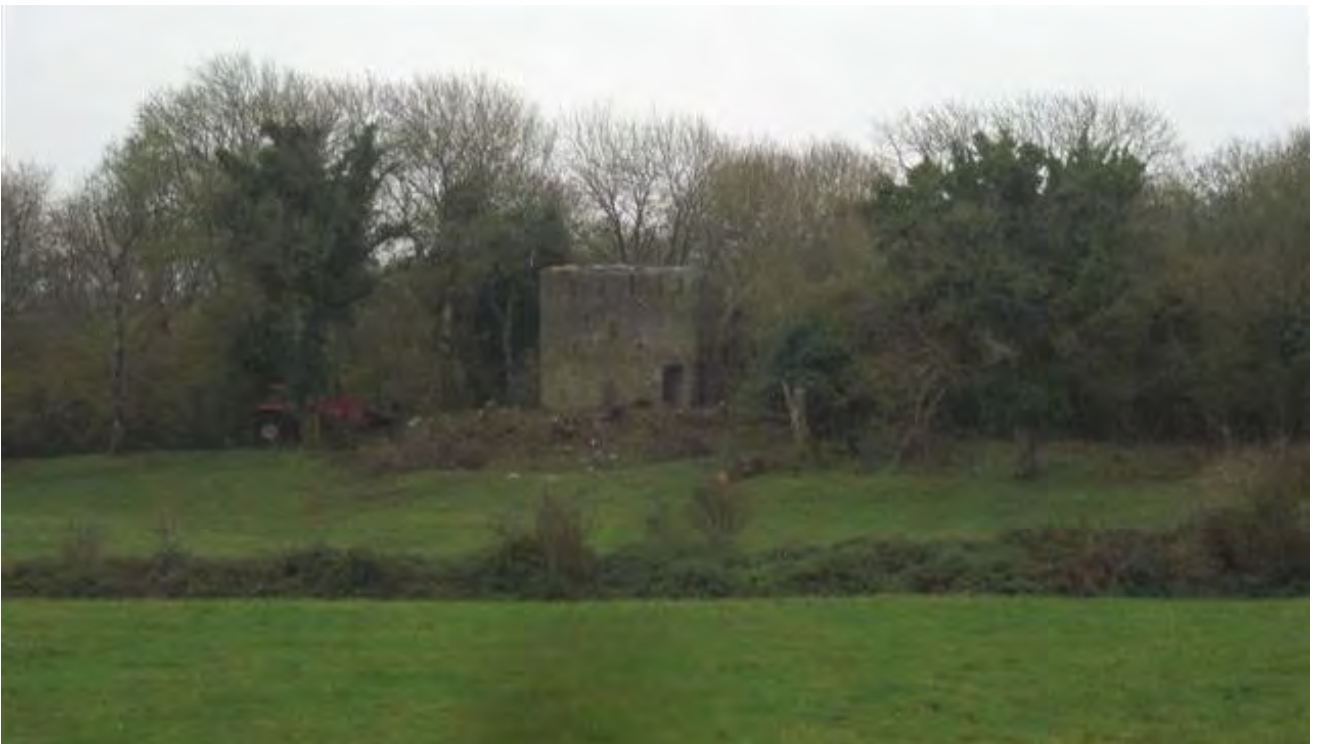
Figure 4.10

The Windmill in context, following conservation works, 2011

No new masonry was required to repair the wall heads but additional stone was necessary to fully repair the ground floor openings.

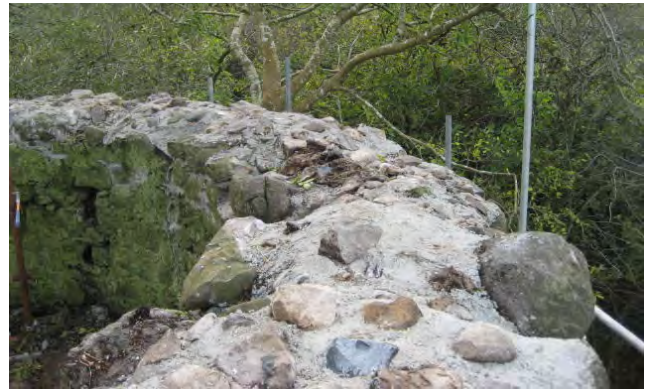
Figure 4.15

Repairs to the wall head

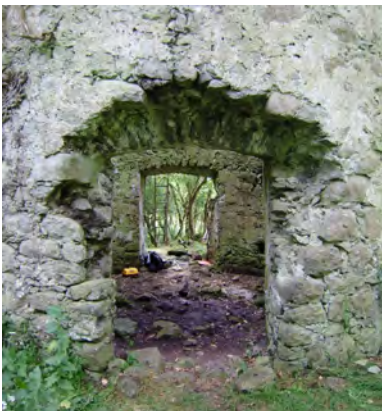
It is likely that the significant damage to the ground floor door openings was caused by livestock rubbing against the masonry, which had been already weakened by loss of mortar. Although these openings have now been repaired and thereby stabilised, sheep have been observed continuing to use these corners as a convenient scratching post, and in the long term this could lead to further damage to the structure.

Figure 4.12 Damaged opening, prior works

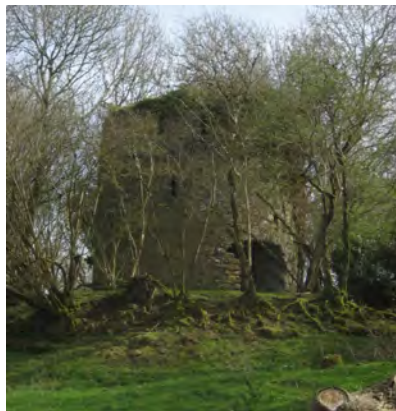
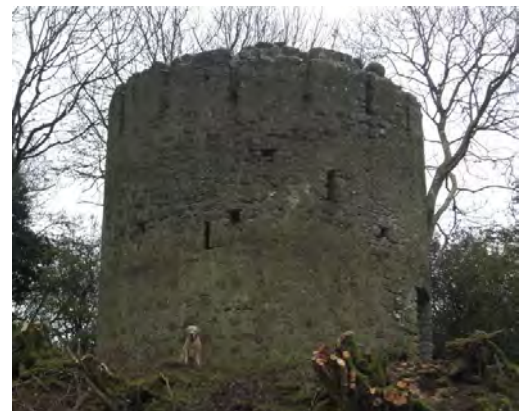
Figure 4.13-14

Windmill before and following conservation works completed in 2011

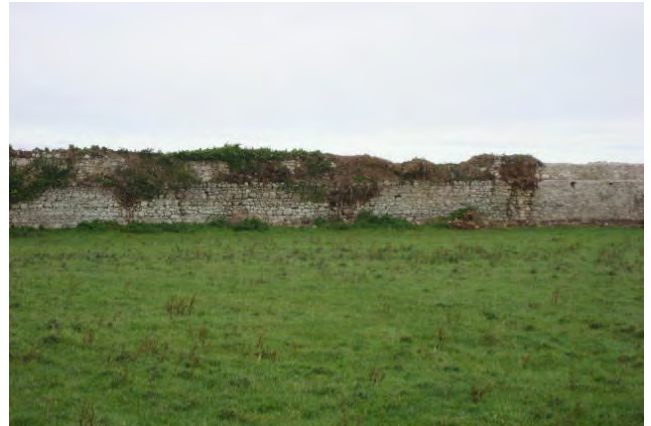
In many parts of the wall, but not for its entire length, there is evidence of a wall walk. This would have been a timber structure along which the towns' defenders could walk. It is indicated by a ledge in the stonework of the upper part of the wall, and putlogs below which could have provided locations for the supporting timber structure. Further interpretation of this feature is recommended.

Figure 4.18 Wall walk between Tower Two and the Gatehouse

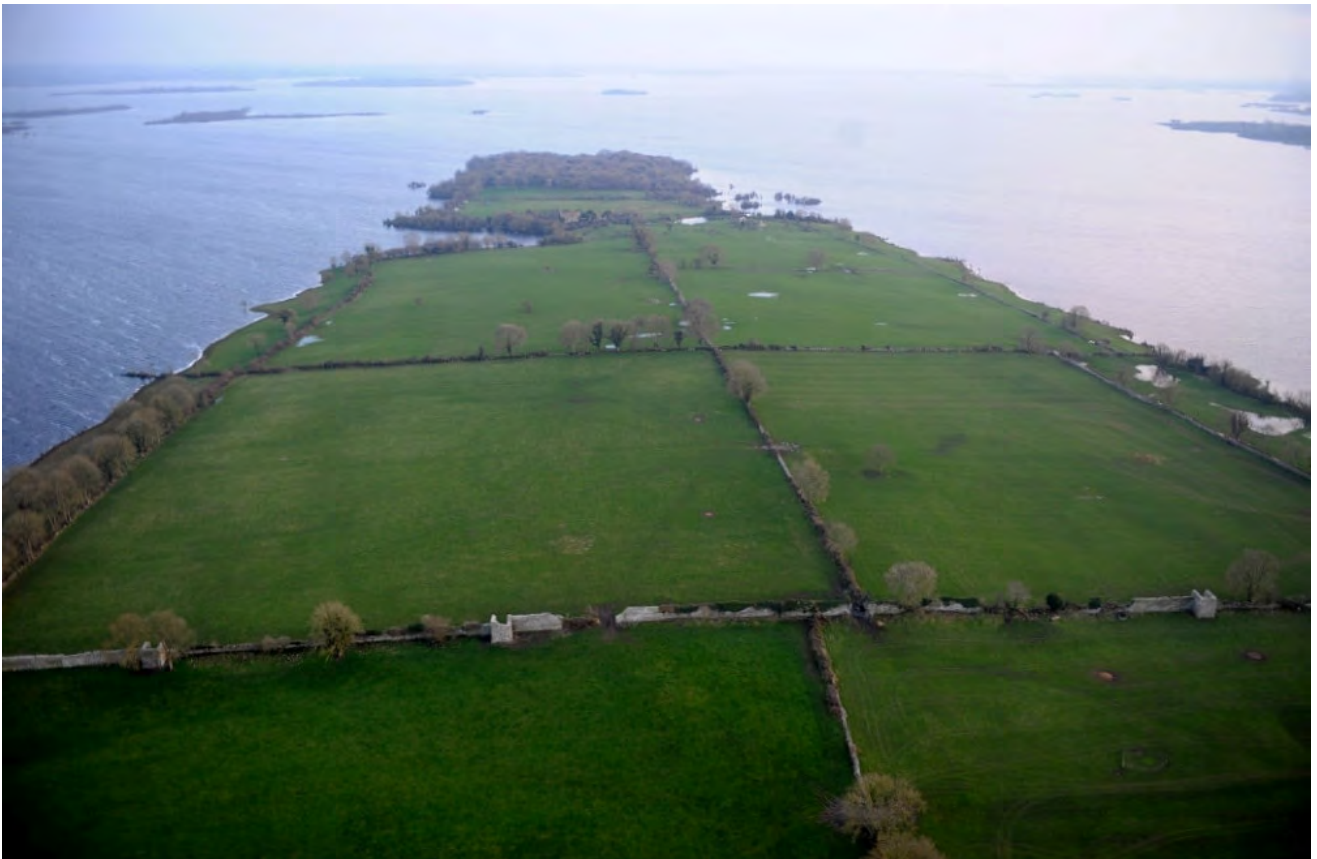
Figure 4.17

The Town Wall, seen from the air. Tower One is on the far left.

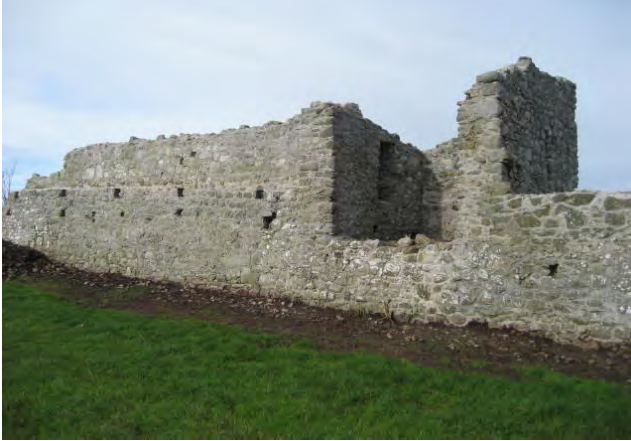
Figure 4.19 Putlogs below the wall walk ledge, adjacent to Tower Two

This is the term used to describe constructed recesses in the stonework to locate timber structure. Sometimes they are evidence of scaffolding used during construction, but may also be evidence of permanent timber structures such as floor beams, or the workings of the gate. More interpretation of these features would be valuable to our understanding of the Town Wall

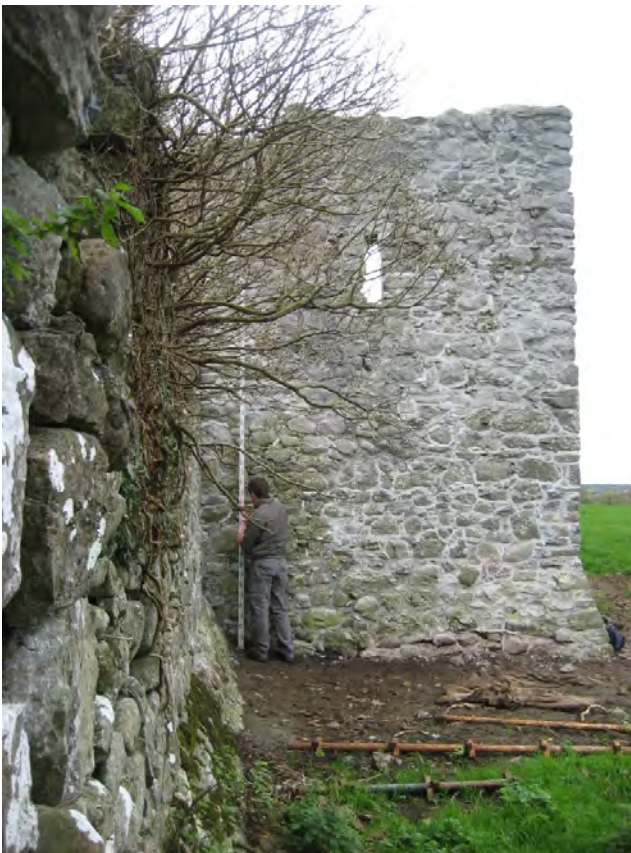
Figure 4.20 Battering at the base of Tower Two and adjacent wall

The outer face of the towers and the main wall are battered. This is a thickening of the base of the wall to provide strength.

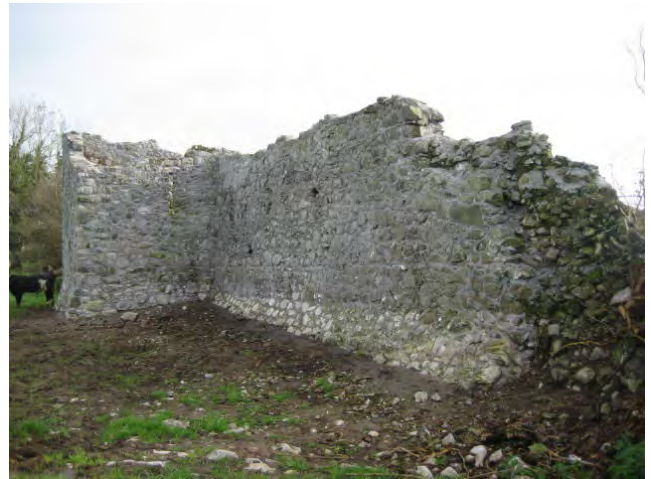
Figure 4.21 Stone course line in the wall adjacent to Tower Two

The masonry consists of medium to large limestone boulders which are coupled with spalls to achieve a rough coursing. A continuous building course line is evident at a height of 1.65 to 2.1 m.

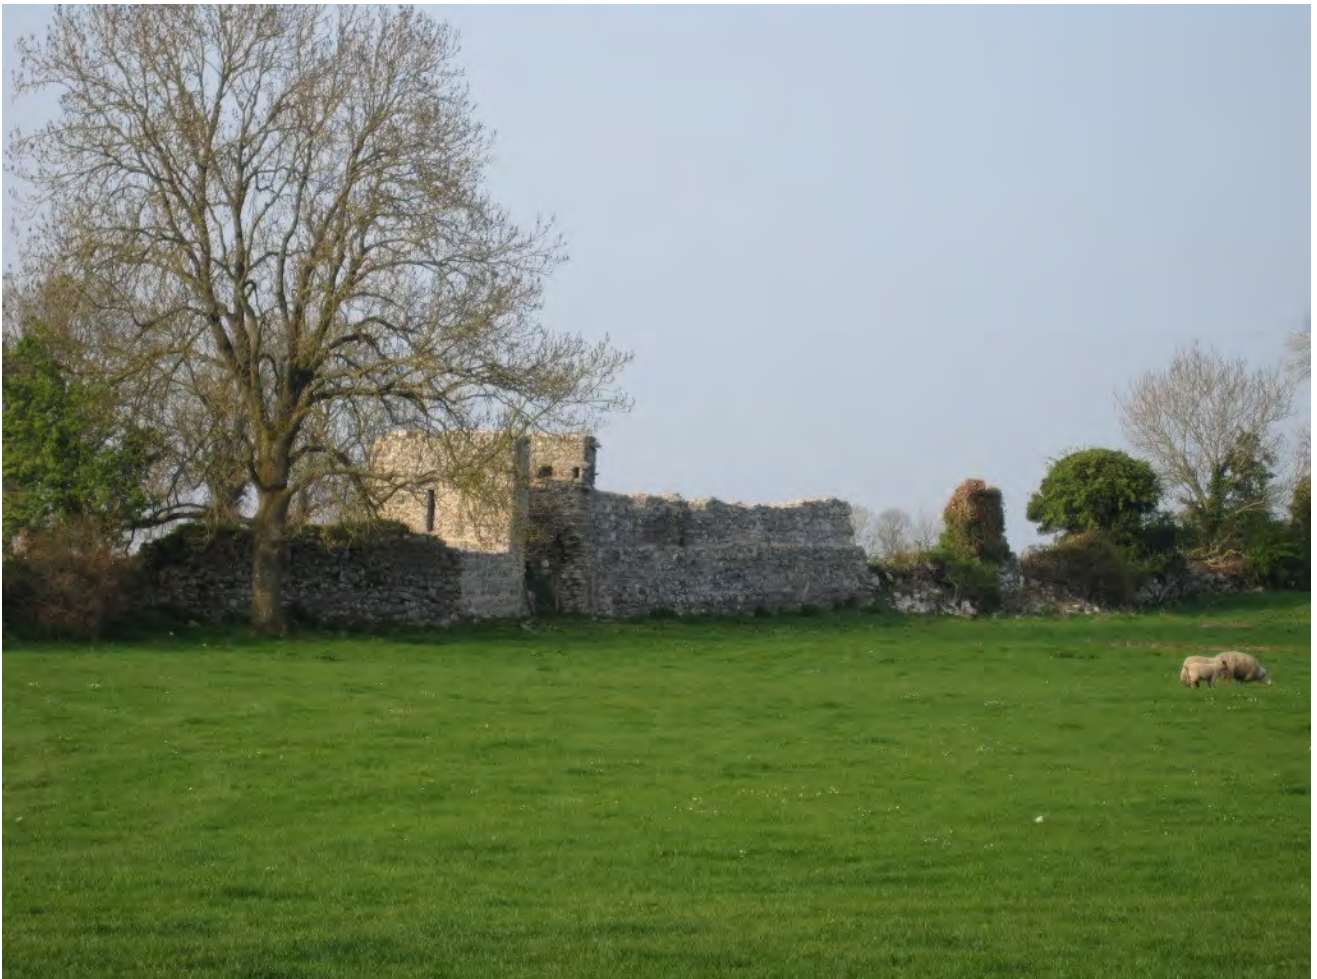
The length of wall to the left (southwest) of the conserved section is in much better condition. However if the ivy growth in the top of this length of wall is left unchecked, the roots will spread, and in time this length of wall will share the same fate as that nearby.

Figure 4.23 Tower Three, and adjacent wall. This illustrates the variation in condition of the surviving wall. The central section and Tower Three underwent emergency conservation works in 2009, and survive close to their original height, and have a wall walk ledge in the masonry. The length of wall immediately to the left (south west) survives to a reasonable height but is in need of stabilisation. Much of the wall to the right (north east) has largely fallen and has been seriously overrun and undermined by trees and ivy growth.

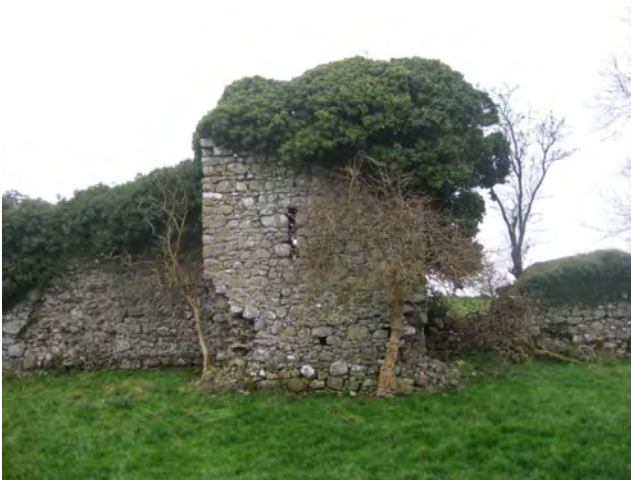
Figure 4.25 Tower Three prior to Conservation Works: The battered corners dangerously lost.

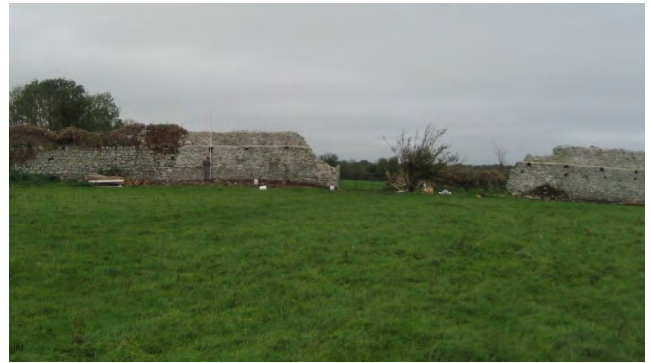
Figure 4.24 Wall loss at field gate opening

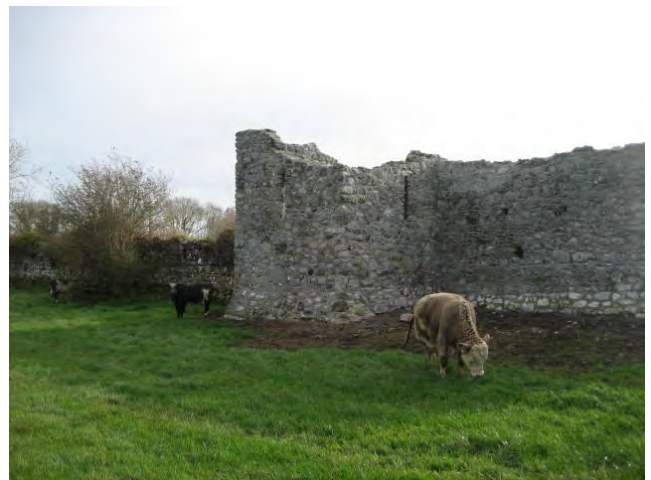
Figure 4.26 Tower Two. Cattle possibly loitering with intent to have a scratch.

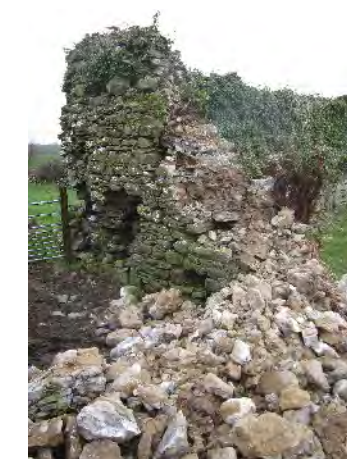
NORTH-EAST PIER OF GATEHOUSE FOLLOWING COLLAPSE

The vulnerability of the Town Wall is emphasised by recent serious collapses at sections of the wall. A corner of Tower Two collapsed between the preparation of the 1998 Plan and the Conservation Works of 2011. Most recently a section of the Gatehouse has collapsed in February 2012. Just because a wall has stood for hundreds of years does not mean it will continue to do so. Once weakened catastrophic collapse happens in an instant, and historic fabric is lost. (Refer Figures 4.46, 4.47, 7.01, 7.02).

There is a serious crack in the North West elevation of the more extensive structure on the South East side of the Town Wall. (Figure 4.46). This was in urgent need of attention. Sadly, no emergency works had been commissioned at this part of the Town Wall and a large section of the Gatehouse collapsed in early February 2012. (Figure 4.47, 7.01, 7.02)

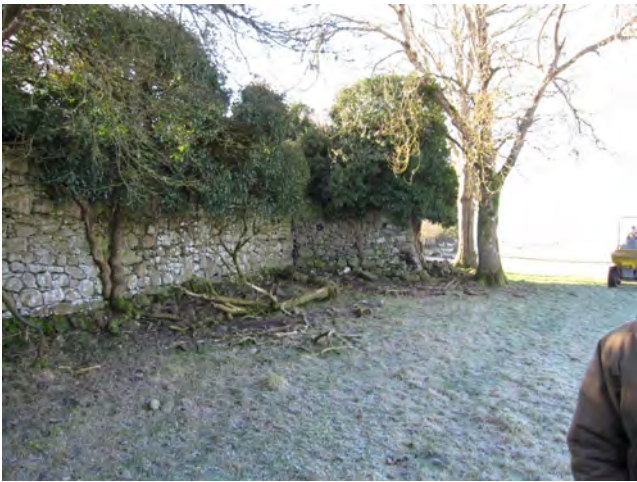
Figure 4.28-9 North East side of Tower I before and after Conservation

The recent works have secured this tower and section of wall for the immediate future, but it is essential that the structures continue to be monitored, and maintenance executed as soon as it is required to ensure their continuing survival.

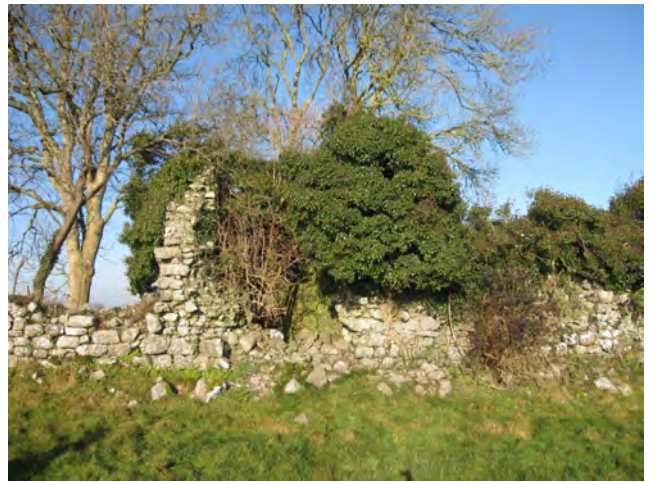
Figure 4.30-31 South East of Tower I before and after Conservation

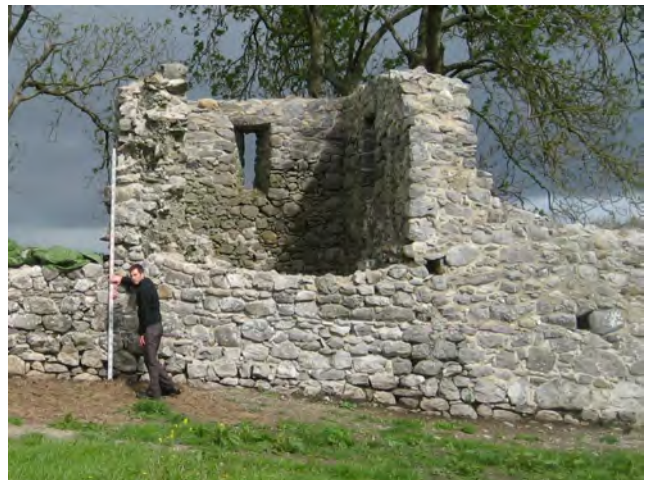
Plan of the conserved Tower One and adjacent wall

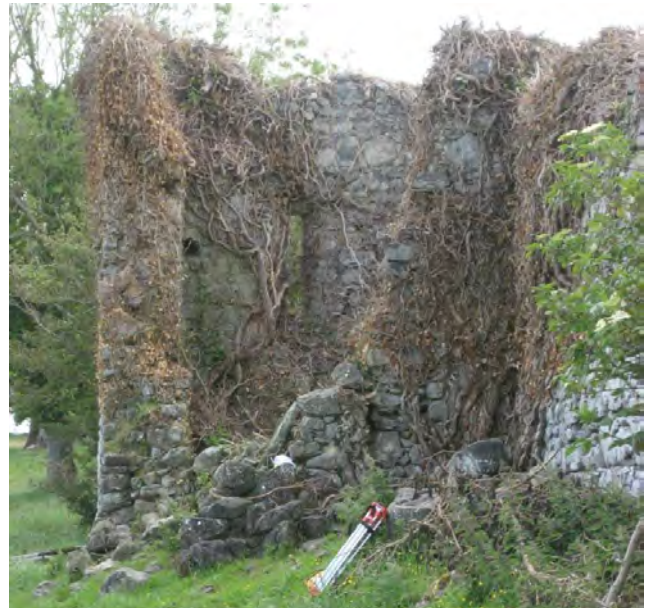
Figure 4.33 Collapsed North West corner, before Conservation

The rebuilding of the northern corner of Tower 2 took place in several phases so that the rebuilding came up to a suitable height to ensure the stability of the remaining standing fabric.

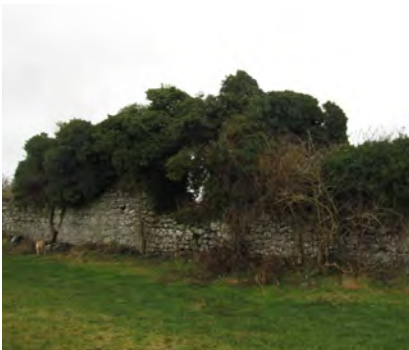
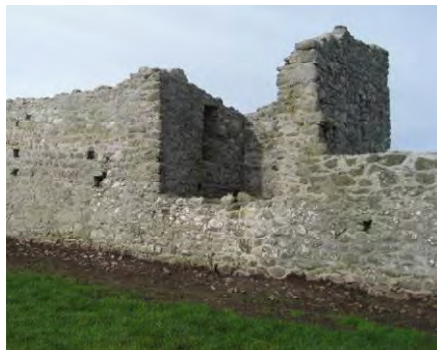
Figure 4.34-35

South East of Tower Two before and after Conservation

This process involved the structural engineer to ensure the tower was stabilised to avoid further fabric loss. The entire cill and position of the head was clearly visible on the south-western elevation so it was possible to rebuild the opening to the same proportions as the original. The position of the head of the north-western opening was clearly evident but the cill width could not be ascertained in the remaining fabric. Therefore this reveal was built at a straighter angle to indicate it is not original.

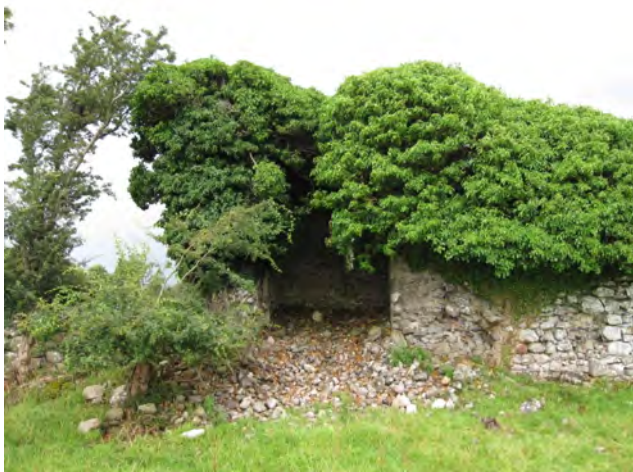
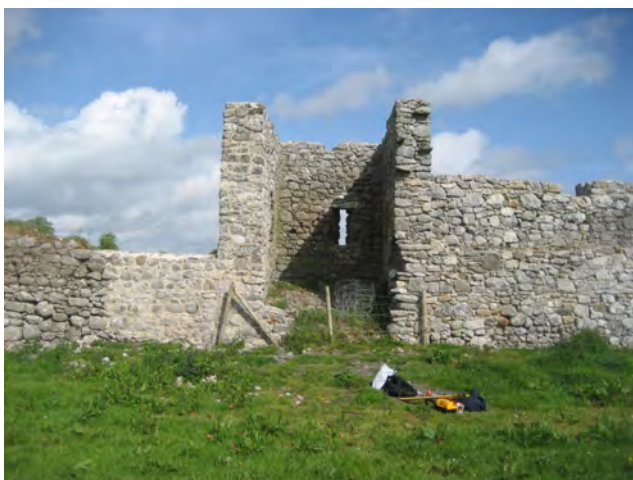
Figure 4.38-9

South East elevation before and after works

In order to retain as much of the medieval craftsmanship as possible, a methodology was developed, with the structural engineer, whereby the stonework would be drilled and stainless steel rods inserted and then grouted in position. Unfortunately between inserting the stainless steel rods and grouting them in, the lowest portion of the wall still in place at the southern end became unstable and collapsed leaving a large section of overhanging walling suspended in mid-air. Upon close examination it was decided, on the grounds of safety, to dismantle this upper section. Fortunately most of the upper wall had been enumerated and recorded prior to the works commencing.

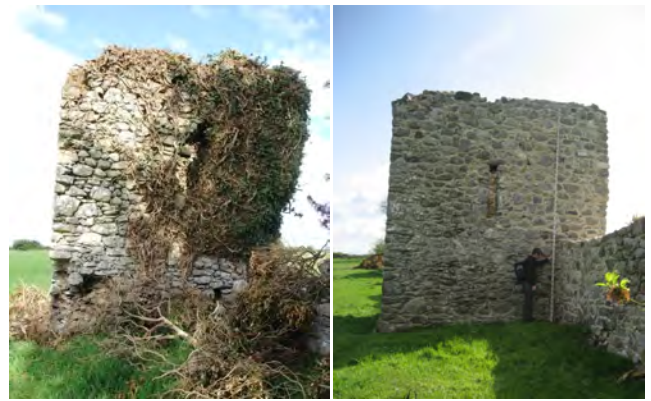
Figure 4.40-41 South West wall before and after conservation works

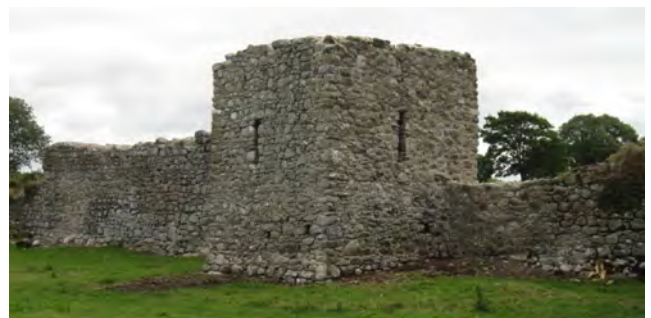
Figure 4.42 North West view of Tower 3 and adjacent wall, after completion of conservation works

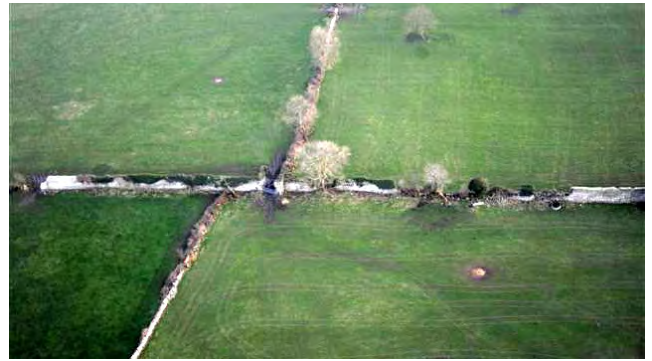
Figure 4.44 Aerial View of Gatehouse from the North West

It is likely that the gatehouse was originally an arched structure, and this arch may have been lost relatively recently to ease farm traffic through the opening. Analysis of the remaining structure and adjacent fallen stones may be able to confirm this matter. The gatehouse walls and adjacent walls display a number of putlogs and other masonry features which may be indicative of the timber structures that were part of the original.

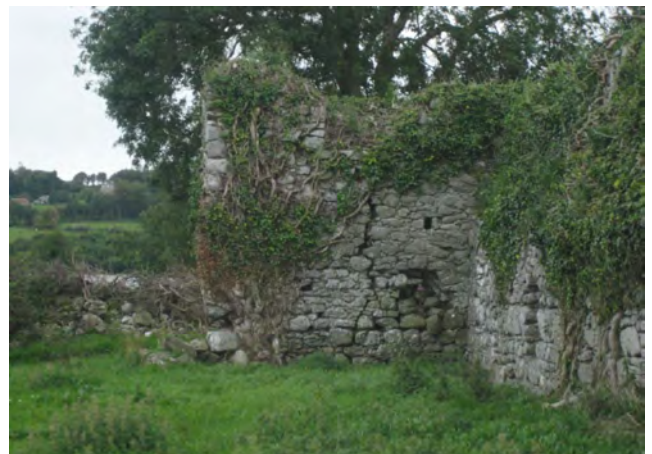
Figure 4.46 South East side of wall: North East Elevation of Gatehouse

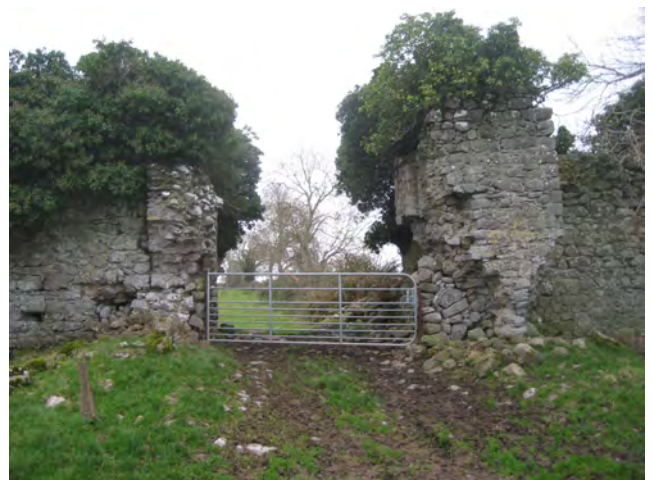
The corners of the structure on the North West side are seriously fallen away and could lead to the further loss of wall here if not conserved soon. (Figures 4.48)

Figure 4.48 North West side of Town Wall: Details of the decayed stonework

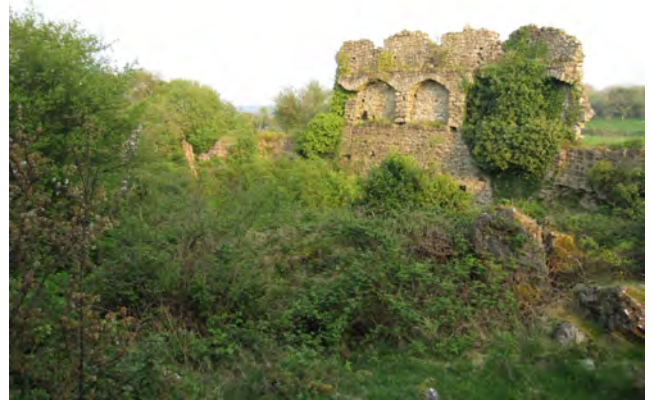
Figure 4.50 The interior of the Castle looking South East. Note the abundance of plants obscuring the ruins.

To some extent the ivy and other plants growing on and in the walls are holding the structure together, and are best left in-situ until such time as conservation works can proceed. However the numerous scrub trees which are growing within the Castle and adjacent to its walls are an immediate and continuing problem. With each year the underground root systems are extending and may be undermining the walls, possibly lifting the ground and destroying the archaeological stratigraphy.

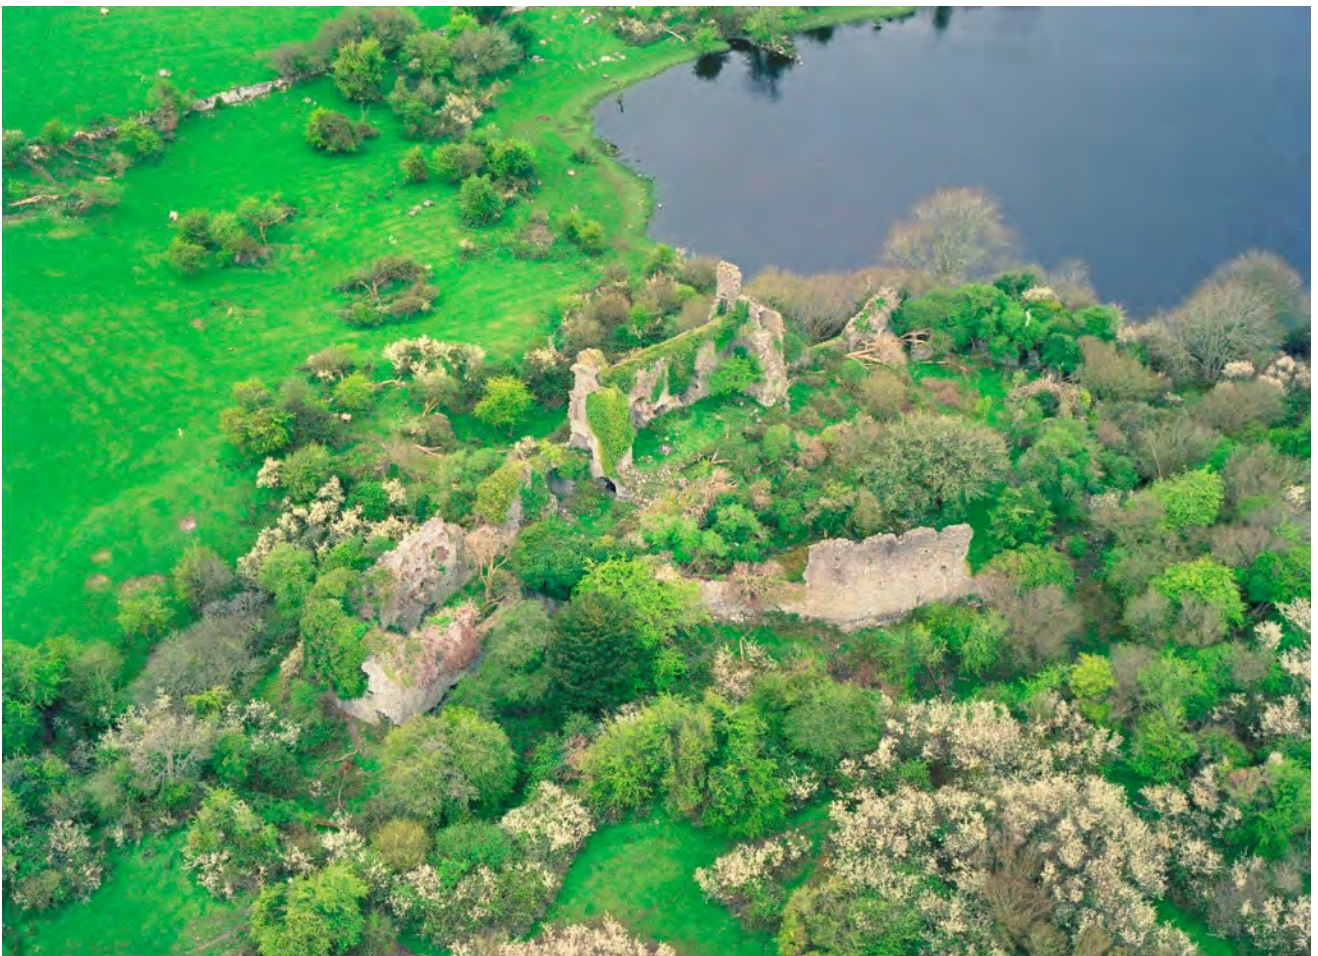
Figure 4.51

The Castle from above, with its abundance of trees

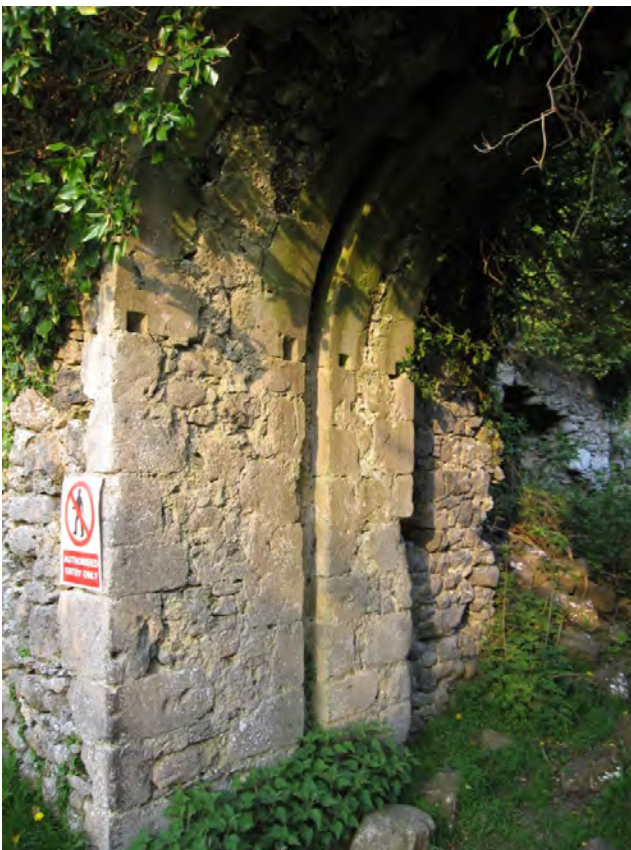
Figure 4.52 The Gate House into the Castle, Note the level of surviving fine detail and the invasive ivy growth and fallen masonry.
