RINN DÚIN CONSERVATION AND MANAGEMENT PLAN

Blackwood Associates Architects

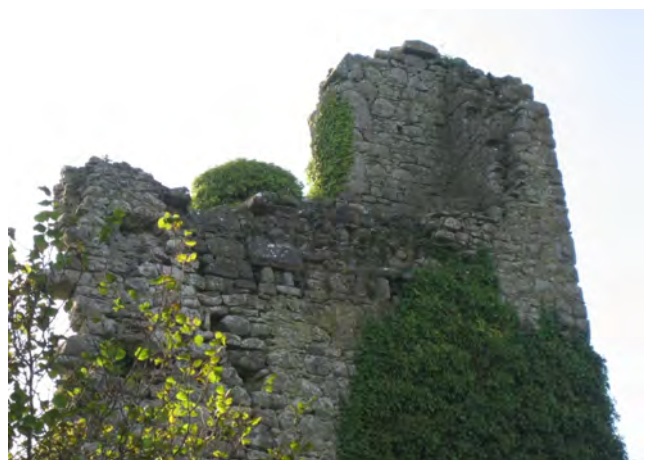
As no structural or conservation work has been carried out at the Castle in the thirteen years since the above report was written, the same issues apply, with respect to the condition and deterioration of the structure. The concerns about the stability of the structure, have become more urgent. Plants that have been growing from the structure of the wall, and thriving on the environment provided, continue to do so, and there is ample evidence, in the form of recently fallen stones, to illustrate that decay and loss of the structure is on-going.

Figure 4.53 The highest section of Castle walls: A wealth of interesting masonry features, vulnerable wall heads and invasive plant growth.

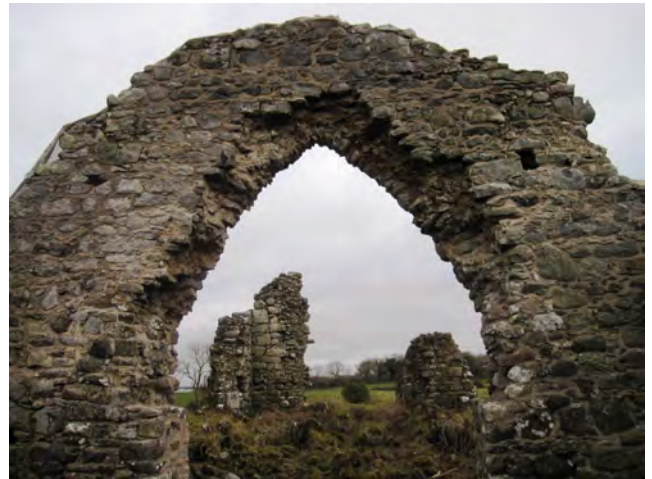
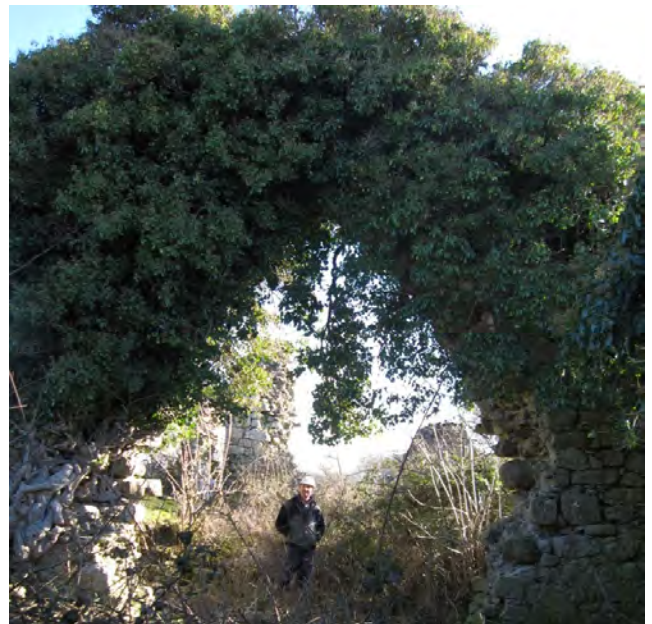
Figure 4.57, 4.58 The Chancel Arch before and after emergency conservation works

The brief was to undertake stabilisation work only; to preserve the arch in its current form without rebuilding it conjecturally or otherwise. Scaffolding was erected and the underside of the arch was carefully propped and braced with small sections of timber.

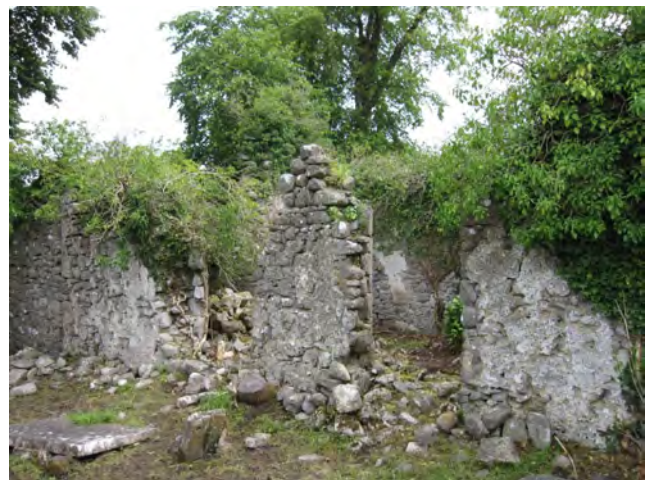
Figure 4.61 The South West corner of the Hospital before conservation

The ivy was killed off and cut back and a full photographic and drawn survey executed. The structural damage caused by the ivy was greater than anticipated necessitating the localised unstitching of the stonework at the corner, the careful removal of the embedded roots and the reassembly of the stonework to match the existing.

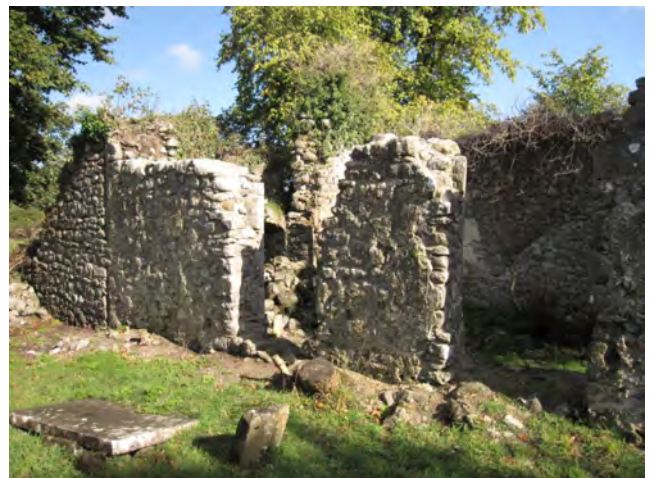
Figure 4. 62 The South West corner of the Hospital before conservation

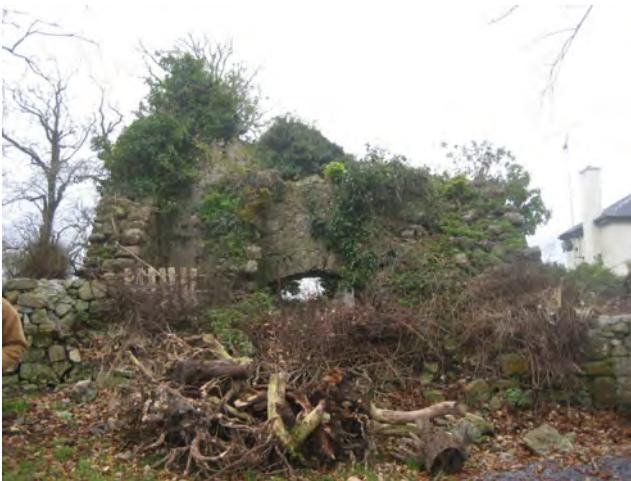
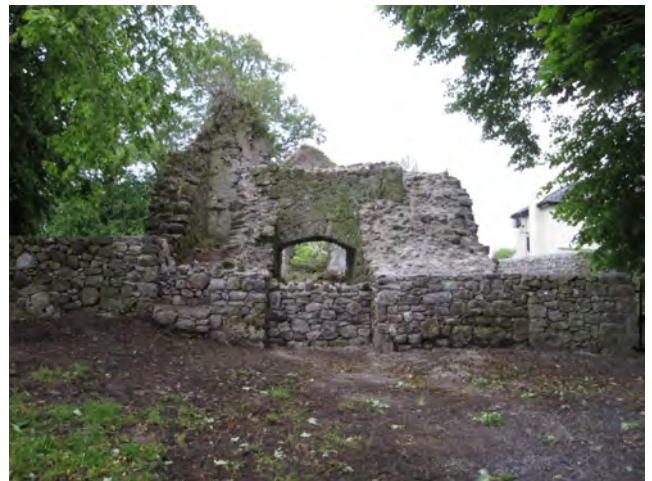
Figure 4. 63, 64

An earlier archaeological assessment in 2003, by Theresa MacDonald, had identified the south west corner of the building as particularly vulnerable. When the condition of the building was assessed, prior to the 2009 works, it was evident that this corner was being prised apart through vigorous ivy growth which would lead to the eventual collapse and loss of the entire section of the church.

The Hospital viewed from the North, before and after the conservation works of 2009

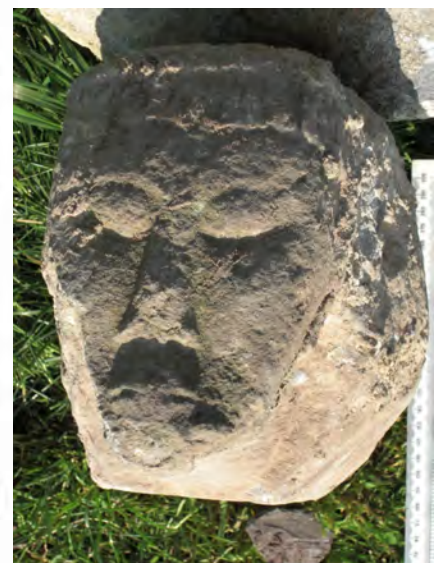
Figure 4.66

In 2010 during emergency works to a section of the graveyard wall, which had collapsed a carved stone head was found which had been built into the heart of the wall as ballast. (see Figure 4.66)

Stone Head

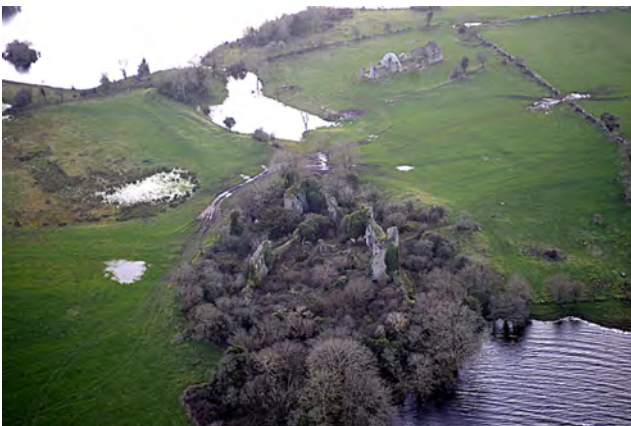
Being essentially man-made enhancements of natural land features they are not vulnerable to the same danger of collapse as the stone constructed monuments. However, they are vulnerable in terms of lack of understanding and recognition. They are also vulnerable to damage by heavy farm or construction machinery, particularly given the waterlogged nature of some of the ground. Any proposal to plough the land in this vicinity should be discouraged.

Figure 4.67 The Bank and Ditch System crossing the peninsula, the Fishpond in the background and the Castle on the raised ground of a

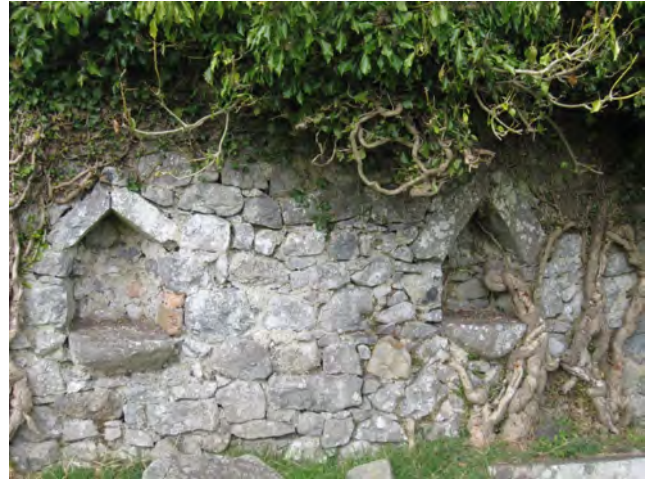
The walled garden and bee-boles date from a later period than the medieval ruins but are still important and in need of conservation. The garden walls are dense with ivy which is damaging the walls and will lead to their eventual collapse if this remains unchecked.

Figure 4.68 Bee-boles: note the ivy trunk penetrating the stonework in the bee-hole

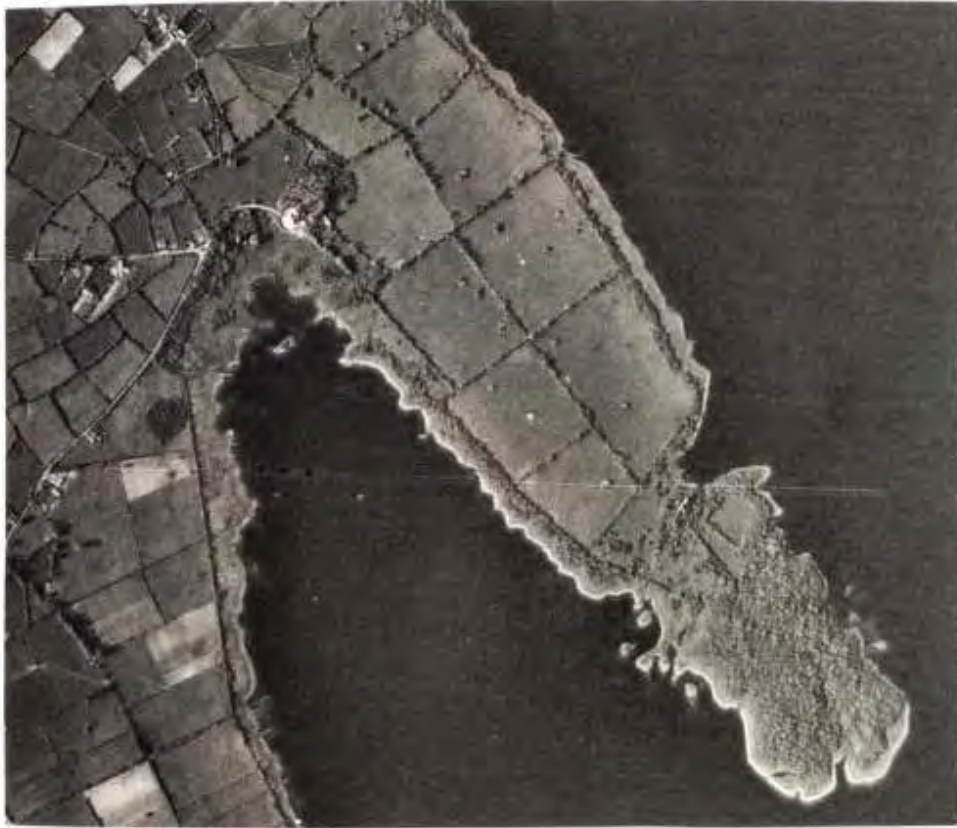
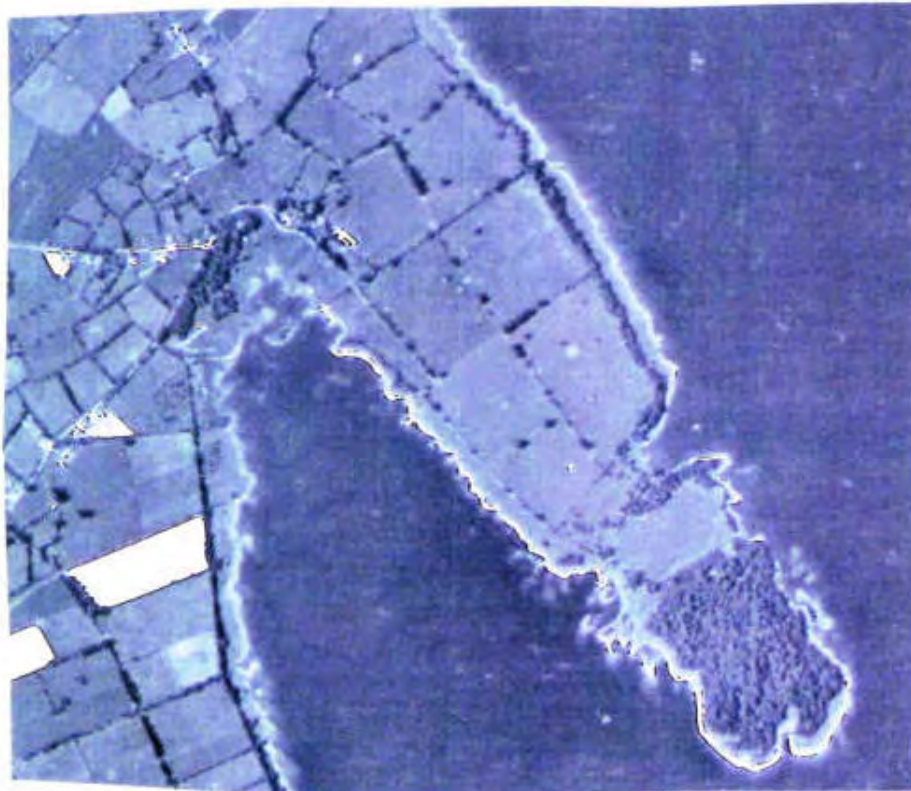
Furthermore, when the 1898 map is compared with the 1975 aerial photograph, (Figure 5.02) little, if any change in woodland cover can be discerned. This suggests that from 1836 to 1975 the extent of woodland cover at Rinn Dúin remained relatively unchanged. When the 1975 and 1995 (Figure 5.02) aerial photographs are compared, however, it is seen that approximately 1.5 hectares of woodland/scrub along the north-western edge of the woodland have been reclaimed. Many of these trees have been incorporated into a large bank which runs in an east-west direction across the peninsula.

Figure 5.02 Aerial photographs of the Rinn Dúin peninsula in 1975 (above) and 1995 (below). Note the decrease in woodland cover along the northern edge of the woodland, the decrease in scrub along the western side of the peninsula and the general decrease in tree / shrub cover in the hedgerows in the time between the two photographs.

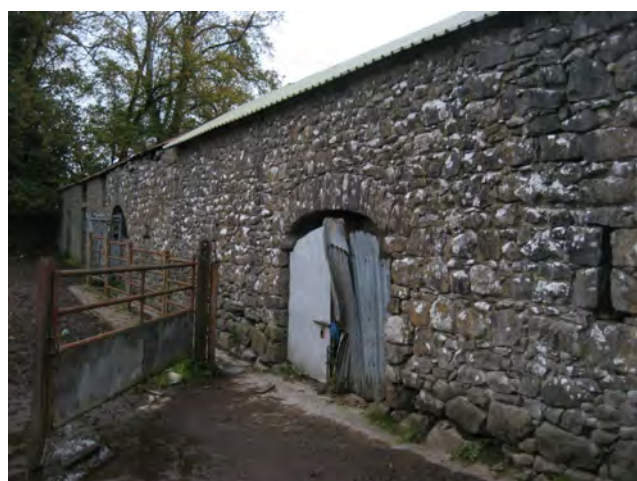
Figure 6.03 19th Century farm buildings may include stone robbed from the town wall

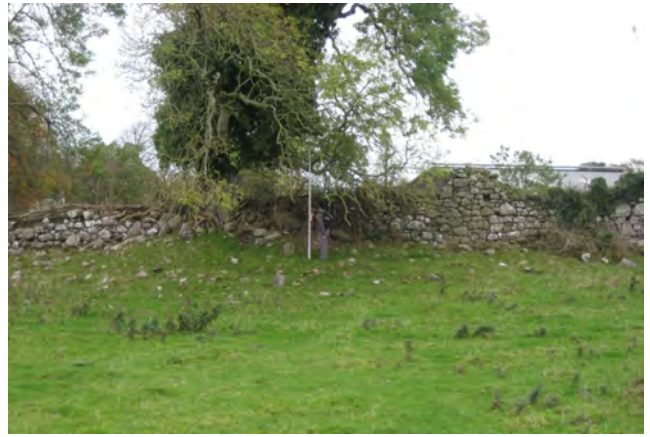
Emergency conservation works, have recently been completed at the Town Walls, Parish Church and Hospital of St. John the Baptist and the Windmill, involving removal of vegetation, re-pointing and rebuilding of loose masonry using lime mortars. Full details of these works are given in Appendices B, C, D and E. These works need to be continued as a matter of priority. The majority of the length of the town wall, is still in urgent need of stabilisation, and there is the very real possibility of losing substantial lengths of medieval masonry here in the next couple of years. Figure 7.04 illustrates the poor condition of a length of wall towards the south west end.

Figure 7.04 The south west end of the Town Wall: In places the wall is little more than a mound of stones, a fully mature tree flourishing in its midst.

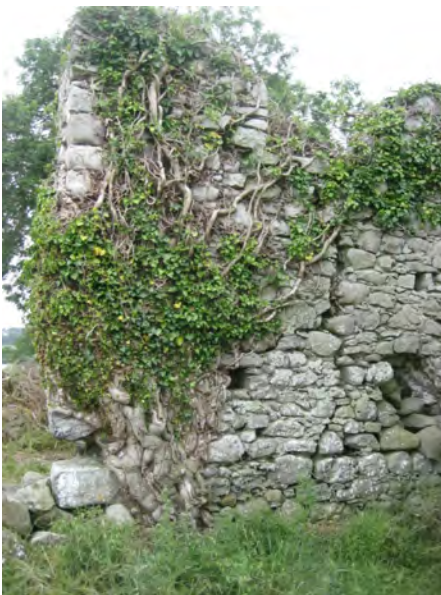
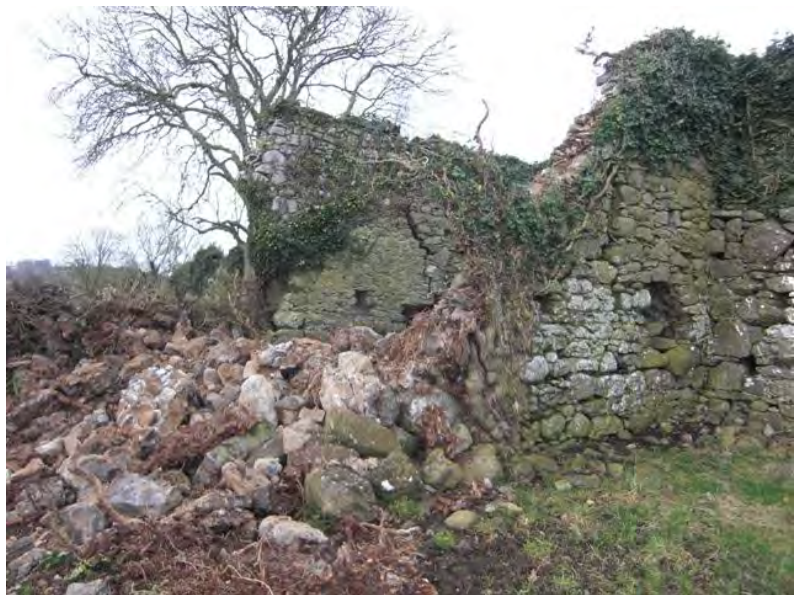
Figure 7.02, 7.03.

There is a serious crack in the North West elevation of the more extensive structure on the South East side of the Town Wall. (Figure 4.46). This was in urgent need of attention. Sadly, no emergency works had been commissioned at this part of the Town Wall and a large section of the Gatehouse collapsed in early February 2012. (Figure 4.47, 7.01, 7.02)

The urgency of the need for on-going conservation work is illustrated in Figures 7.02, 7.03 below. This shows the East wall of the Town Wall Gatehouse before, and after the collapse which occurred in early February 2012.

The Eastern Gatehouse wall, on the southeast side of the Town Wall; before and after the collapse of February 2012

The vulnerability of the Town Wall is emphasised by recent serious collapses at sections of the wall. A corner of Tower Two collapsed between the preparation of the 1998 Plan and the Conservation Works of 2011. Most recently a section of the Gatehouse has collapsed in February 2012. Just because a wall has stood for hundreds of years does not mean it will continue to do so. Once weakened catastrophic collapse happens in an instant, and historic fabric is lost. (Refer Figures 4.46, 4.47, 7.01, 7.02).

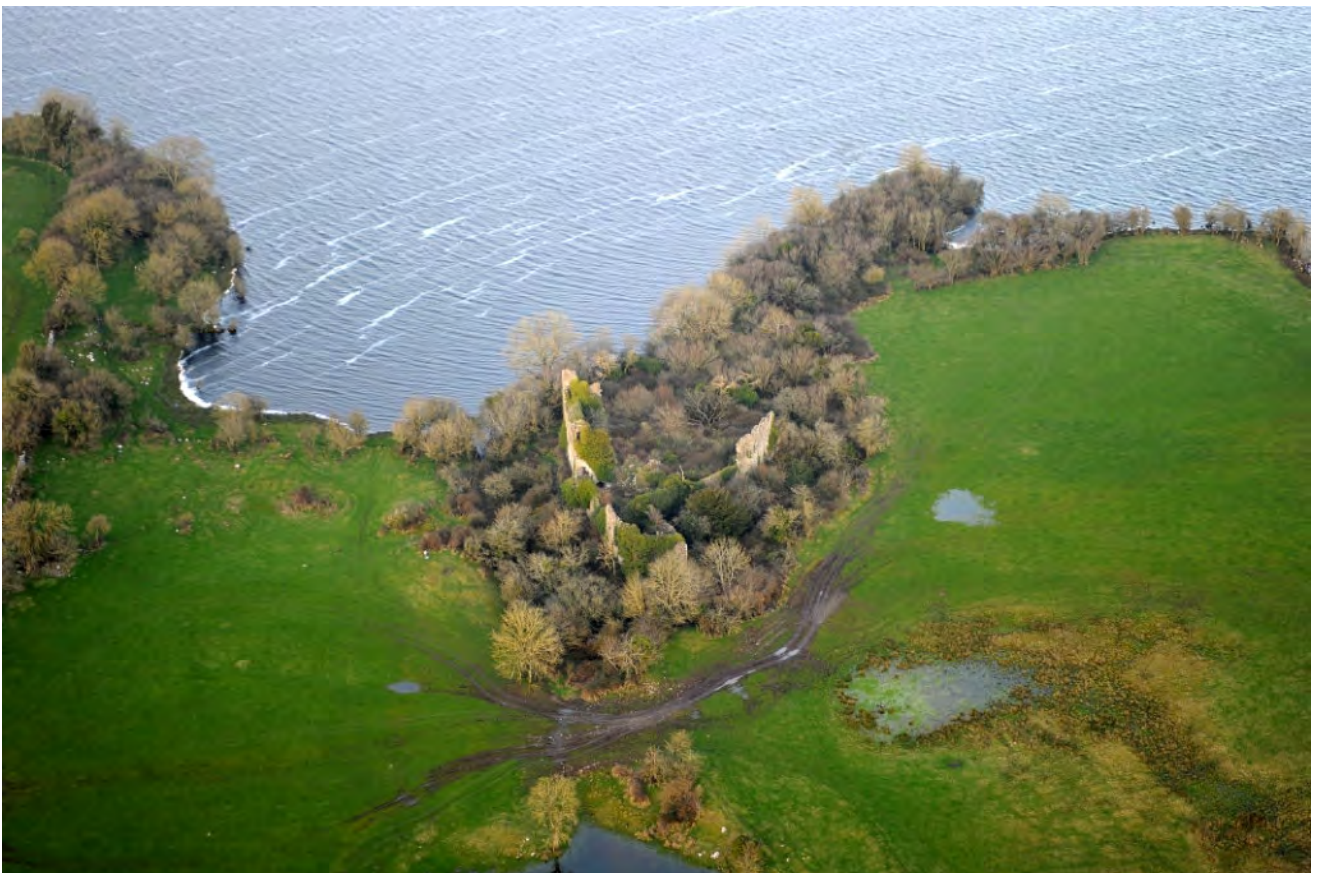
Figure 7.05 The Castle: in effect a wood, it is so overgrown with trees. The density of growth prevents full inspection of the stability of the structure

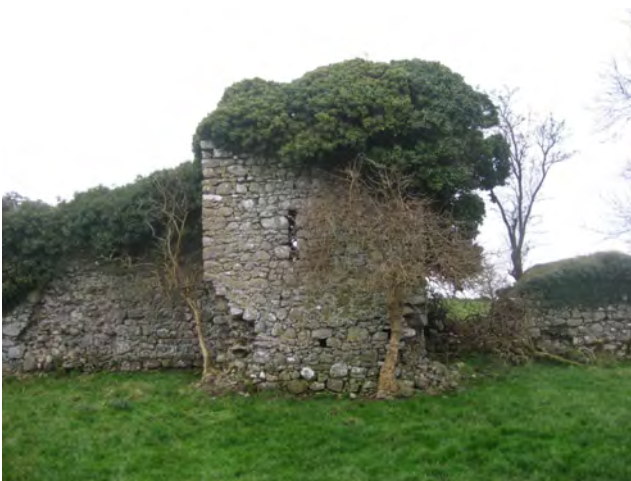
Figure 8.02 Loss of masonry at corners

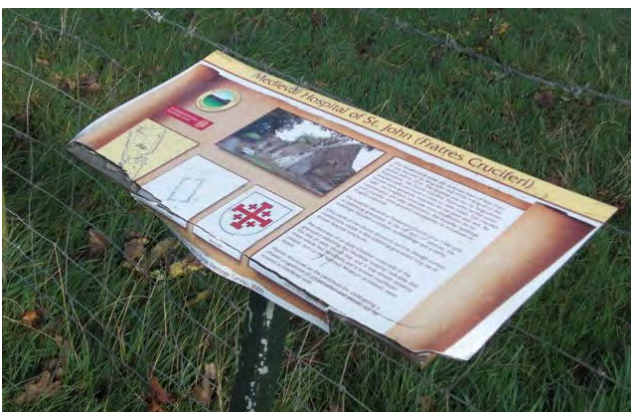
Figure 8.03 Light weight signage, damaged by livestock

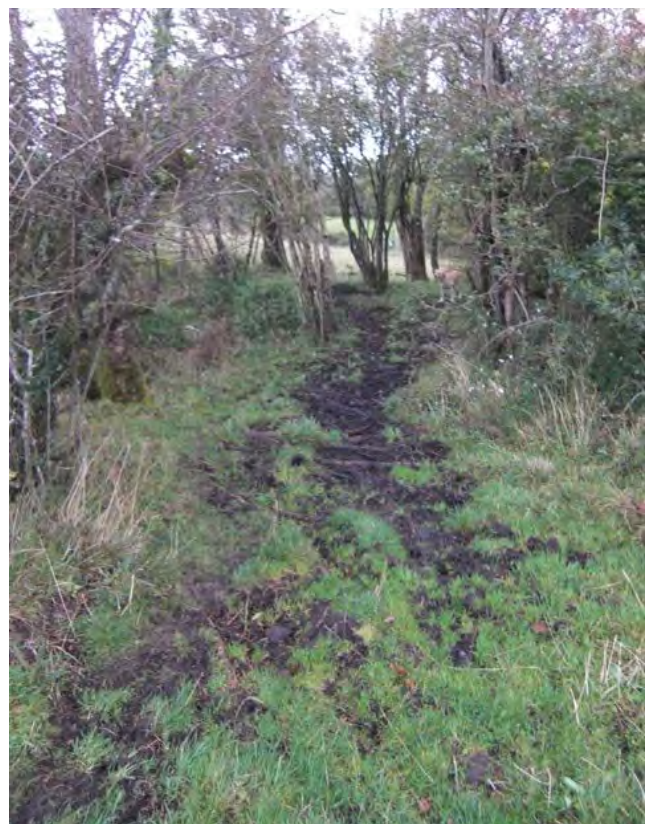
Figure 8.04 Muddy path, made more so by heavy feet
