THE THOLSEL GATE, CARLINGFORD CONSERVATION PLAN

Address Tholsel Street / Fairgreen, Carlingford, Co. Louth
Date; November 2020

Paraic McKeivitt MRIAI
Conservation Architect (Grade 2)

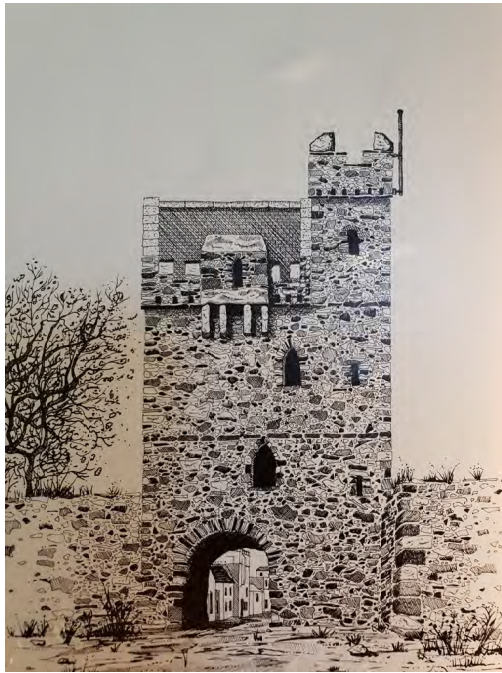
Commissioned Artist's impression of the original Tholsel – Heritage Centre, Carlingford

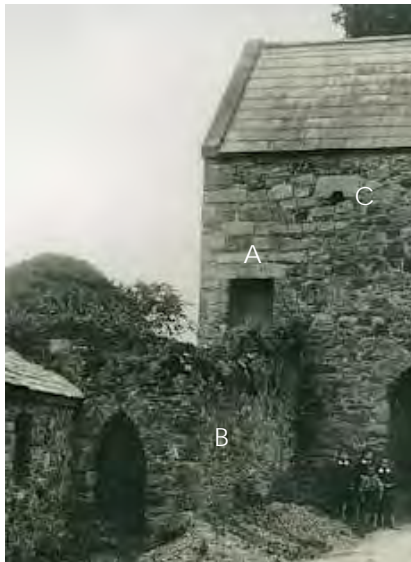
Rebuilt Northeast corner and revised stepped entrance

These alterations were probably carried out by the Marquess of Anglesey, dating these modifications to the 1820/1840 period. The same may be said about roof and tower adjustments to the building or buildings which became Holy Trinity Church at this time. The Church of Ireland Schoolhouse was also constructed in this period.

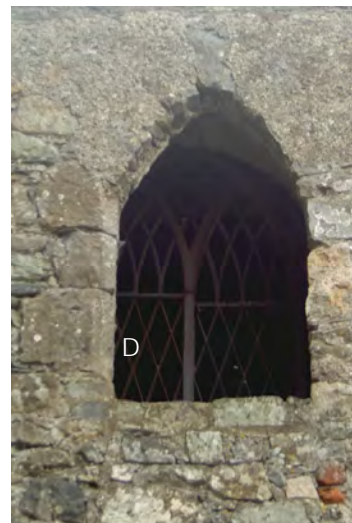
As you enter the first-floor chamber you are greeted with a further flight of five limestone steps leading to floor proper of the chamber. The floor is nearly 3.25m above the level of the current street under and possibly 4m or more above the original ground level. The wall just to the east of the steps and the doorway is narrower at this point than the rest of the eastern wall as can be seen in the survey drawings (first floor plan). Why or how this occurred is not known but it certainly made the wall weaker and may suggest why a corbelled soldier course is laid above returning it to a wider, more robust, thickness.

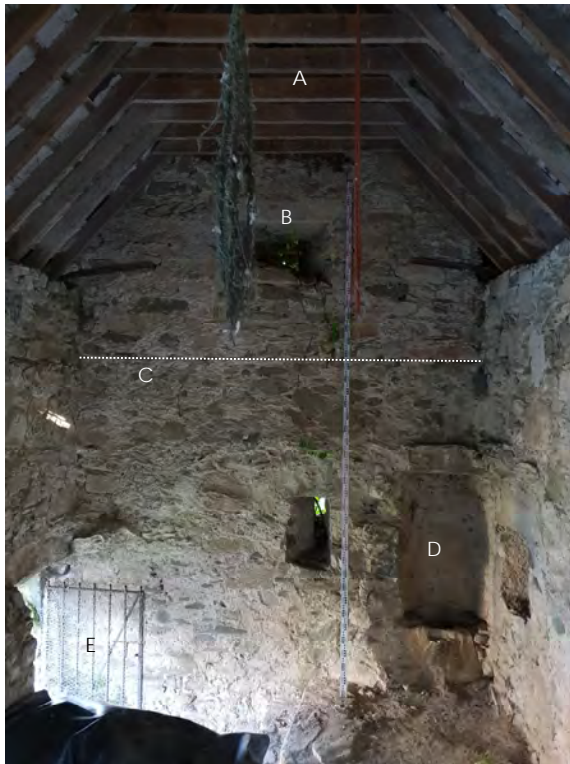
East wall

- A. Collared roof trusses
- B. High level loop – partly blocked up
- C. Corbelled soldier course strengthening and straightening the gable
- D. Garderobe
- E. Entrance doorway

There is also a loop with an internal splay in this eastern wall at the top of this flight of steps looking seaward. Also pointing seaward, and very possibly evacuating onto the shore at one point is a garderobe chute (or a toilet facility to non-archaeologists) perfectly positioned for seated comfort. It would appear to have been a separate little chamber with its own loop facing south and shaped with a curved wall and semi-circular alcove for the seat. Sunlight pours through it during the day which must have made the call of nature an enjoyable experience! Why wouldn't you have a parliamentary gathering with such state-of-the-art facilities.

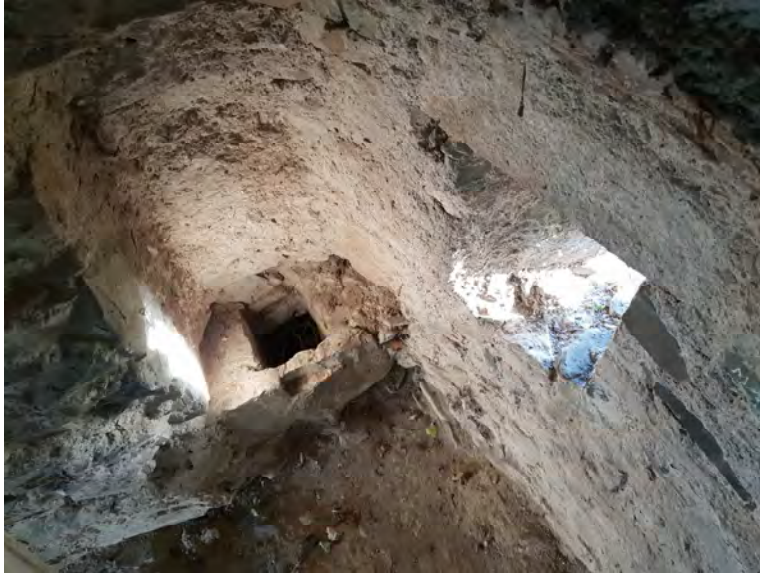
The Garderobe with a semi-circular alcove for the seat and south facing loop in a gently curved wall on the right hand side

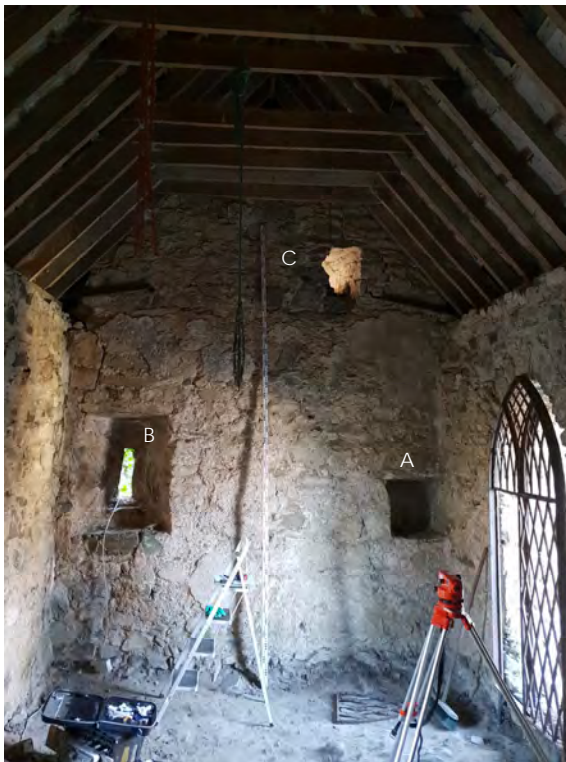
The west wall has three notable details. In the northwest corner there is a small rectangular cupboard (A) and a loop window to the south west (B). This is the most architecturally composed loop given the splays and stepped cill stones. At high level there is another larger internally splayed window which has been partly blocked up (C). This is one area where judicious removal of the blocking stones would restore the window to its original design intent. As it is west facing it would also allow more light, and sun-light, to fill the chamber.

A similar 'sister' high level window is located in the opposite east wall. It is also partly blocked up and may also be restored for similar reasons.

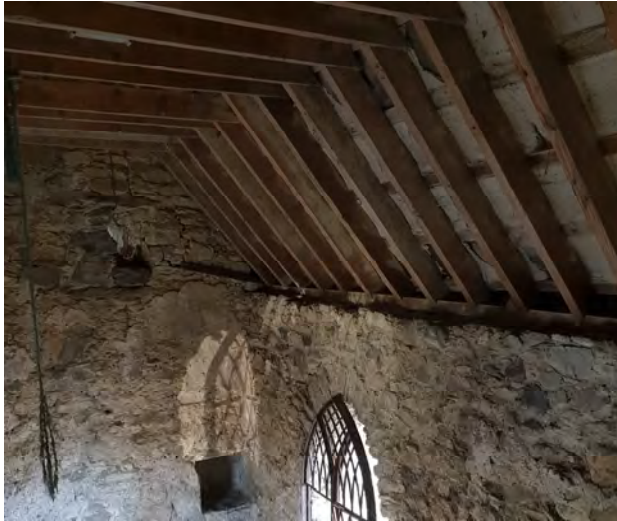
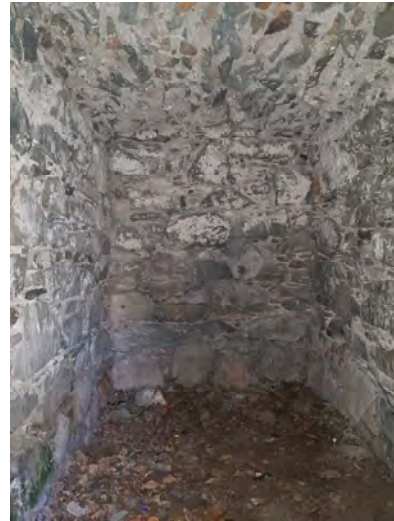
The ground floor consists of a barrel-vaulted passage with a small rectangular chamber to the east side which is entered from the north with a flat arched doorway. There is tentative evidence that part of the south wall of the chamber was adjusted and may have also opened out onto the Fairgreen side. There is no evidence of an original stair on ground floor prompting the suggestion that access to the upper floor was from the wall-walk of the town wall originally.

There is tentative evidence of a spiral staircase in the northeast corner at first floor but this would not have extended to the ground level. Certainly, the level of the adjacent church property is at the correct level to support this position.

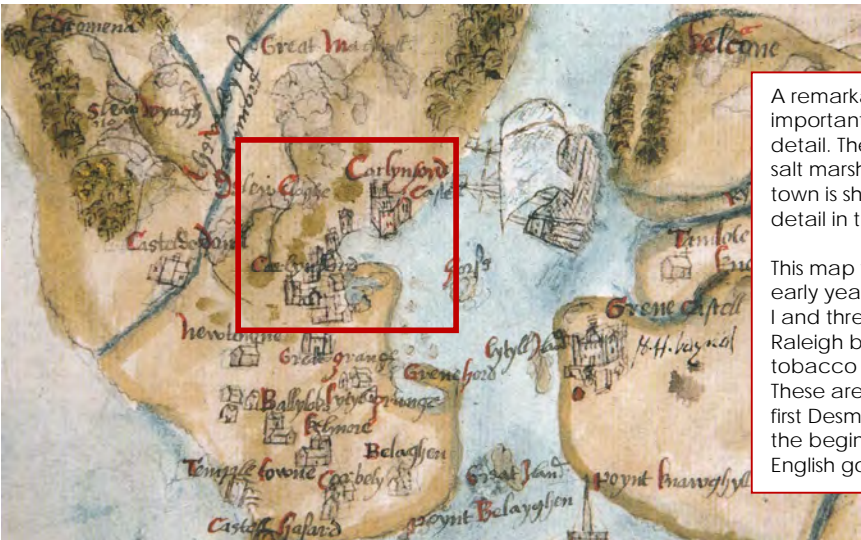
1568 - ROBERT LYTHE

Part of map of Cooley (The National Archives: Public Record Office)

A remarkably well drawn map with important buildings shown in some detail. The medieval seascape and salt marsh to the south west of the town is shown along with a lot of detail in the surrounding area.

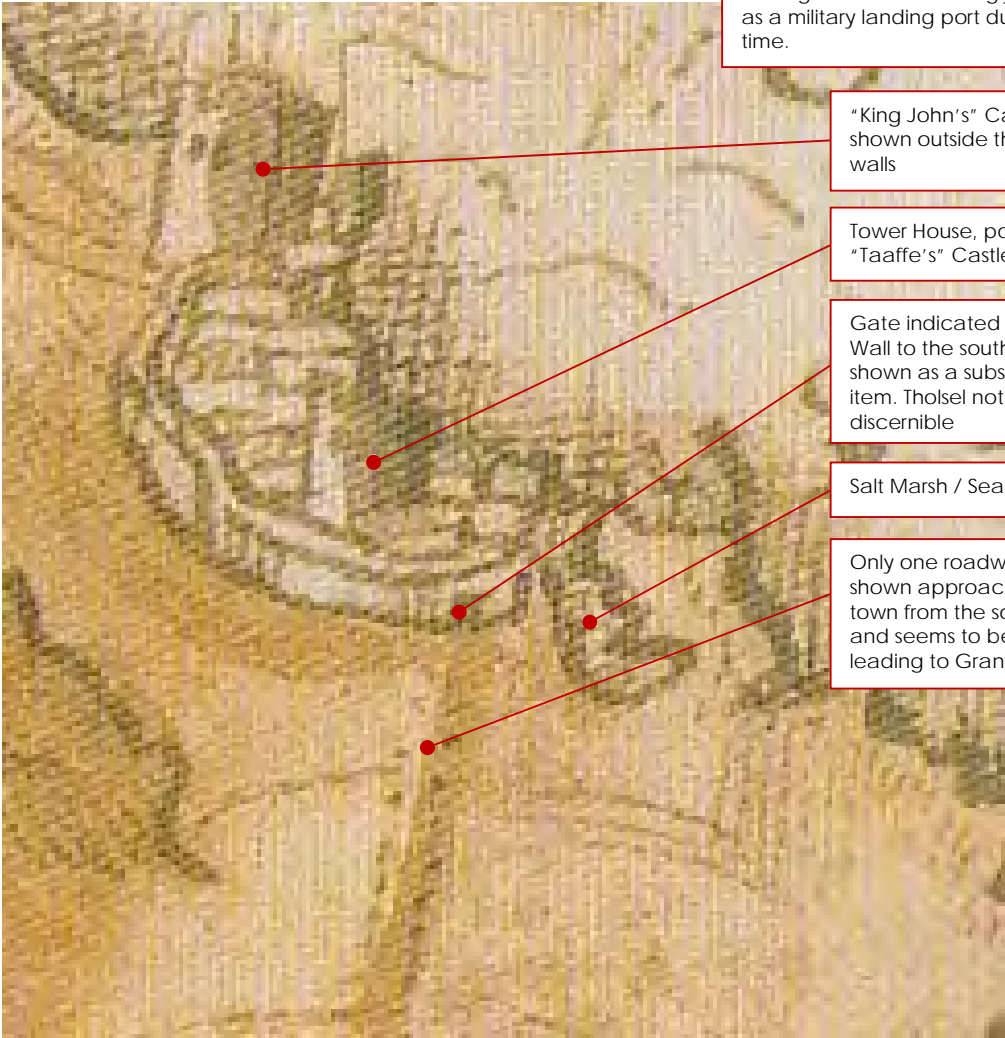
"King John's" Castle shown outside the town walls

Tower House, possibly "Taaffe's" Castle?

Gate indicated in Town Wall to the south. Wall shown as a substantial item. Tholsel not discernible

Salt Marsh / Seascape

Only one roadway shown approaching the town from the south and seems to be leading to Grange

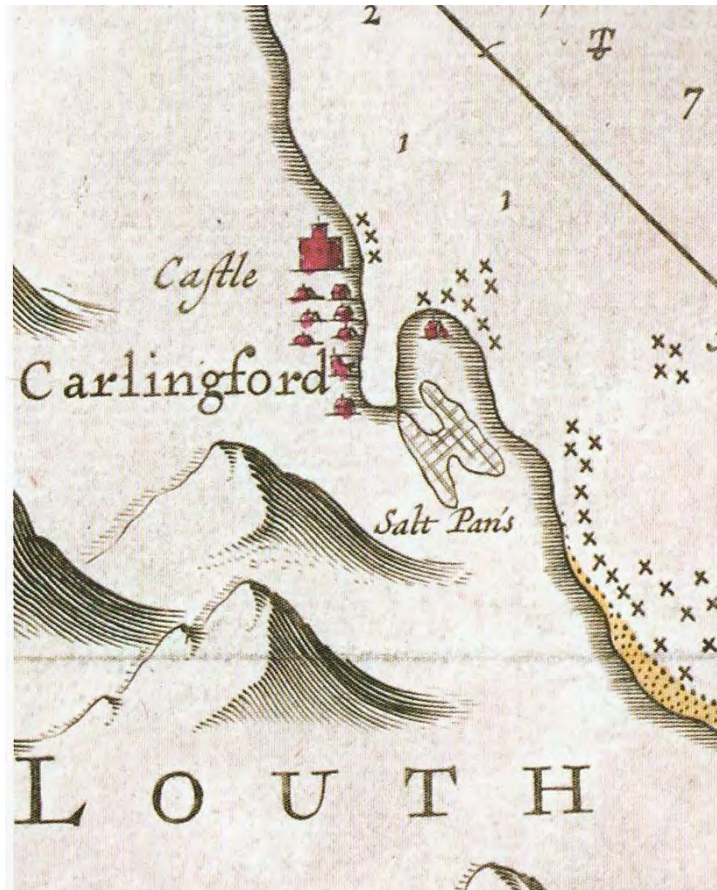
1693 - GREENVILE COLLINS

Chart of Carlingford Lough (National Library of Ireland)

The map is of interest as it provides proof of the existence of Salt Pans (Salt production) to the east/southeast of the town. This will have been of importance to military thinkers given the need to feed thousands of soldiers in an age when refrigeration did not exist.

A town wall is not indicated although the map is simplistic. Areas where ships would be in danger of running aground are marked with 'x's.

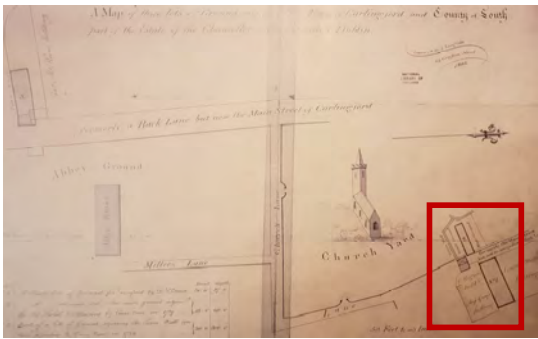
1805 - JOHN LONGFIELD

Part of 'A map of three lots of ground situate in the town of Carlingford' (National Library of Ireland)

- The wall connecting to the western side of the Tholsel is noted as being the Town Wall
- The Tholsel
- Tholsel Street. Noted as being "formerly the Main Street but now an insignificant Back Lane"
- Stepped entrance to Tholsel not shown or indicated
- Elsewhere on the same document Dundalk Street is noted as "formerly a Back Lane but now the Main Street of Carlingford".

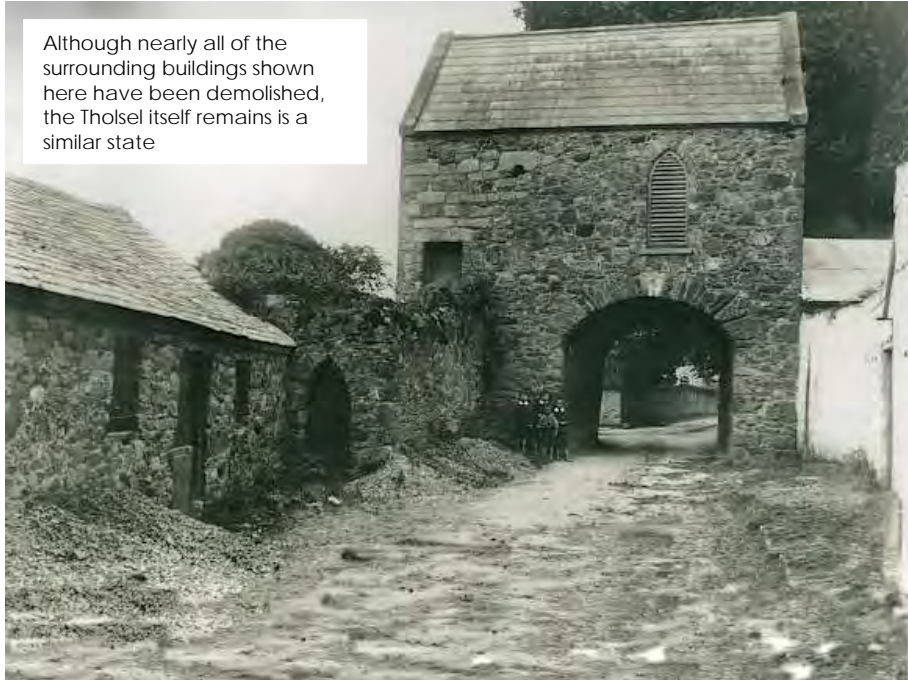
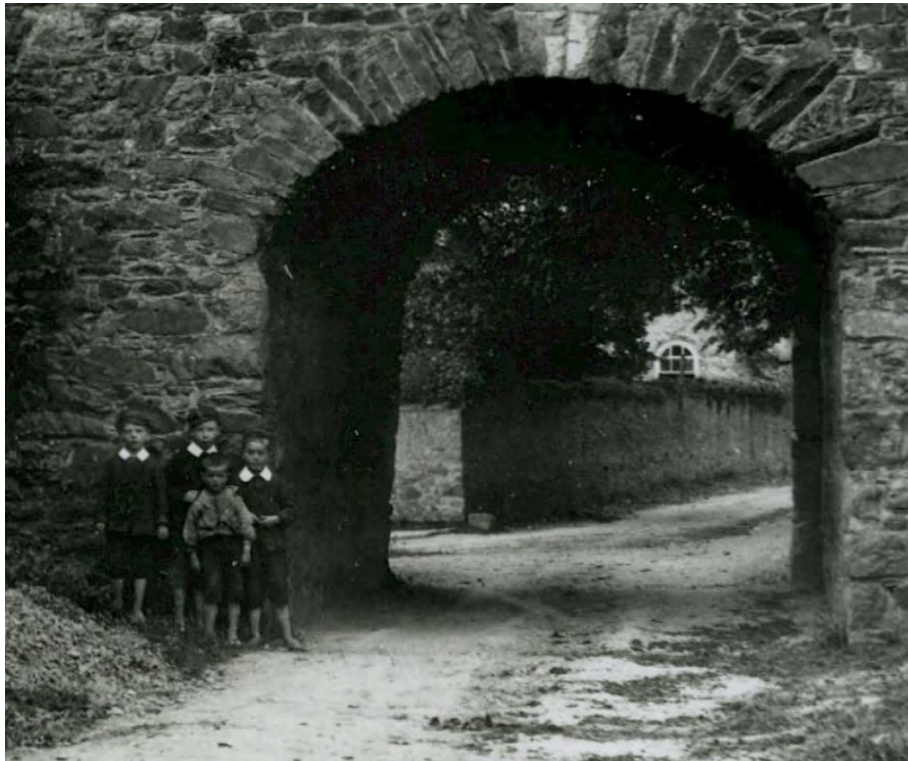
Author not known (c. 1900); www.carlingfordpeople.ie

Although nearly all of the surrounding buildings shown here have been demolished, the Tholsel itself remains in a similar state

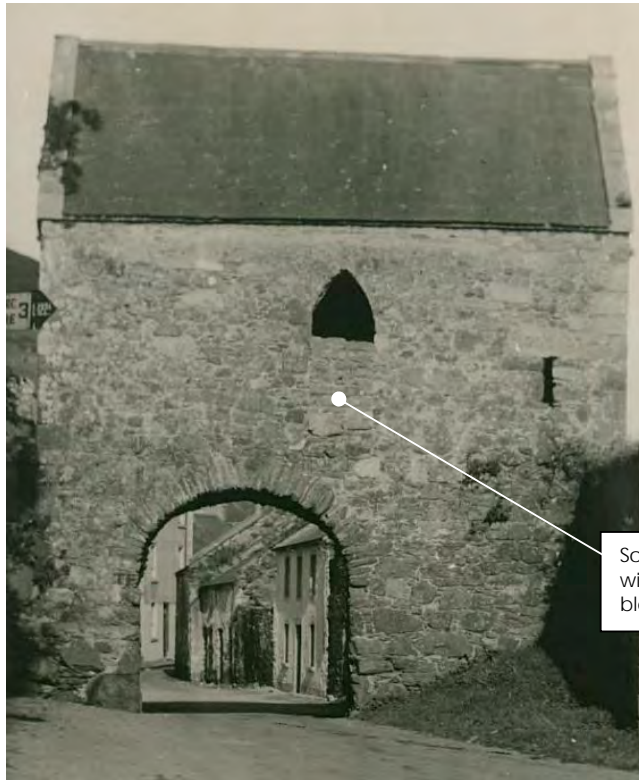
Southeast facing
window partly
blocked up.

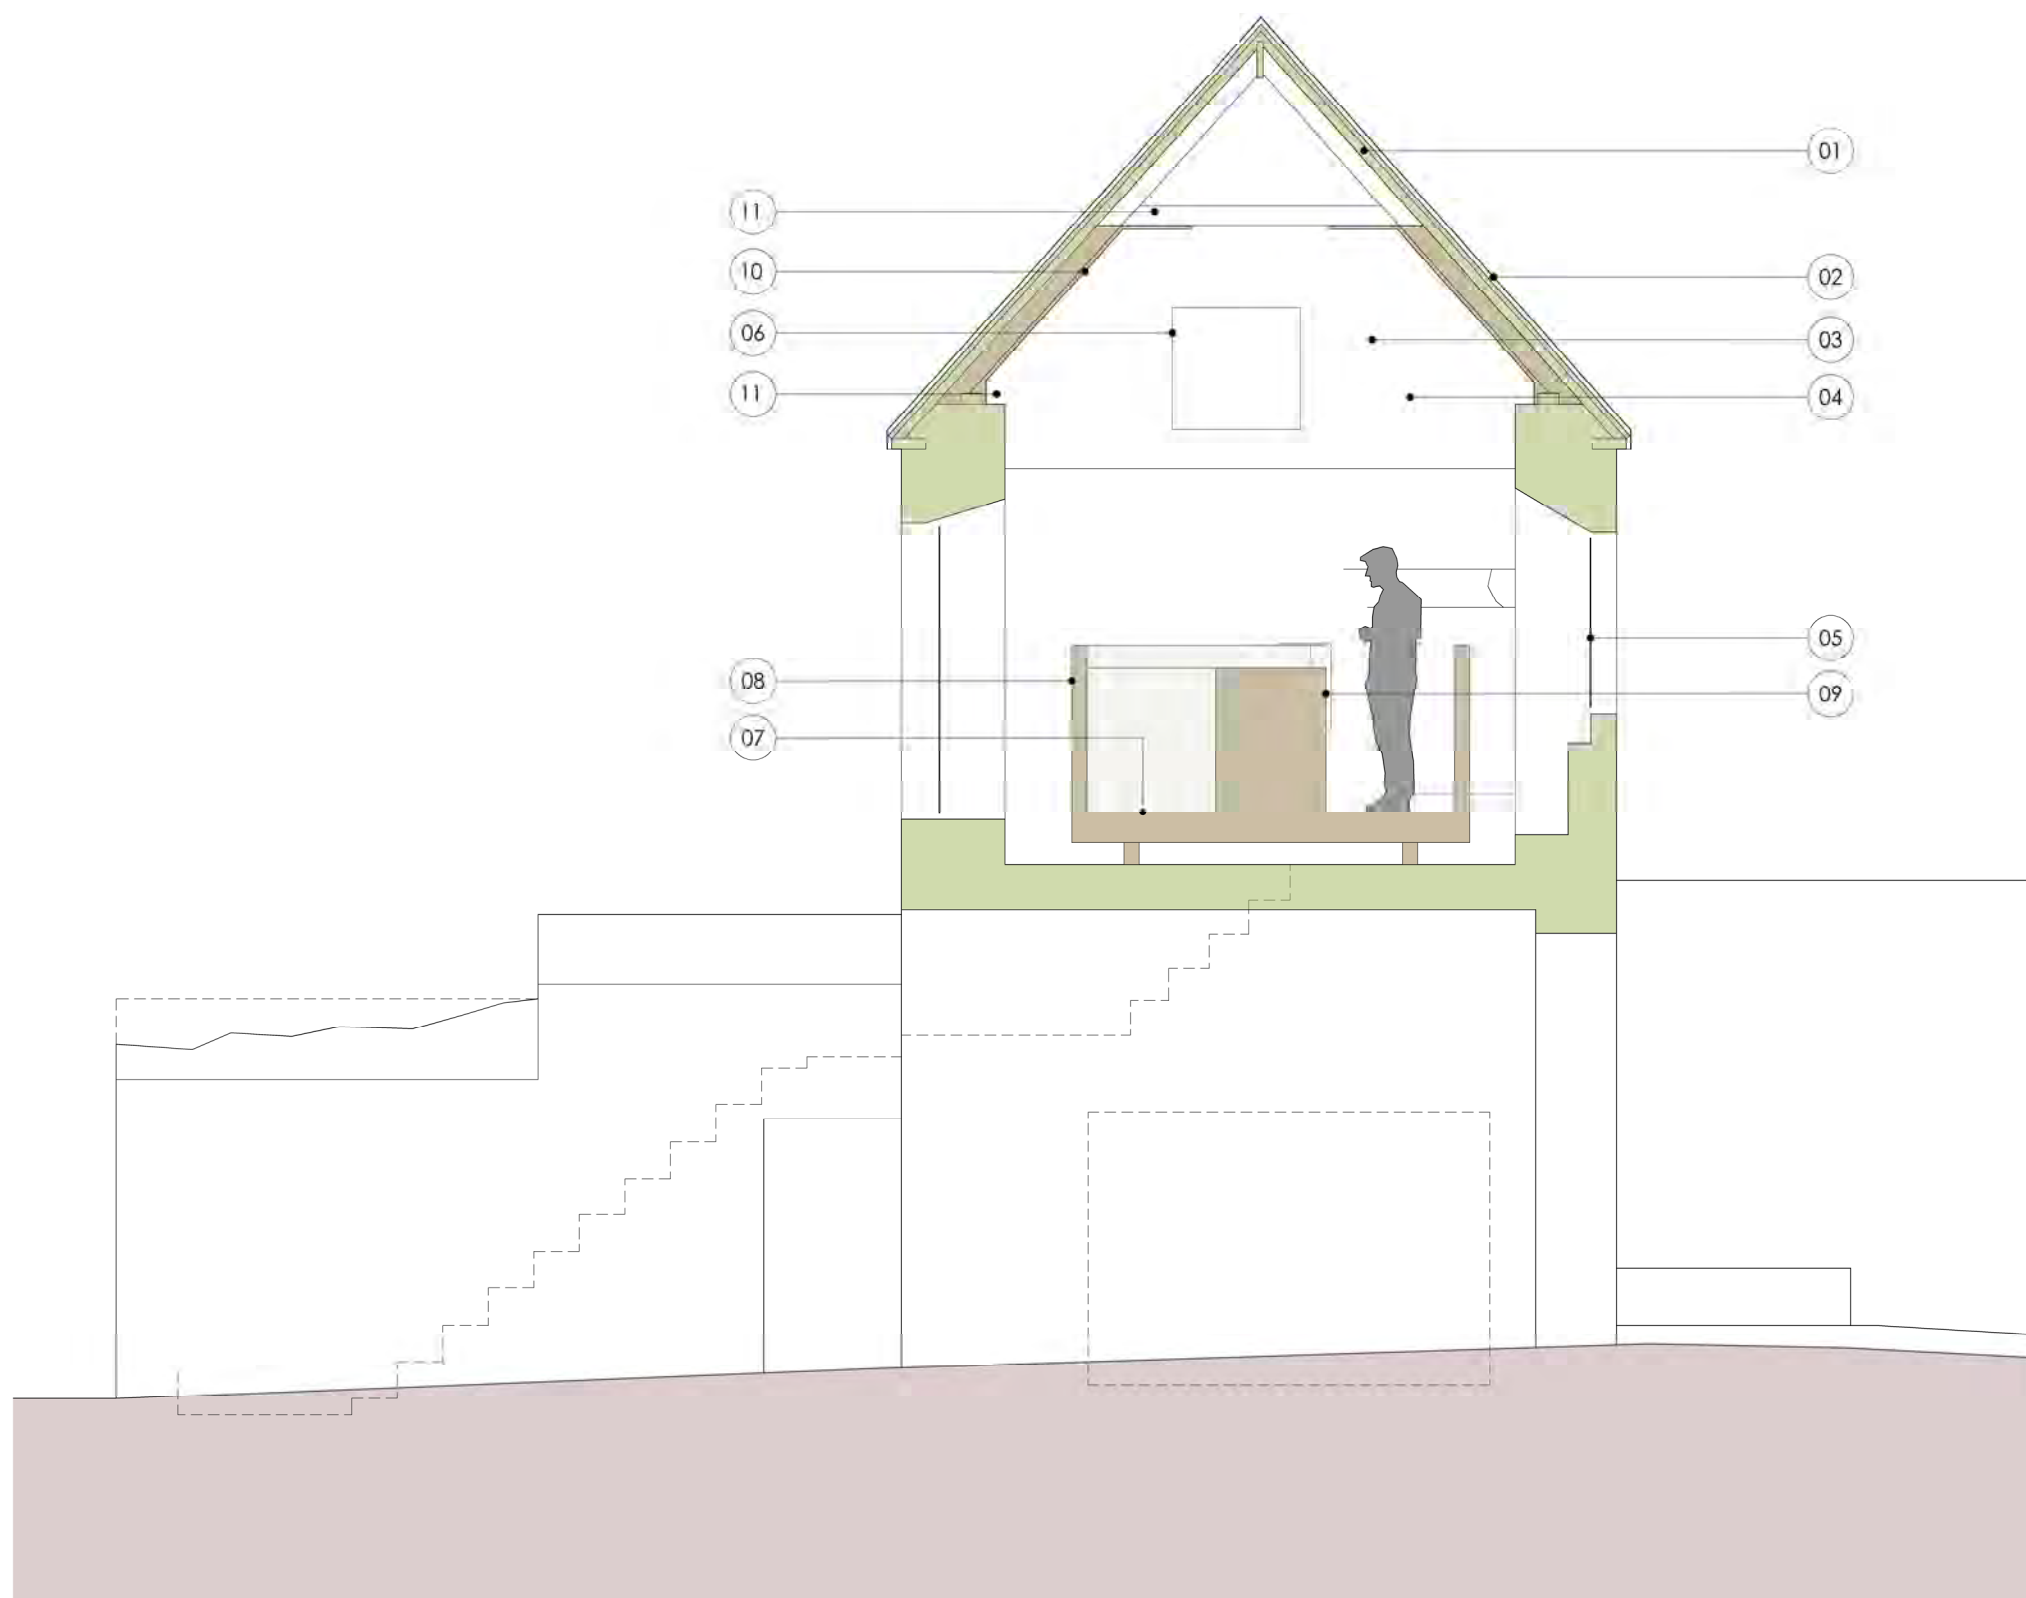
8.0 PROPOSAL DRAWINGS

- 1. WALLS SHOULD BE CLEANED DOWN AND REPAIRED WITH LIME MORTAR TO CONSERVATION BEST PRACTICE BY COMPETENT STONE MASON
- 2. STEPS, THRESHOLDS AND LANDINGS TO BE REPOINTED AND MADE AS LEVEL AS POSSIBLE

- 3. NEW HANDRAIL TO ASSIST ACCESS
- 4. CLEAN DOWN AND MAKE GOOD ALL WALLS AND FEATURES THEREIN IN ACCORDANCE WITH BEST CONSERVATION PRACTICE. EXPLORE THE POSSIBILITY OF LOCALISED POINTING AND PAINTING USING LIMEWASH.

- 5. FIT ALL OPENINGS WITH SENSITIVELY DESIGNED AND FITTED GLASS SCREENS TO PREVENT VERMIN
- 6. EXPLORE POSSIBILITY OF UNBLOCKING HIGH LEVEL WINDOW LOOPS TO THE EAST AND WEST WALL

- 7. INSTALL A NEW TIMBER FLOOR PLATFORM OR FLOATING OVER THE EXISTING FLOOR AND SUPPORTED SENSITIVELY OFF STABLE MASONRY BELOW
- 8. SOLID EDGE GUARDING WALL TO WAIST HEIGHT SURROUNDING FLOATING FLOOR

- 10. WRITTEN AND IMAGE RELATED INTERPRETATION
