GLAS 2020

Chris Southgate Conservation
Engineer with Southgate
Associates

**Typical structural
issues and possible
fixes!**

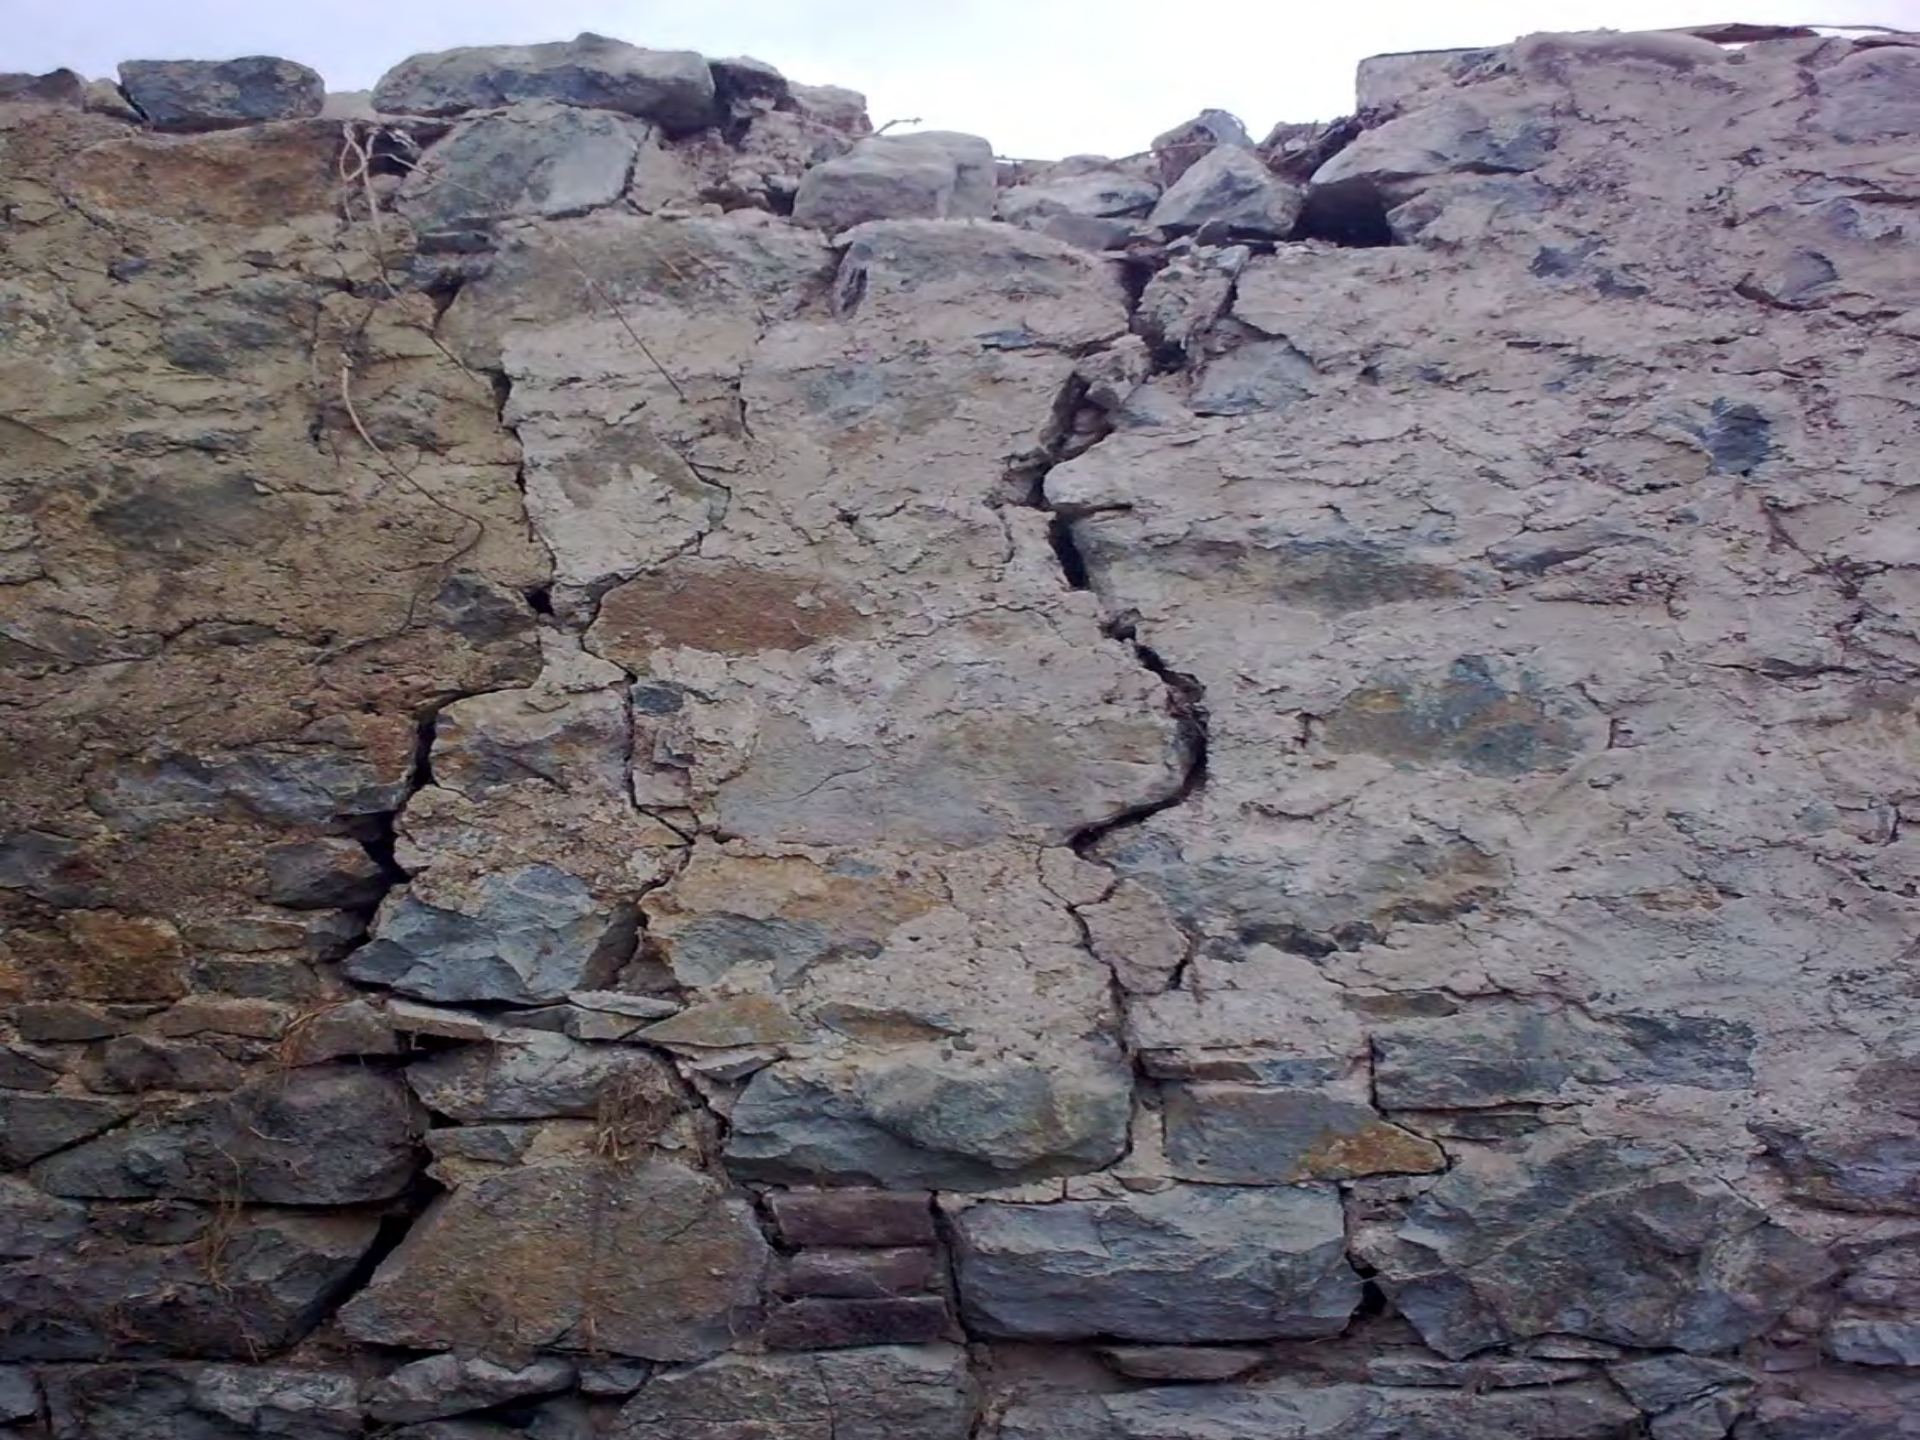
Cracks are pointed in lime
mortar and grouted with lime

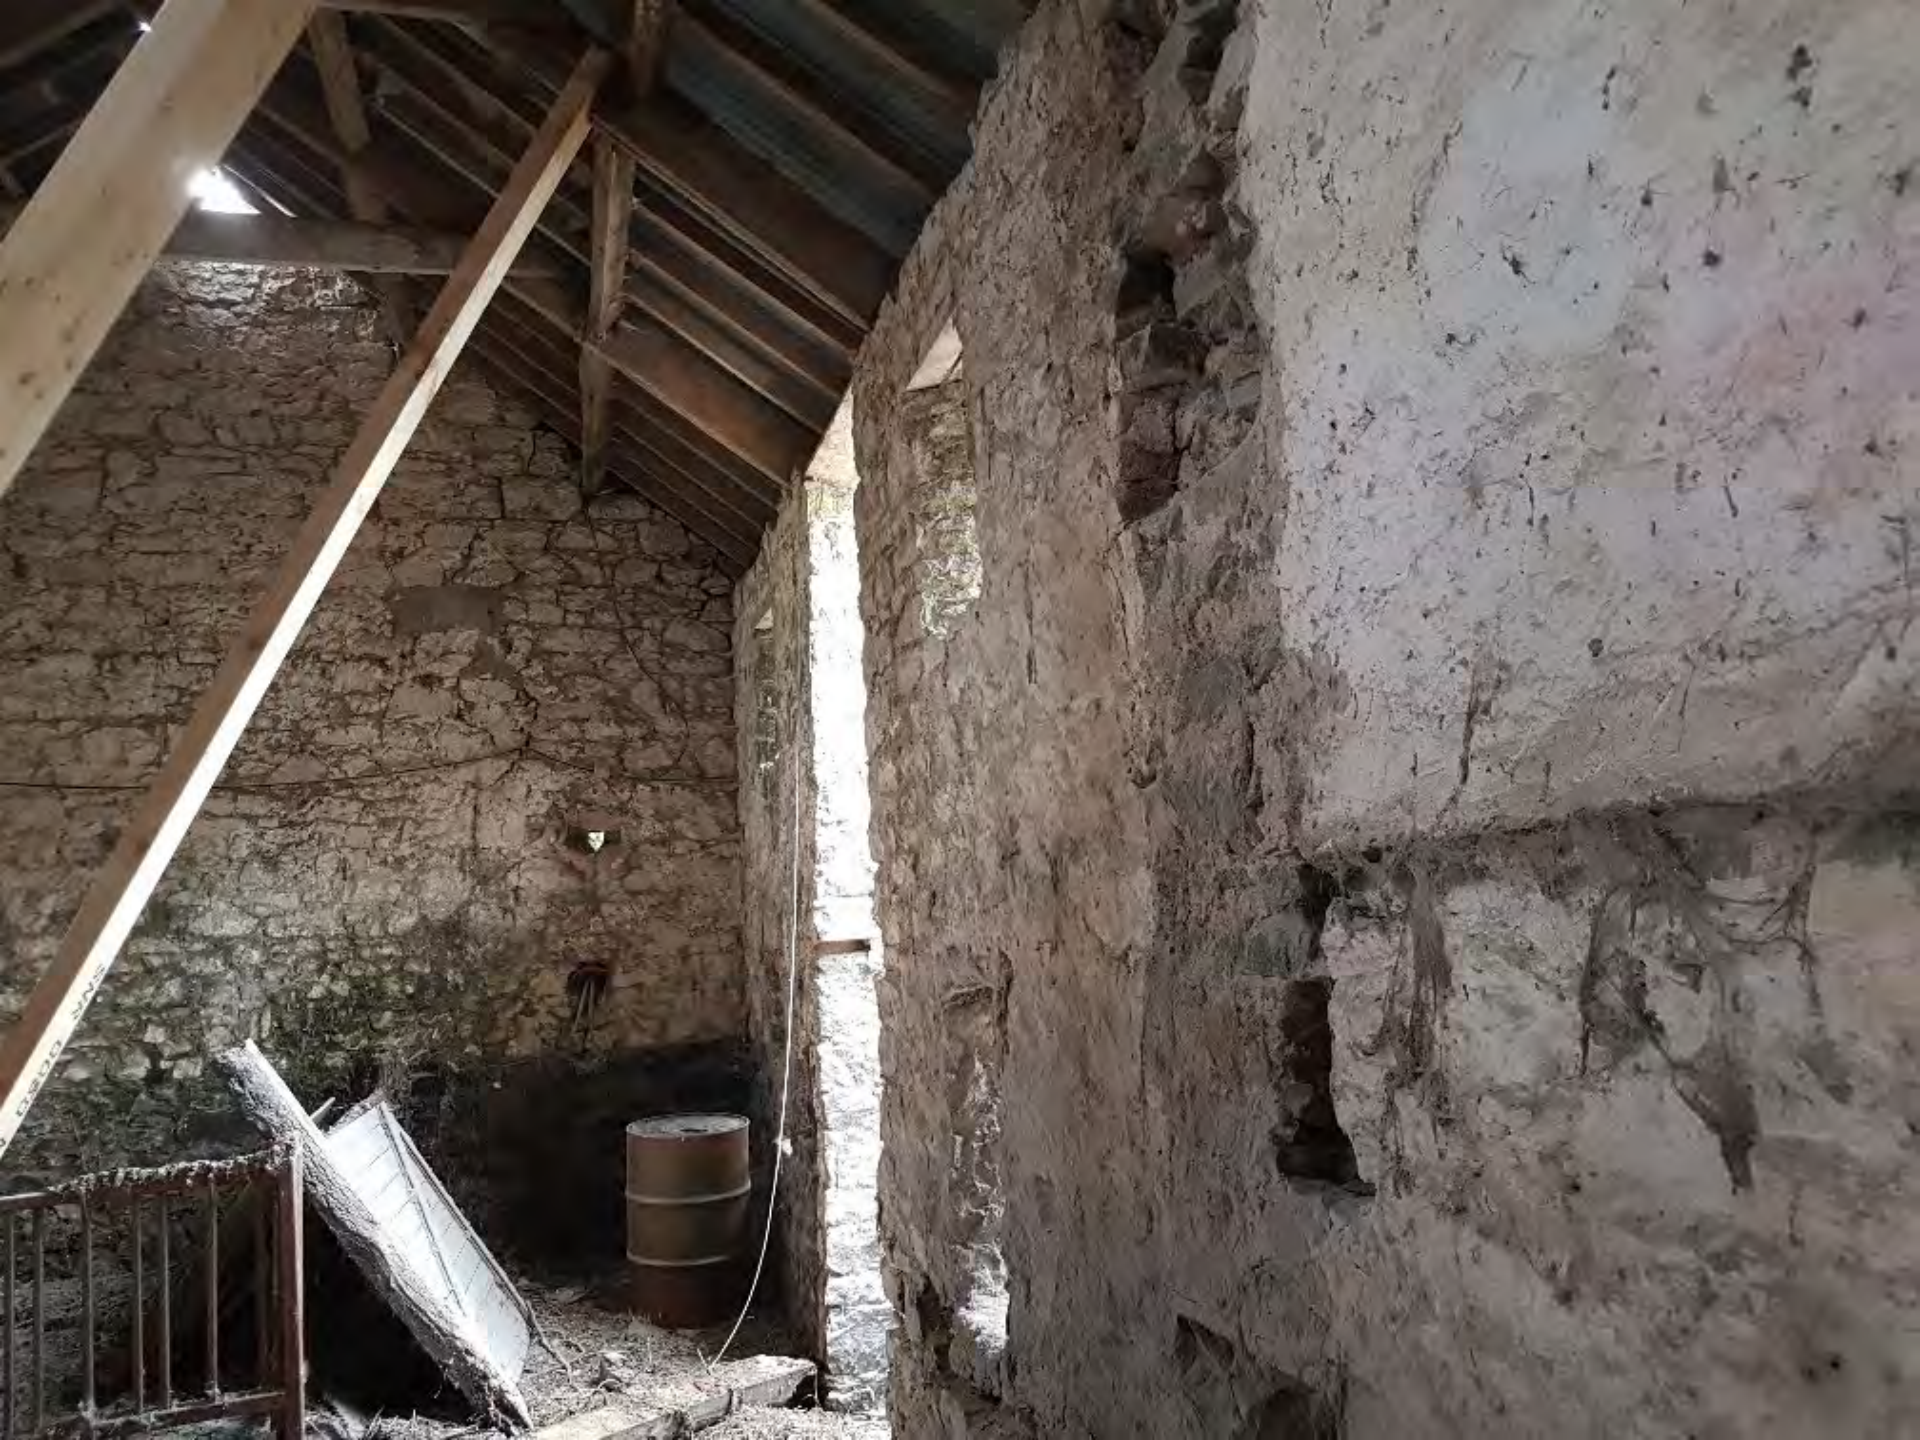
- ▶ On Saturday, 29 September following set up by the main contractor, the wall was jacked back into its original position. The walls were leaning out by about 250 mm and had moved so far that the trusses and rafters were no longer able to bear on the wall.
- ▶ Jacking was carried out from the concrete floor and the steel columns on the adjoining shed and prior to the jacking taking place, the steel columns had to be strengthened with cross bracing. After this a chase was cut on the wall to weaken it at the base of the wall. The chase was approximately 50 mm x 75 mm deep and this produced a weak point in the wall.

- Internally the existing roof was jacked to its original position using a system of raking 9" x 3" timbers which were jacked received distance in the position of the wall opposite. Following this wall was gradually jacked in position using two taps of a sledgehammer at each jacking point in rotation. This was carried out under the careful supervision of Chris Southgate. The wall was able to realign to its original position.
