**June and Ken Bourke Farm Buildings Case Study,
Knappagh, Westport, Co. Mayo GLAS TFB 2016**

Áine Doyle MUBC Conservation Consultant

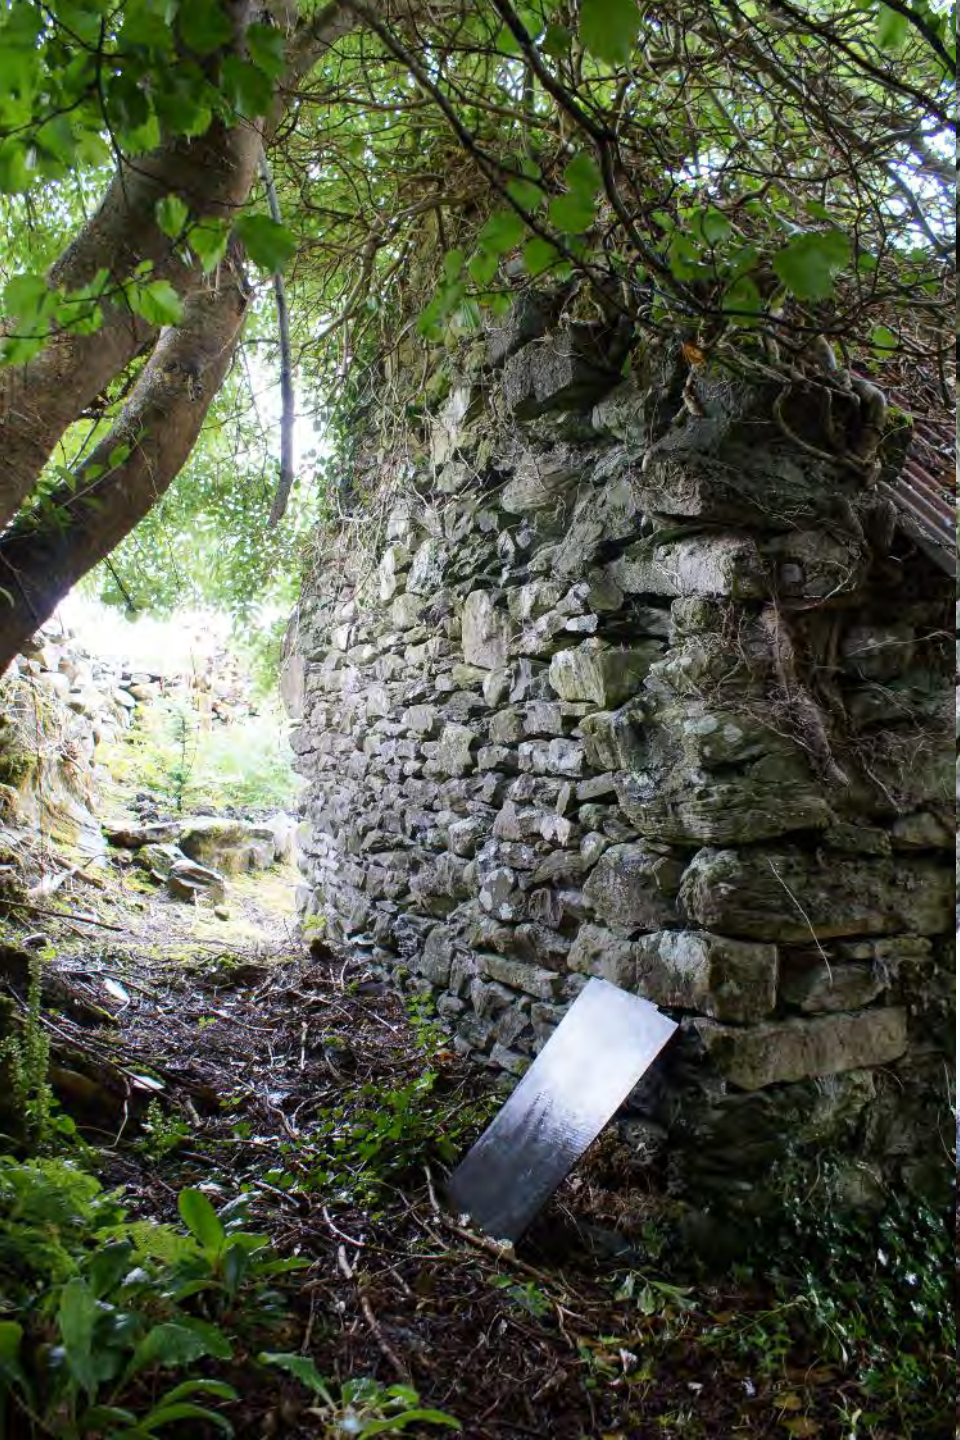
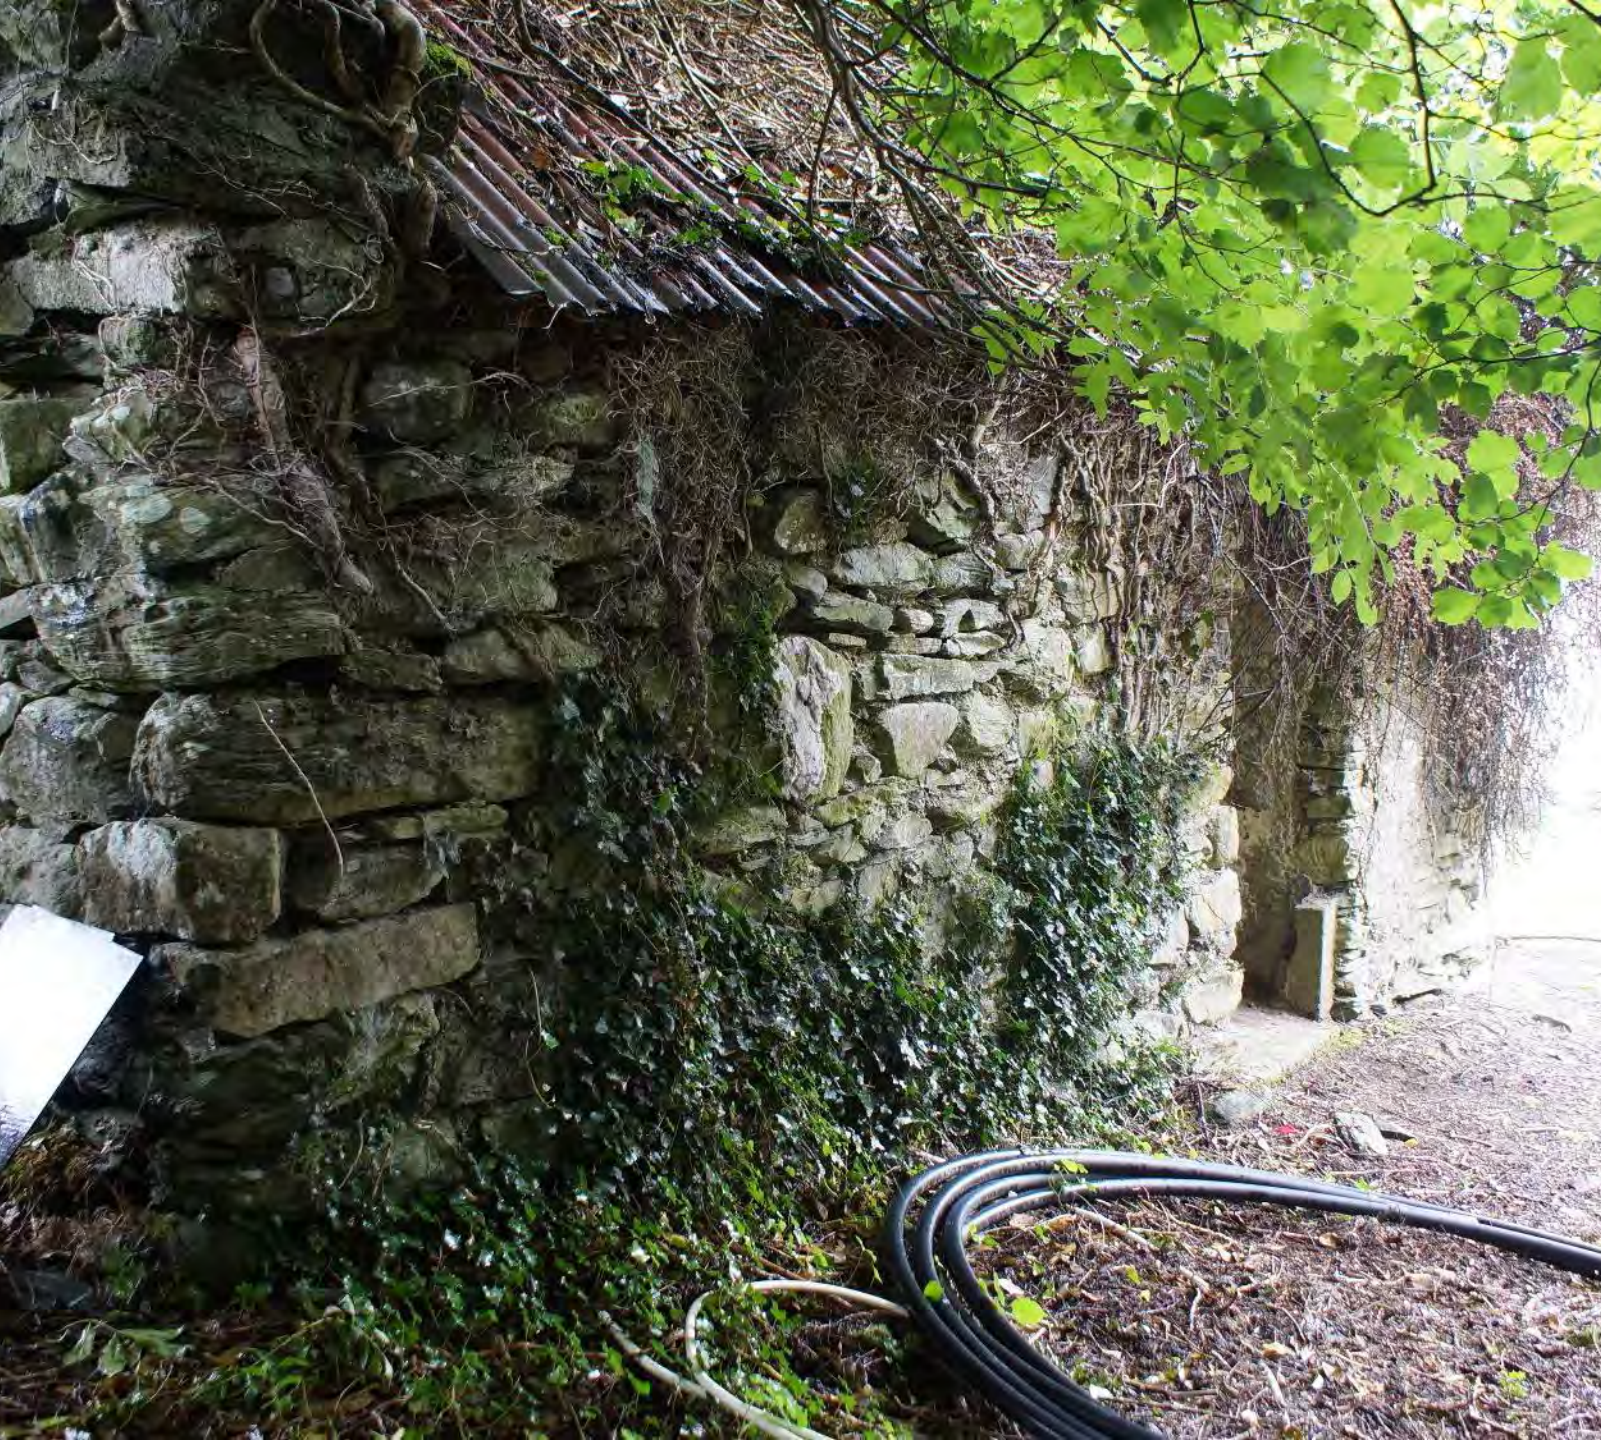
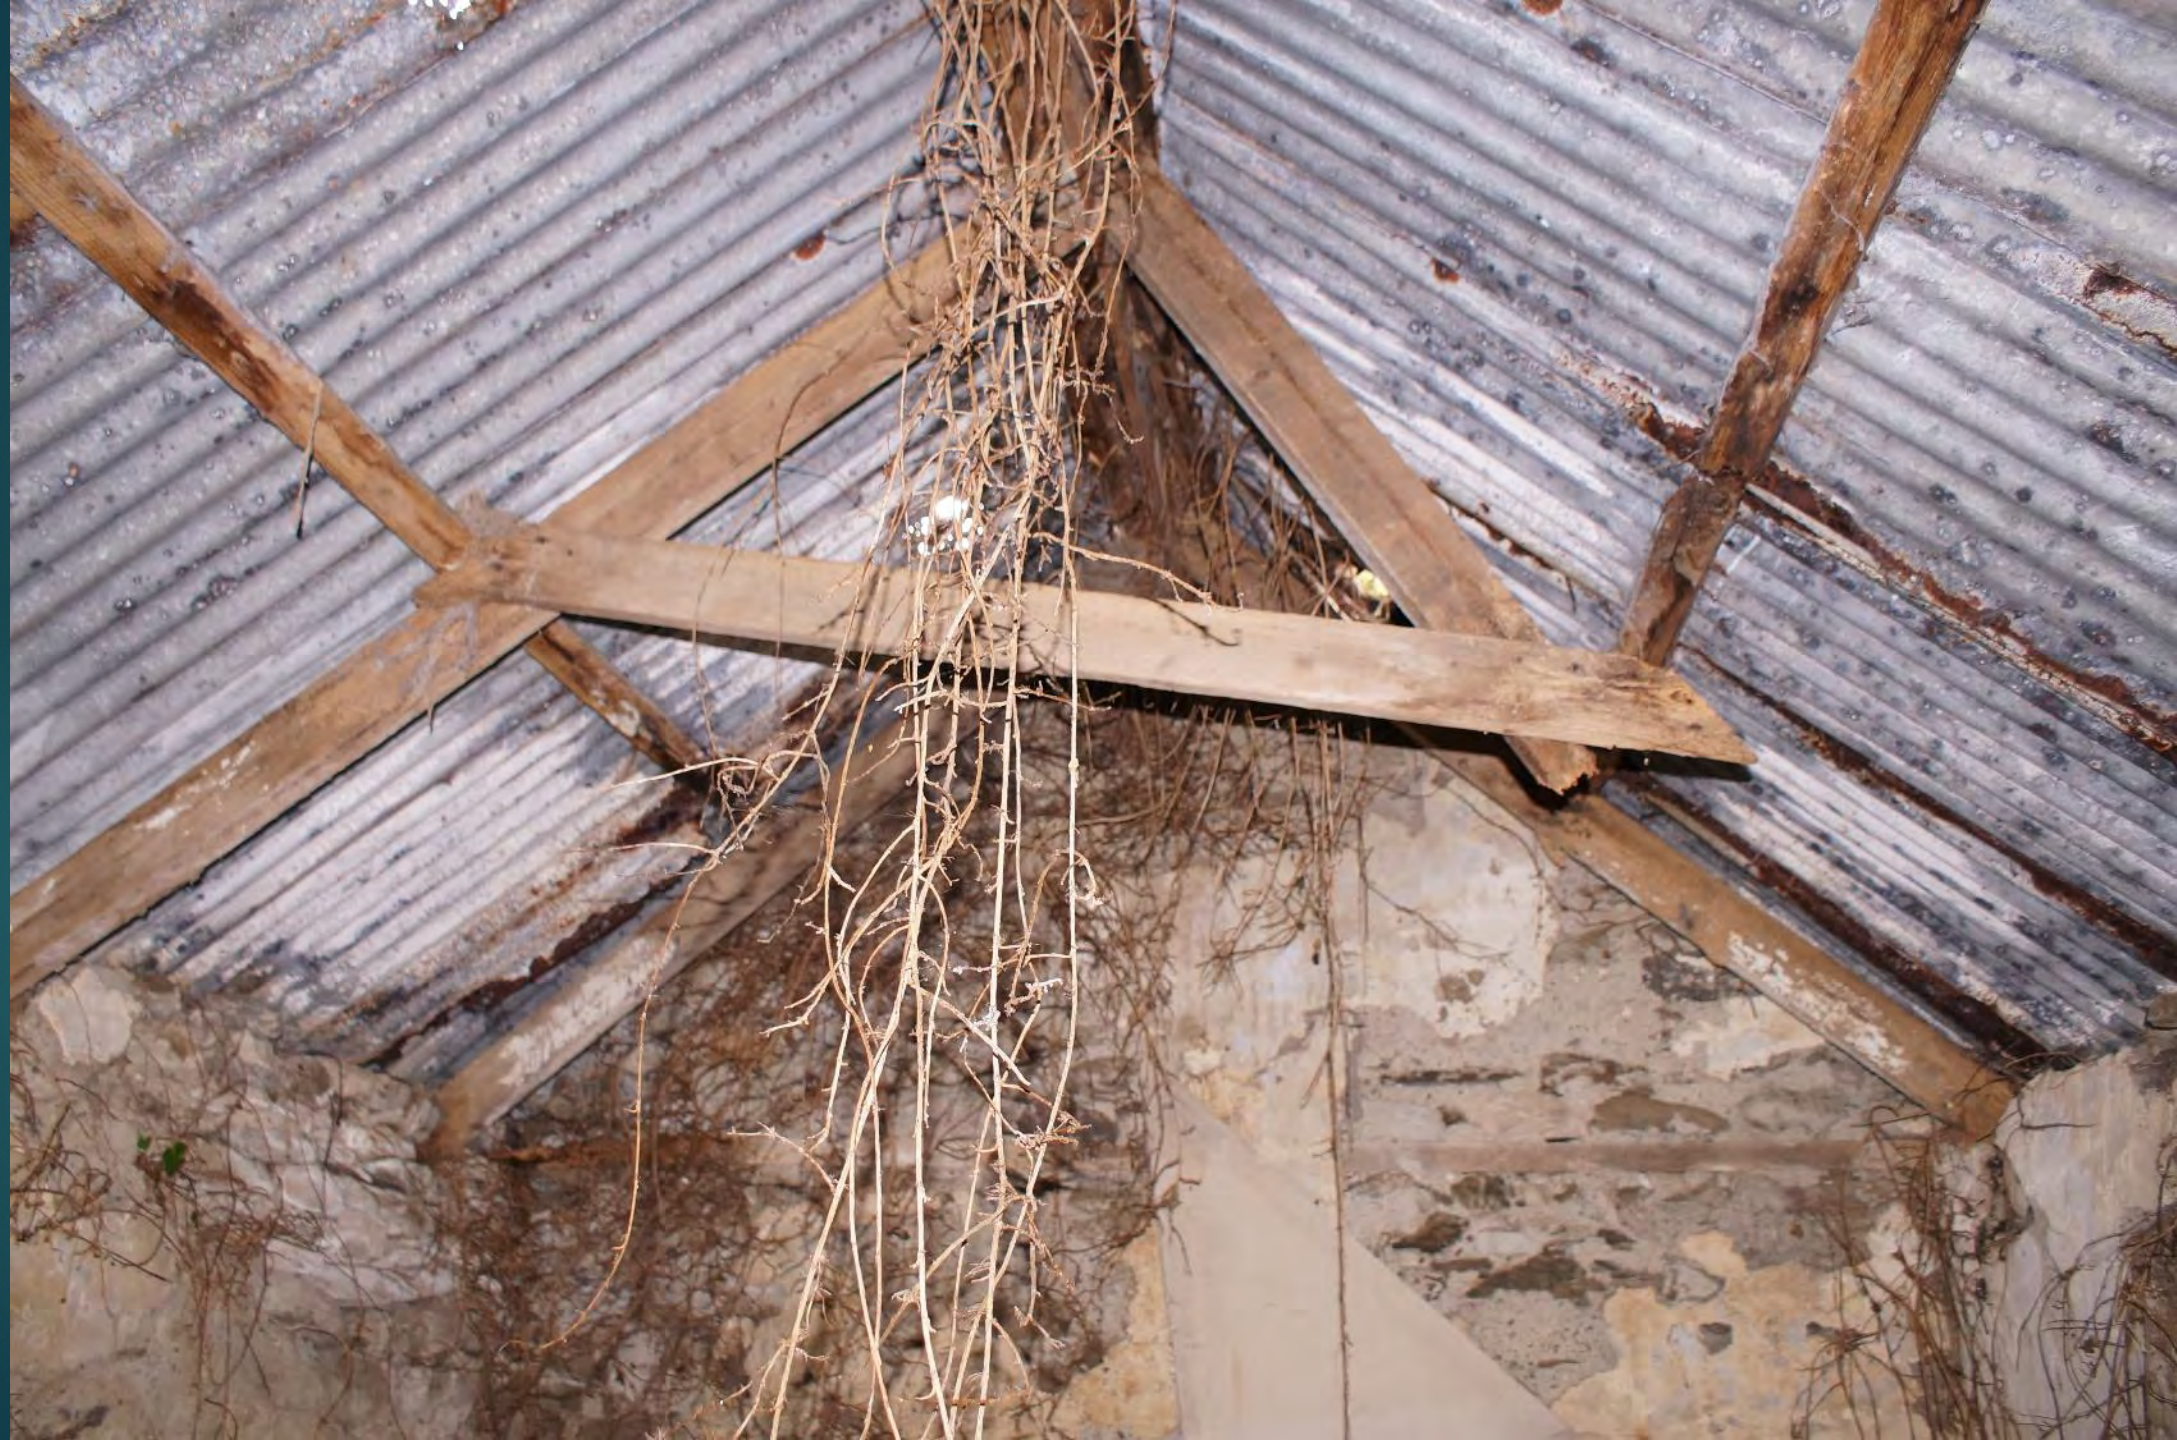
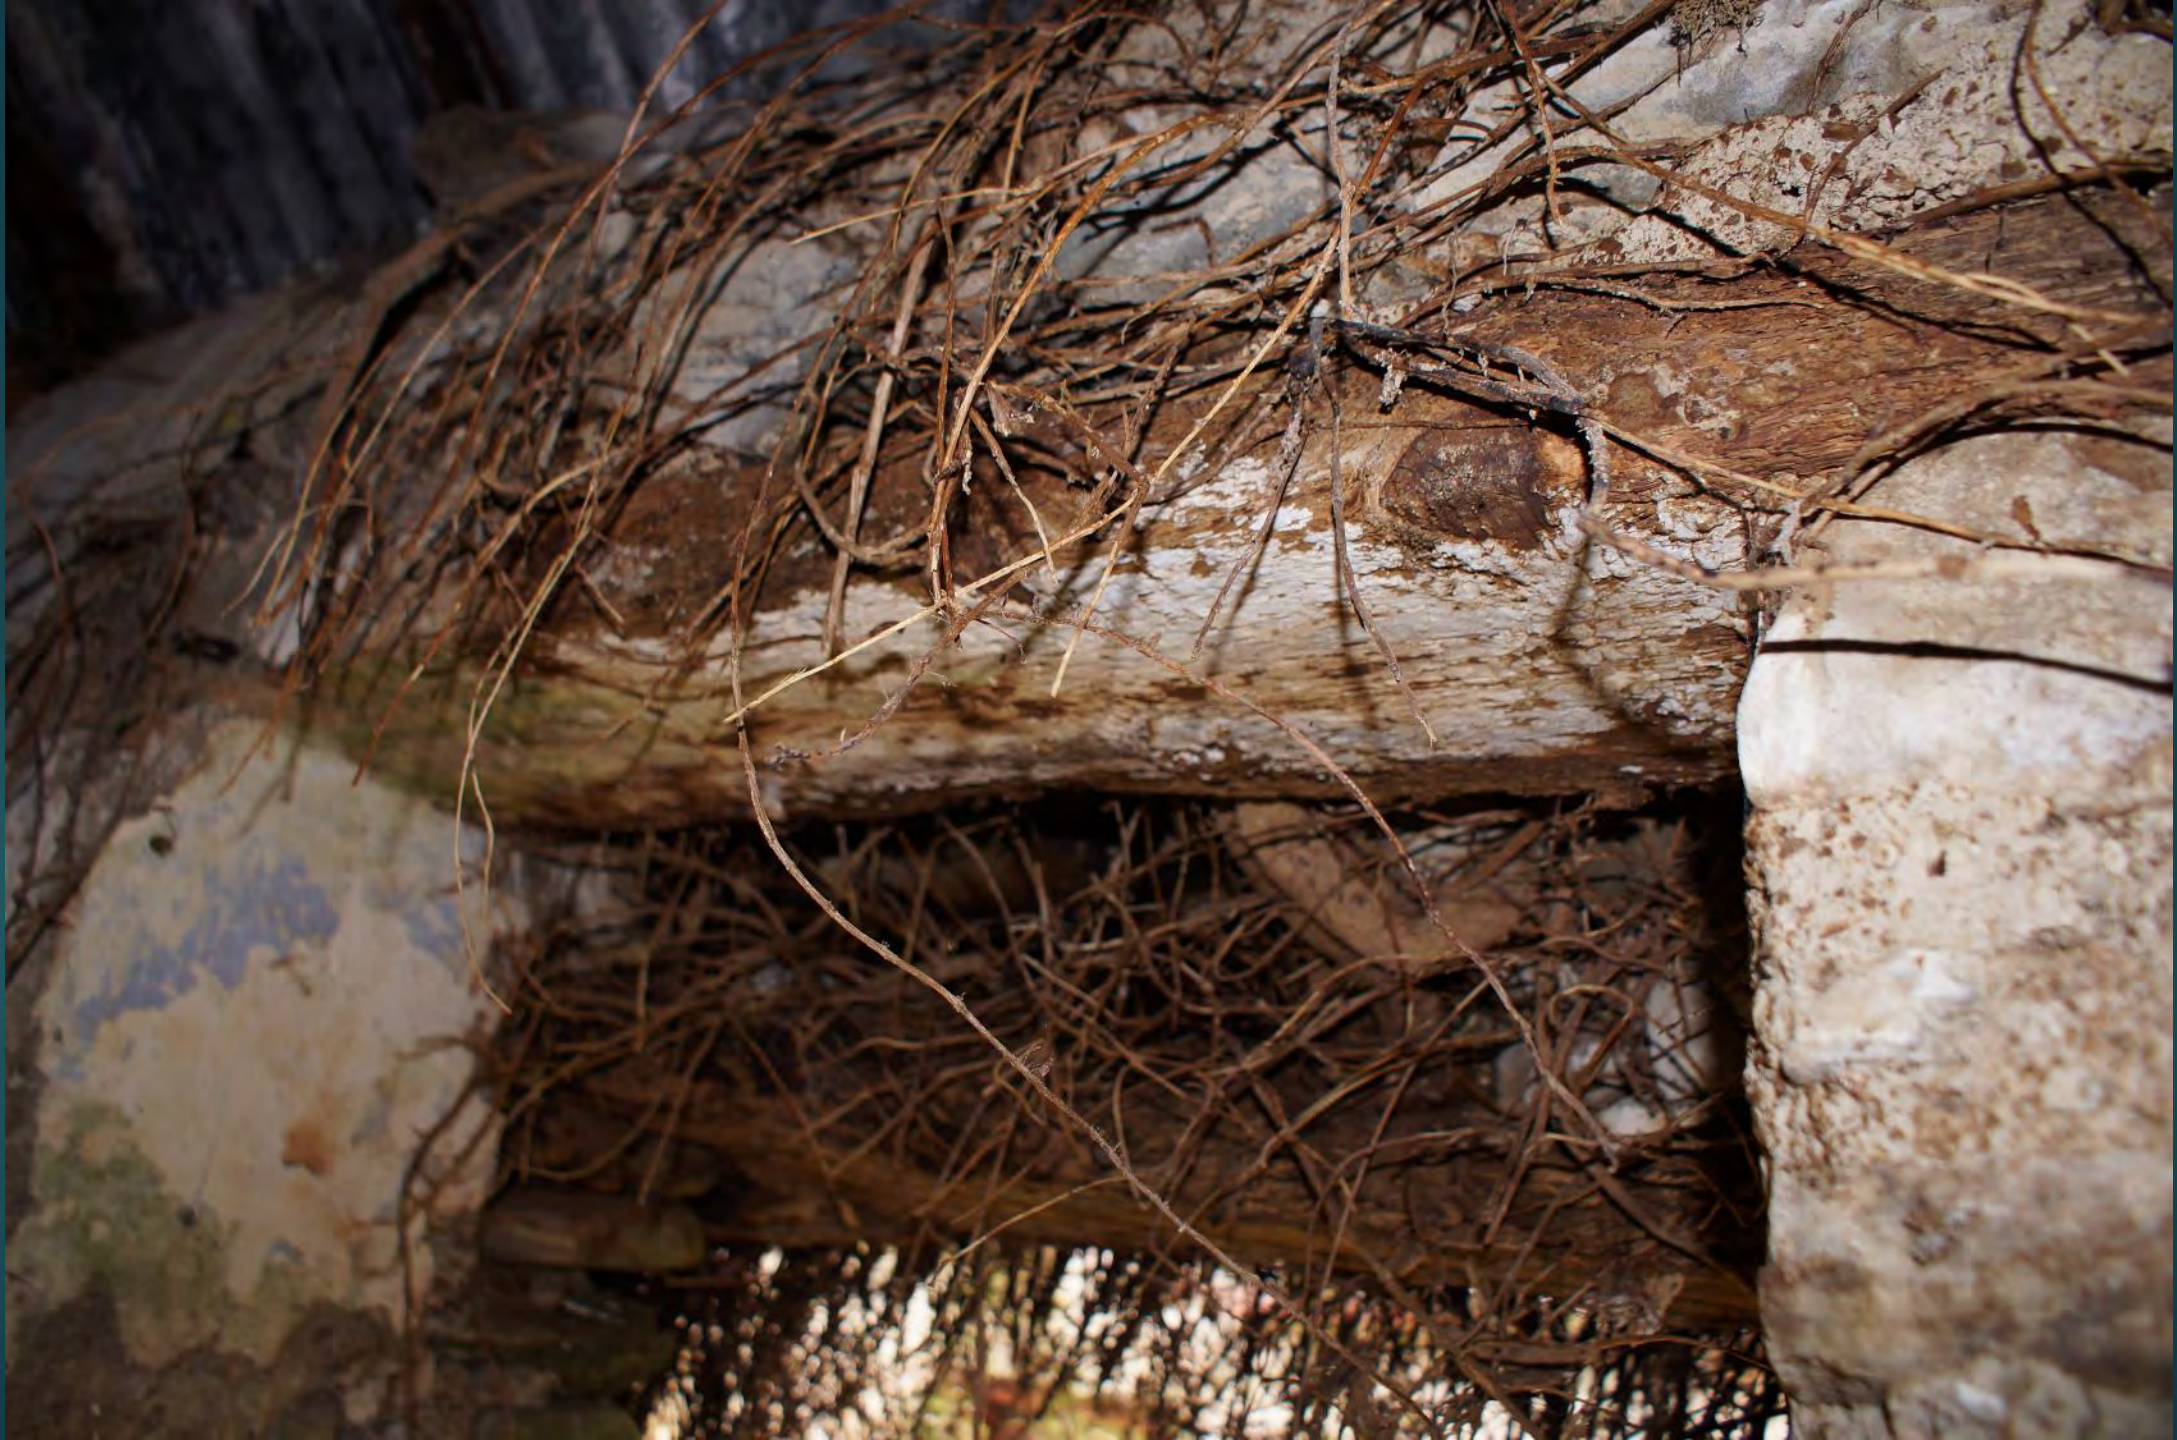
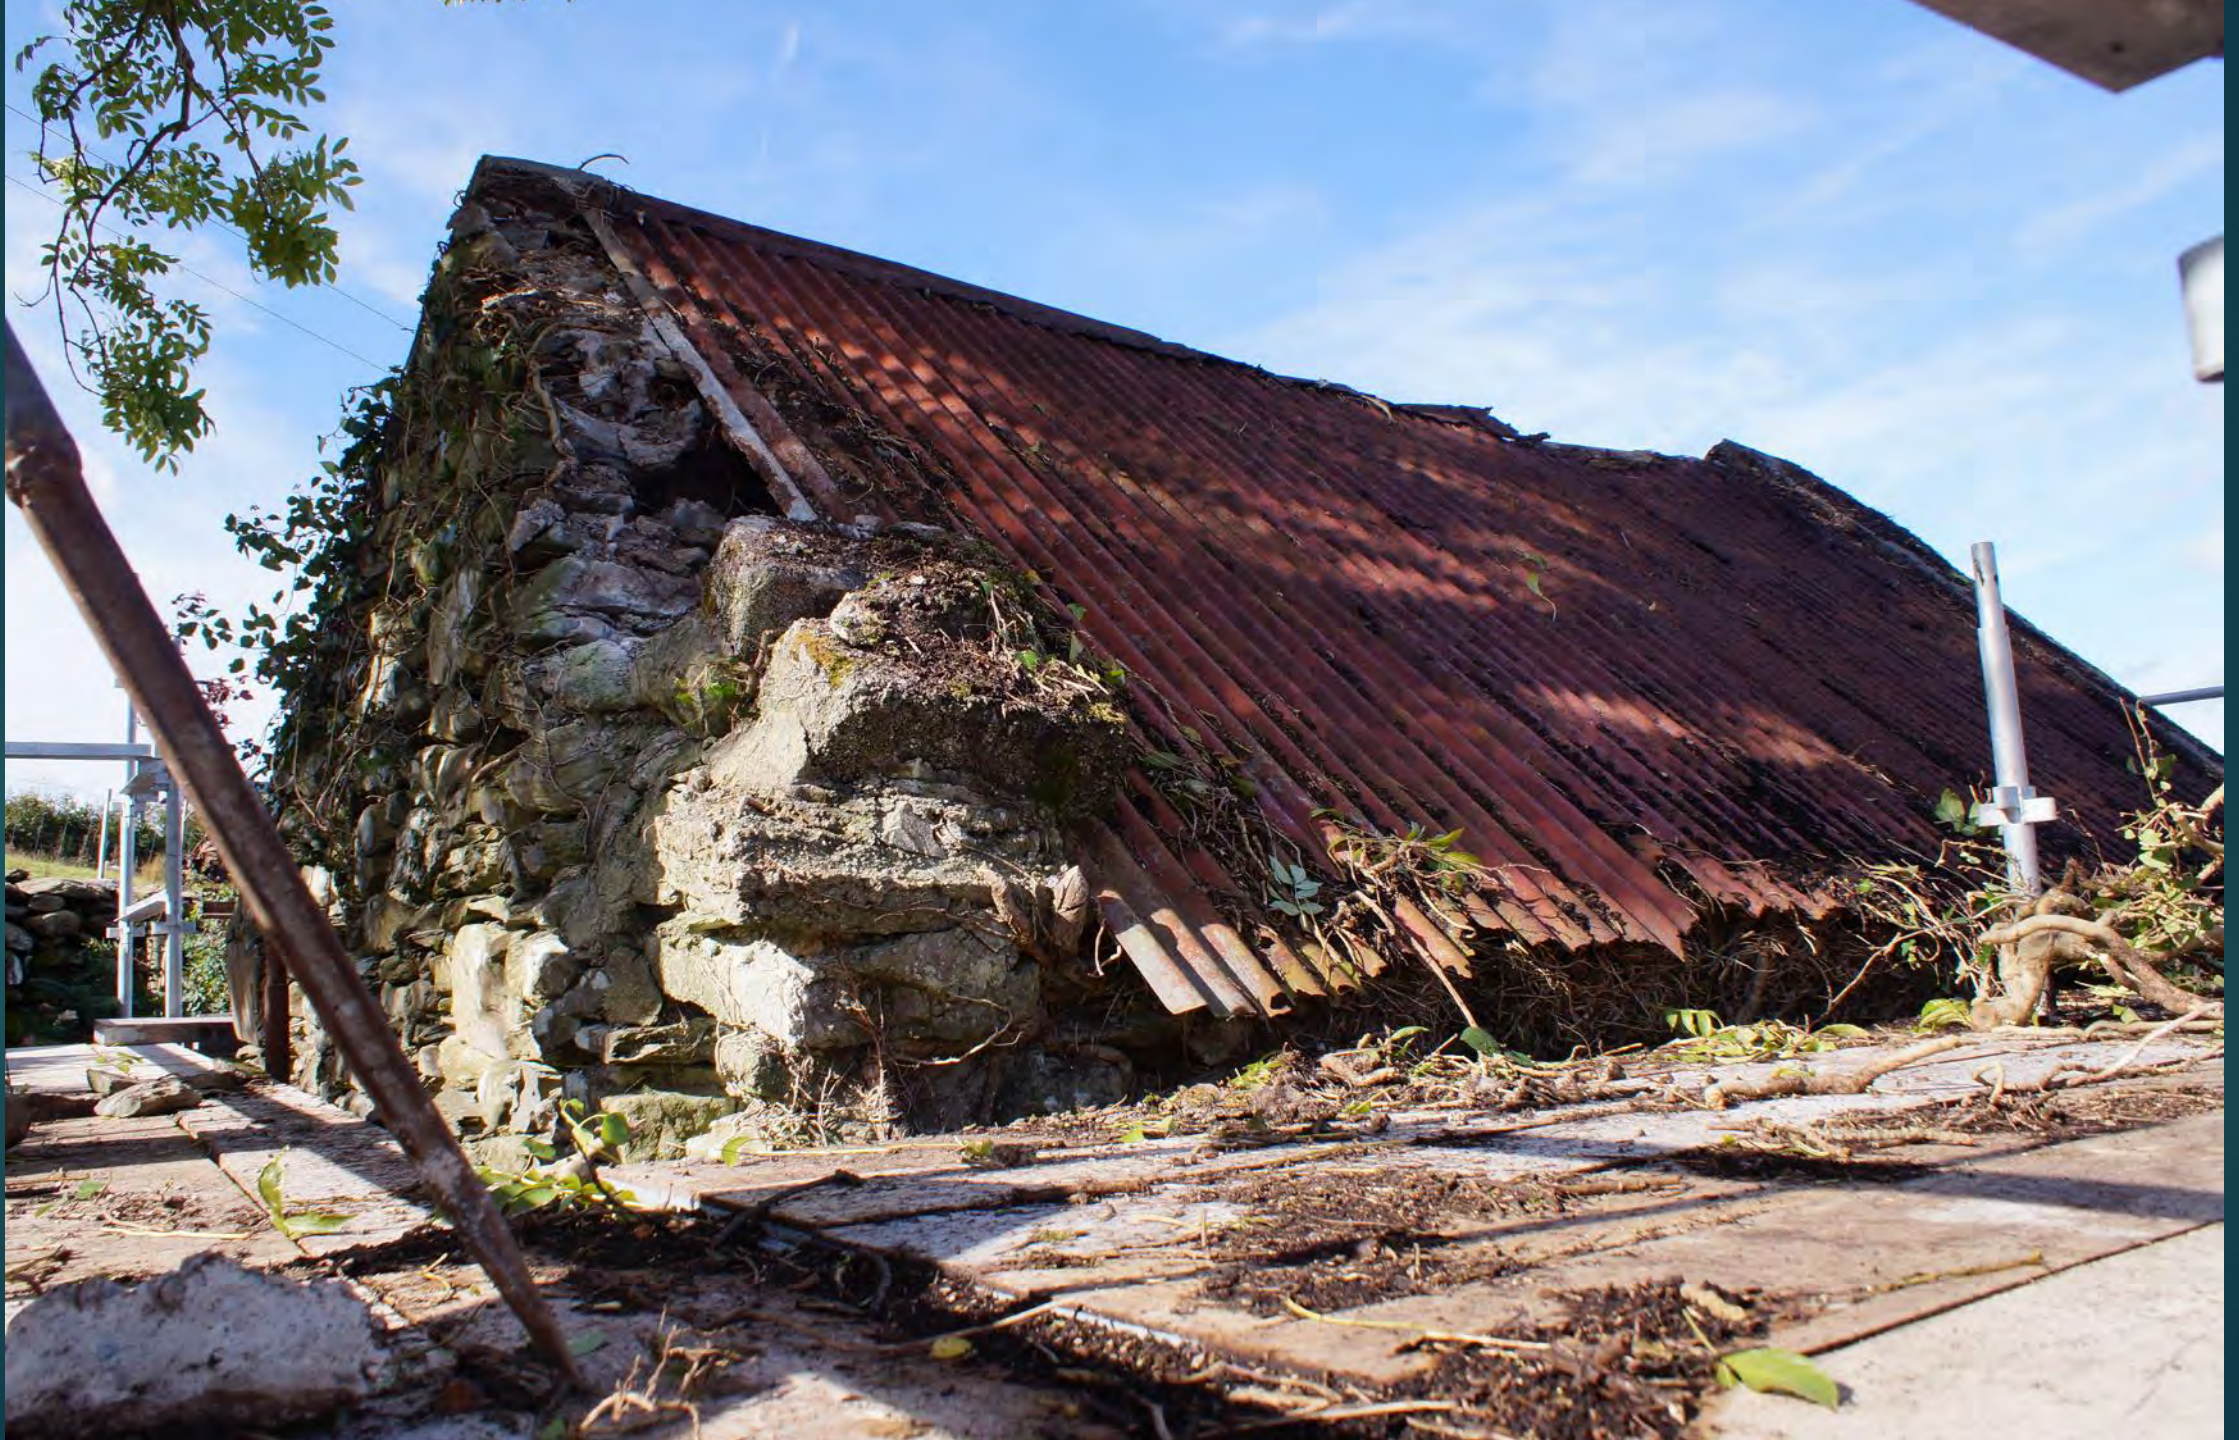
Hen House

- Vegetation/ivy damage to stonework and corrugated iron roof sheeting
- Large overhanging branches to rear
- Extensive pointing loss to walls
- Decay of timber door lintel
- Timber window repairs required
