**June and Ken Bourke Farm Buildings Case Study,
Knappagh, Westport, Co. Mayo GLAS TFB 2016**

Áine Doyle MUBC Conservation Consultant

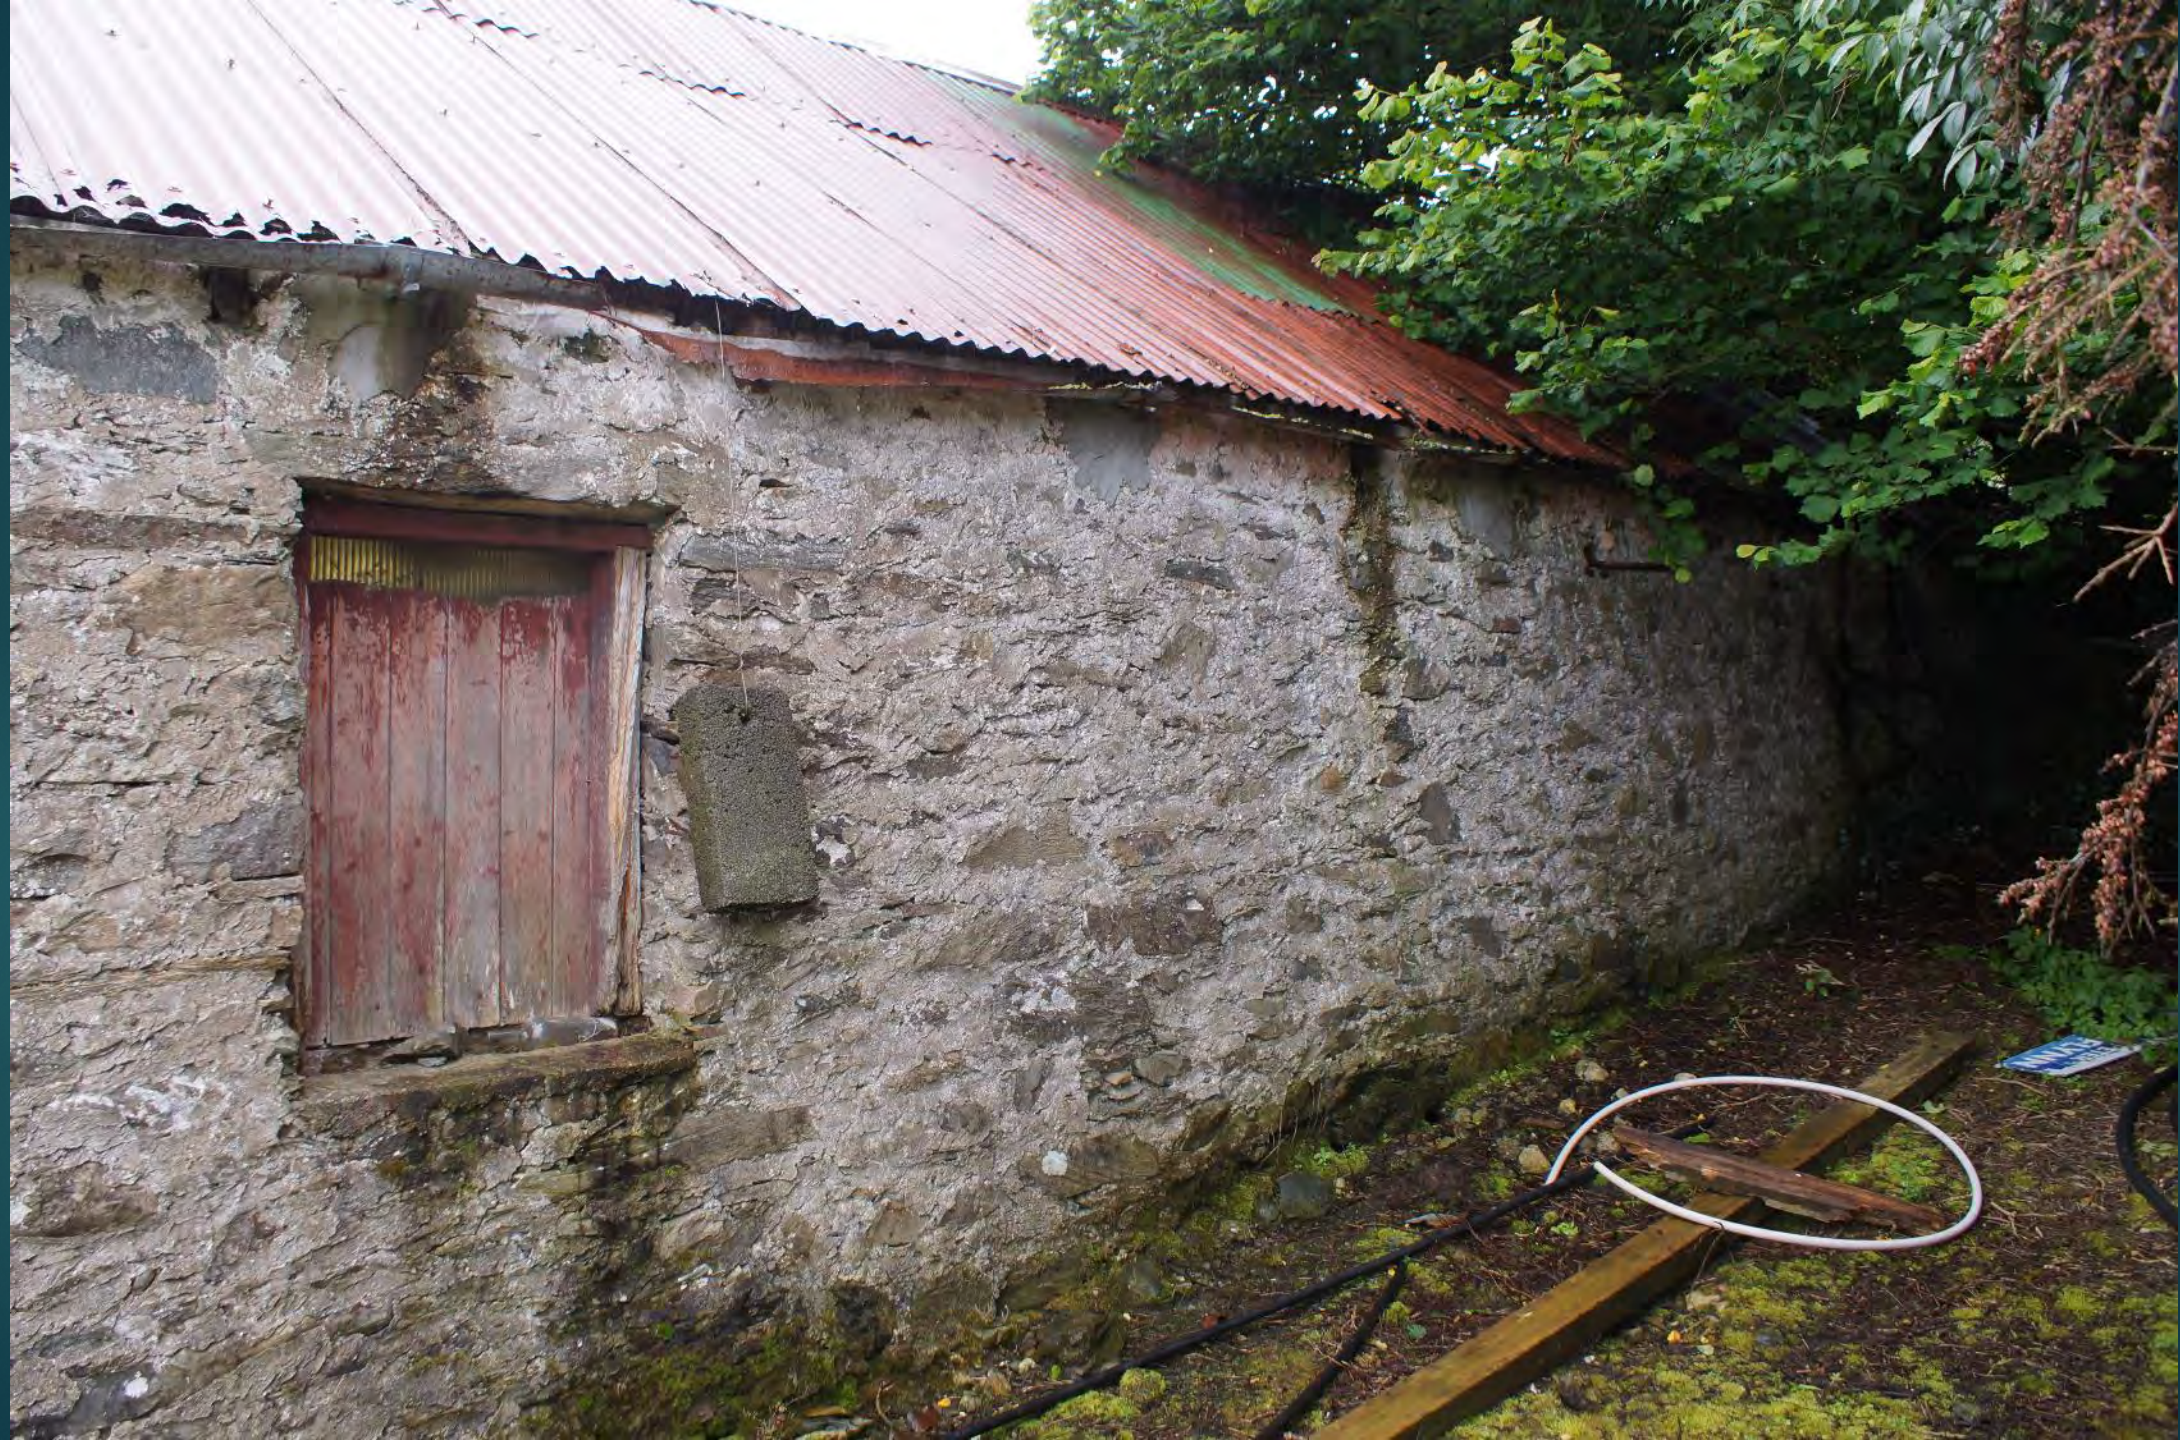
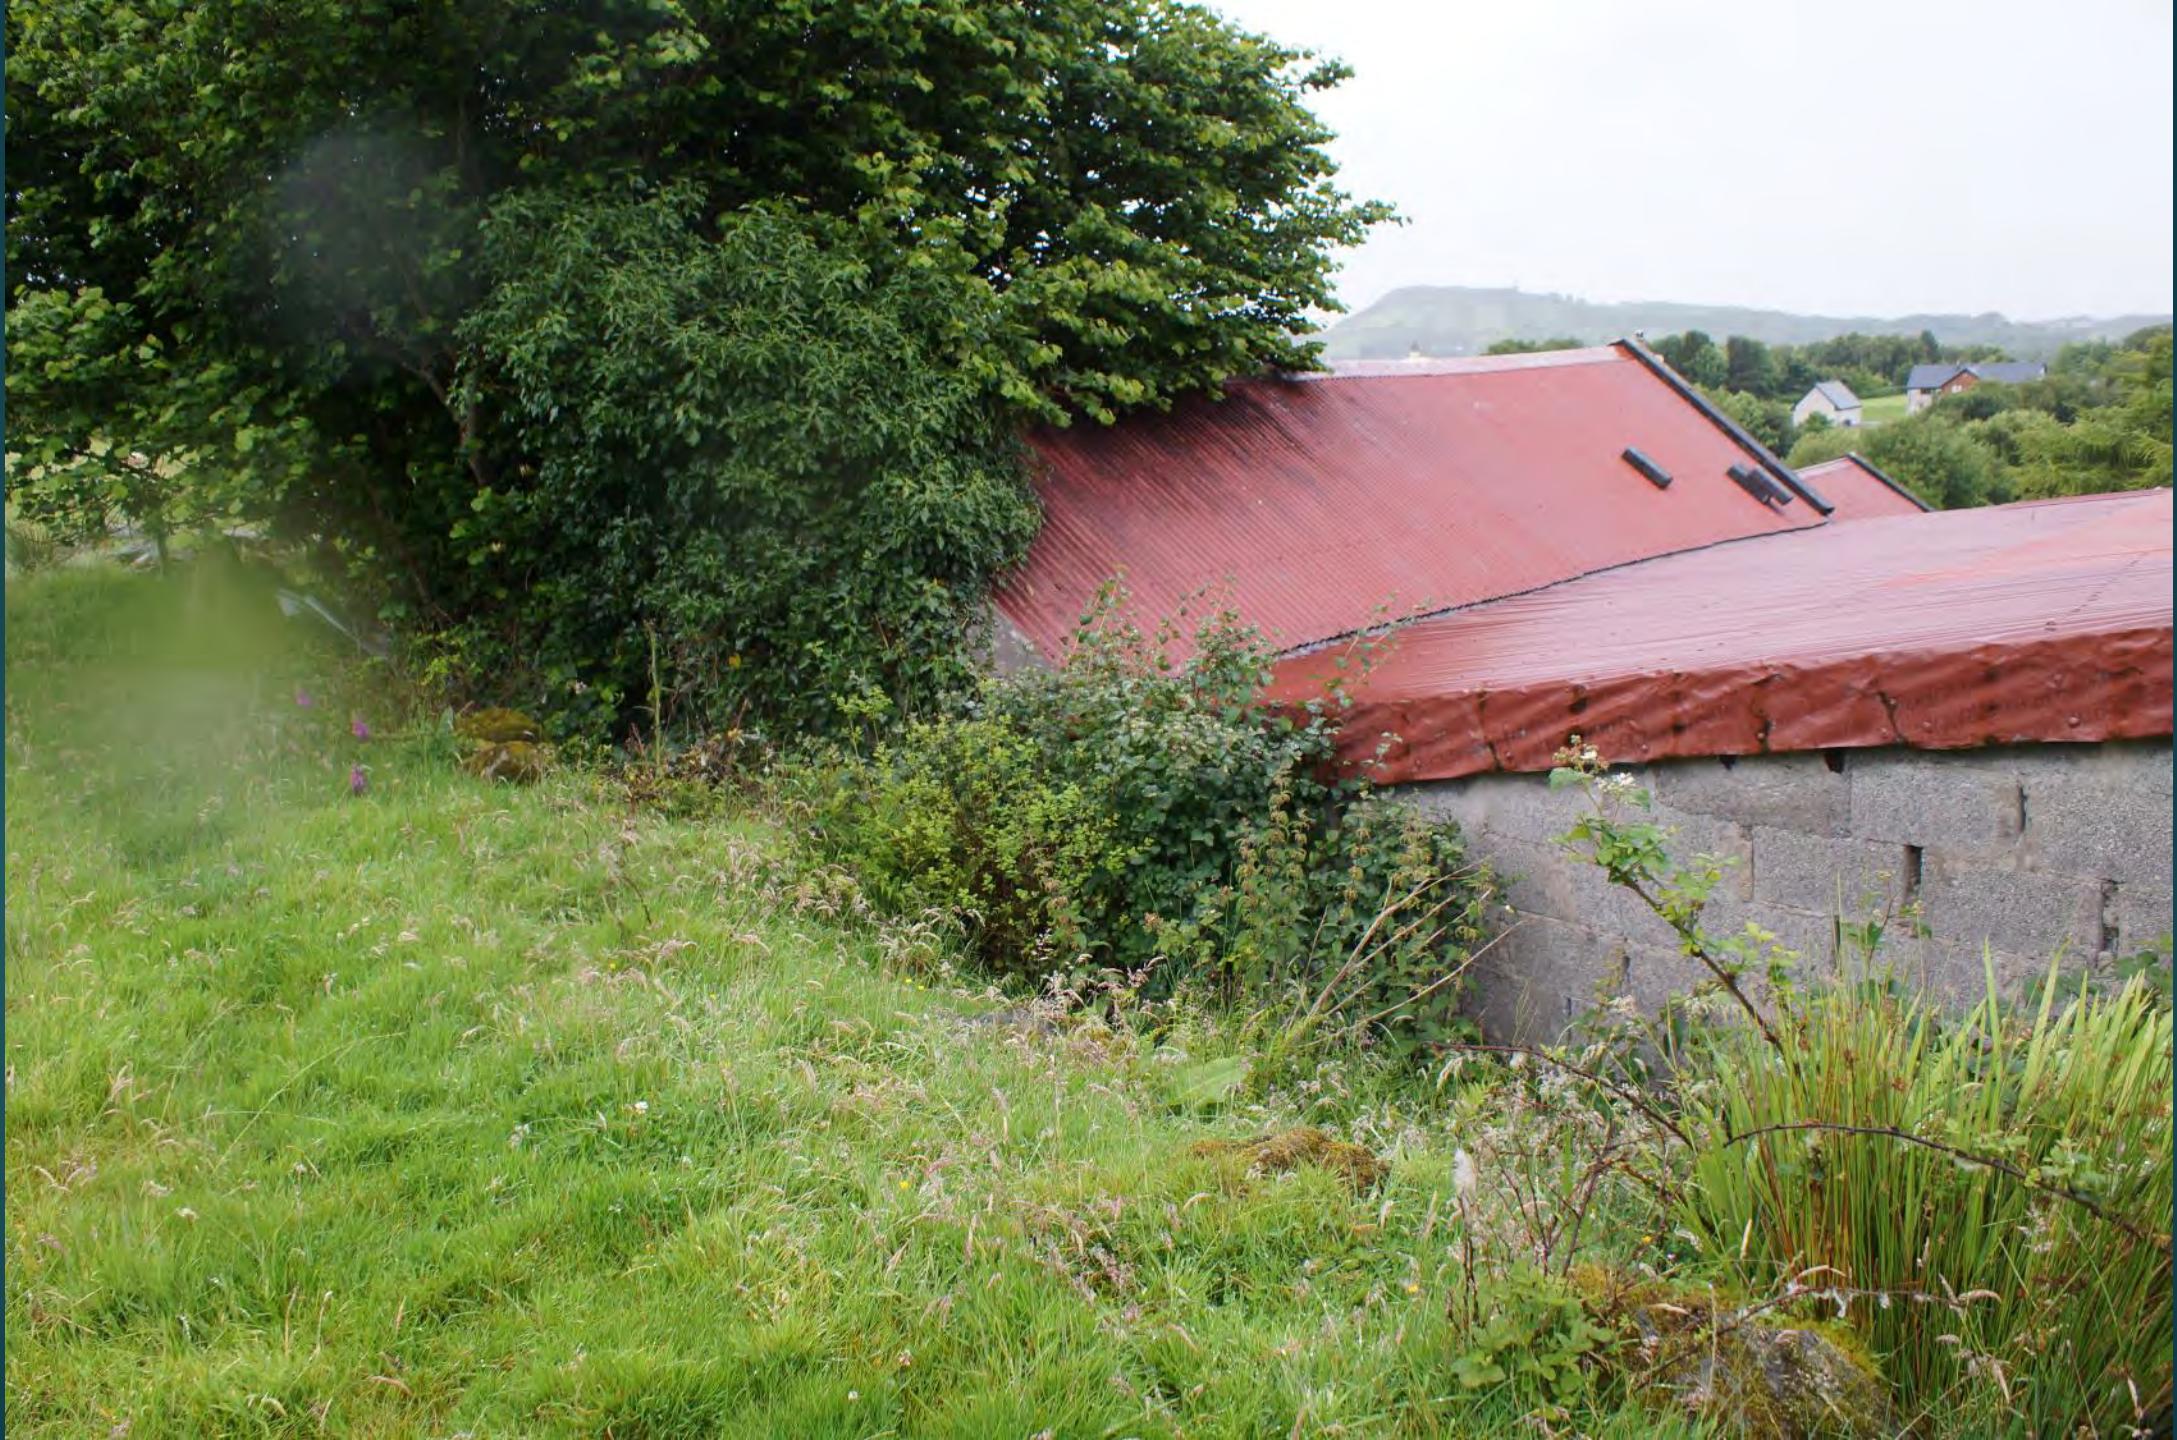
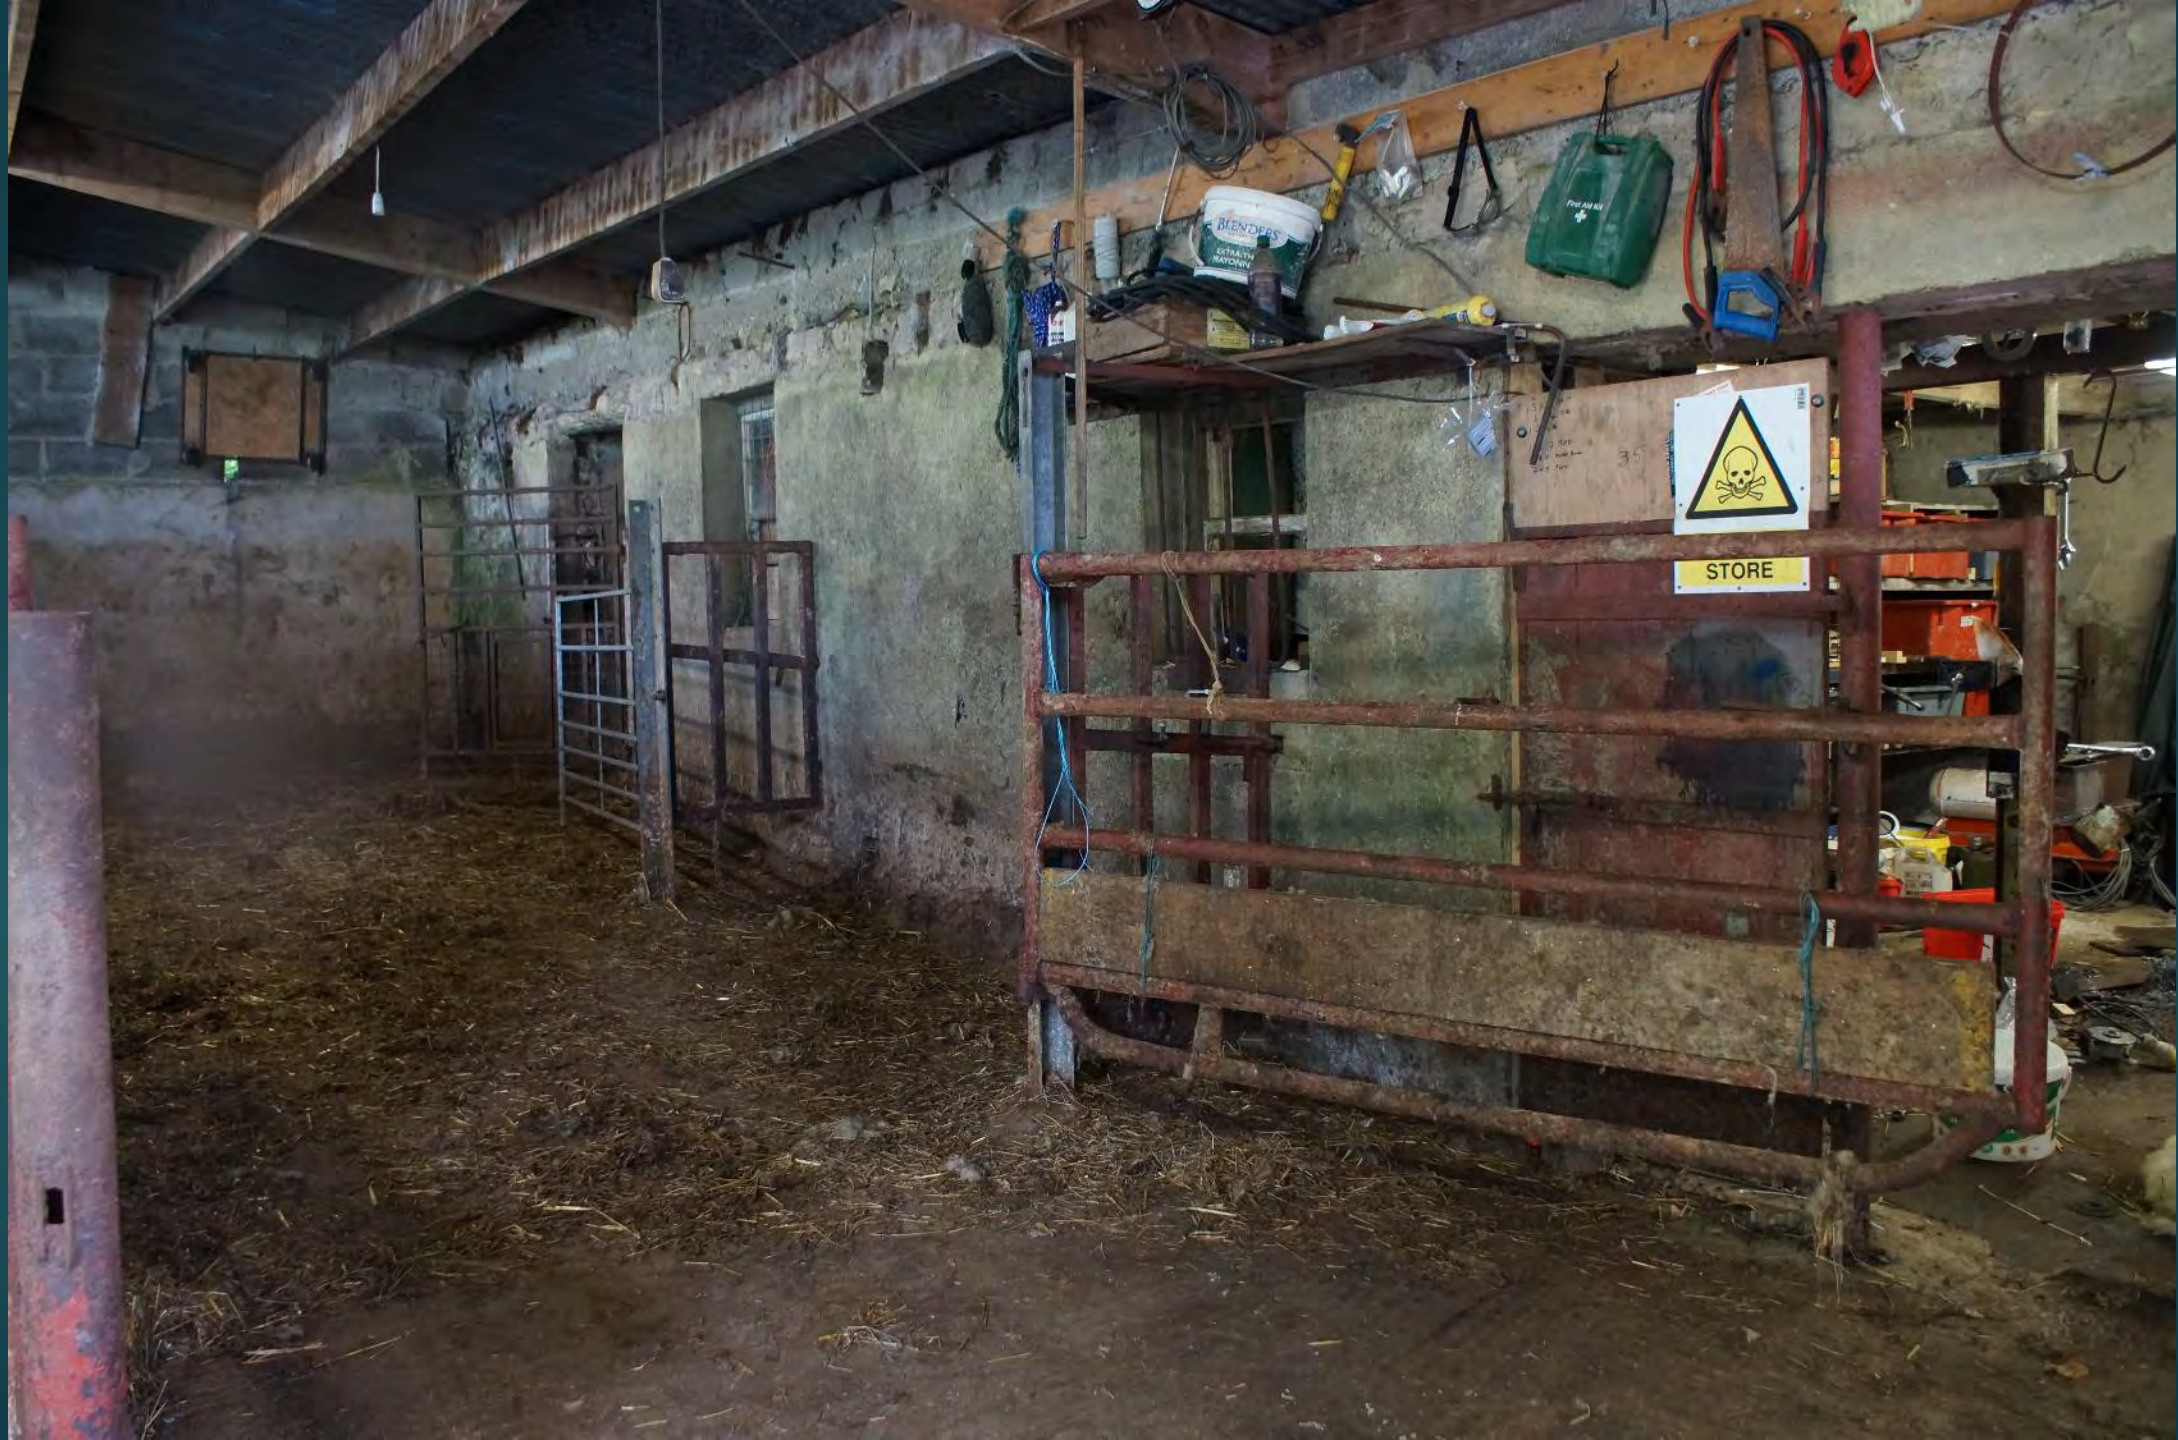
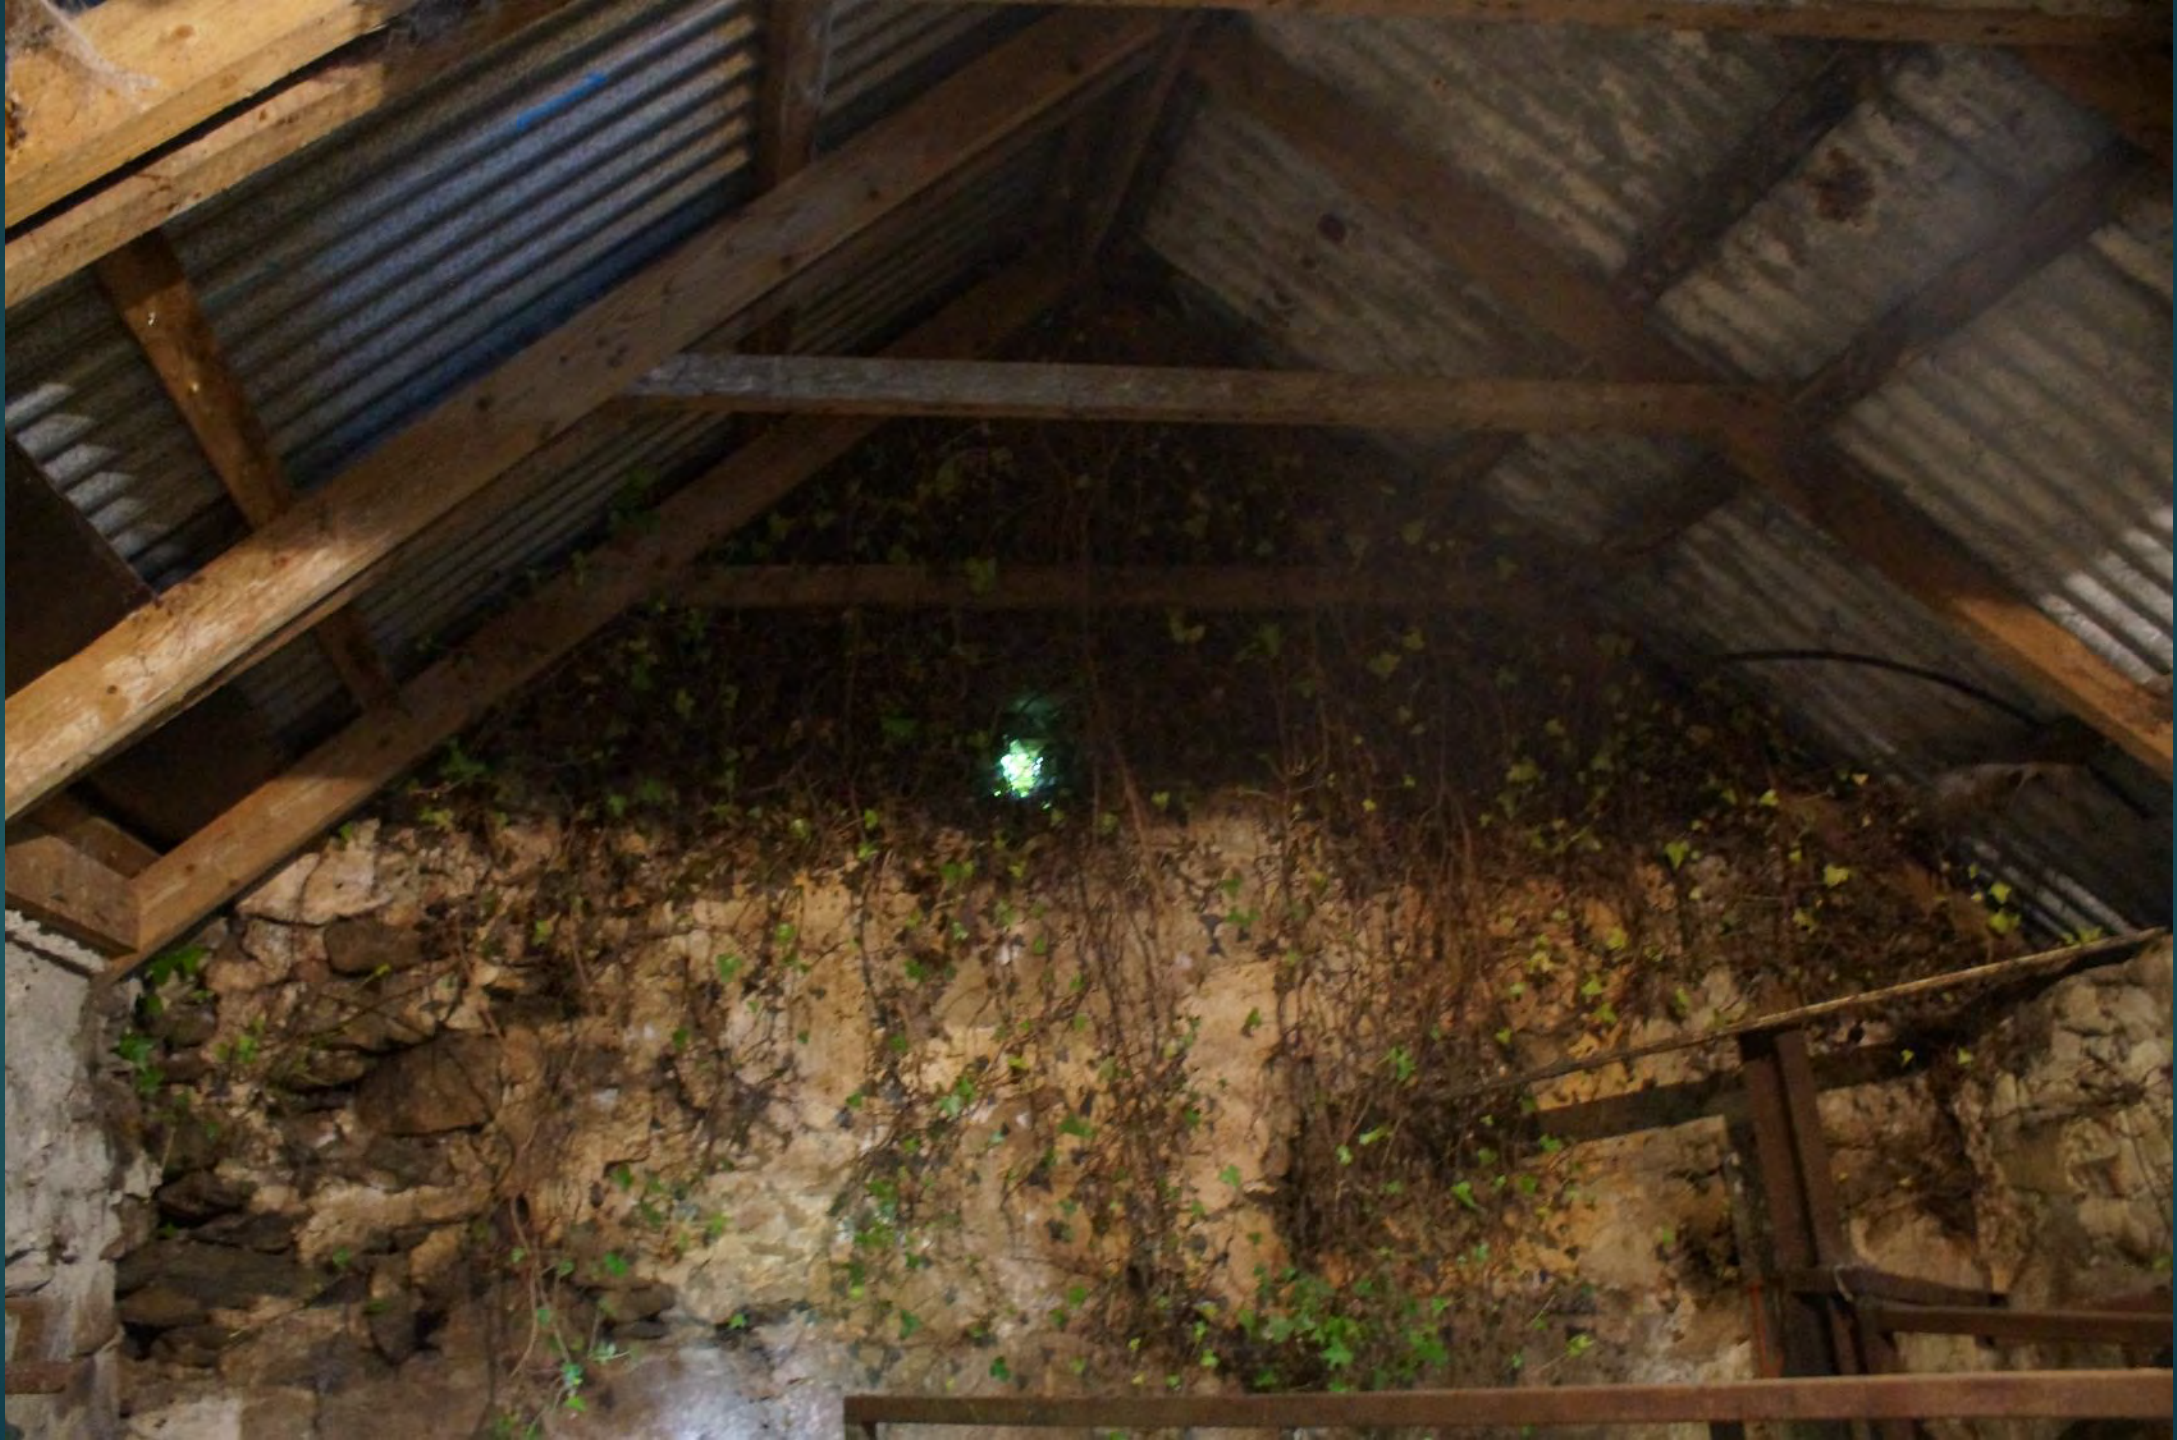
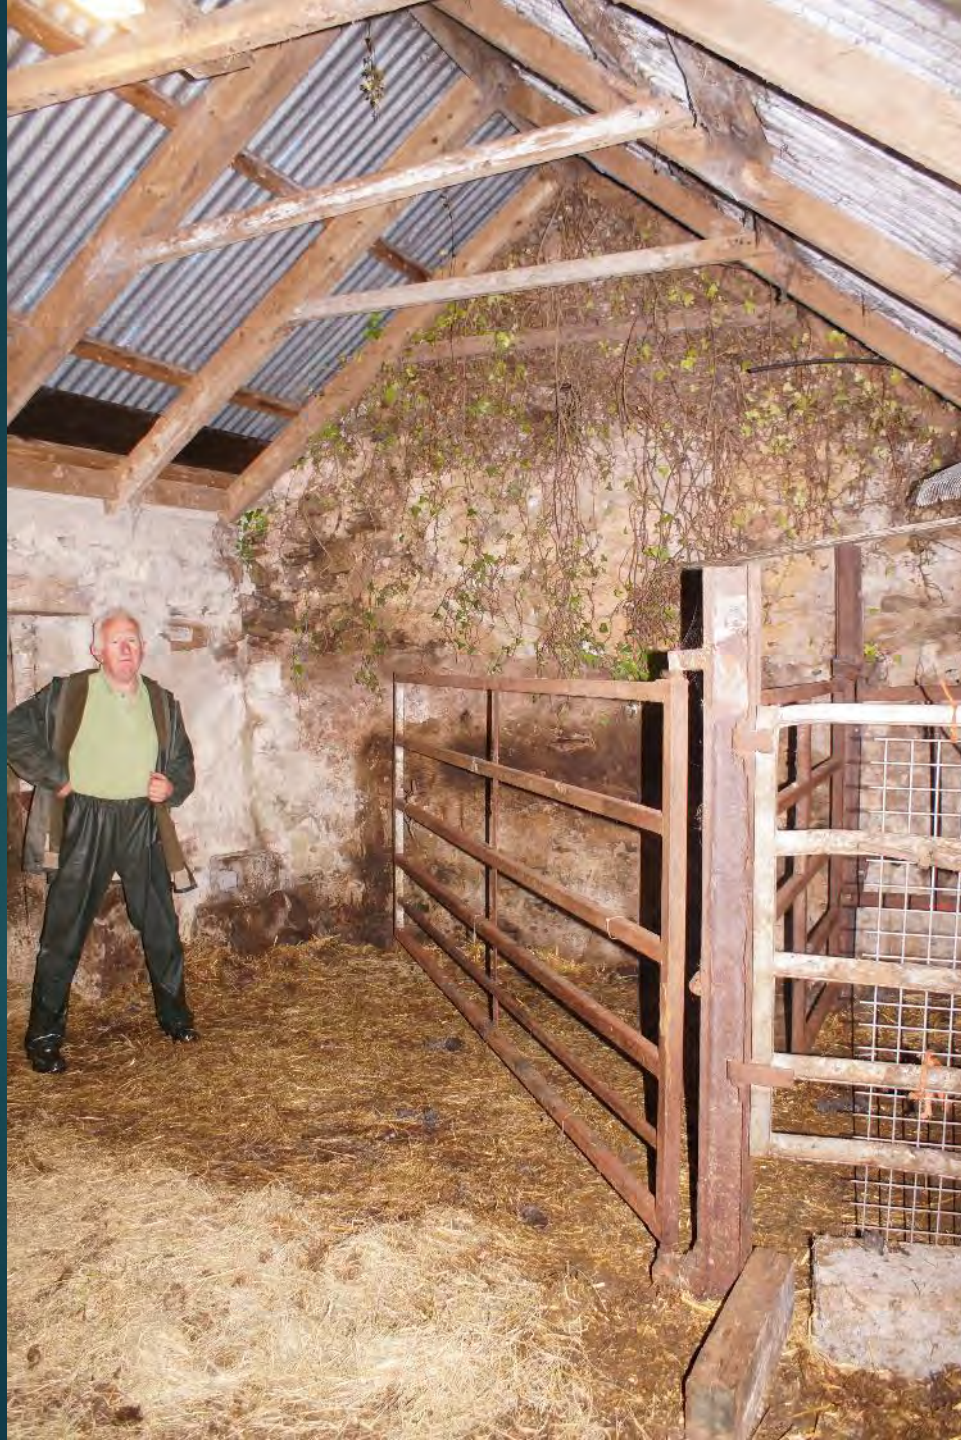
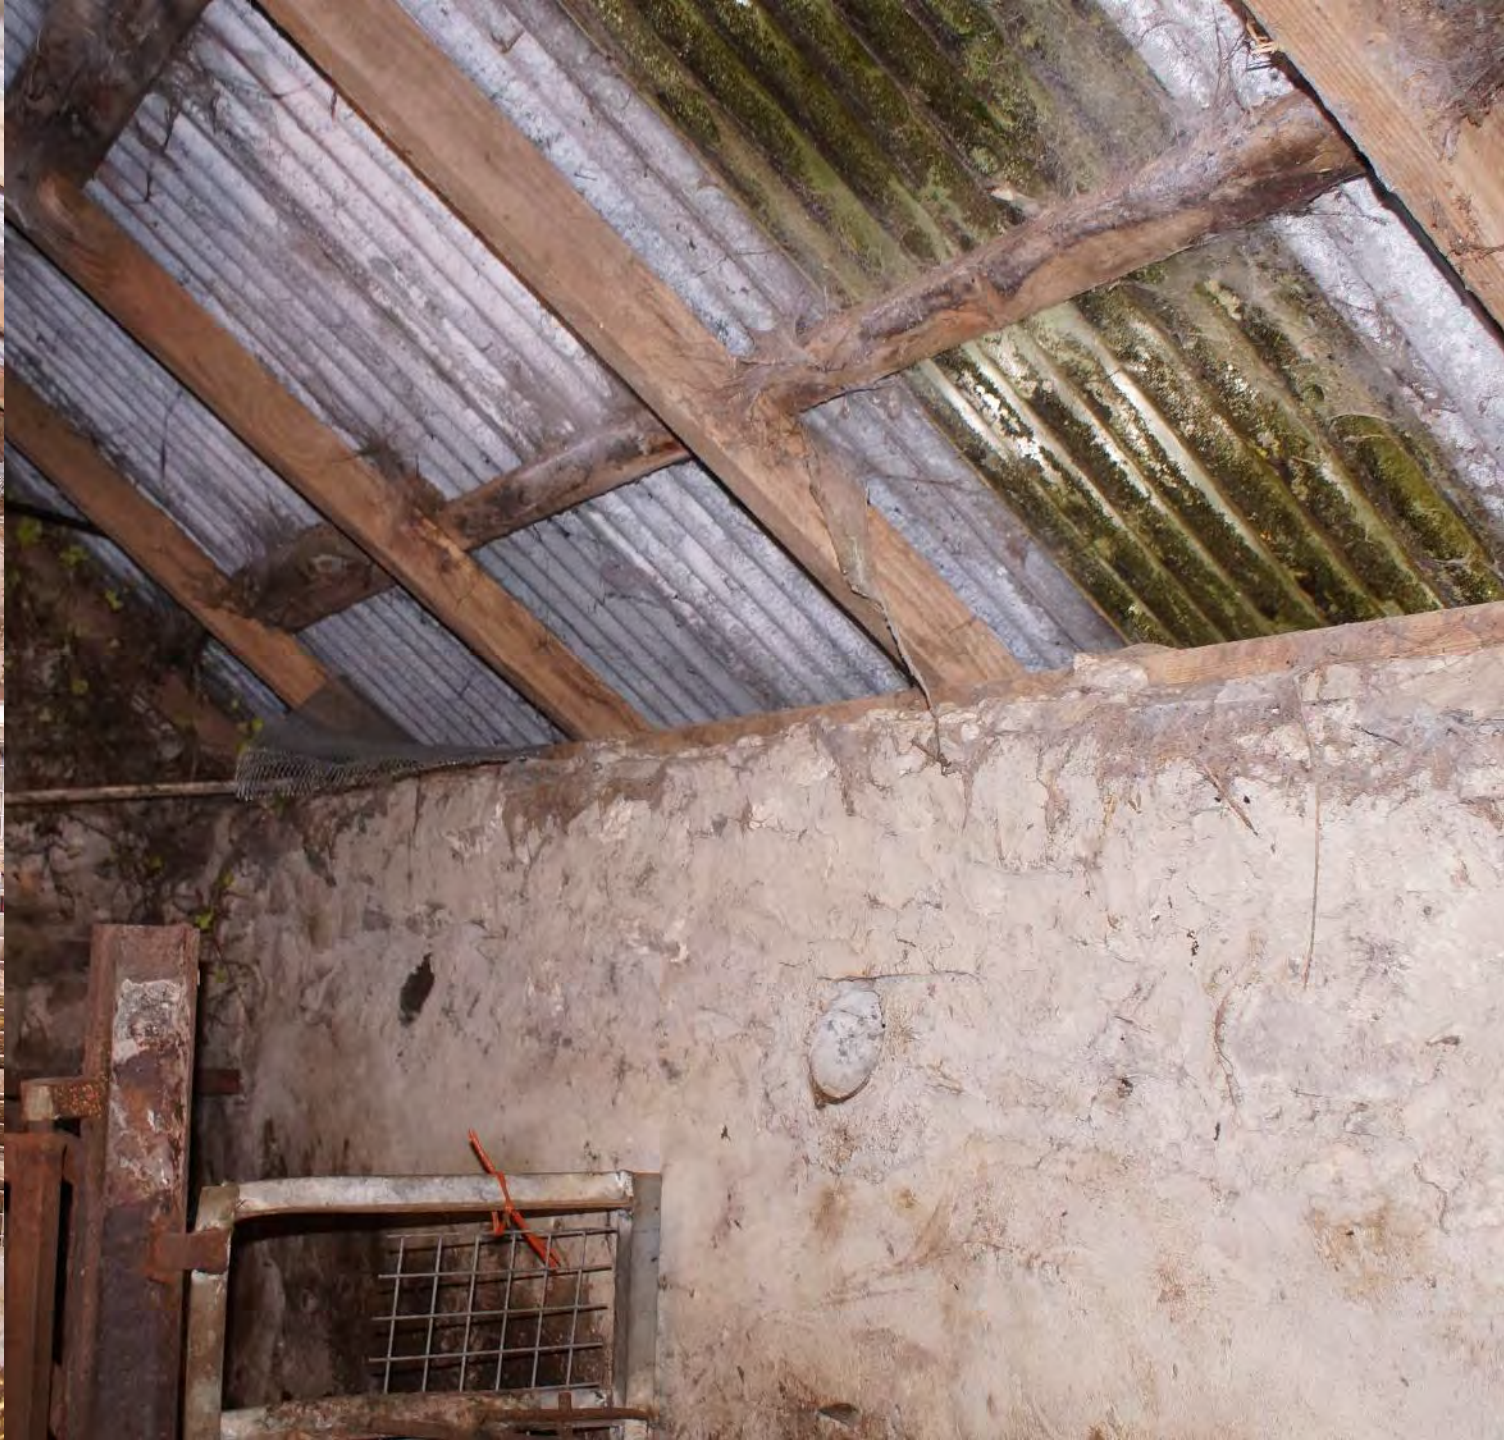
Former Dwelling House

- Large overhanging branches and ivy damage to rear gable
- Roof held down with concrete blocks
- Large number of holes in corrugated sheeting on garden side
- Gutters in poor condition, downpipe missing
