**June and Ken Bourke Farm Buildings Case Study,
Knappagh, Westport, Co. Mayo GLAS TFB 2016**

Áine Doyle MUBC Conservation Consultant

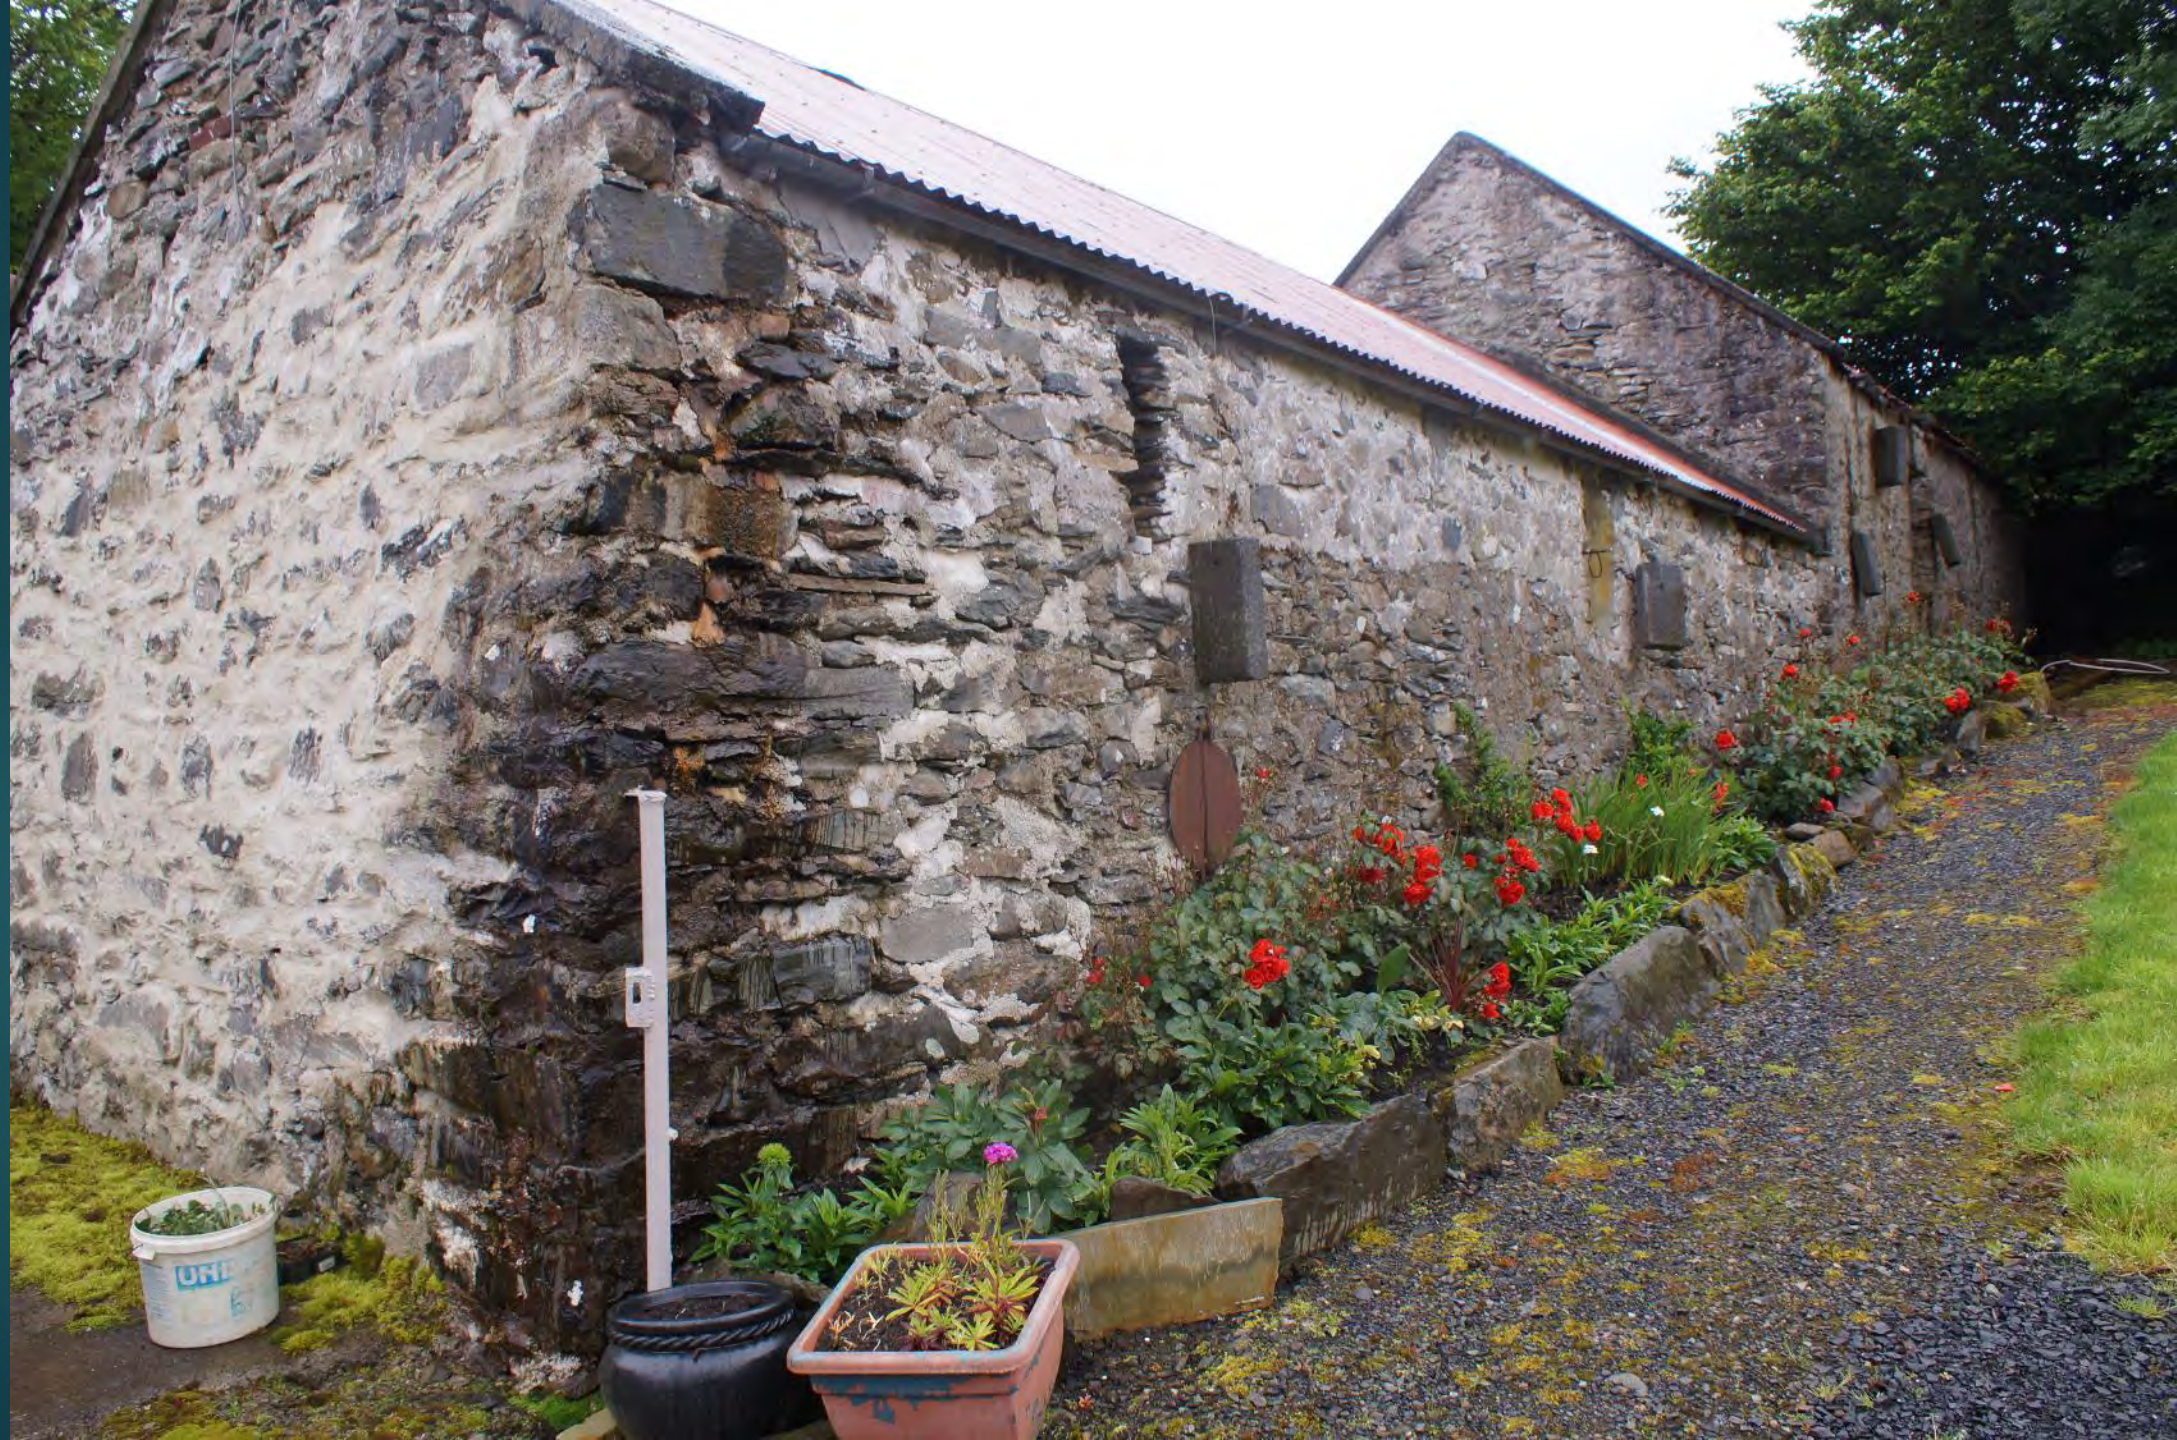
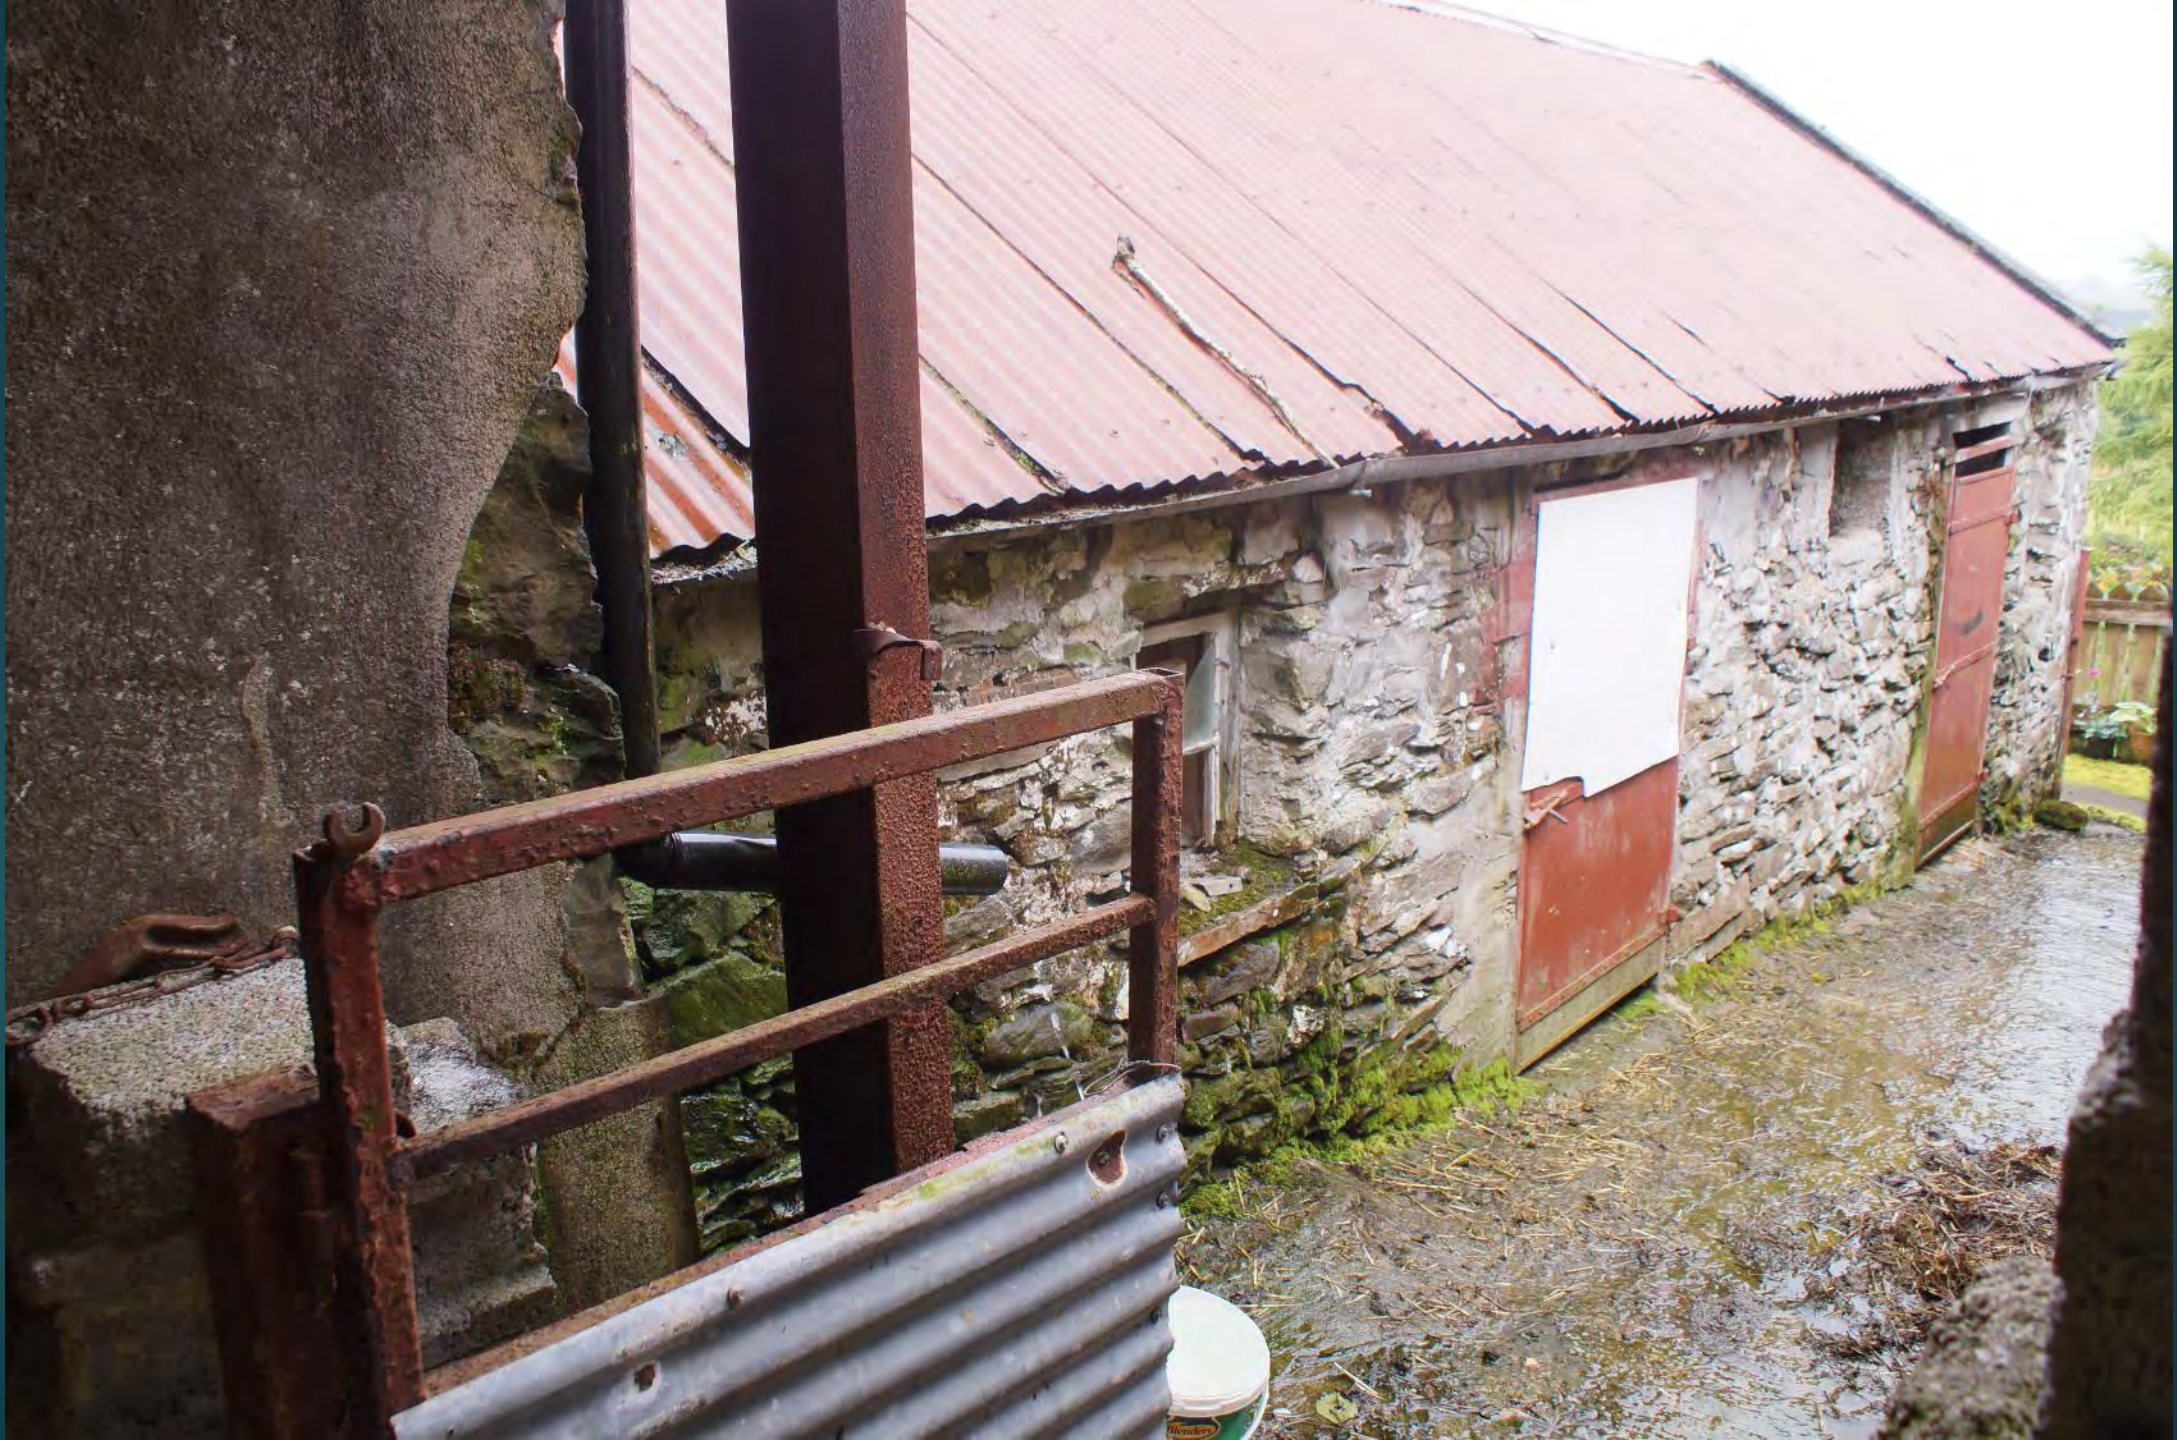
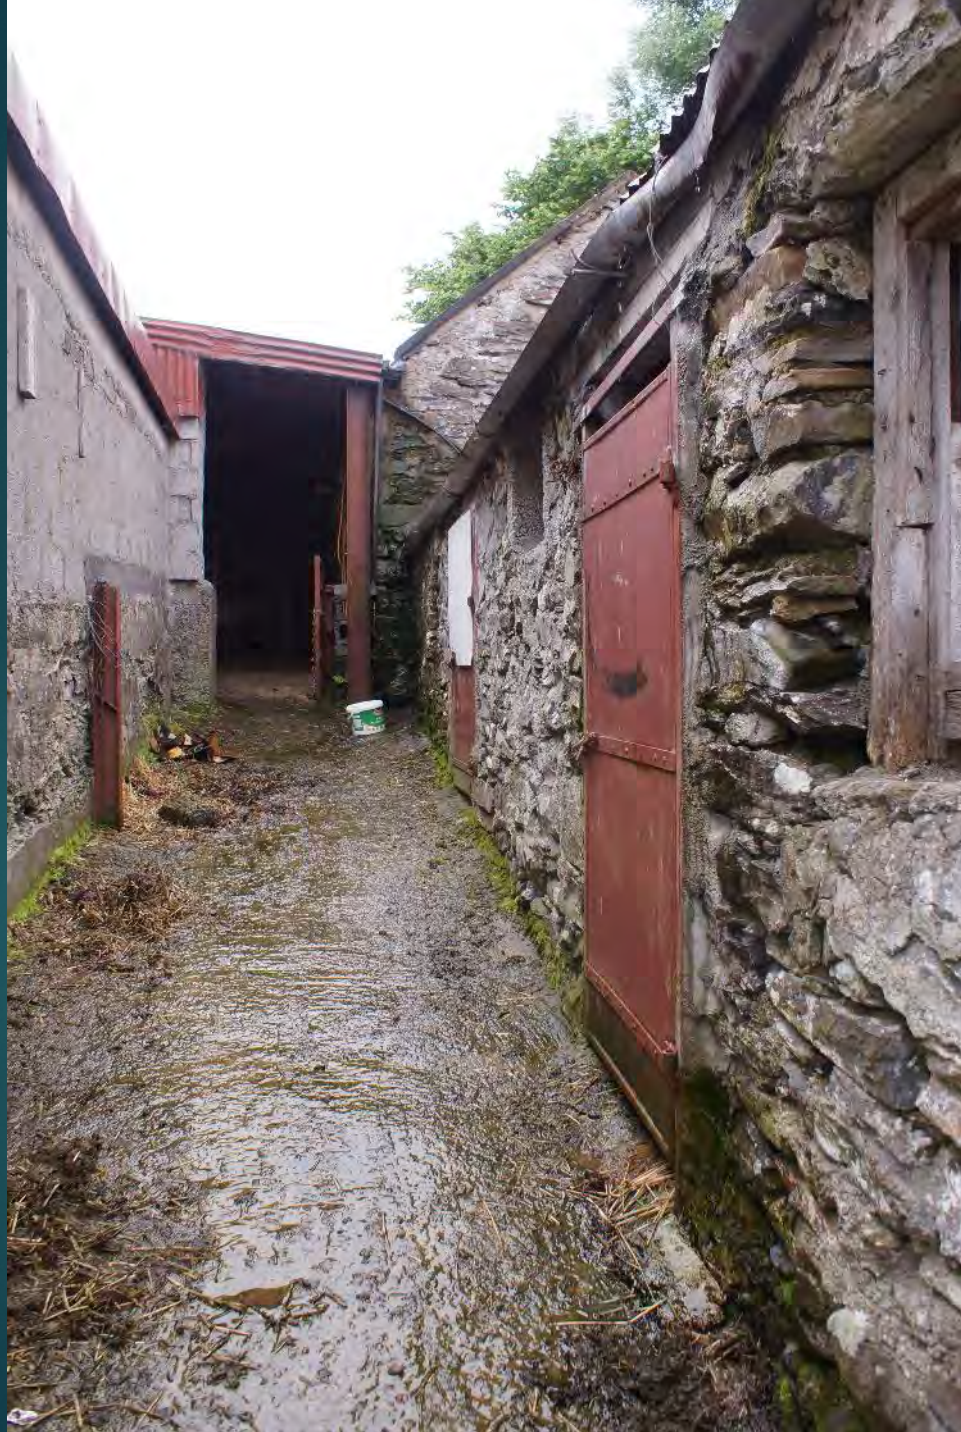
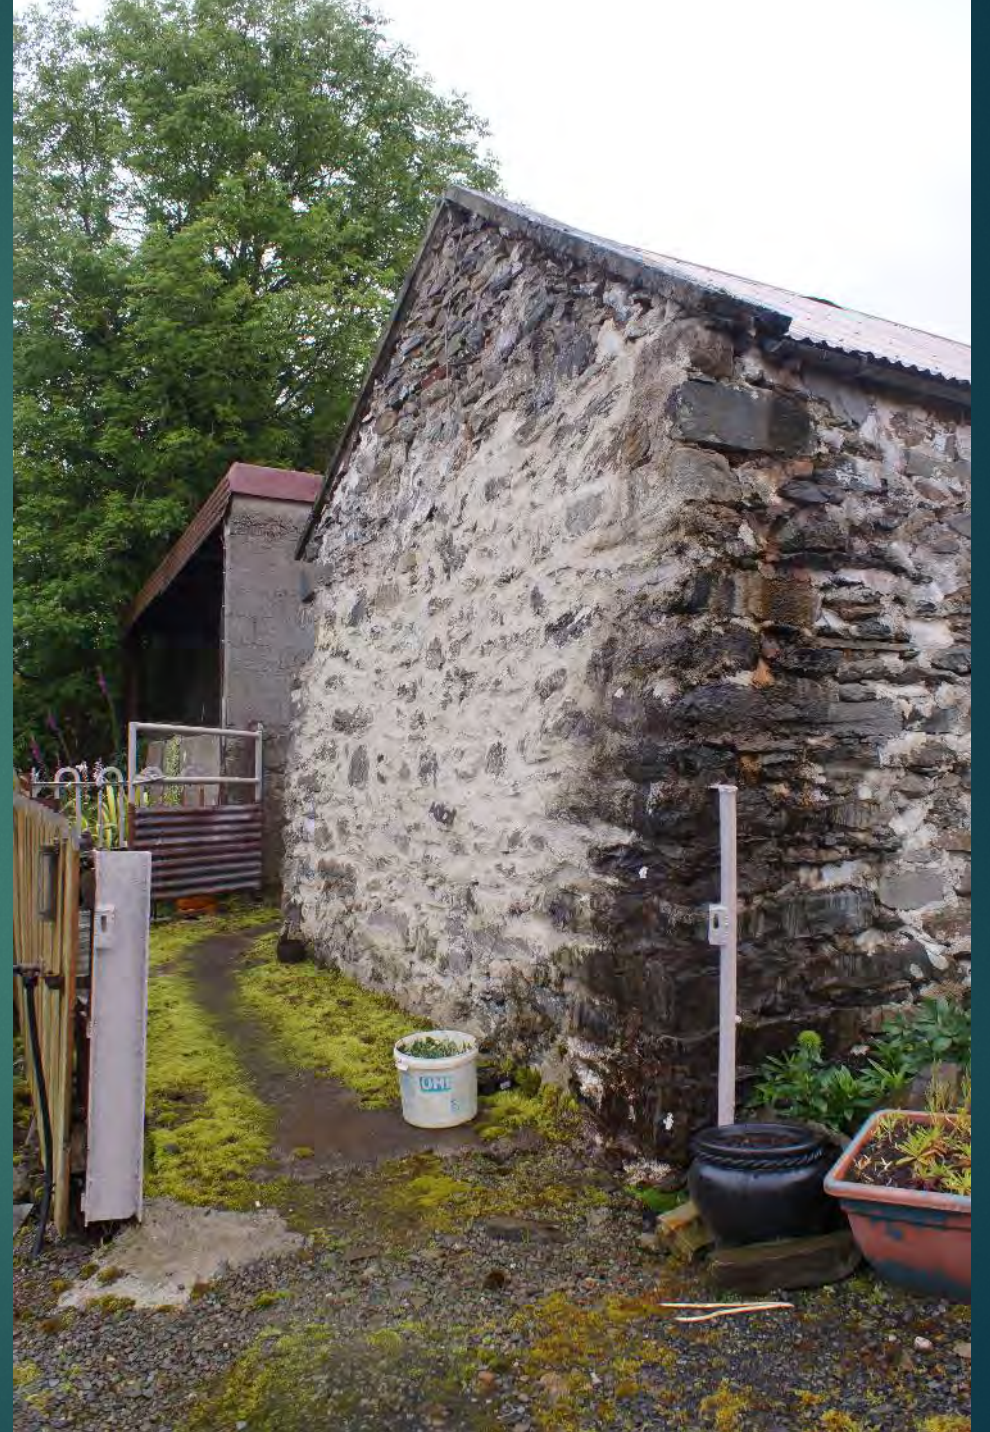
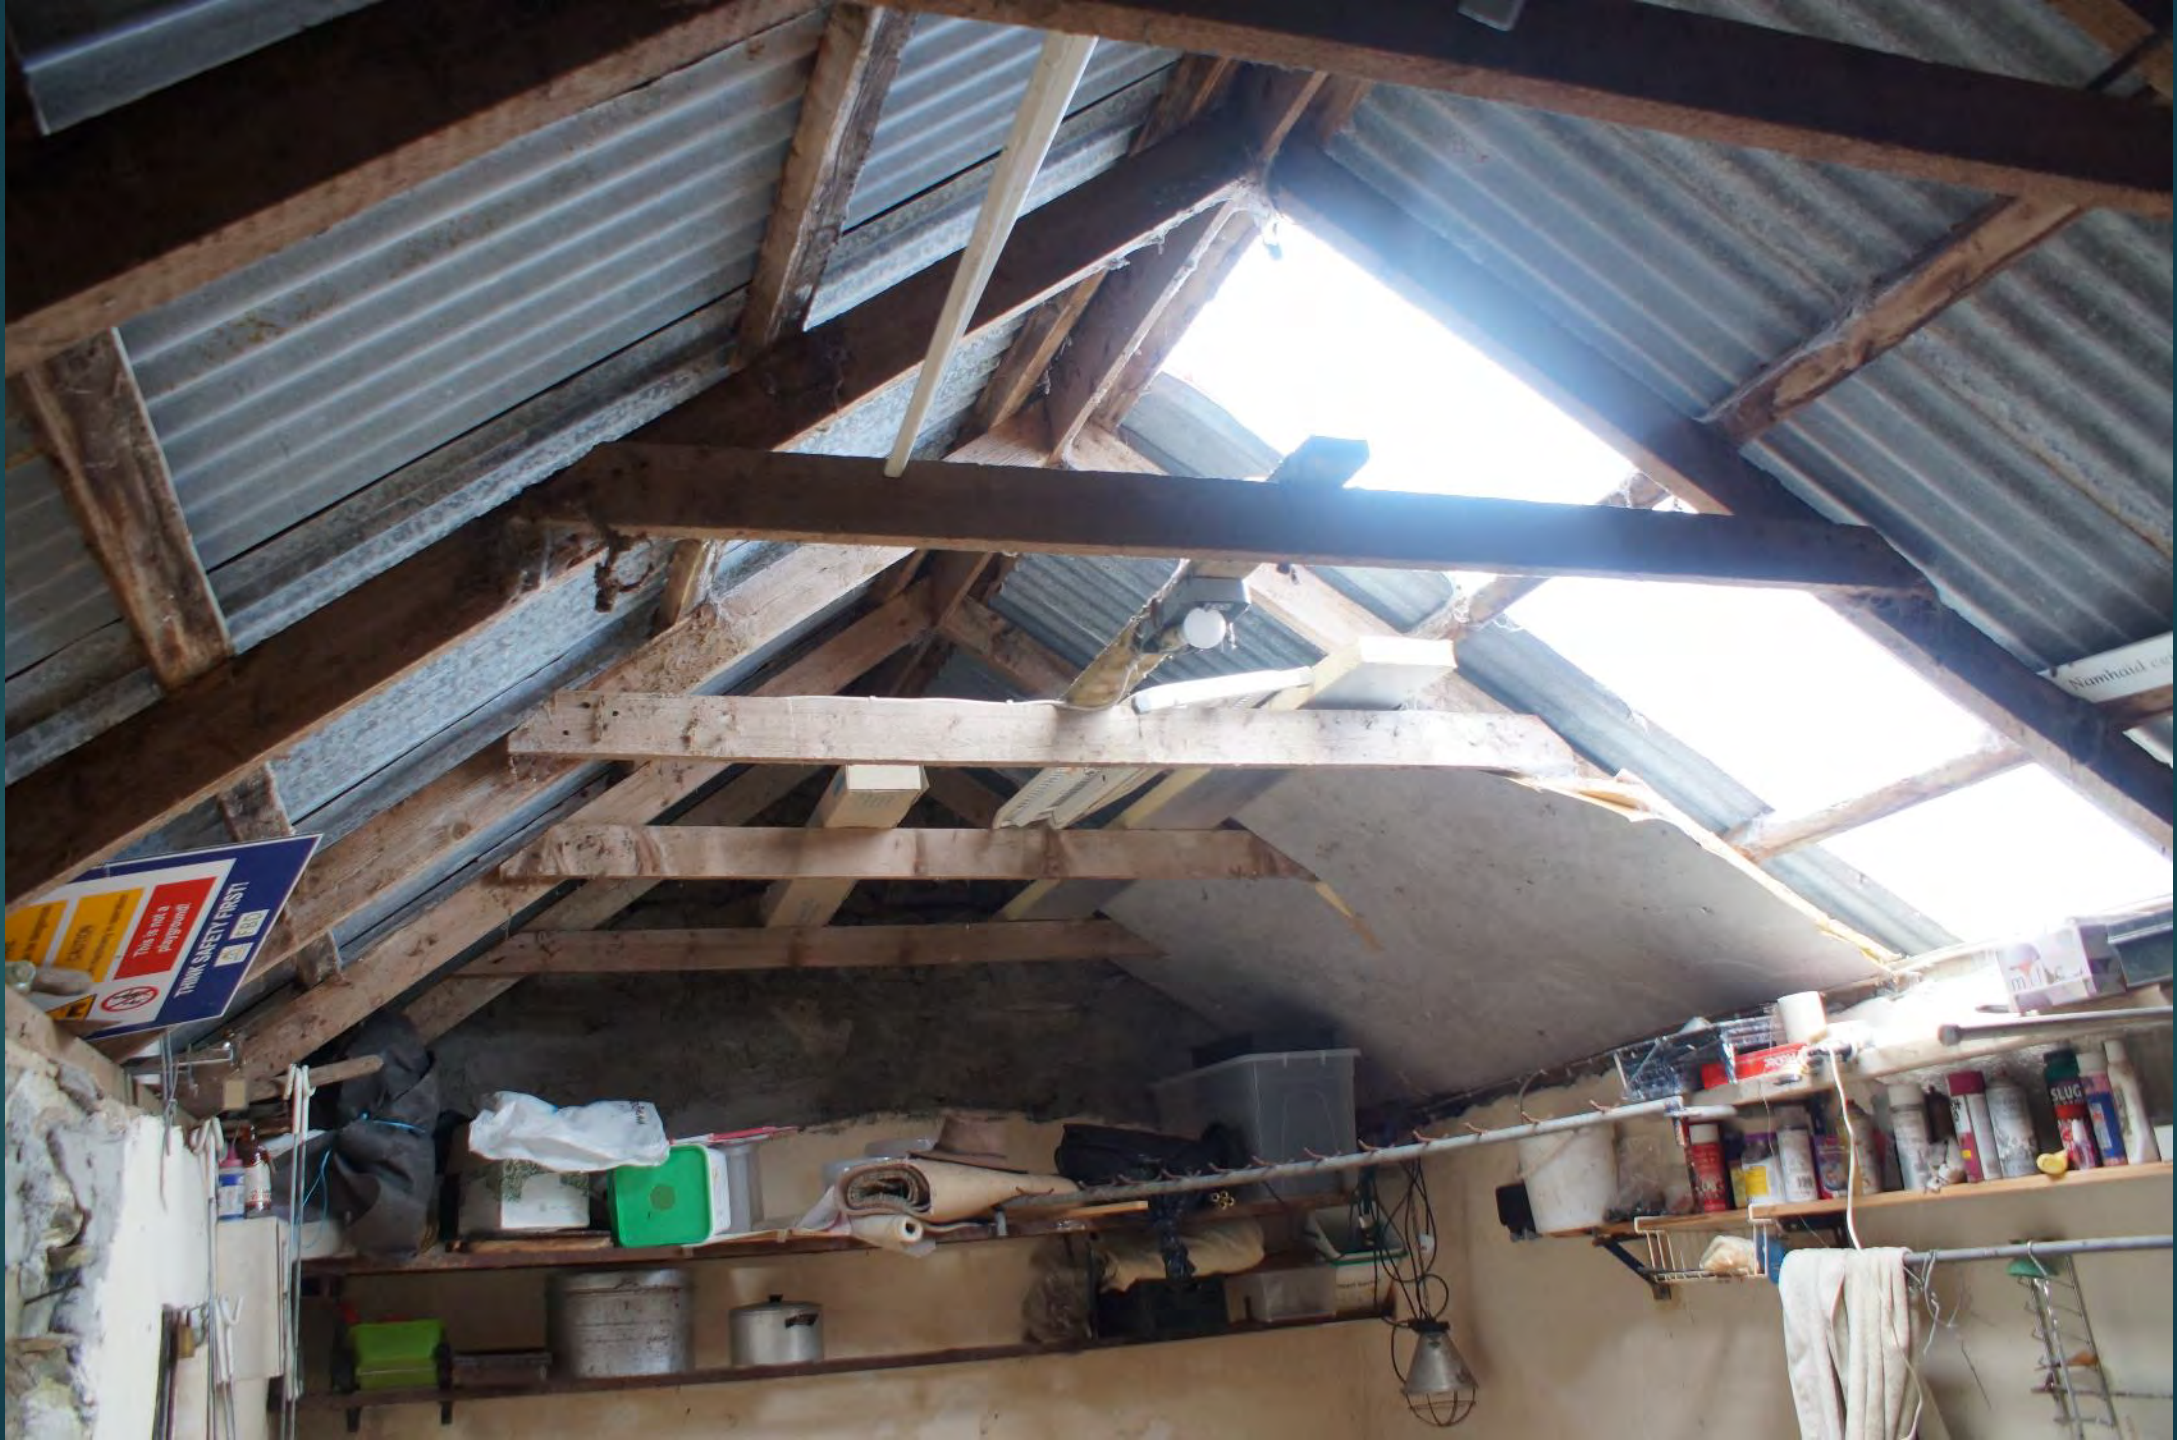
Wool Dying Shed

- Roof timbers in poor condition
- Corrugated iron held on with concrete blocks
- Gutters in poor condition and downpipe missing
- Isolated repointing required on rear side
