**June and Ken Bourke Farm Buildings Case Study,
Knappagh, Westport, Co. Mayo GLAS TFB 2016**

Áine Doyle MUBC Conservation Consultant

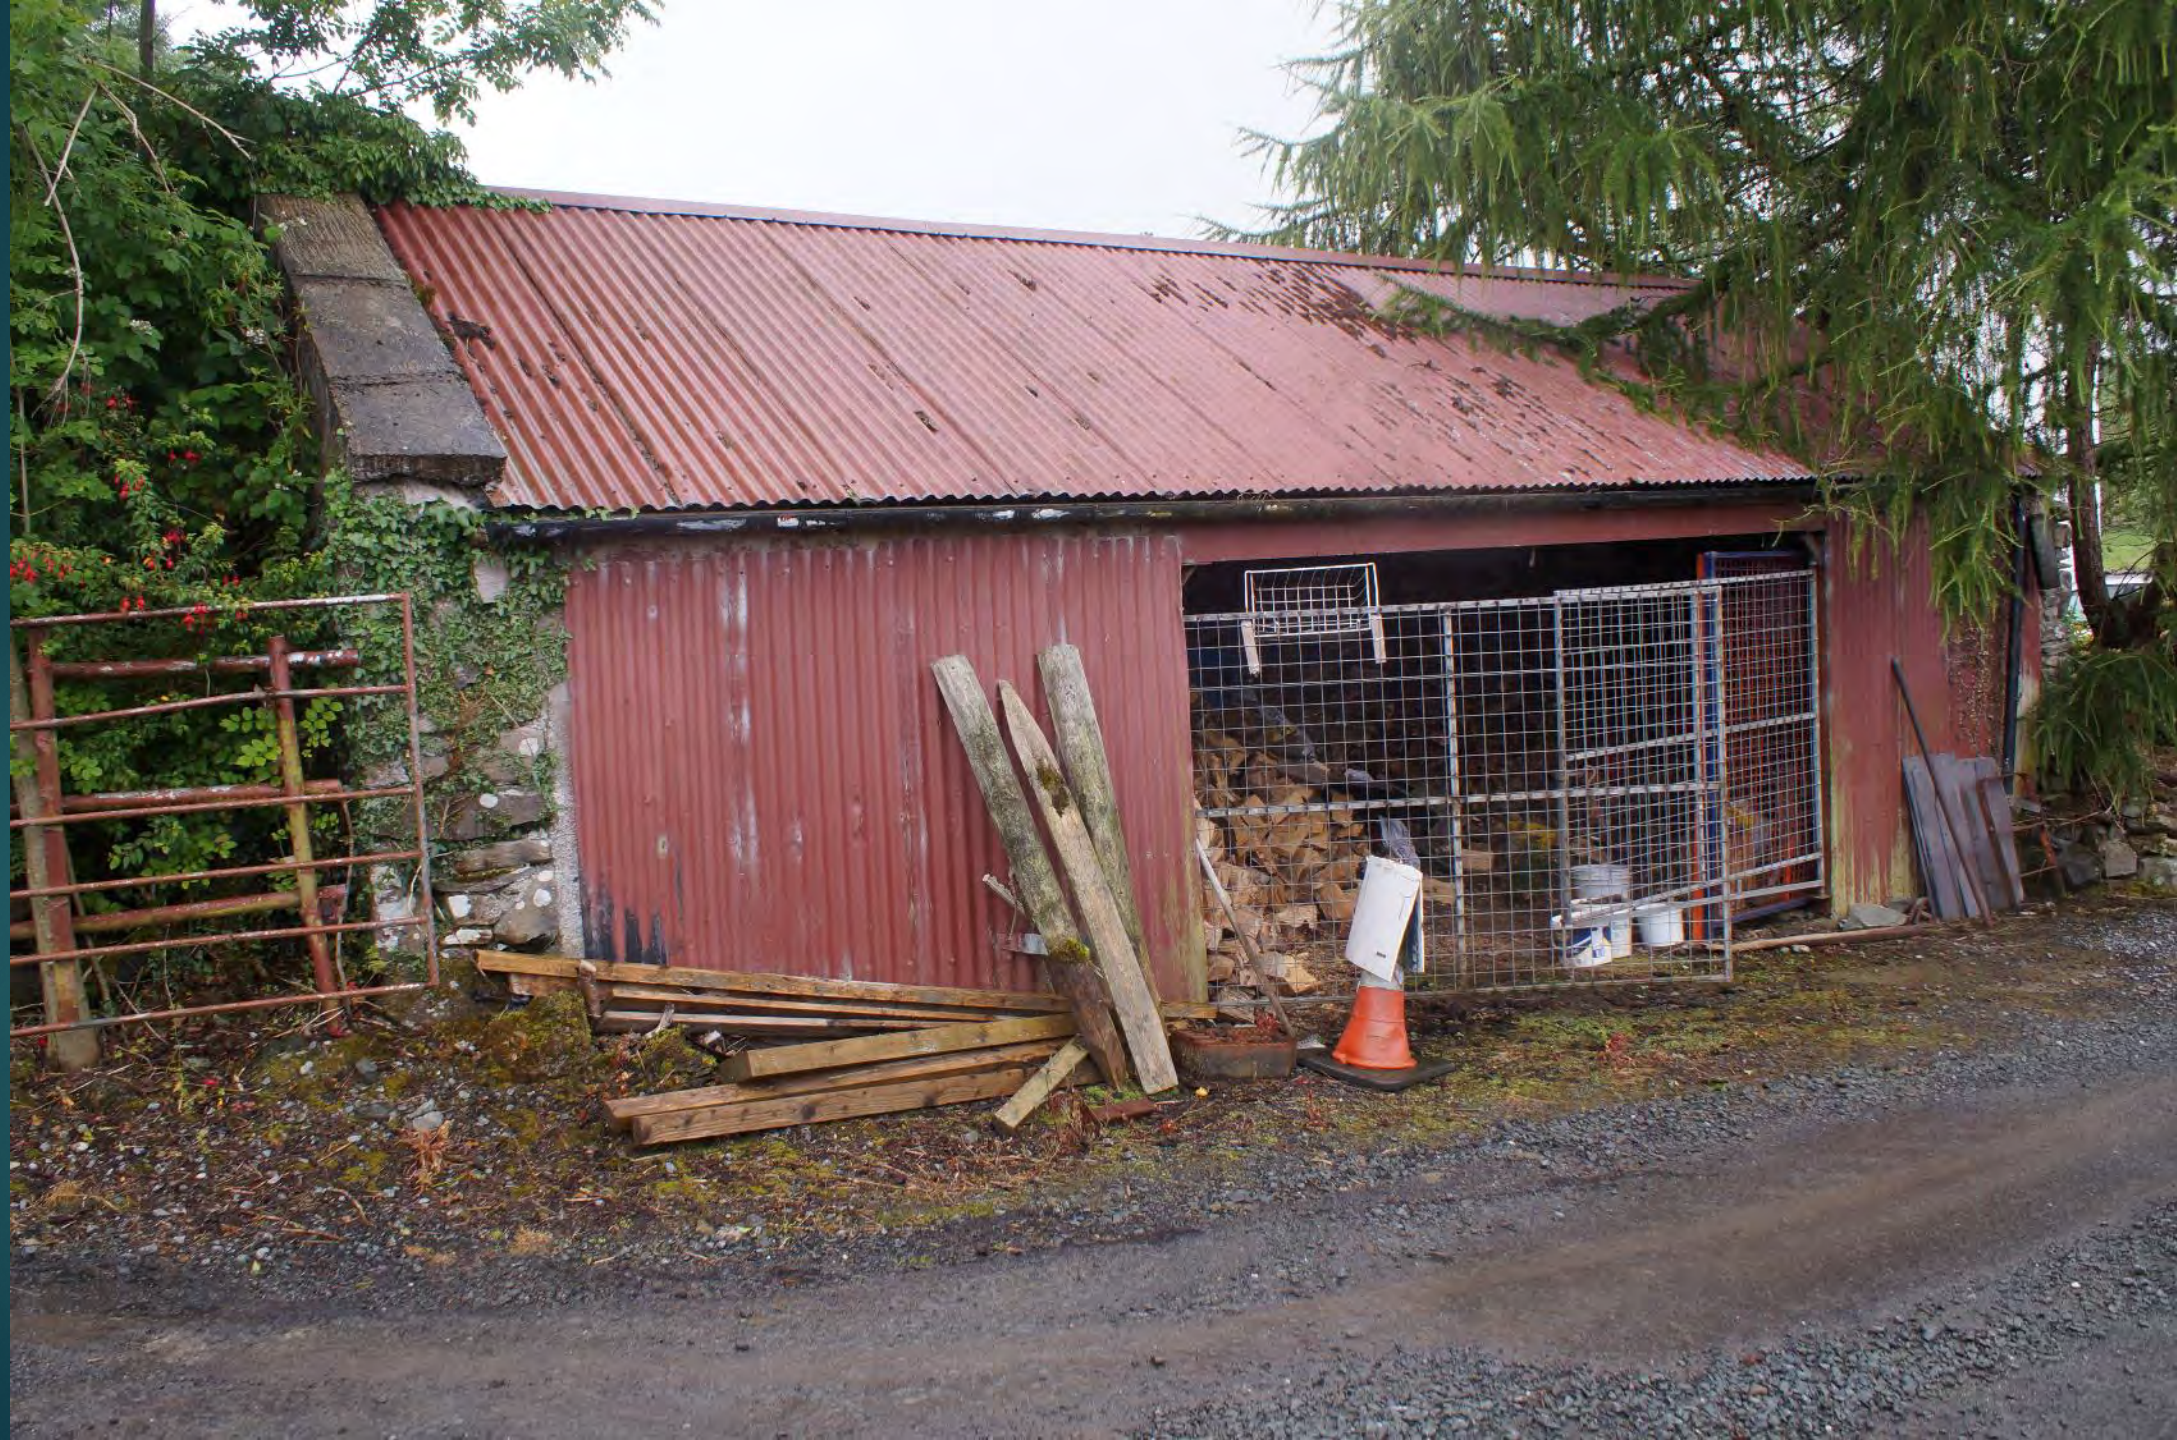
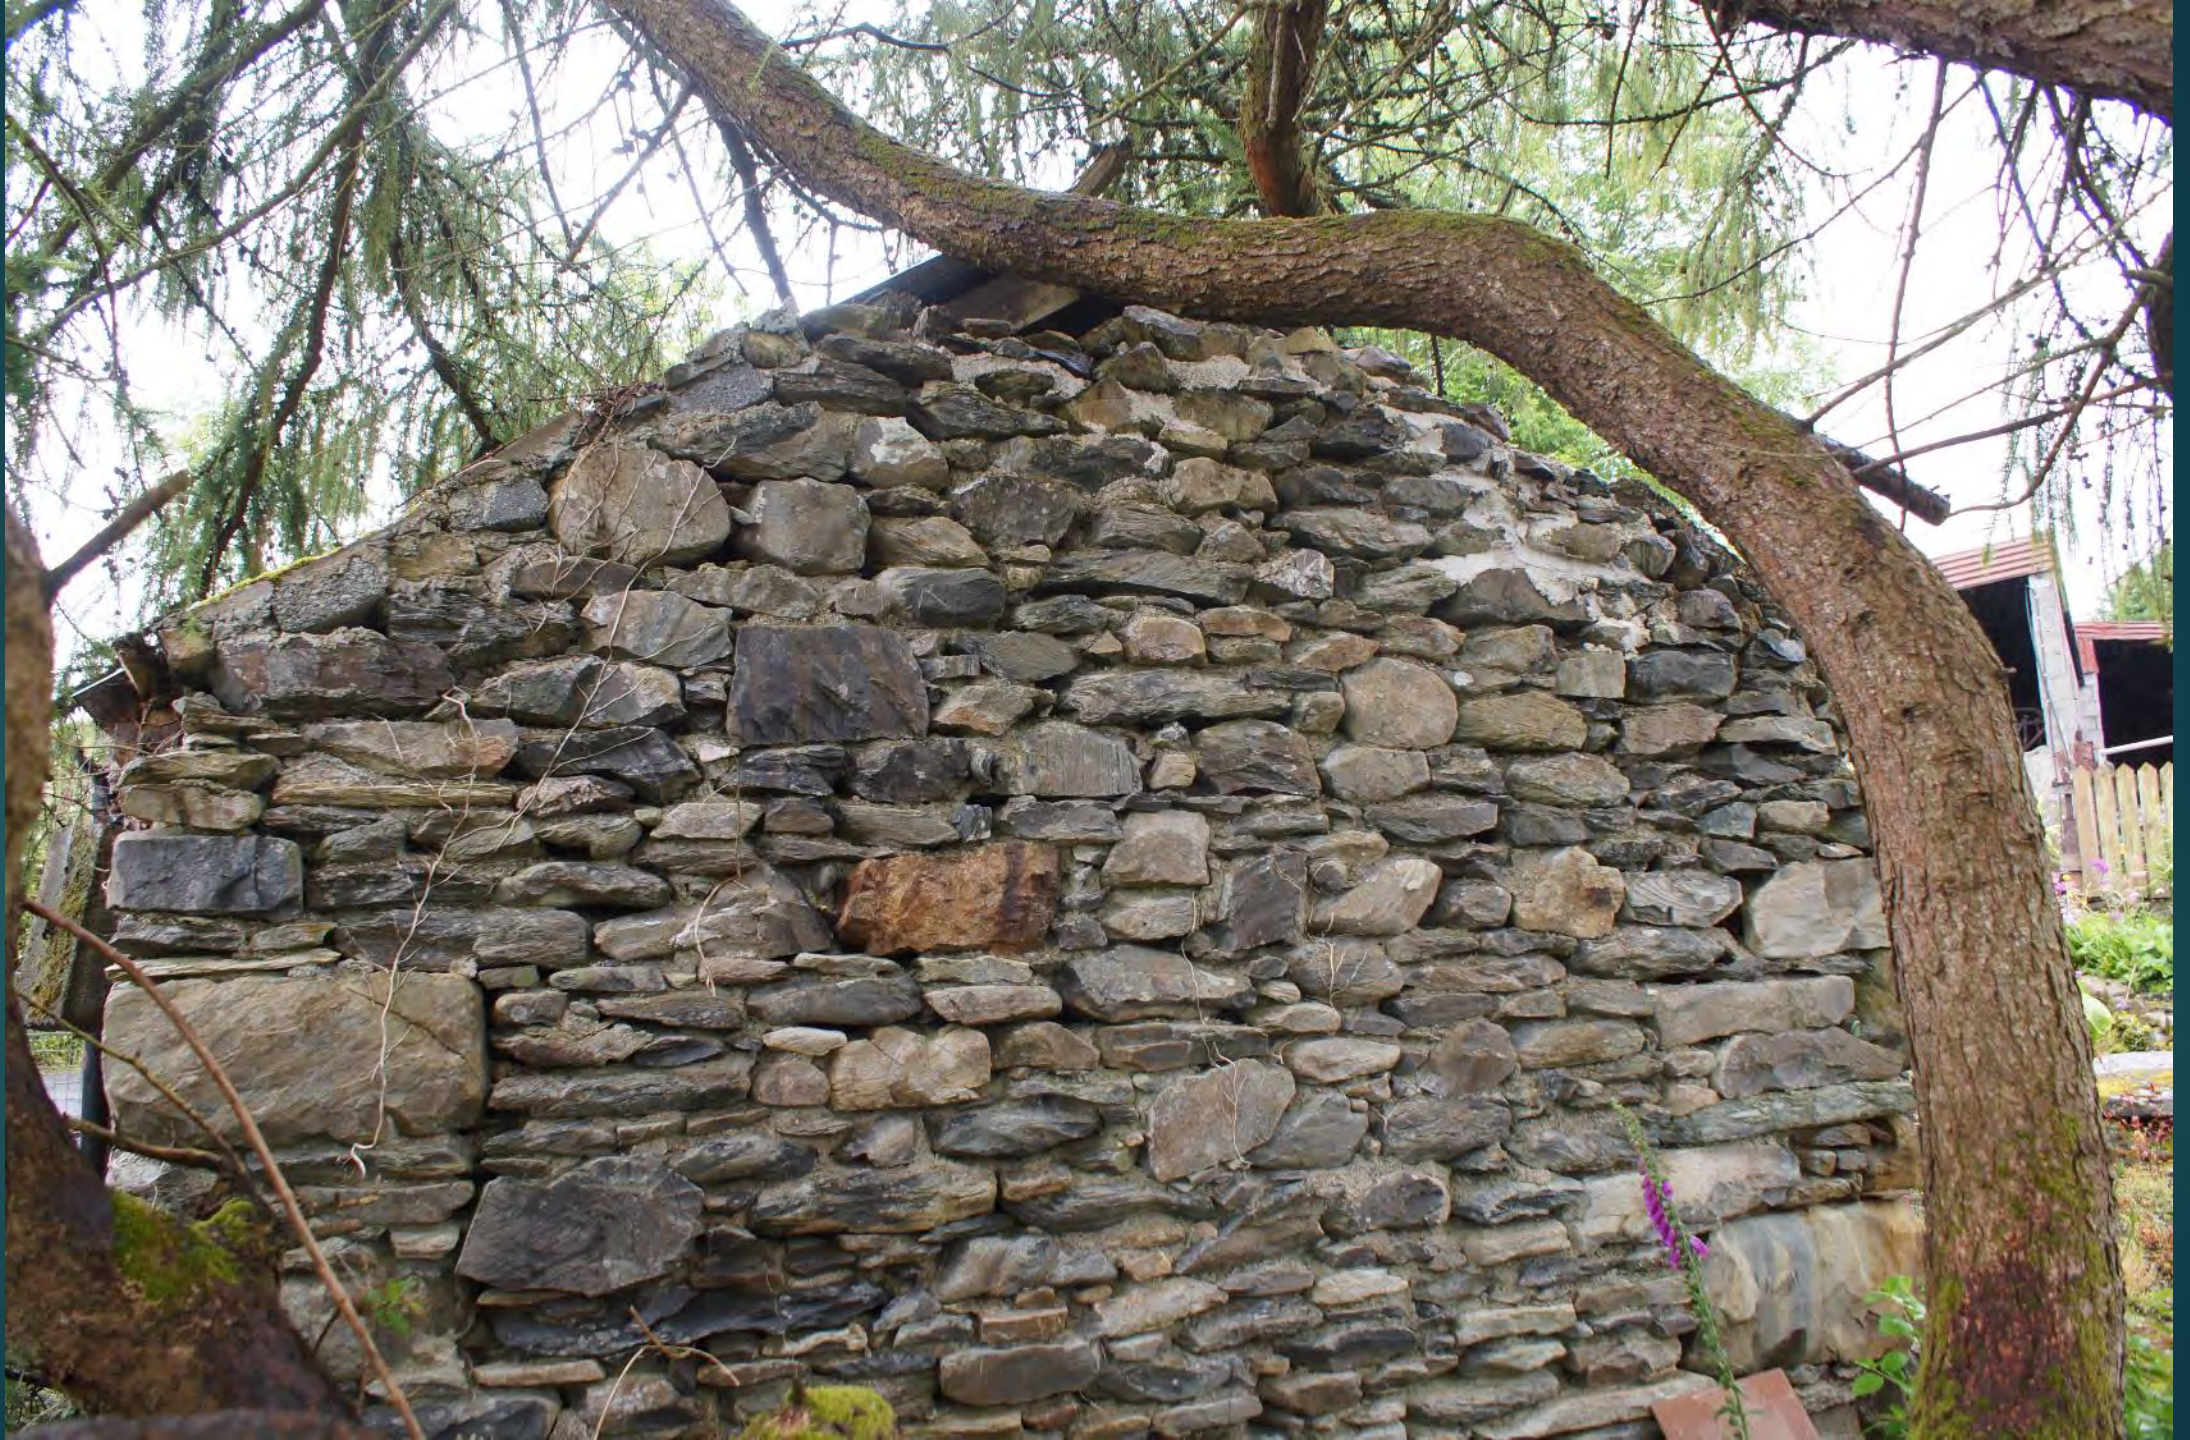
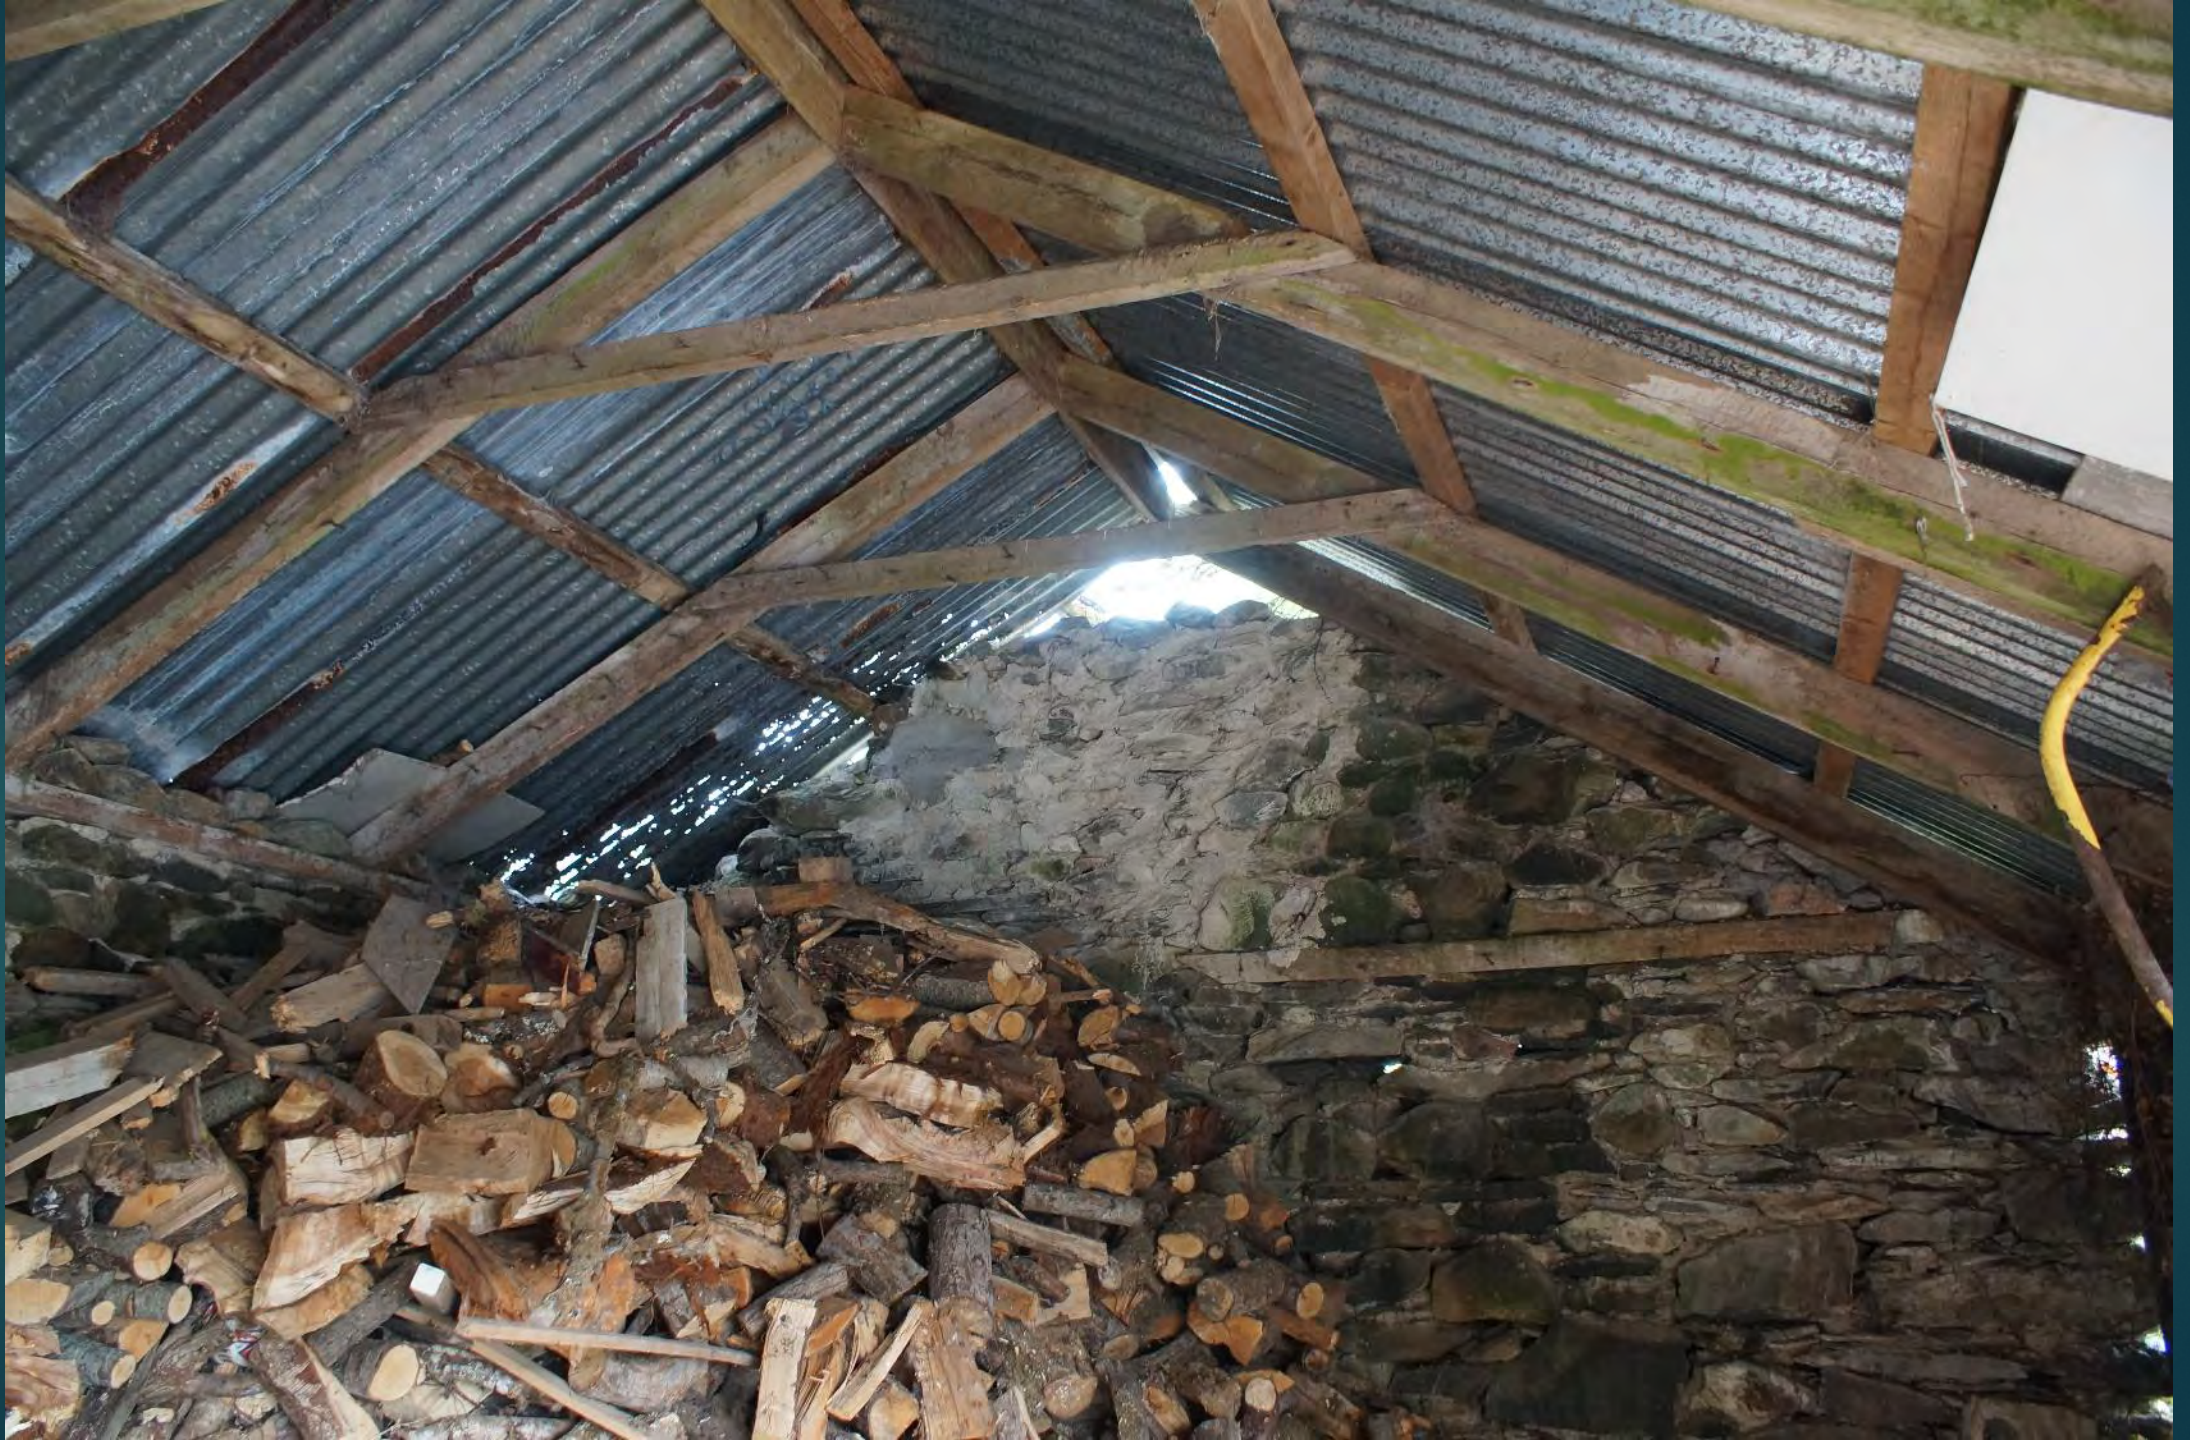
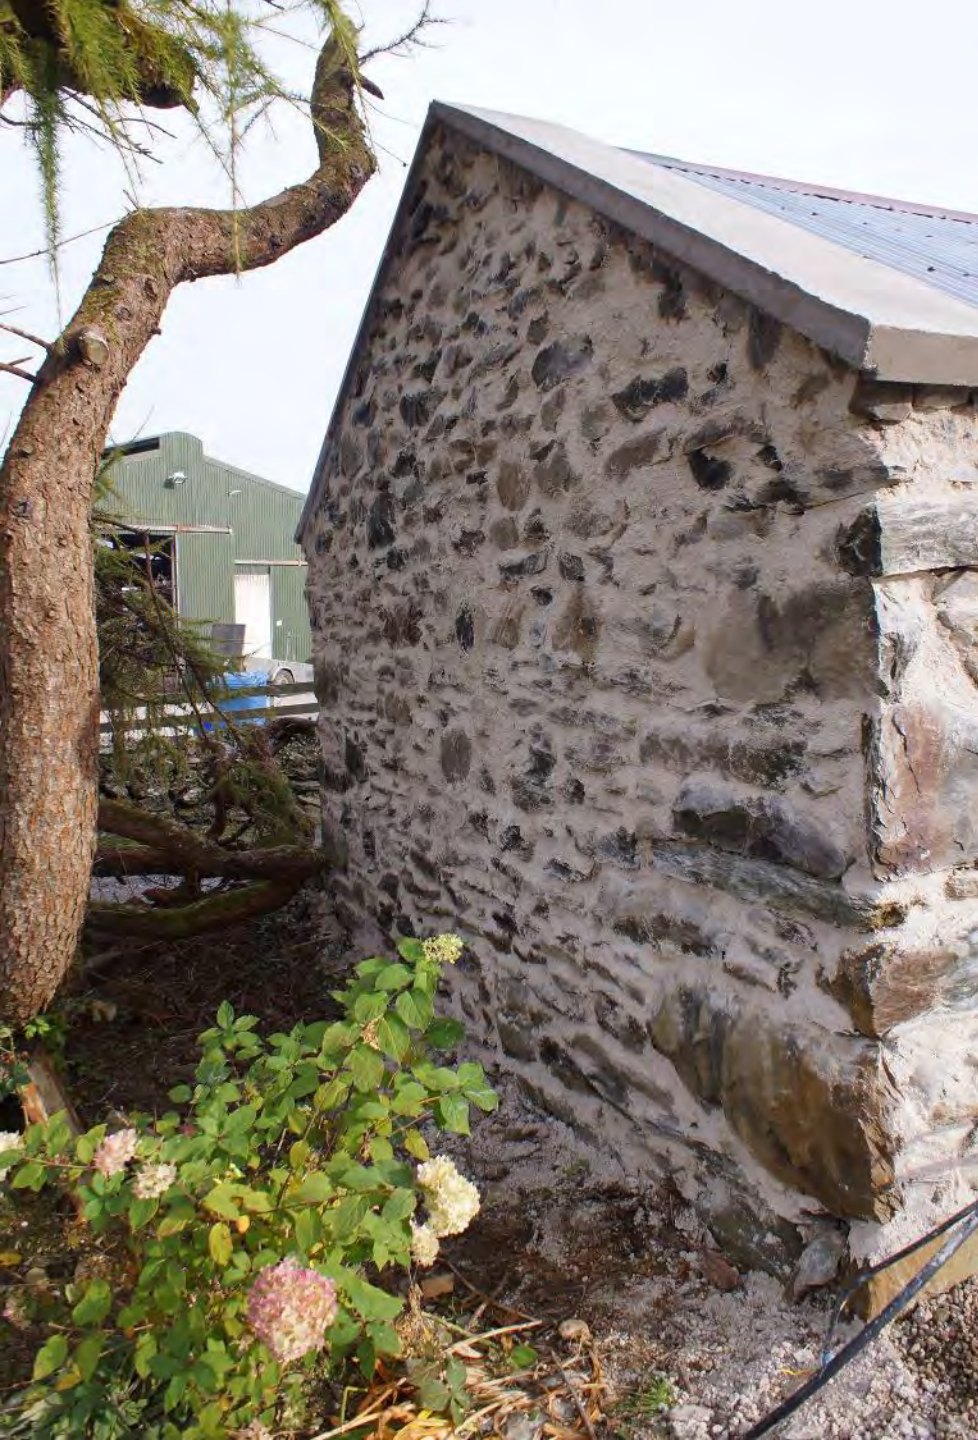
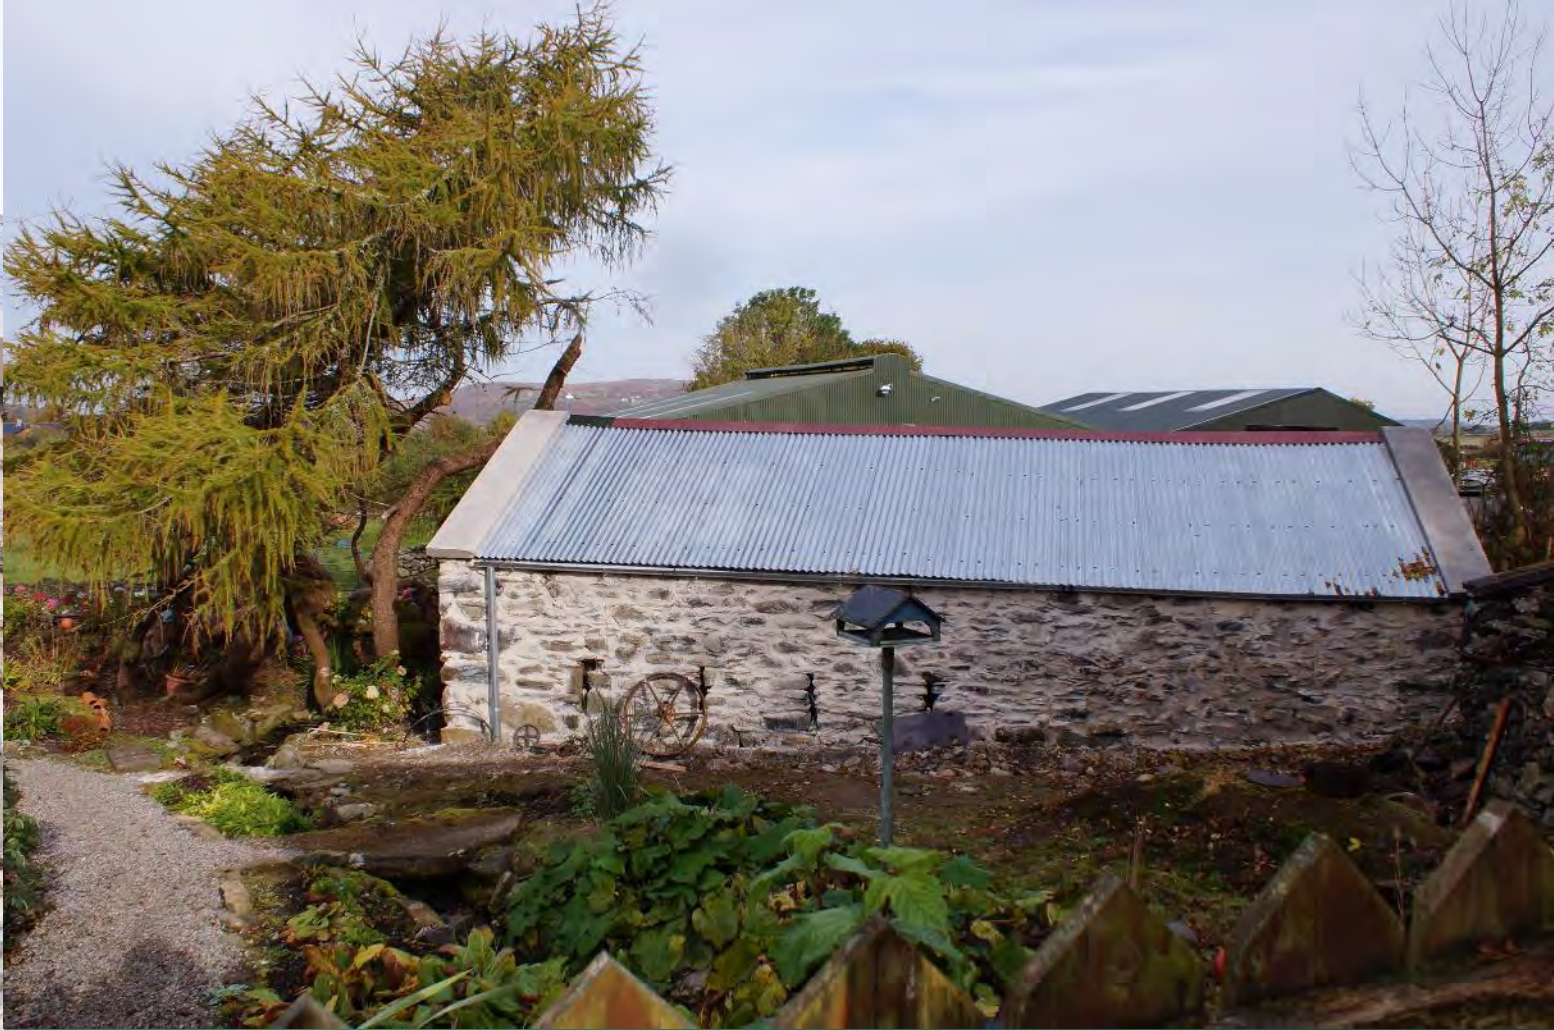
Turf Shed

- Large tree breaking down apex of gable nearest house
- Ivy growing on other gable
- Corrugated sheeting held down with concrete blocks
- Extensive loss of mortar from joints
