KILKENNY CITY WALLS CONSERVATION PLAN

Oxford Archaeology

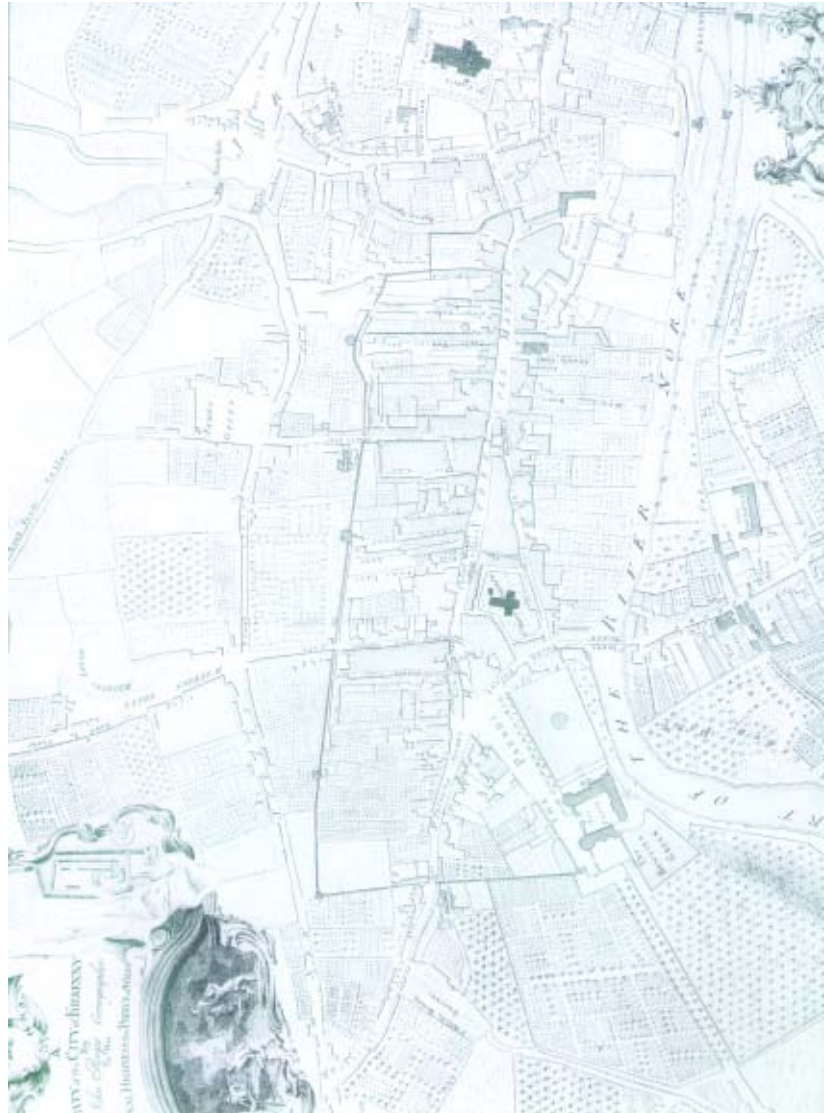
Figure 1: Rocque's Map of Kilkenny, 1758

The main evidence suggesting the route of the wall is John Rocque's map of Kilkenny, published in 1758 (Figure 1). This shows the walls of Hightown making three sides of a rectangle, with the River Nore to the east of the city acting as the fourth side. The walls possess four mural towers, all facing to the west, and seven gateways: Castle Gate, St Patrick's Gate, Walkin's Gate, St James' Gate, Black Freren Gate, Irishtown Gate and Bridge Gate. Although there is no wall to the east of the city, there is a suggestion that the north wall may have turned east, close to St Francis' Abbey, terminating in Evans Tower.

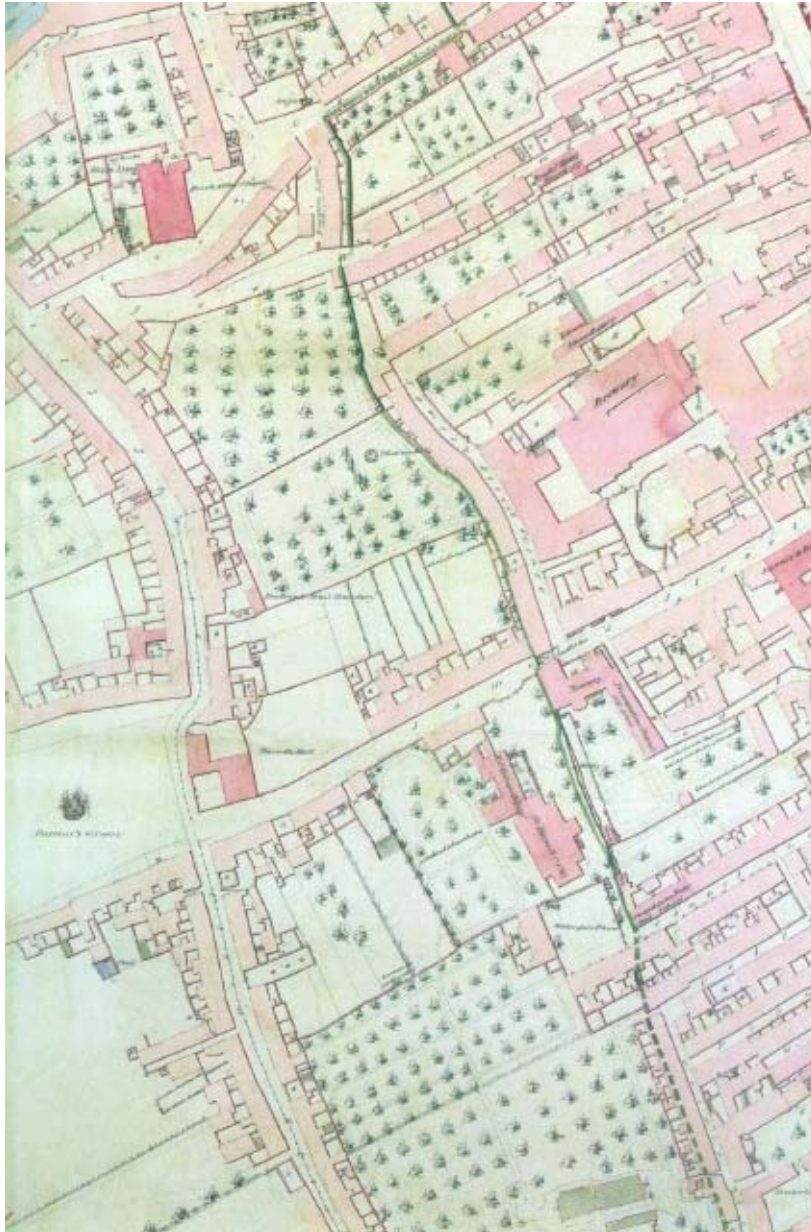
Figure 2: Extract of the Ordnance Survey manuscript plan, 1841, 1:1056

The Ordnance Survey draft city plan of 1841 (Figure 2) specifically indicates the surviving lengths of wall, and the course of the lost wall; it does not show any walls in Irishtown or St John's (National Archives, part reproduced in Bradley, 2000). The large-scale plan that was eventually published in 1871 (at a scale of 1:1056) gives much the same information.

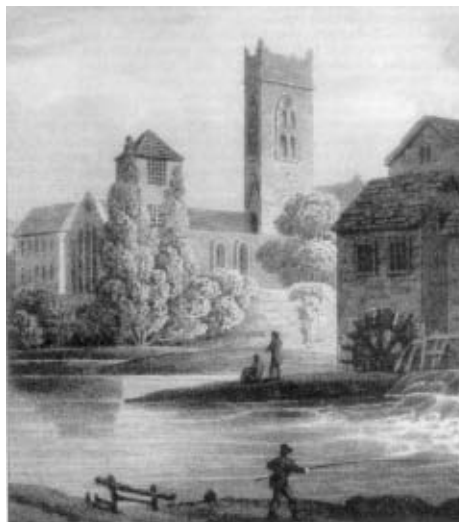
Plate 1: ‘Evans Turret’ from *Robinson’s Antiquities and Scenery of County Kilkenny*, 1851

A polygonal tower (Plate 1) and short stretch of related river revetment wall exist at the extreme north-east corner of the St Francis’s Abbey Brewery complex, where the Bregagh meets the Nore. The form of the tower suggests a later (*c.* 15th century?) date, although its location may reflect an earlier structure. The tower is built as an irregular quadrilateral, with an angled face on the north side,

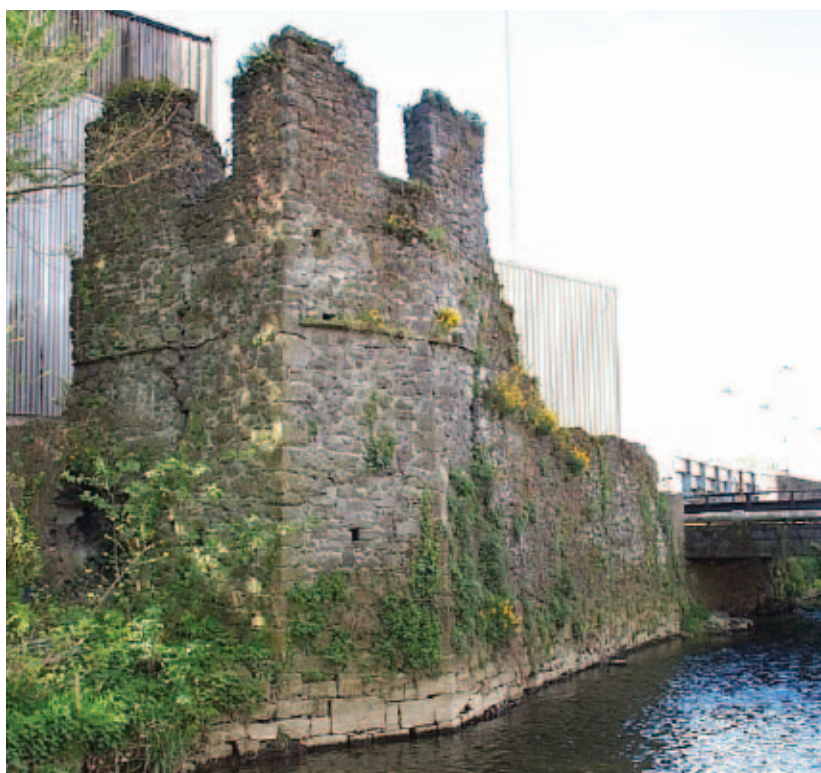
Plate 2: North-eastern polygonal tower (Evans Turret) and adjacent section of revetment wall from the north (May 2001)

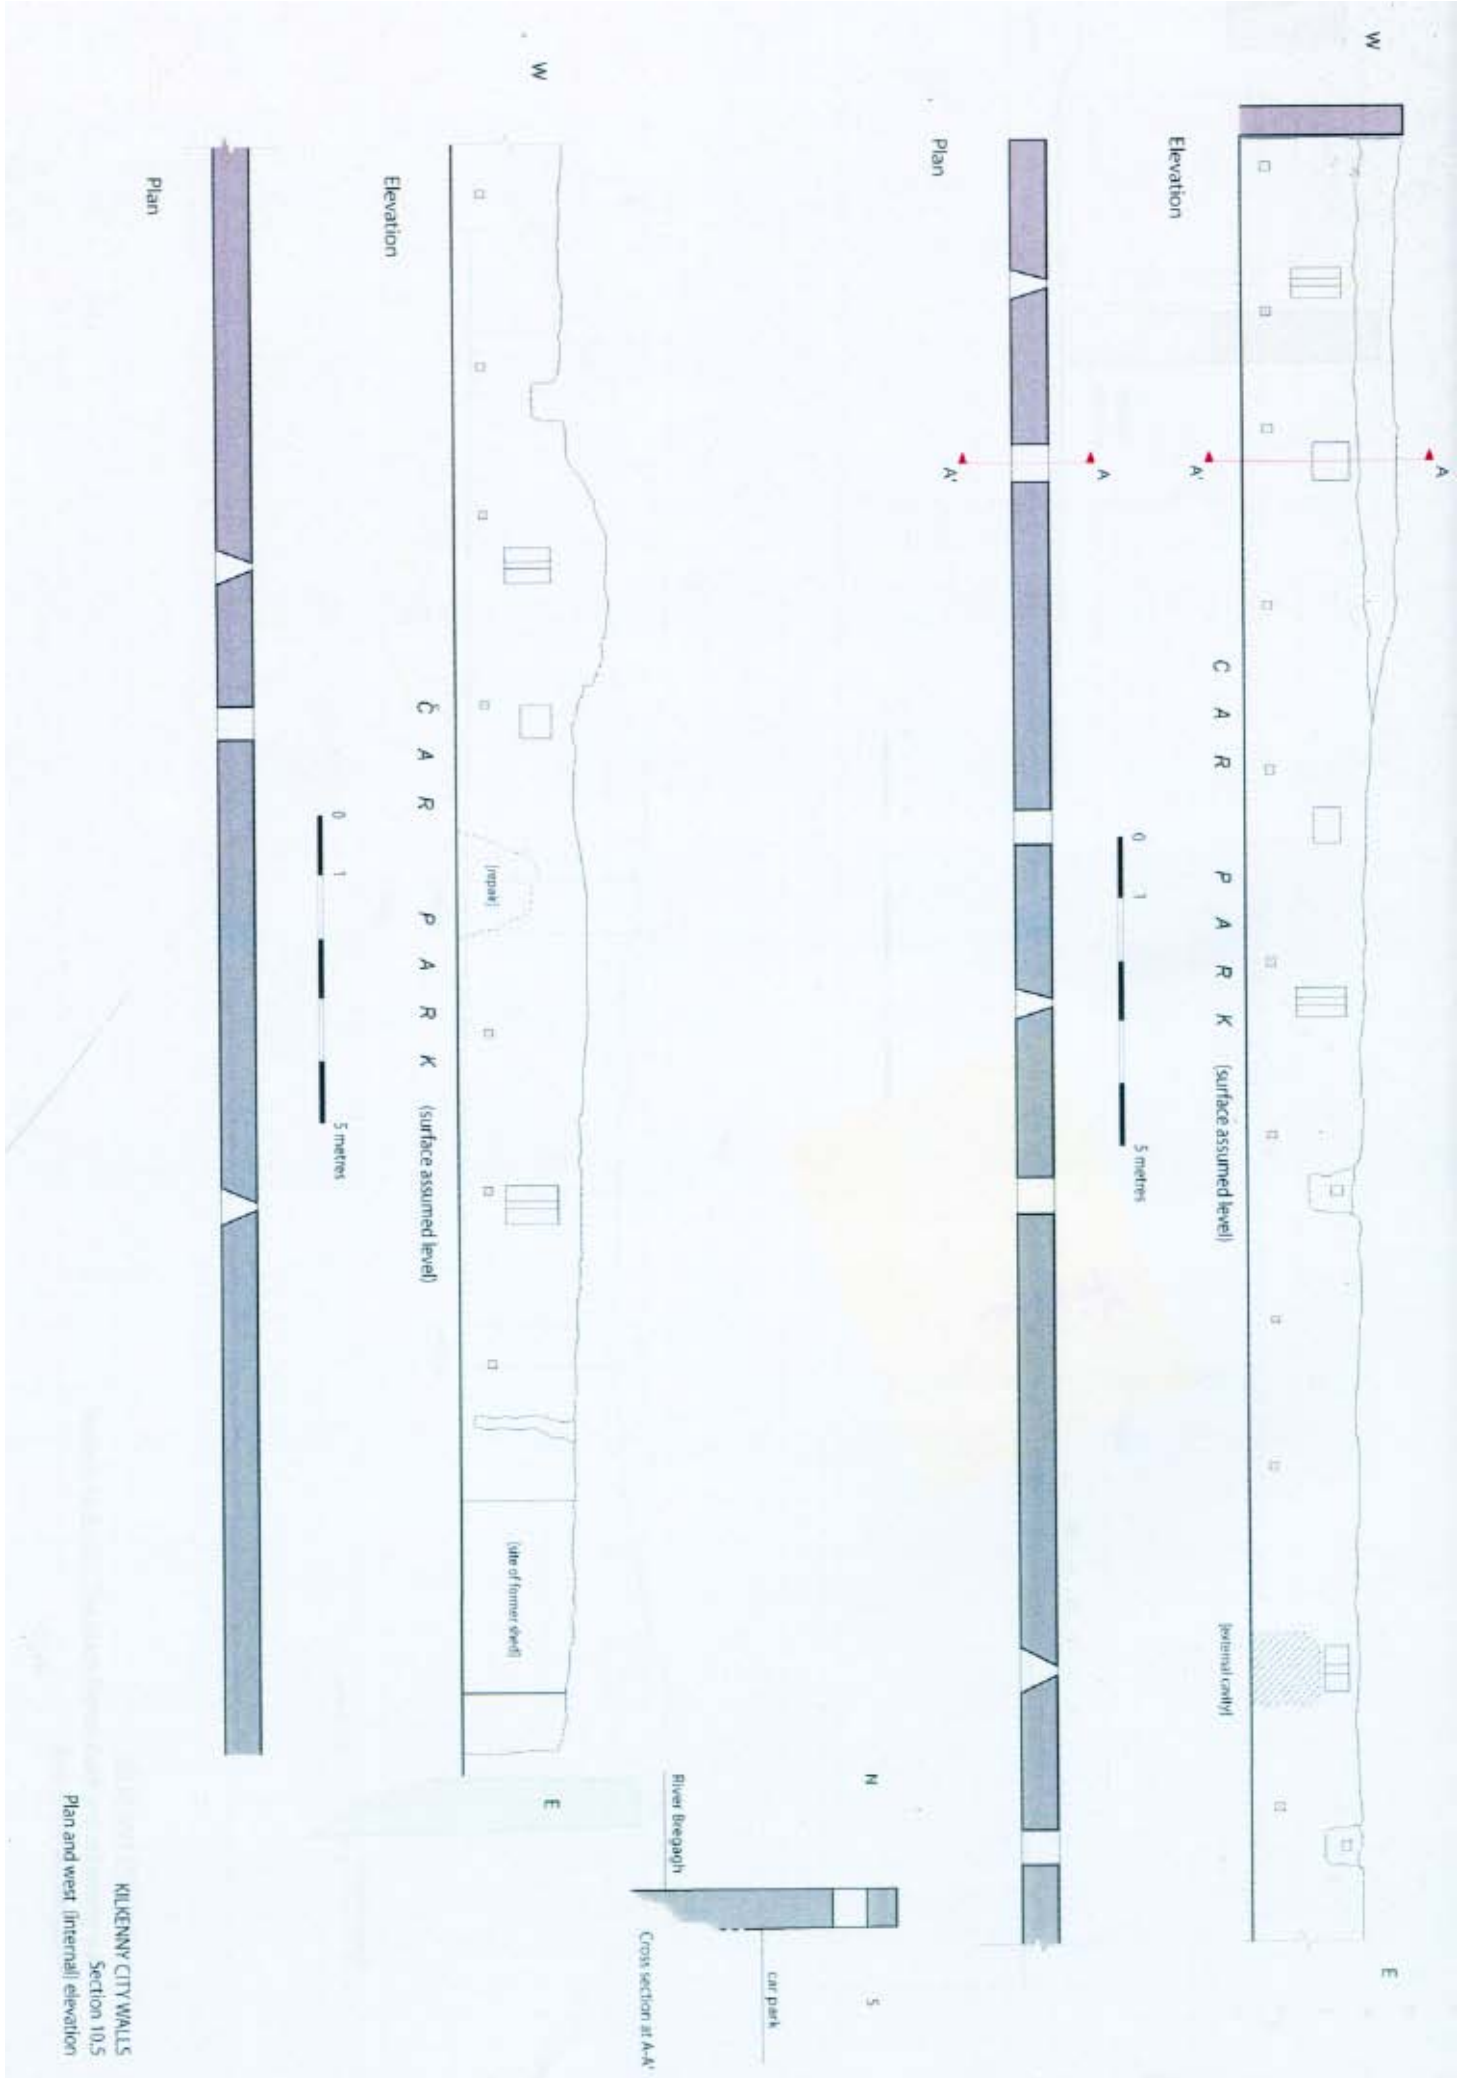
KILKENNY CITY WALLS
Section 10.5
Plan and west (internal) elevation

This section is visible from the northern bank of the River Bregagh; the interior is also accessible from the car park of the residential development on the south bank immediately north of the Black Friars Gate (Section 10.6). The wall survives to a maximum length of 57.5m and stands to a maximum height of 2.8m at the western end, although the upper courses here represent rebuild. For much of its length, the wall stands to a height of between 1.8m and 2.4m. Externally, the level of the river is *c.* 2m below the internal ground level. A total of ten openings of varying forms survive along the length of the wall. Of these, five are of splayed form with narrow (0.1m wide) external openings and internal dimensions averaging 0.8m tall x 0.6m wide. The splayed openings, which are late or possibly post-medieval in date, are arranged at fairly regular intervals of between 11m and 12m. Other openings are rectangular in form and display perpendicular jambs. Two of the latter openings have been partially blocked, leaving a reduced, square central opening. A level line of 17 putlog holes at 2.5 - 3m centres are located at a height of *c.* 0.45m above the internal ground surface.

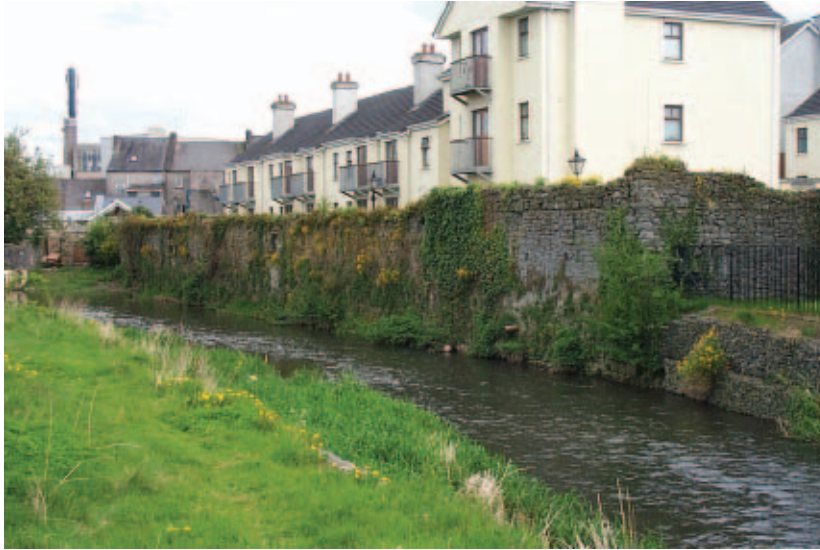
Plate 3: Section of City Wall fronting onto the River Bregagh from the west (May 2001)

At its western end, the wall would appear to abut the southern return wall, the joint between the two being ragged in appearance.

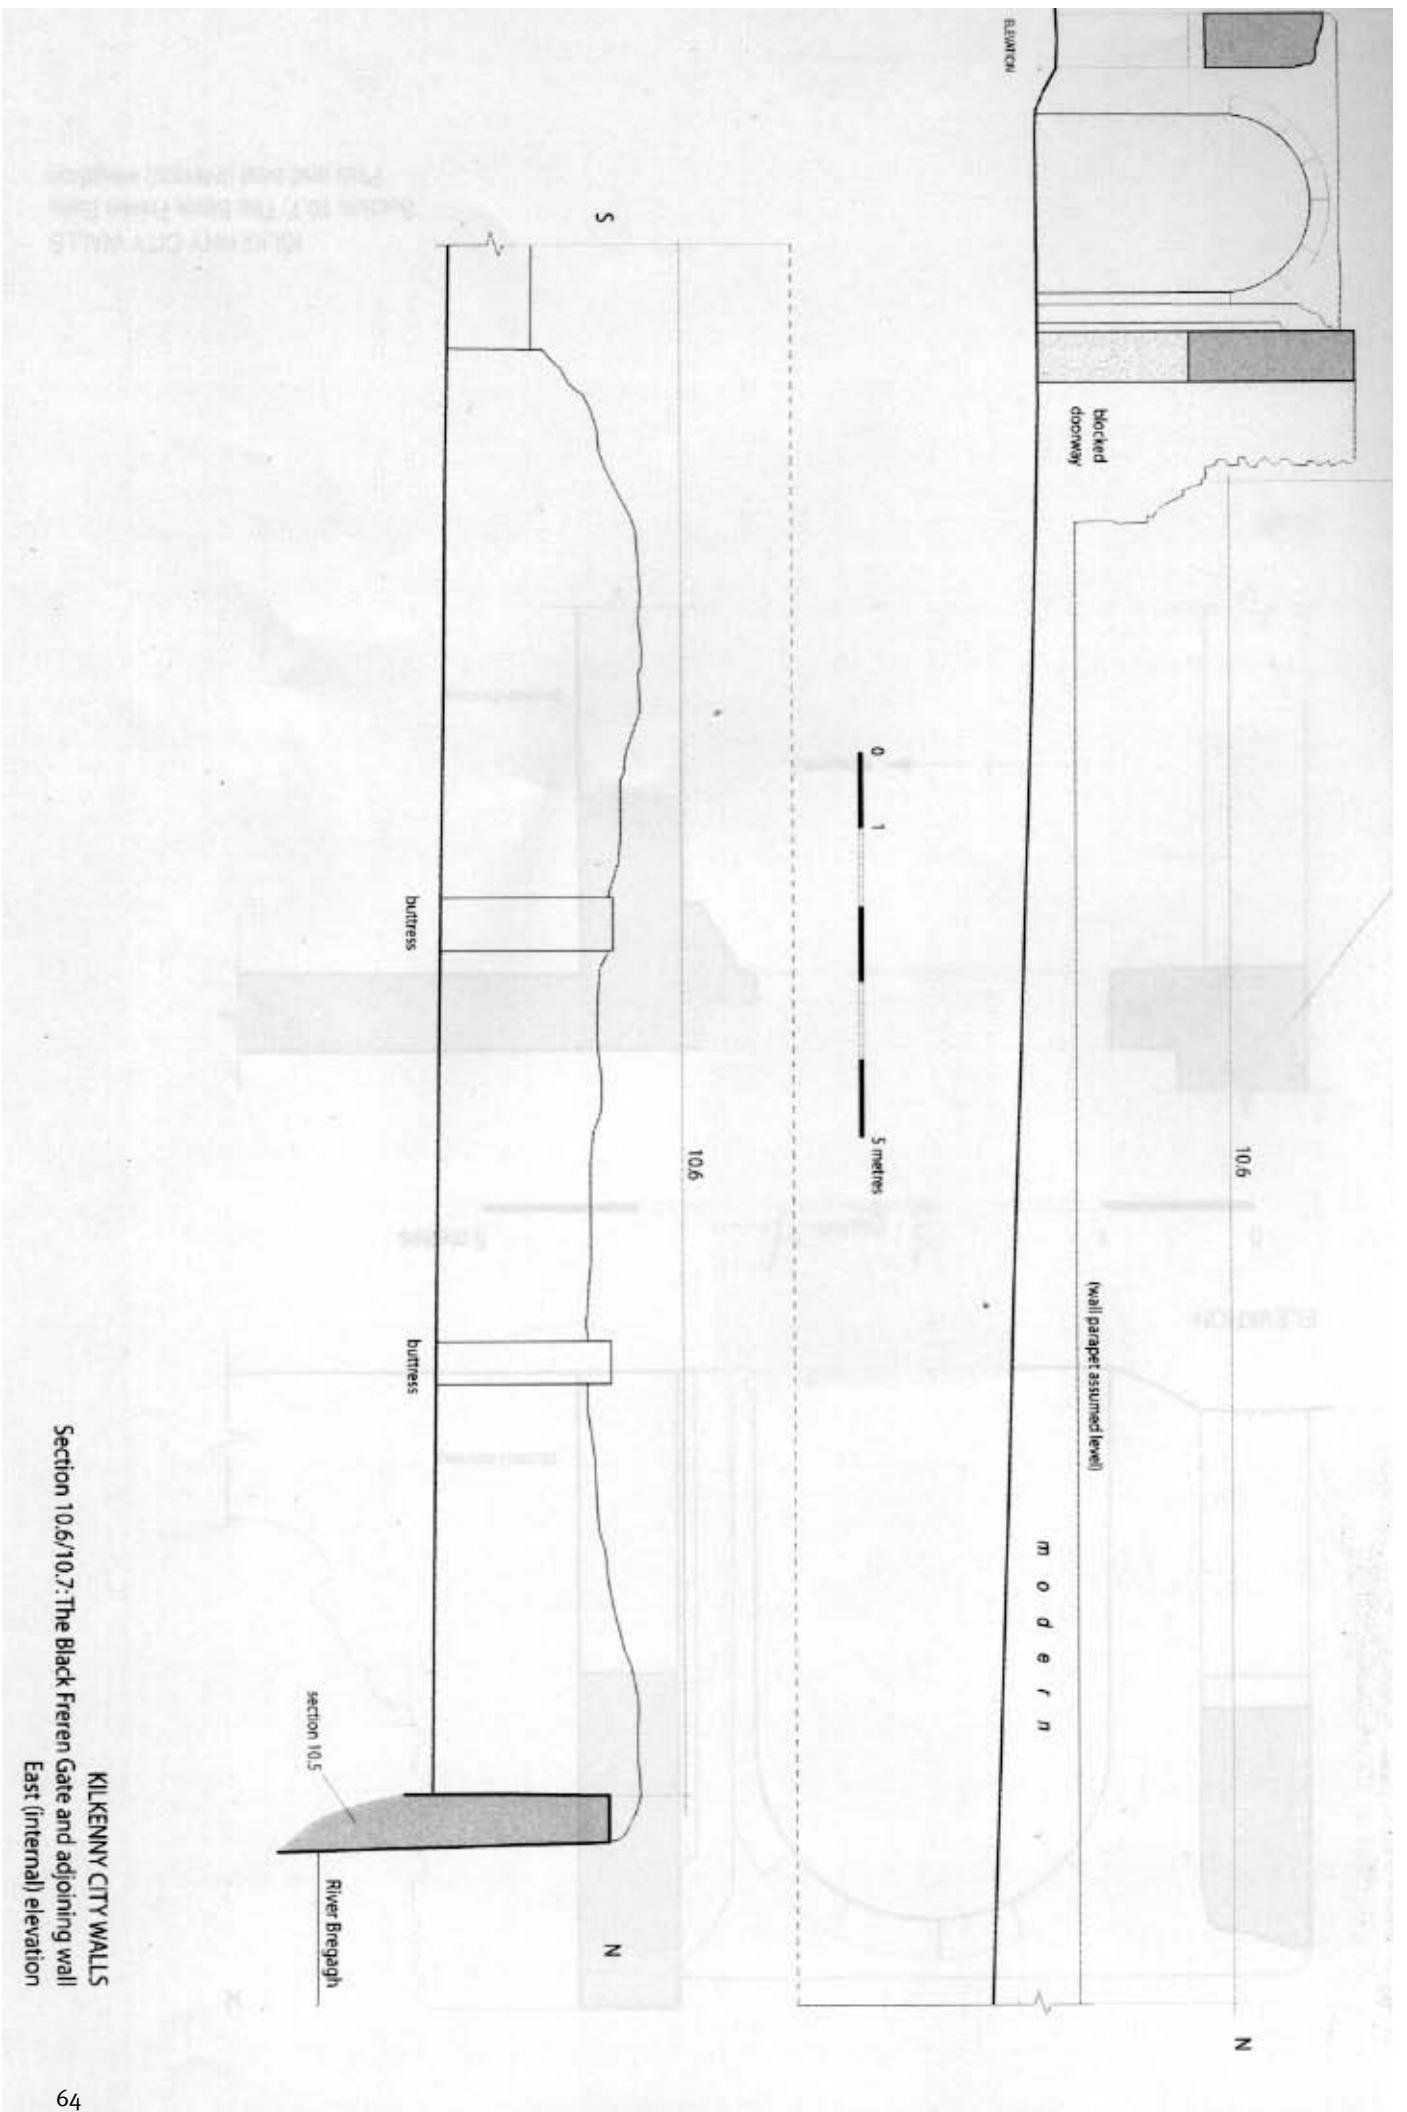
KILKENNY CITY WALLS
 Section 10.6/10.7: The Black Friars Gate and adjoining wall
 East (internal) elevation

The southern section of the wall is *c.* 21m in length and is a minimum of 0.5m and a maximum of 1.25m high. Although the wall reflects the historic mapped line of the city wall, the structure itself is clearly modern, rebuilt probably at the time of the construction of the carpark for the present residential development in the last decade. At its southern limit, it adjoins the northern side of the Black Friars Gate. While the northern part of the wall is of greater antiquity, its phasing is uncertain (the buttresses are bonded into the wall), and it may be post-medieval in date. It extends for 19.2m and is a maximum of 2.8m high, supported on its eastern (internal) side by two stone buttresses. At its far northern limit, the wall would appear to be abutted by the east-west riverside wall (10.4), the joint between the two being ragged in appearance.

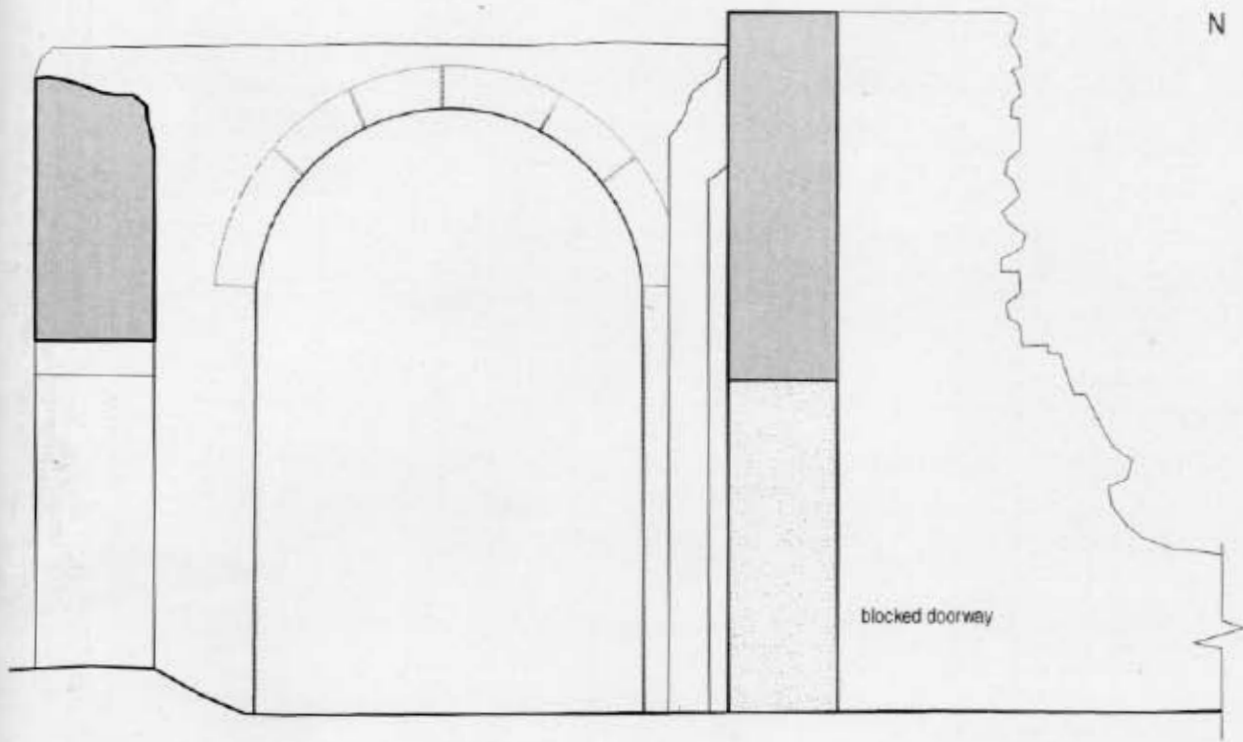
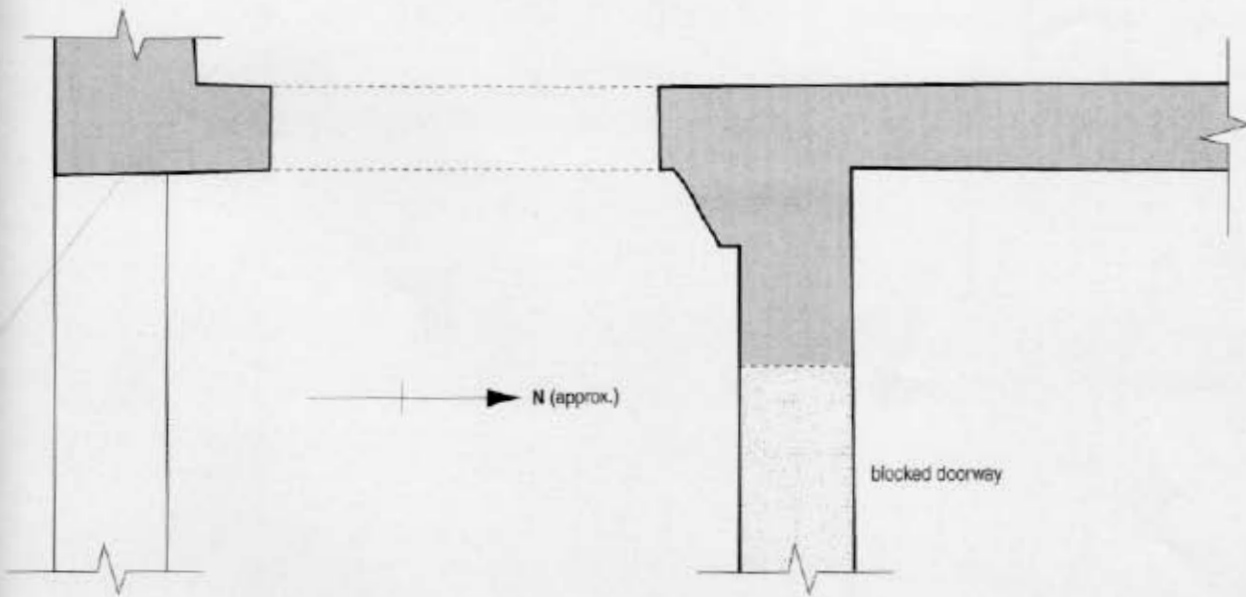
Figure 7: Black Friars Gate. Plan and east (internal) elevation

The archway of the former gate survives and takes the form of a semi-circular headed arch, 3.6m high, 2.4m wide and 0.52m thick. The arch springs from a height of 2.58m and is formed of six dressed-stone blocks. To the north, a small section of possible original flanking wall survives, though rebuilding events are evident. A blocked door opening is located 1.3m to the east of the gate, though the major part of this section has been substantially rebuilt.

Currently supported by steel and timber supports, with tell-tales in place on a number of cracks within the masonry to the north of and above the arch. The gate has sustained damage from vehicle impact, possibly exacerbated by deep excavation in the roadway. The north side of the arch appears to have suffered vertical displacement.

- Protection of the gate from vehicular damage. [Policy 7]
- Detailed survey and analysis of surviving fabric. [Policies 12, 14]
- Condition survey to determine amount of repair. [Policy 11]
- Archaeological record of any alterations or maintenance works. [Policy 15]

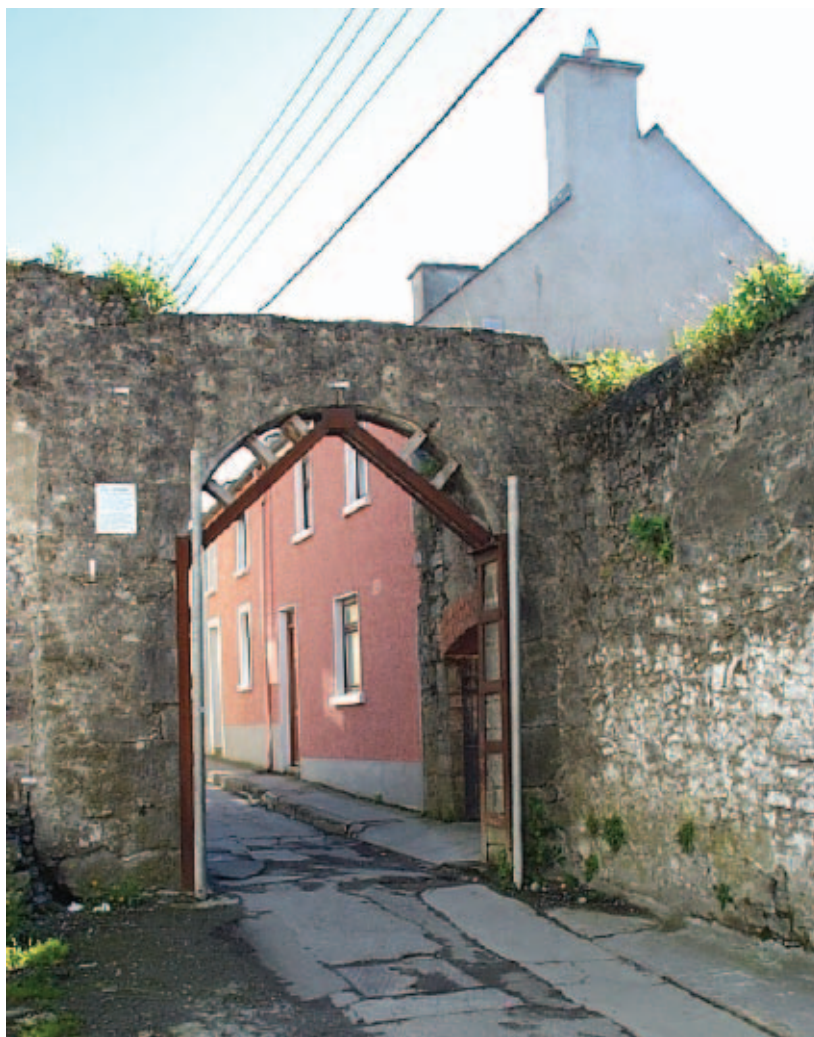
Plate 4: Black Friars Gate from the west (May 2001)

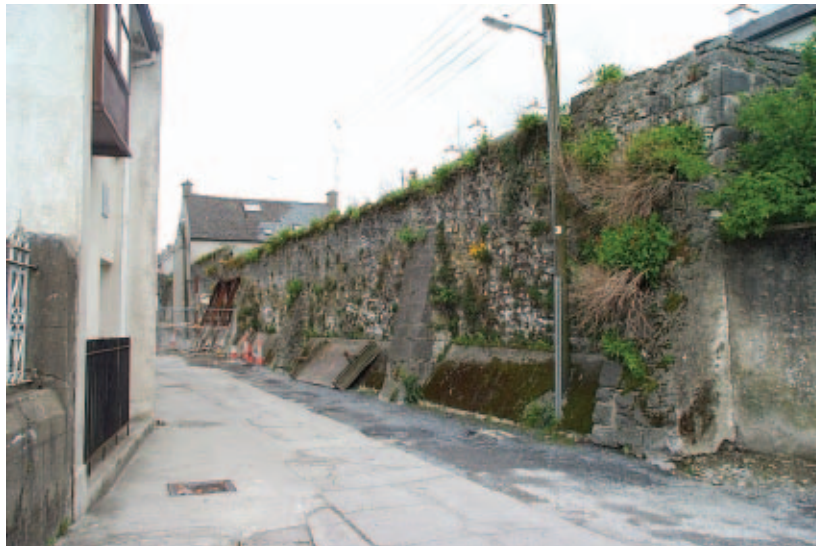
Plate 5: Section of City Wall flanking Abbey Street from the west (May 2001)

The section is a maximum of 53m long, including a section incorporated into the gable end of a house, and stands to a height of 4.75m. The wall displays a significant lean in its upper levels and is supported by a total of five buttresses along its length. At its western end, the wall returns (as 10.9); the quoin has been rebuilt in regular, angular grey limestone blocks. The wall partly retains a covering of whitewash which serves to conceal any architectural detail, though a relieving arch can be seen at road level just east of the first buttress. Internally, much of the garden is built up to more than 2m above the road level. The lower patio section near the house reveals a large offset (like a parapet walk), so the upper part of the wall is actually based on a broad foundation.

The wall has an alarming appearance, but has clearly been that way for a long time. A degree of extra movement may have followed deep excavation in the roadway. The additional steel supports in contact with the wall have now been removed. The masonry is in reasonable condition.

The wall may be unsafe if it continues to move, but may fundamentally be more stable than it appears. It may be vulnerable to further road excavation and possibly to build-up of ground water if not drained internally. The power cables detract from the setting of the monument.

- Protection of the wall from any further external disturbance from service excavations. [Policy 7]
- Detailed survey and analysis of surviving fabric. [Policy 12, 14]
- Condition survey and monitoring to determine necessity of any structural repair. [Policy 11]
- Archaeological record of any alterations or maintenance works. [Policy 15]
- Removal of suspended power cables. [Policy 17]

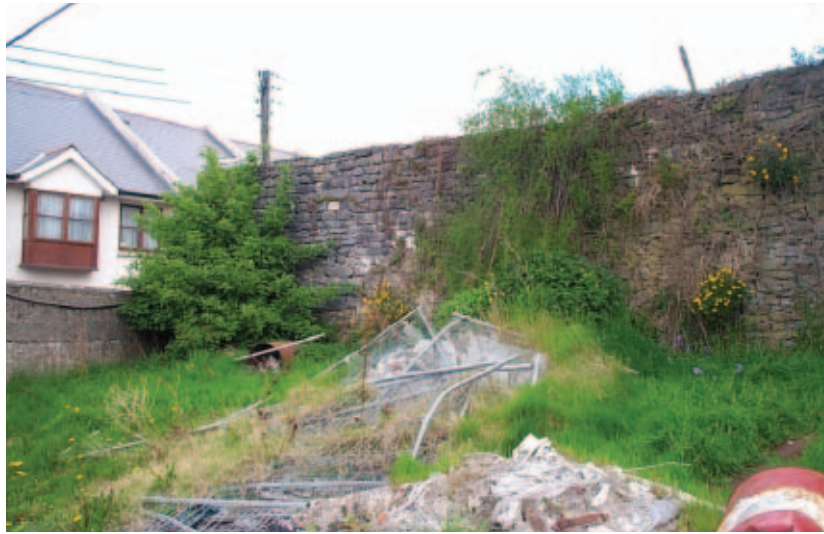
The northern end of wall, which forms the retaining wall for a garden and continues around the corner (10.8), has been entirely rebuilt in regular, angular grey limestone blocks up to and including the western quoin (Plate 6). Beyond this point, the wall is heavily overgrown with elder and sycamore, but is apparently built of rough battered (*i.e.* sloping) masonry, with some shuttered concrete repairs. The wall stands on top of a natural slope and internally stands as a low parapet, with a row of cypress trees inside it.

Plate 6: The northern end of the wall is heavily overgrown with elder and sycamore

- Protection of the wall from damage from growth of trees and shrubs. [Policy 9]
- Clearance (as part of landscaped scheme) to allow wall to be seen. [Policy 17]
- Detailed survey and analysis of surviving fabric. [Policies 12, 14]
- Condition survey to determine necessity of any structural repair. [Policy 11]
- Archaeological record of any alterations or maintenance works. [Policy 15]

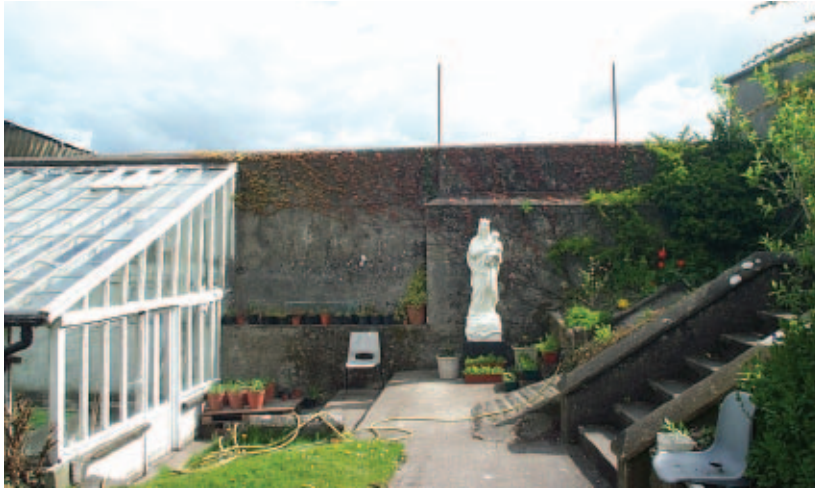
Although most of the wall here was demolished in 1860, it is possible that some sections of the standing, concrete rendered wall forming the eastern boundary of the Christian Brothers' Monastery Garden (Plate 7), in particular the lower courses, include remnants of the city wall (see *Status* below). Tilbury Tower would have stood about where the garden shed is, at the top of the rising ground.

Plate 7: Wall on east side of Christian Brothers' garden near site of the lost Tilbury Tower (May 2001)

The standing walls are in reasonable condition.

- Surveys or investigations to determine the extent of any standing or buried remains of the defences in this area. [Policy 15]
- Protection of below-ground remains of the defences. [Policy 7]
- Future development to respect the line of the wall. [Policy 18]
- Marking out or signalling site of lost structures. [Policy 20]
- Provision of access along the course of the wall. [Policies 16, 19]

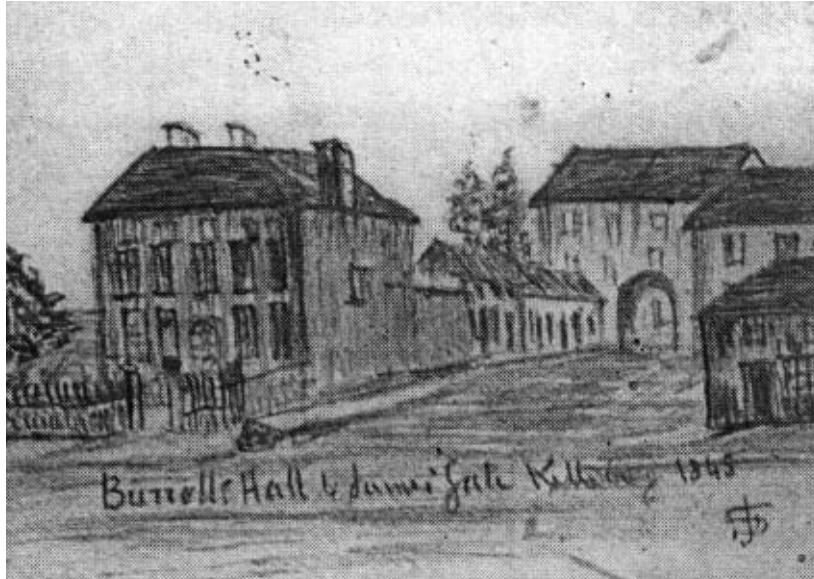
Built across the head of James's Street. No physical remains survive, but the lease of 1599 implies that the gate had a stone vault. A 19th-century drawing (Plate 8) shows the gate in the background as a two-storey structure with five windows and a pitched roof.

Plate 8: St James's Gate in 1845: Shearman Mss, Maynooth (after Birch, *St Kieran's College*, 1951)

- Survey or investigation to determine extent of any remains. [Policy 15]
- Protection of below-ground remains of the defences. (The site of the gate should be noted in mapping of services, with appropriate archaeological watching briefs undertaken in works on the road or services.) [Policies 6, 7, 15]
- Marking out or signalling of lost features in roadway. [Policy 20]

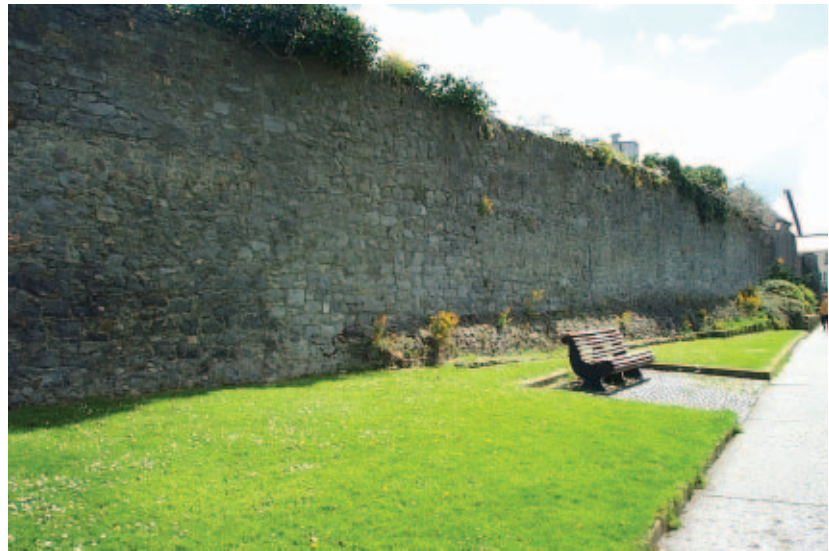
The length of wall formerly in the garden of the Presentation Convent (the new Market Cross development) is one of the best surviving sections in the public domain (Plate 9).

Plate 9: City Wall flanking former Presentation Convent Garden from the north-west (May 2001)

The condition of the masonry is reasonable.

This length is now reasonably secure from damage from any further development, though access to the garden terrace could be improved by the provision of steps or other means of access. While the retention of some garden planting is entirely appropriate, the growth of woody shrubs on the masonry should be discouraged. There is scope for further investigation of the masonry and the blocked loops.

- Detailed survey and analysis of surviving fabric. Investigation of blocked loops. [Policy 14]
- Careful maintenance of vegetation, and removal of unsuitable woody species (ivy, sycamore, elder). [Policies 9, 11]
- Monitoring of condition of fabric to determine any need for repairs. [Policy 11]
- Provision of steps or ramp to internal terrace. [Policy 16]
- Archaeological record of any alterations or maintenance works. [Policy 15]

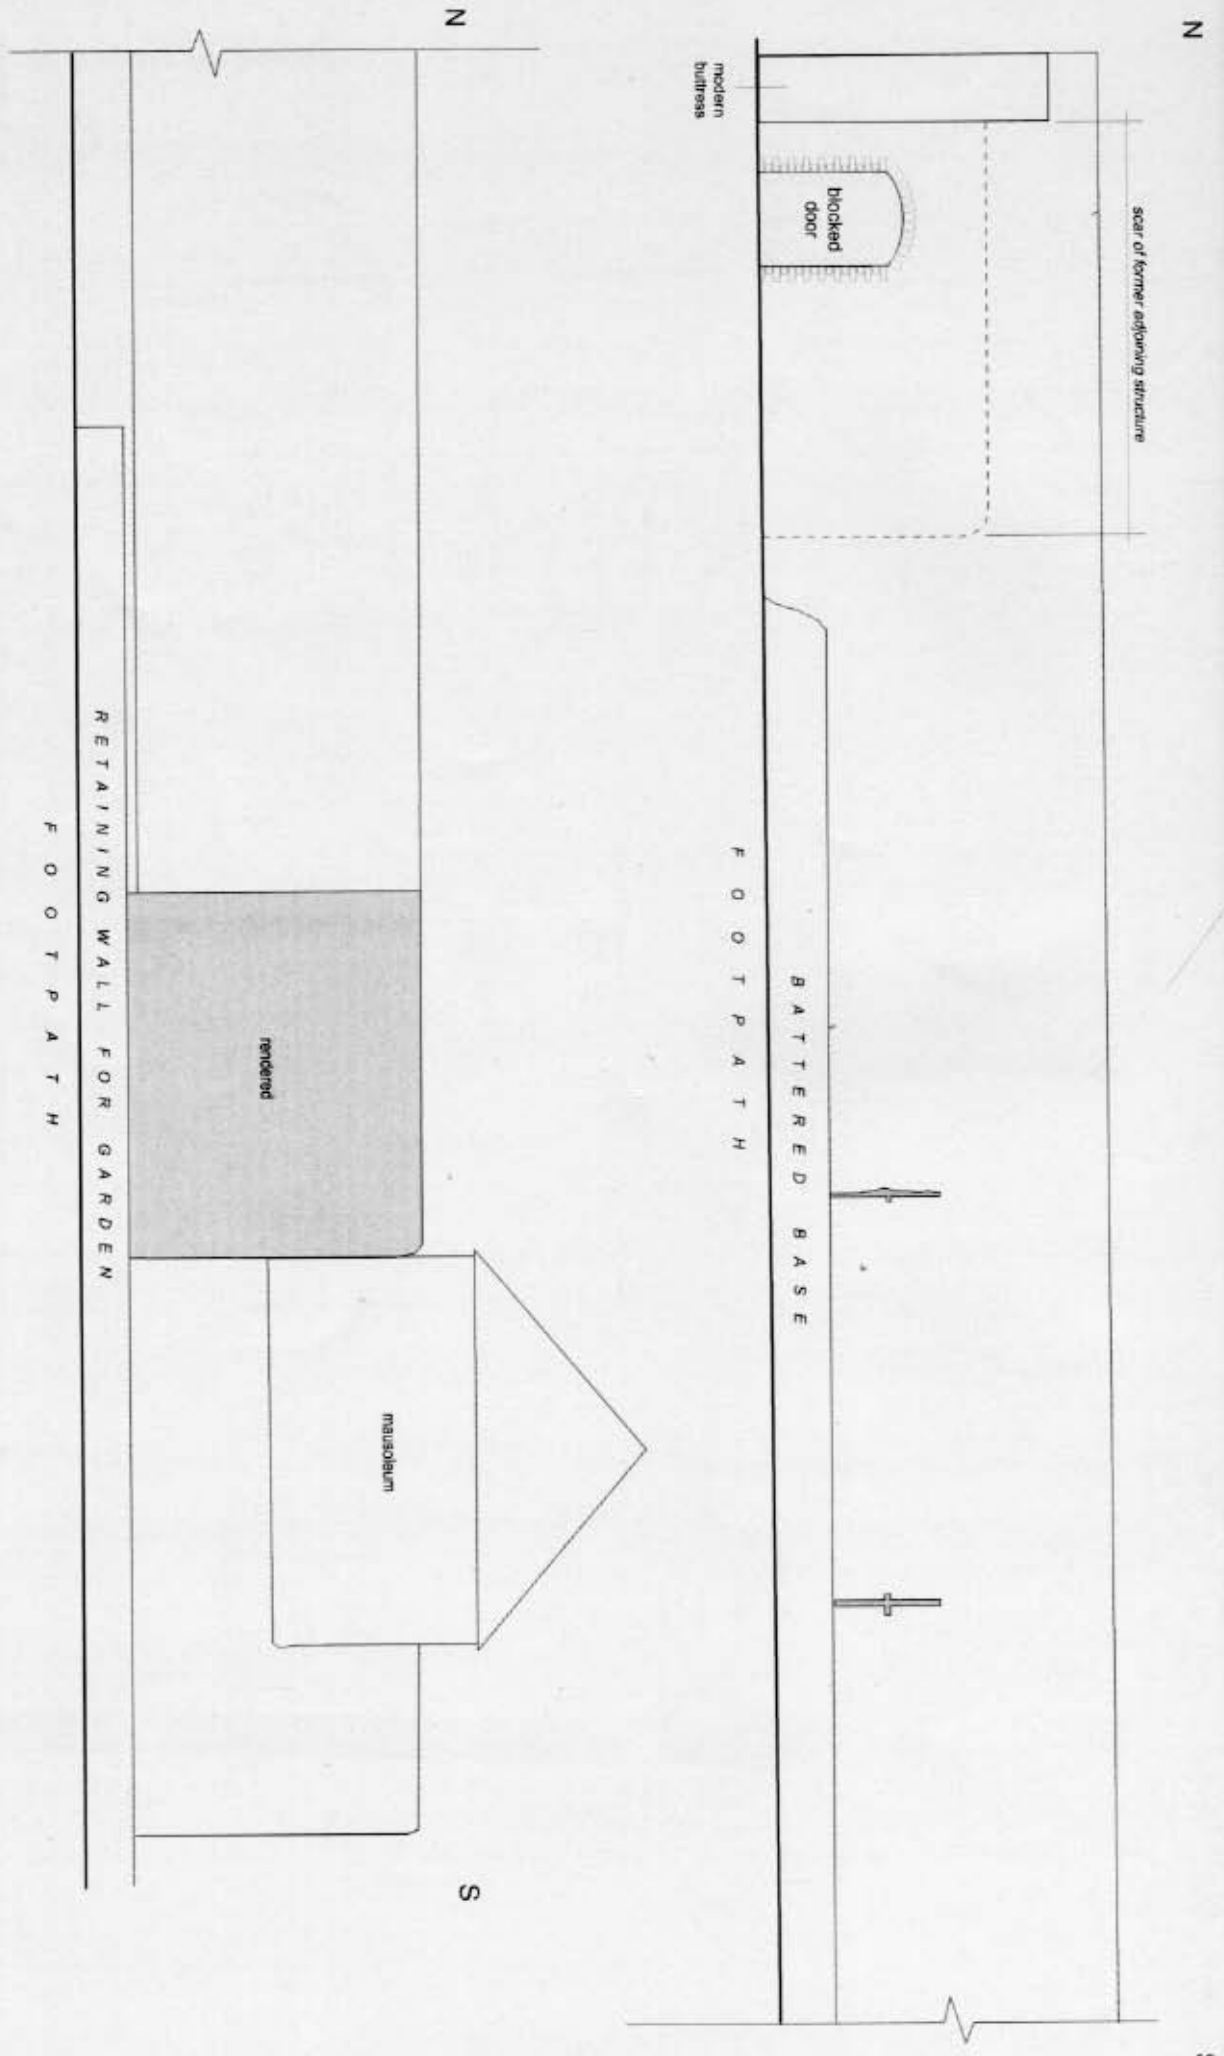
KILKENNY CITY WALLS
 Section 10.13
 External elevation

This section of wall represents one of the best preserved and most readily accessible parts of the city circuit. Situated half-way along the western wall line to the south of James Street, it is 49.5m in length, 4.6m tall and 0.55m wide. The upper courses are modern. There are two arrow embrasures and a battered external plinth. The embrasure loops measure 1.4m in height and 0.09m in width. The southern example is the better preserved and is of cruciform type.

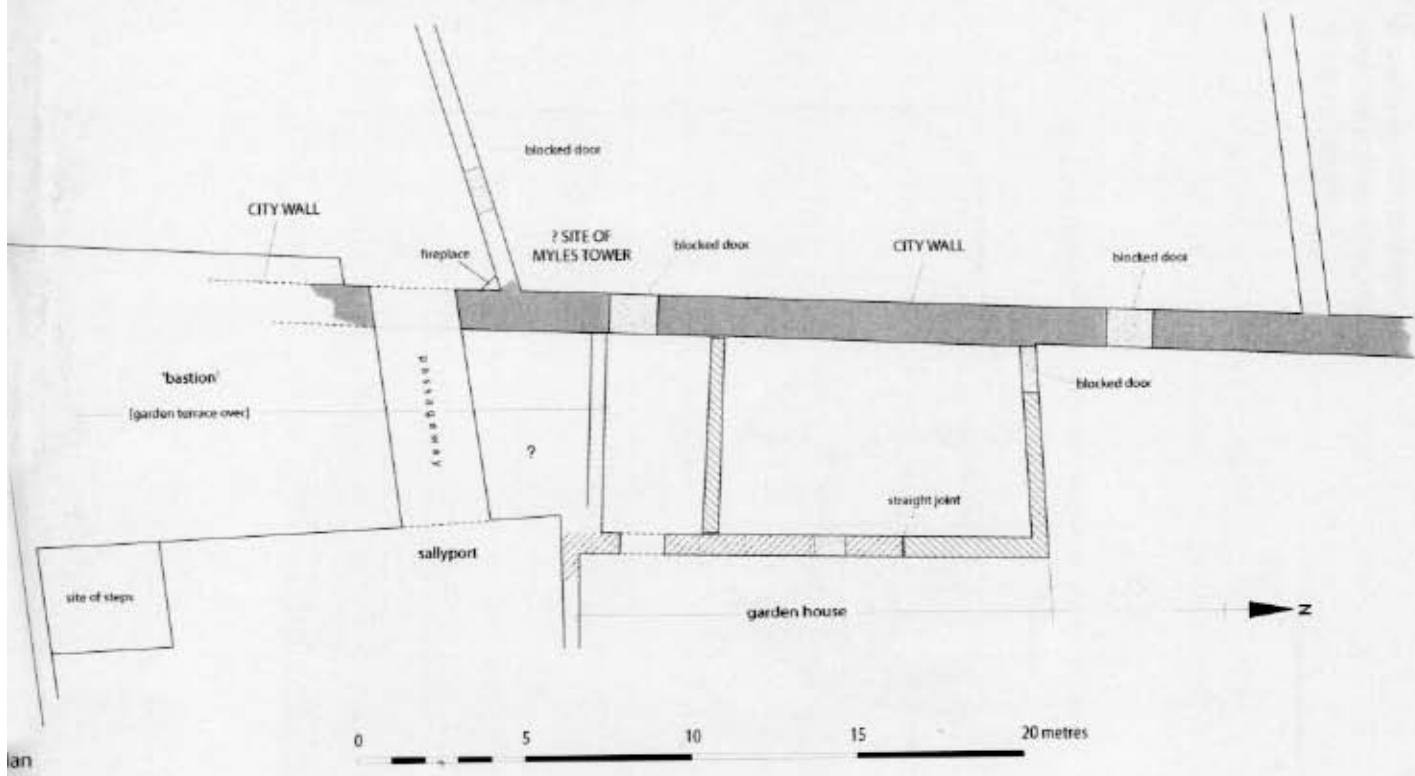
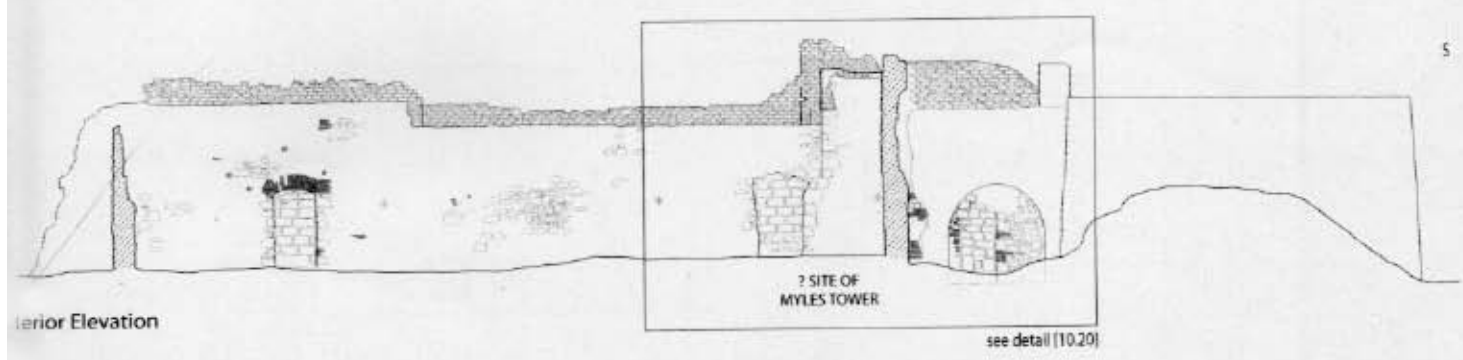
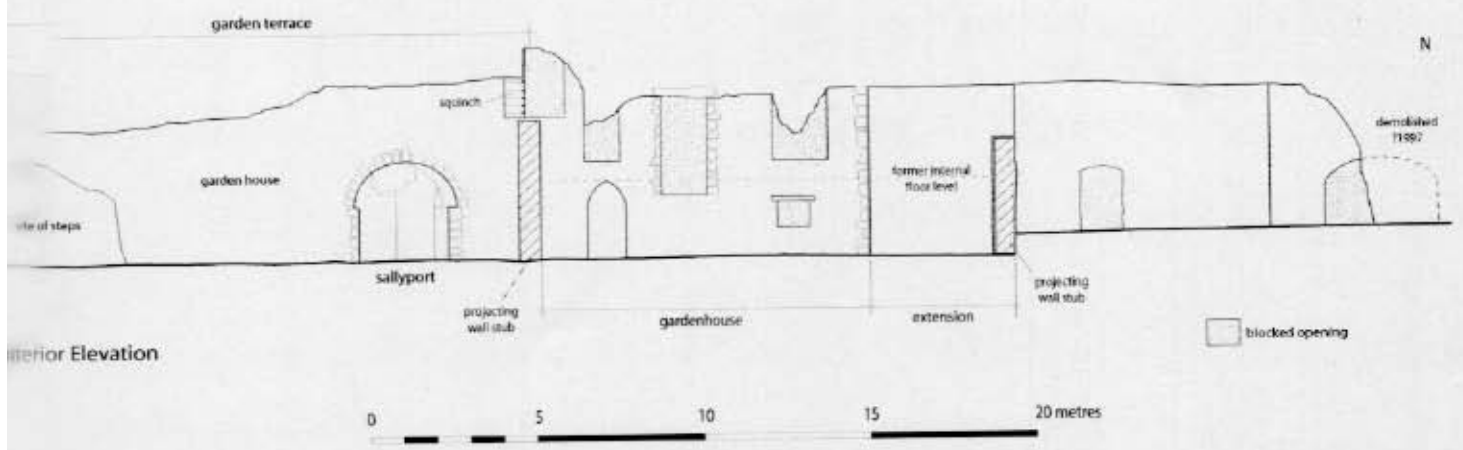
KILKENNY CITY WALLS
 Sections 10.19 - 10.20
 Plan, western (external) and eastern (internal) elevations

Lost length of c. 8m at north end (approximately on line of metal fencing). Wall to south of this is 49m in length and includes the remains of Myles Tower (Section 10.20). The wall is 4m high and 1.7m wide. The upper courses may not be original. It is pierced by two doors of modern origin, both of which are now disused. A structure (probably a former garden house) is built up against it, with several doors and windows of 18th or 19th-century date. A portion of the wall (then behind the *Kilkenny Journal* Office) was damaged during a storm in 1947 and a concrete wall was erected in its place (Bradley 1976, 213). The west side of the wall, at No. 6 Lower New Street, has been the subject of a detailed archaeological survey which concluded that the wall had 'undergone several phases of modification and considerable rebuilding and/or refacing in the course of its history, most likely during the 17th century and later' (Figure 8, OA report to Judith Carroll & Co. Ltd, 2001).

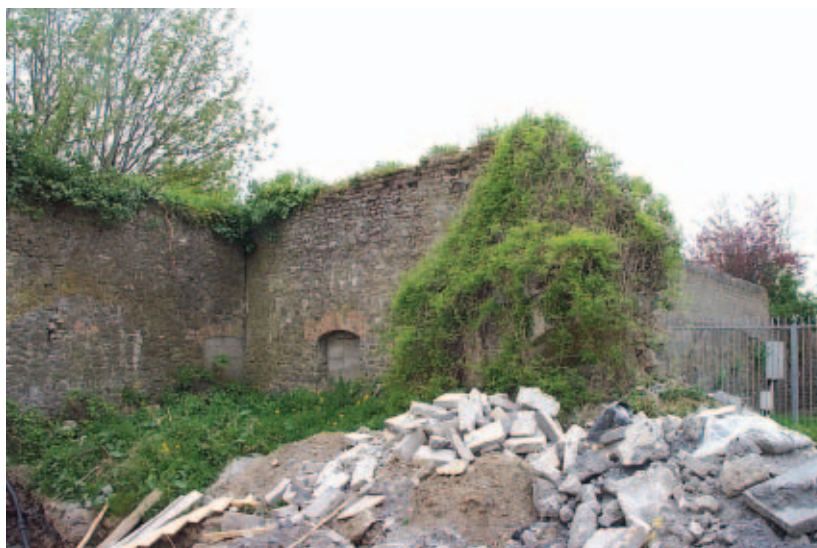
Plate 10: A length of wall, part standing and part lost, behind the Ormonde Hotel (Nos 29-32 Patrick Street)
