KILKENNY CITY WALLS CONSERVATION PLAN

Oxford Archaeology

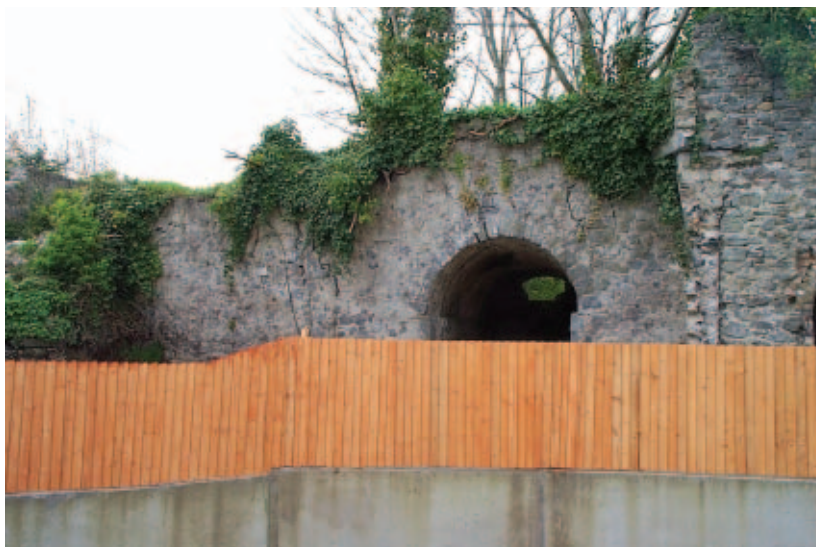
The existing 'tower' (Plate 11) is probably a post-medieval garden house or gazebo, built inside and over a standing portion of the town walls and adjacent to the former Myles Tower at No. 28 Patrick Street.

Plate 11: The garden terrace and passage in the postern gate at the site of Myles Tower (May 2001)

- Detailed survey and analysis of surviving fabric. Investigation of adjacent structures. [Policy 14]
- Careful maintenance of vegetation and removal of unsuitable woody species (ivy, sycamore, elder). [Policies 9, 11]
- Monitoring of condition of fabric to determine any need for repairs. [Policy 11]
- Improved access with path and steps. [Policy 16]
- Rebuilding of steps to upper terrace/gazebo. [Policy 18]
- Improve setting by removal of water tank. [Policy 17]
- Archaeological record of any alterations or maintenance works. [Policy 15]

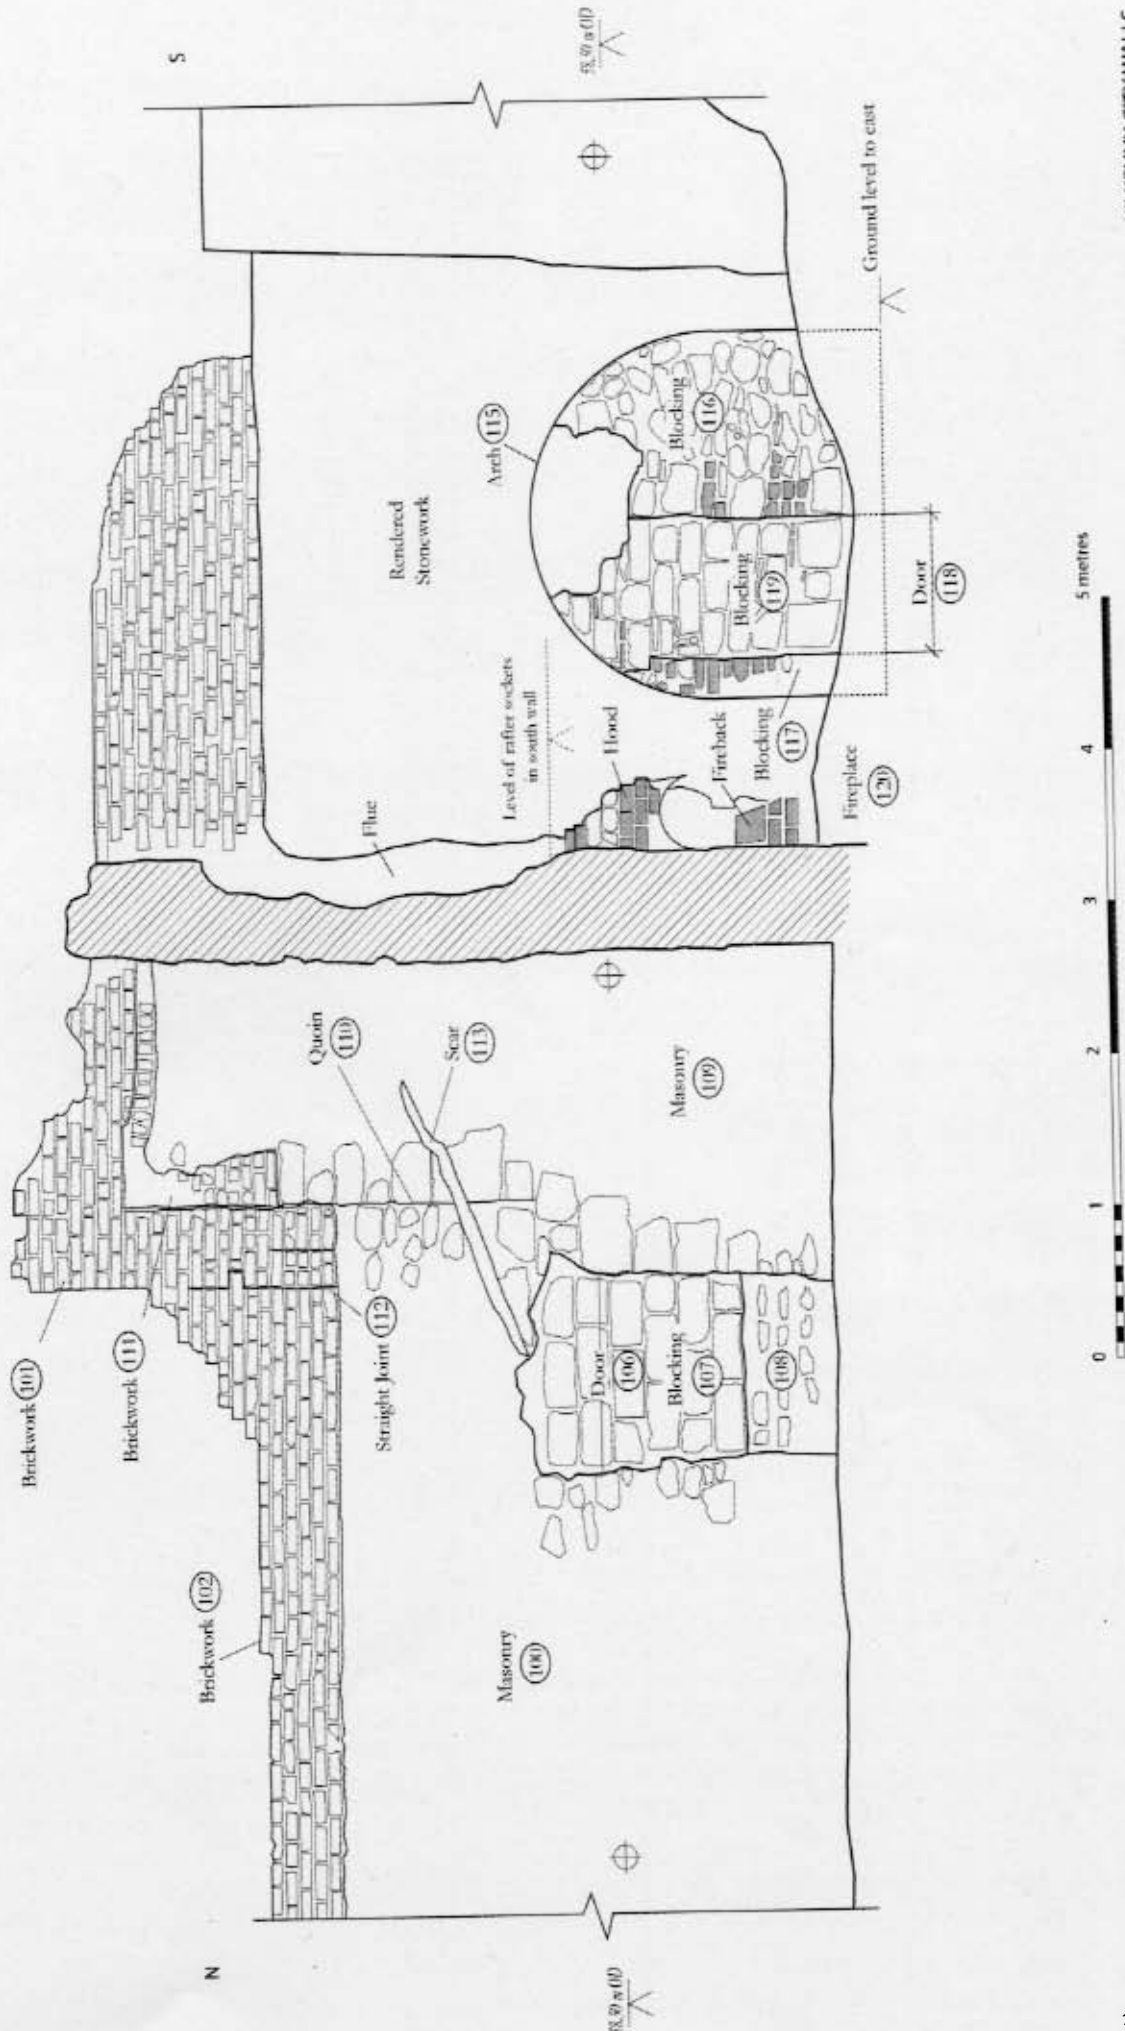
KILKENNY CITY WALLS
 Section 10.20: Site of 'Myles Tower'
 Western (external) elevation

The condition of the masonry is poor to fair, but the staircase against the wall has been part demolished. A concrete walkway and platform have been constructed inside the wall as the base for the hotel's water tank.

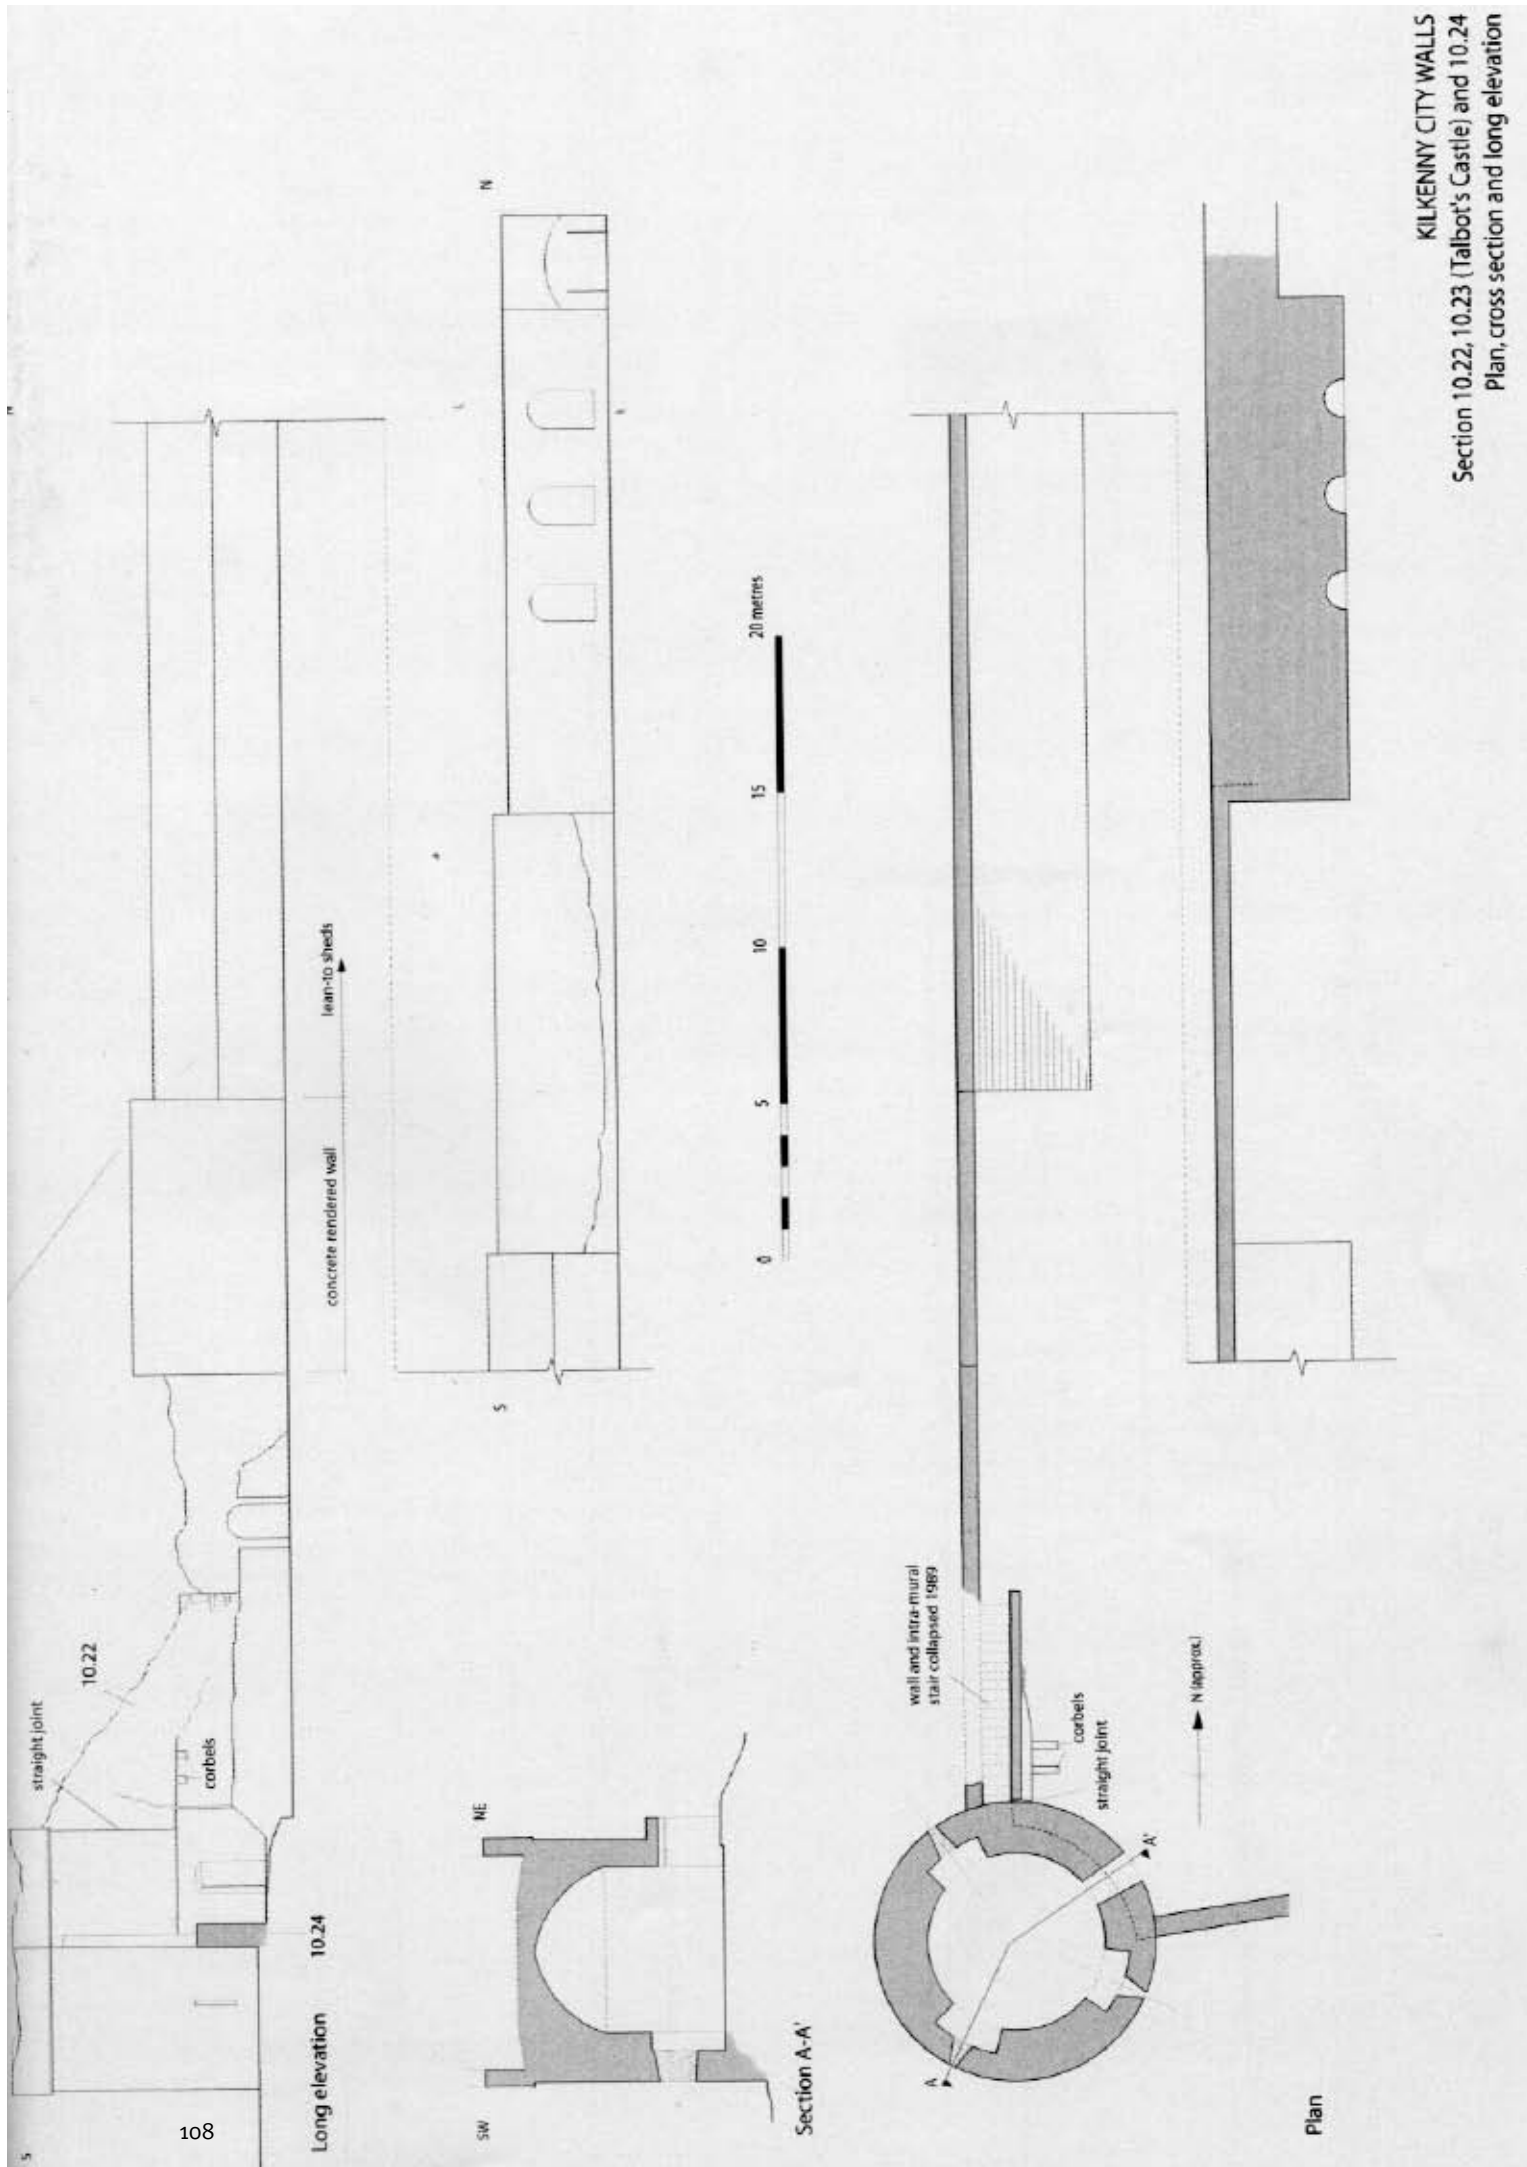
KILKENNY CITY WALLS
 Section 10.22, 10.23 (Talbot's Castle) and 10.24
 Plan, cross section and long elevation

The tower is located in the angle of Ormonde Road and Lower New Street. It formed the south-west angle of the city's defensive wall, which returns east at an acute angle. Talbot's Castle represents the most complete defensive feature of the city circuit, comprising a circular tower standing to a maximum height of 9.7m, 5.58m in diameter internally, with walls 1.65m thick. There is open space east and west of the tower, while to the south, the tower is abutted by the back yards of three houses (Nos 12-14 Ormonde Road), which date from c. 1860, unless they are the buildings that were present in 1841.

- Detailed survey and analysis of surviving fabric. Investigation of relationship to adjacent structures. [Policy 14]
- Careful maintenance of vegetation, and removal of unsuitable woody species (ivy, sycamore, elder). [Policies 9, 11]
- Establishment of maintenance regime. [Policy 11]
- Monitoring of condition of fabric to determine any need for repairs. [Policy 11]
- Careful recovery and investigation of collapsed fabric. [Policy 12]
- Rebuilding of steps to top of tower, and consideration to re-creation of wall-walk. [Policy 18]
- Archaeological record of any alterations or maintenance works. [Policy 15]
- Consideration of best means of presenting the site (external and internal access, opening vistas and spaces, information and display) as a key element of the Kilkenny defences, and in relation to adjacent wall sections. [Policies 19-22]

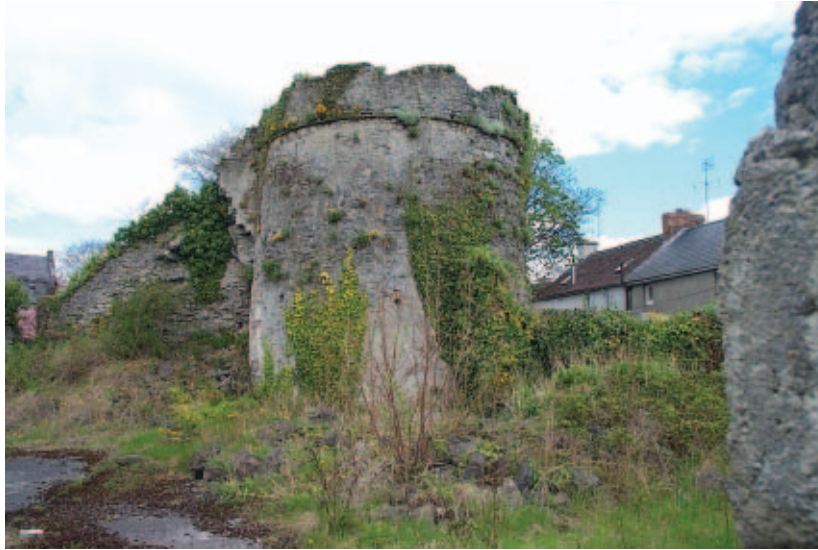
Talbot's Castle forms the south-western corner of the Hightown defended circuit and represents the only surviving complete defensive tower of the City Wall circuit. The architectural style of the tower and form of the three surviving embrasures suggest a construction date of the late 13th or early 14th century.

Plate 12: Talbot's Castle from the south-west (May 2001)

Access to the ground floor is through a single doorway with segmental head on the north-east side. Above the level of the doorway, the face of the tower in this sector (*i.e.* its north-east quadrant) is reduced in width to form a 0.75m offset. The level of this offset relates to two surviving corbels within Section 10.22 (Figure 12), presumably reflecting the level of an original internal wall walk, which was thus carried round the exterior of the tower between the west and the south curtains.

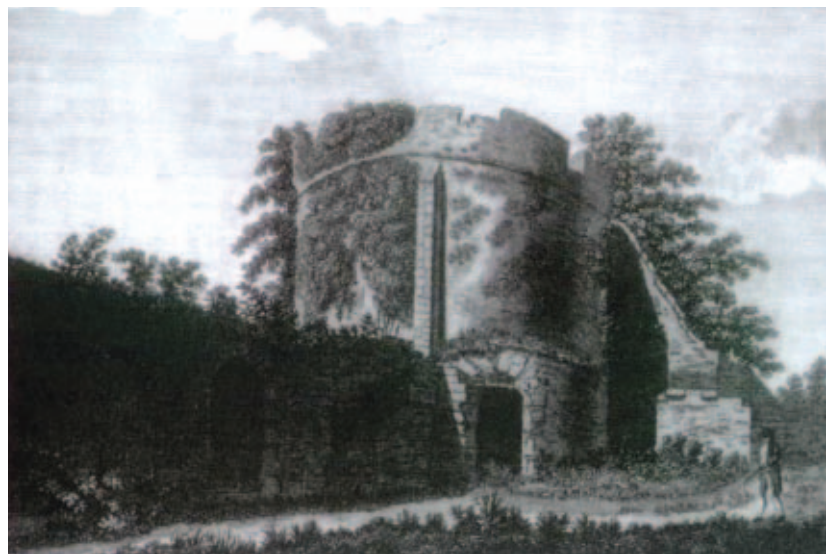
Plate 13: Grose's engraving of 'Bastion in Kilkenny' from an engraving in his *Antiquities of Ireland*, 1791

The walls of Hightown were begun in the mid 13th century, and this corner would have been part of the main circuit. This part of the walls was shown standing entire on Rocque's 1758 map. By the time of the OS 1841 map, the new Ormonde Road had been cut through the walls just to the east of the tower. The engraving of Talbot's Castle in 1791 by Francis Grose indicates a doorway within this section of wall.

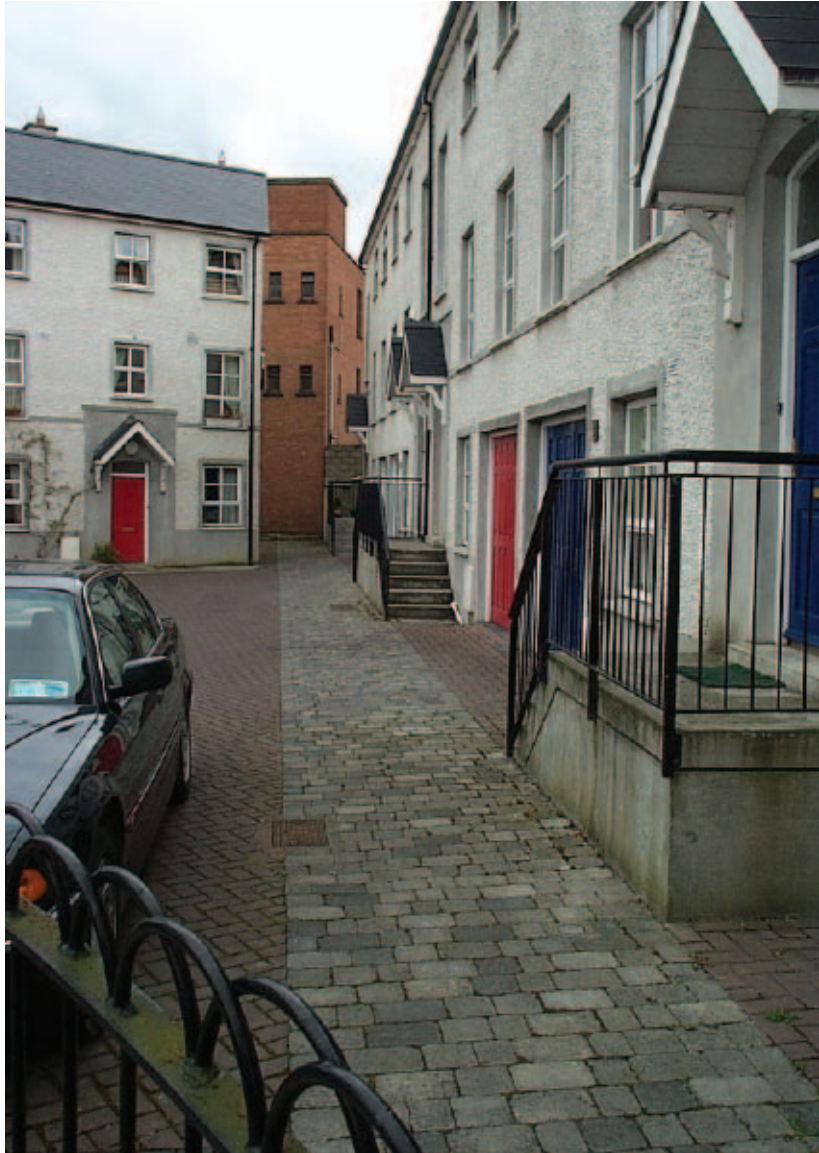
Plate 14: Line of City Wall delineated in grey stone paviours, Ormonde Road (May 2001)

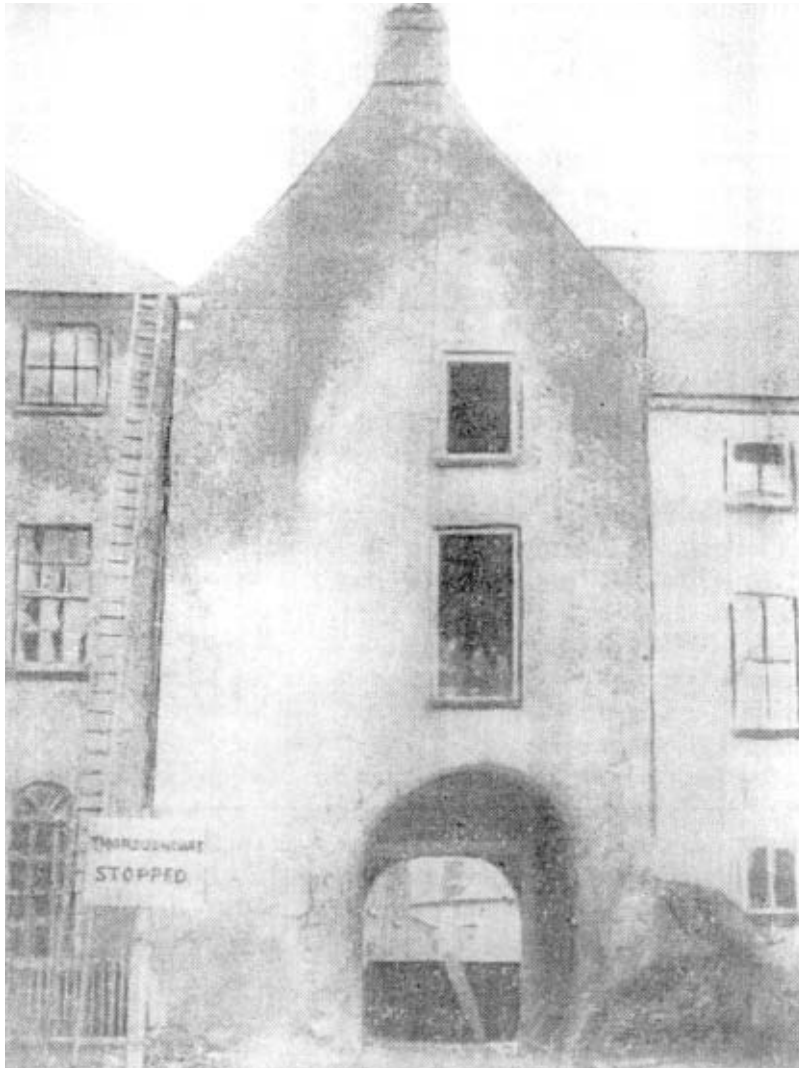
Plate 15: St Patrick's Gate, c. 1895

Judging from the photograph (Plate 15), the gate had a wide gate placed off-centre, and two storeys above with a gabled roof containing a chimney stack. While this may have contained medieval fabric, it certainly has more the appearance of a 17th-century domestic building, though it no longer retained evidence of the 'corbel towers'.

The condition of any buried remains is uncertain.

- Survey and investigation to determine the extent of any remains. [Policy 15]
- Protection of below-ground remains of the defences. (The site of the gate should be noted in mapping of services, with appropriate archaeological watching briefs undertaken in works on the road or services.) [Policies 6, 7, 15]
- Marking out or signalling of lost features in the roadway. [Policy 20]

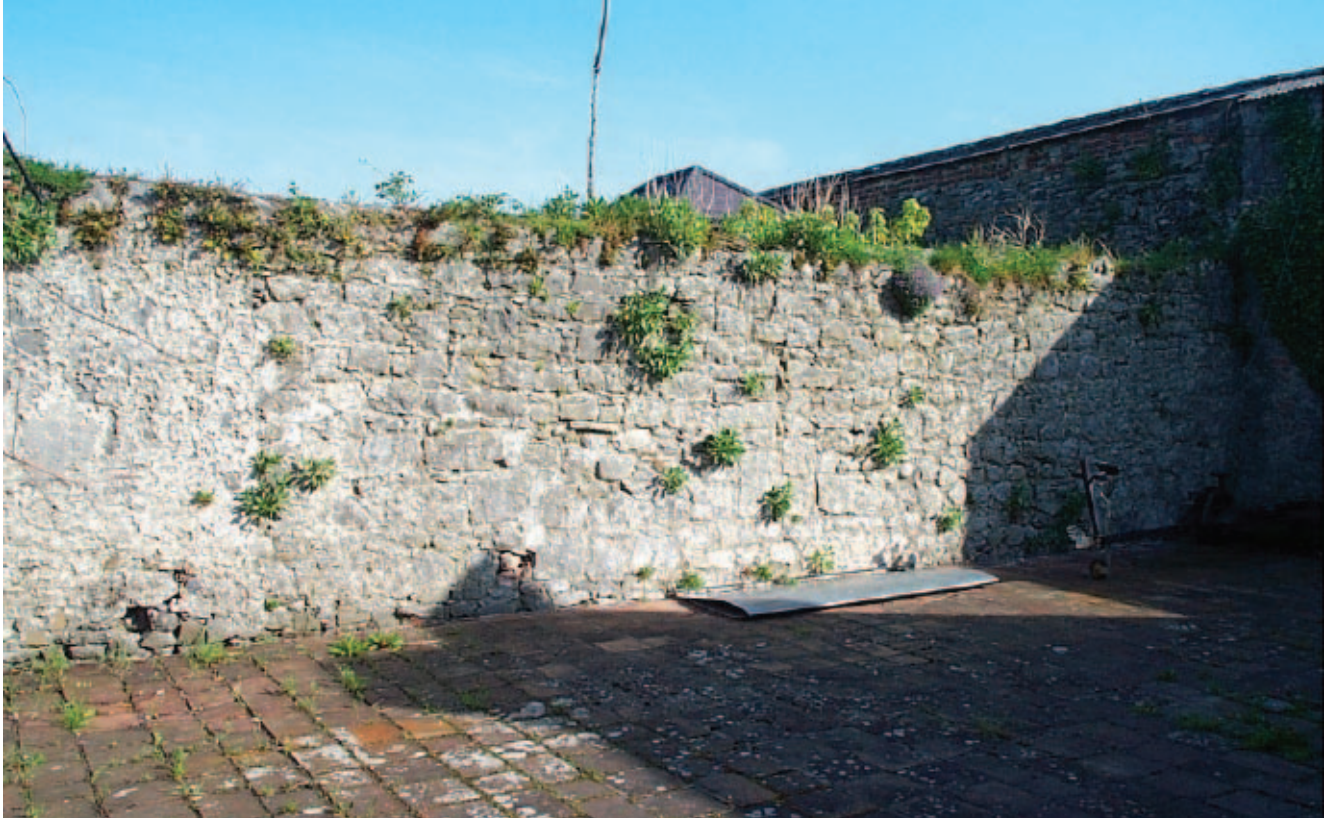
The masonry is of roughly dressed and coursed angular grey limestone blocks. A single vertical loop is visible on the external elevation of the wall, measuring 1.25m tall by 0.08m wide. The loop is not visible to the internal face of the wall where it is obscured by the raised ground level.

Plate 17: City Wall viewed from the south-east (exterior) (May 2001)

- Detailed survey and analysis of surviving fabric. [Policy 14]
- Careful maintenance of vegetation growth on wall (removal of unsuitable woody species). [Policies 9, 11]
- Monitoring of condition of fabric to determine any need for repairs. [Policy 11]
- Establishment of maintenance regime. [Policy 11]
- Archaeological record of any alterations or maintenance works. [Policy 15]
- Consideration of display and access. [Policies 19, 20]

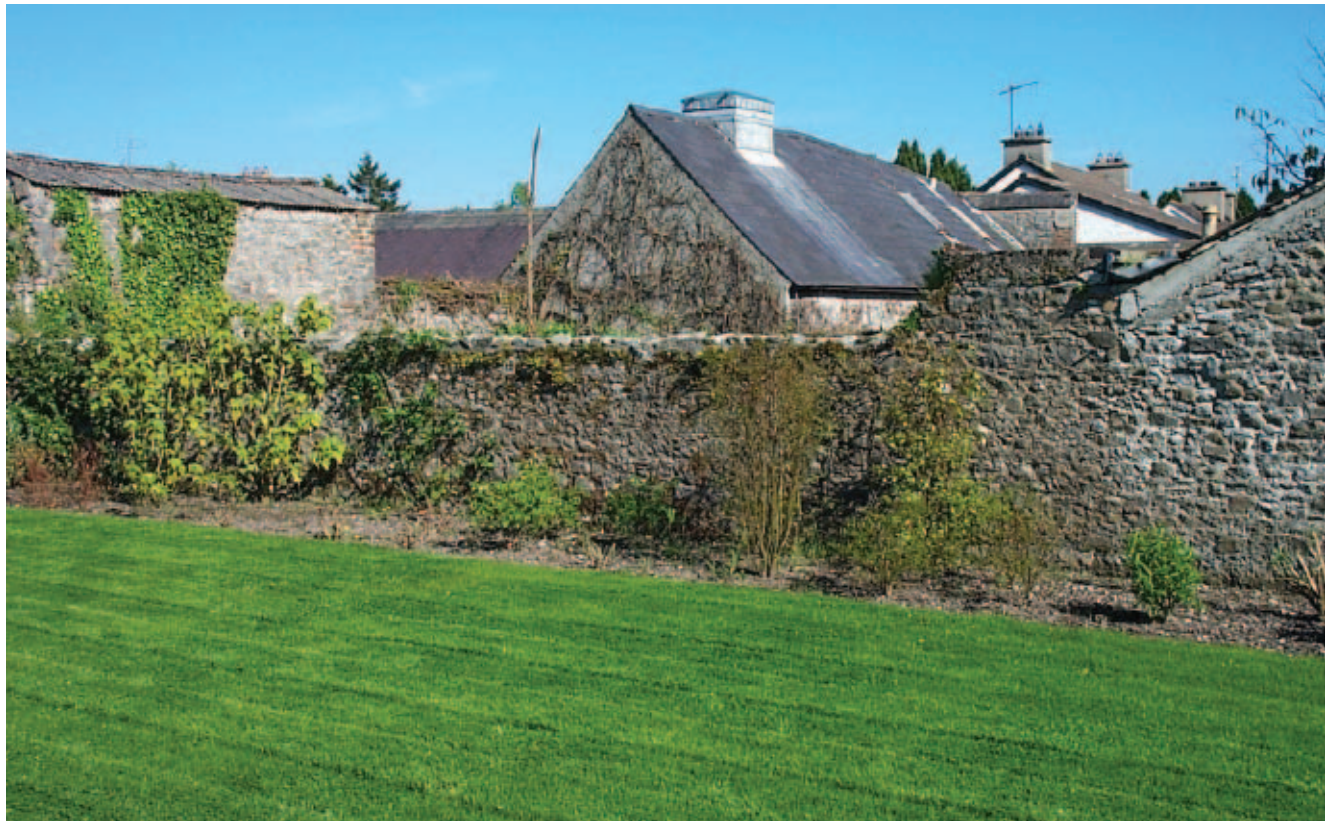
Plate 18: City Wall viewed from the north-west (interior) (May 2001)

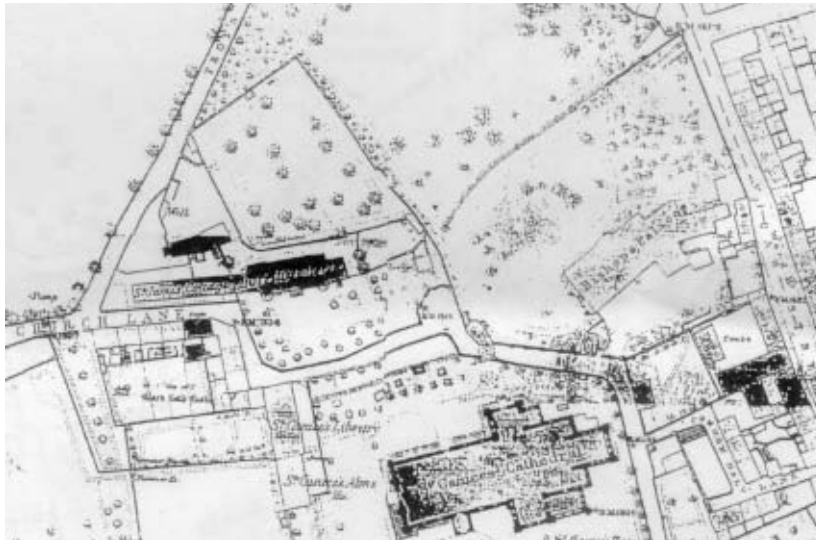
Plate 20: OS 1871 Town Plan showing garden of the Bishop's Palace following the removal of the town wall

The defences of Irishtown are known from a murage grant (to Hightown) in 1377, and a further grant in 1384 (*Liber Primus*, 41, 44). Irishtown is shown as walled on the Down Survey of c. 1655 (Bradley 2000c Map 4), but only one gate (Troy's Gate) is shown on Rocque's 1758 map (*ibid.*, 14). The garden wall of the Bishop's Palace along Drysdal's Lane is shown on Rocque as well as the OS 1841 manuscript plan; it may represent remains of a wall, though none was recognised on the OS 1841 manuscript town plan. It had been removed by the time of the printed OS 1871 plan (Plate 20) to form an extension to the gardens, but the line remained.

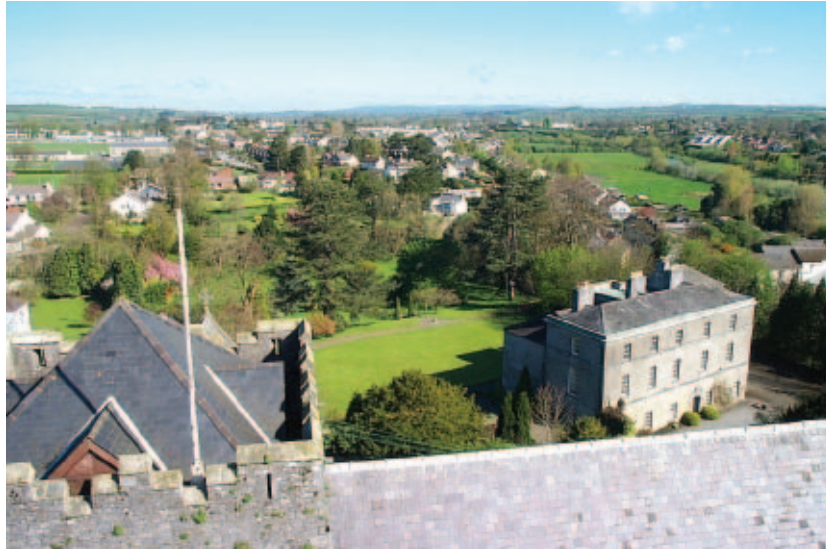
Plate 21: Bishop's Palace and Gardens: view from the top of St Canice's Round Tower (May 2001)

The earlier garden boundary would be the most natural course for a line of defence from Troy's Gate to the Cathedral Precinct, and may in part coincide with an early medieval ecclesiastical enclosure. It is today marked by a slight change of slope in the garden, while the final length of wall may still survive in the lower part of the west garden wall. A geographical survey in the area of the former Bishop's Palace Gardens was carried out early in 2005. A linear trend was noted at this point, marked by the change of slope in the garden. This may represent the remains of the city wall.

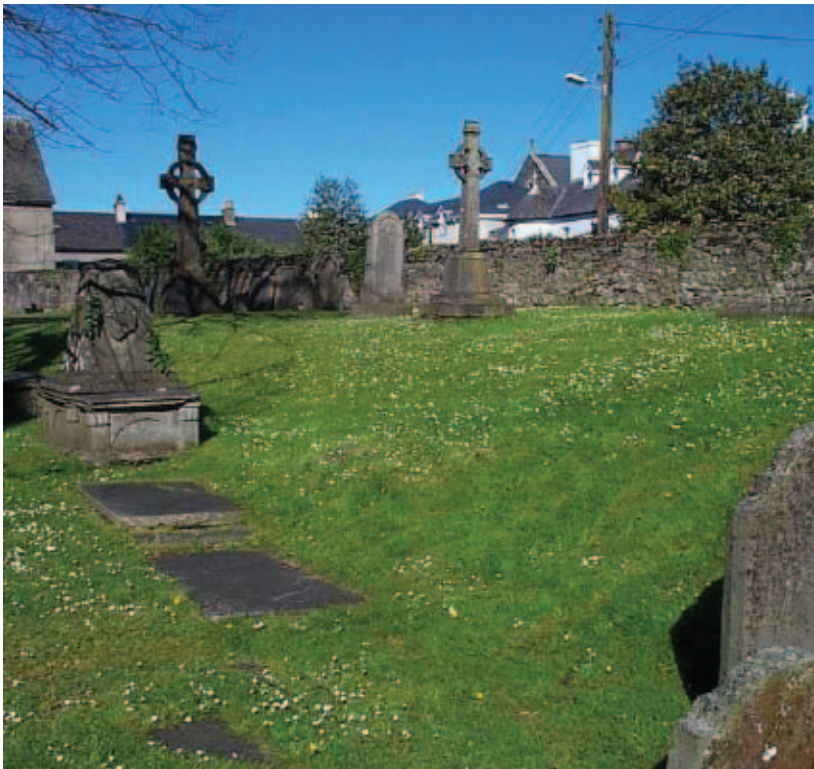
Plate 22: City Wall and related earthen rampart enclosing north side of St Canice's Churchyard (May 2001)

This section of standing wall, surviving to a maximum length of 44m, forms the northern retaining wall of the churchyard of St Canice's Cathedral (Plate 22). The visible section of wall is 0.4m wide and stands to a maximum visible height of 1.25m to the interior (graveyard side), though it stands considerably taller (3.42m) to the north where it overlooks Church Lane. Internally, the lower part of the wall is obscured by an earthwork rampart which stands 1.6m high x 8m deep (5m platform + 3m scarp). A number of mid-late 19th-century funerary monuments indicate that the body of the rampart has been used for interment, while a number of memorial stones have been built into the masonry of the wall. The wall is constructed of roughly dressed grey limestone, roughly coursed. Towards the western end of the wall, two phases of construction can be discerned – the lower part being of small rounded stones, while the upper part is in larger roughly dressed angular limestone blocks. At the extreme western end, the wall and rampart have been truncated by the construction of the Cathedral Library.

The built fabric is in reasonable condition.

- Survey or investigation to determine extent of any remains, and the age and form of the rampart. [Policies 14, 15]
- On-site display or explanation of the significance of the structure. [Policy 21]

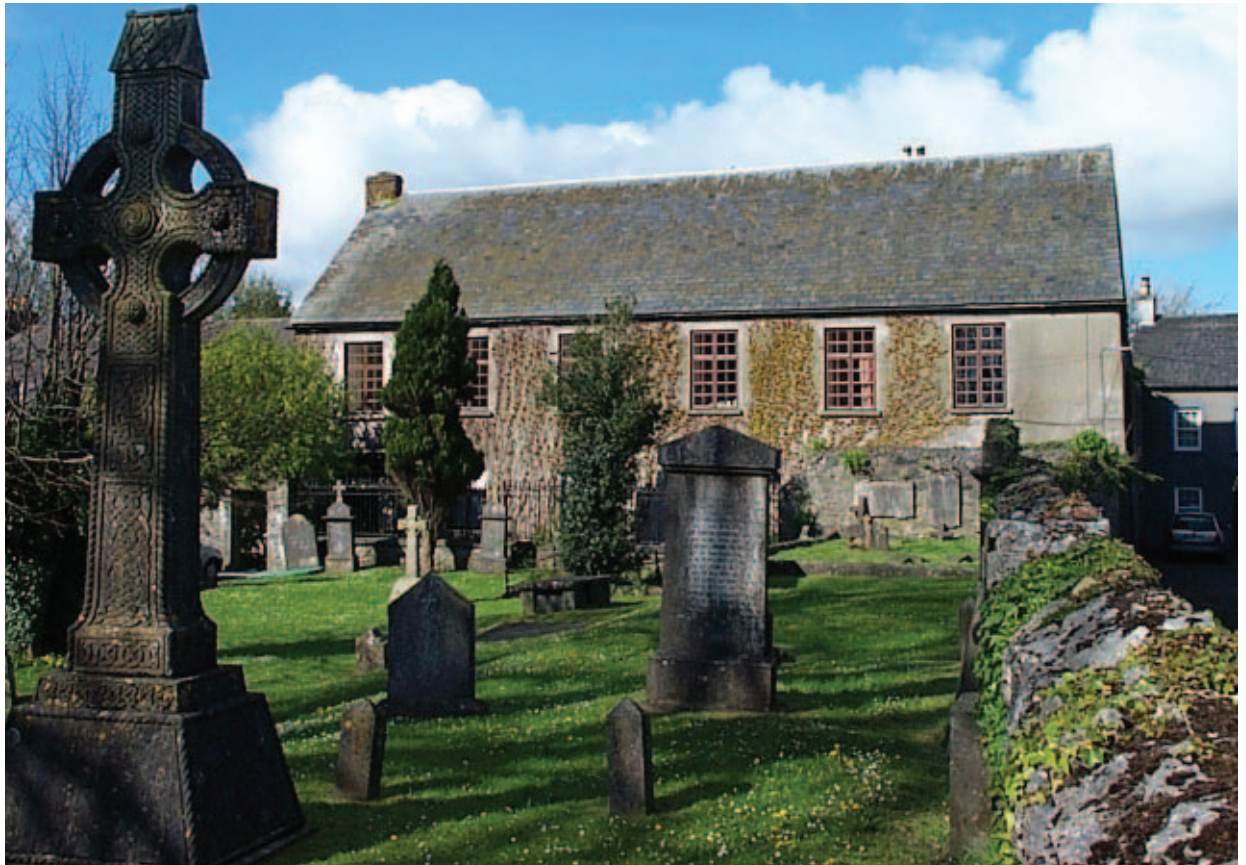
Plate 23: St Canice's Library, built against the defences on the west side of the churchyard

Although the course and history of the walls of Irishtown are not well established, they probably existed from the late 14th century. The north and west sides of the cathedral churchyard appear to have formed part of the defensive line, and the 17th-century Cathedral Library (Plate 23) occupies the site of a medieval prebendal house, 'Black Rath's Castle'.

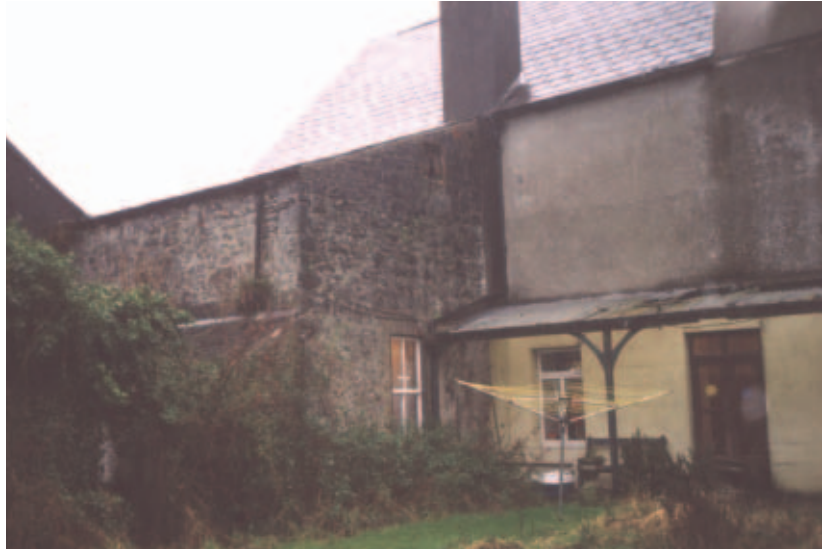
Plate 24: The exterior of Black Rath's Castle

Substantial remains of a medieval tower *c.* 5m square on the outside of the wall stand at the north-west corner of the churchyard behind the library (previously used as a garage). The lower stage is reached through a pointed arch from the kitchen of the ground-floor apartment below the library. It has thick walls and a stone-vaulted ceiling still bearing the marks of the wattle shuttering (Plate 25), but the openings in each of the outer walls are all modern. A mural stair rises in the thickness of the library wall (*i.e.* the town wall), turning at the top. The upper stage has been truncated down to a small space beneath a sloping slate roof, and is now inaccessible except from a small window opening in the south wall. No features relating to the tower can now be seen inside the library, but may survive behind the bookcases and wall plaster.

The built fabric is in reasonable condition.

- Detailed survey and analysis of surviving fabric. [Policy 14]
- Monitoring of condition of fabric to determine any need for repairs. [Policy 11]
- Establishment of maintenance regime. [Policy 11]
- Archaeological record of any alterations or maintenance works. [Policy 15]
- Consideration of future display and access. [Policies 19-21]

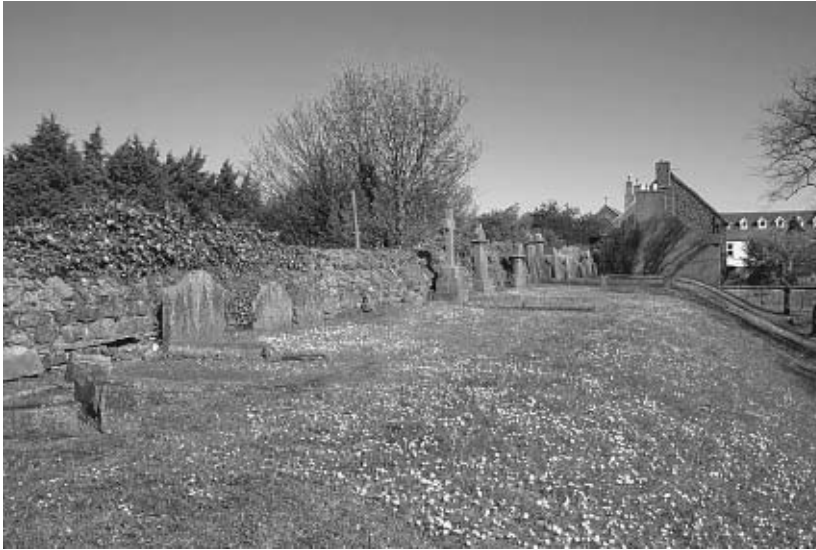
Plate 26: Earthen rampart behind western section of City Wall bounding St Canice's Cathedral Yard (May 2001)

This section of standing wall, surviving to a maximum length of 48m, forms the western retaining wall of the churchyard of St Canice's Cathedral (Plate 26). The wall stands to a height of 1.1m to the interior (graveyard side), though it stands considerably taller (4.5m) to the west where it forms the rear wall of the gardens to properties fronting onto St Thomas's Square. Internally, the lower part of the wall is obscured by a well-defined earthwork rampart which stands 2.2m high x 9.2m deep (4.5m platform + 4.7m scarp). The rampart is more clearly defined than that to the north (Section 11.5, St Canice's Churchyard [N]). A number of 19th- and 20th-century burials have been dug into the body of the rampart, marked by a series of funerary monuments set against, though not into, the masonry of the wall. The wall is constructed of roughly dressed and coursed angular grey limestone blocks. At the northern end, the earthwork rampart has probably been truncated for the construction of the library (Section 11.6, St Canice's Library). It is possible that the masonry of the wall continues as the rear wall of the Poor House. Likewise to the south, it is possible that the masonry of the city wall is incorporated into the rear wall of the Deanery stables.

The built fabric is in reasonable condition.

- Survey or investigation to determine extent of any remains, and the age and form of the rampart. [Policy 15]
- On-site display or explanation of the significance of the structure. [Policy 20]

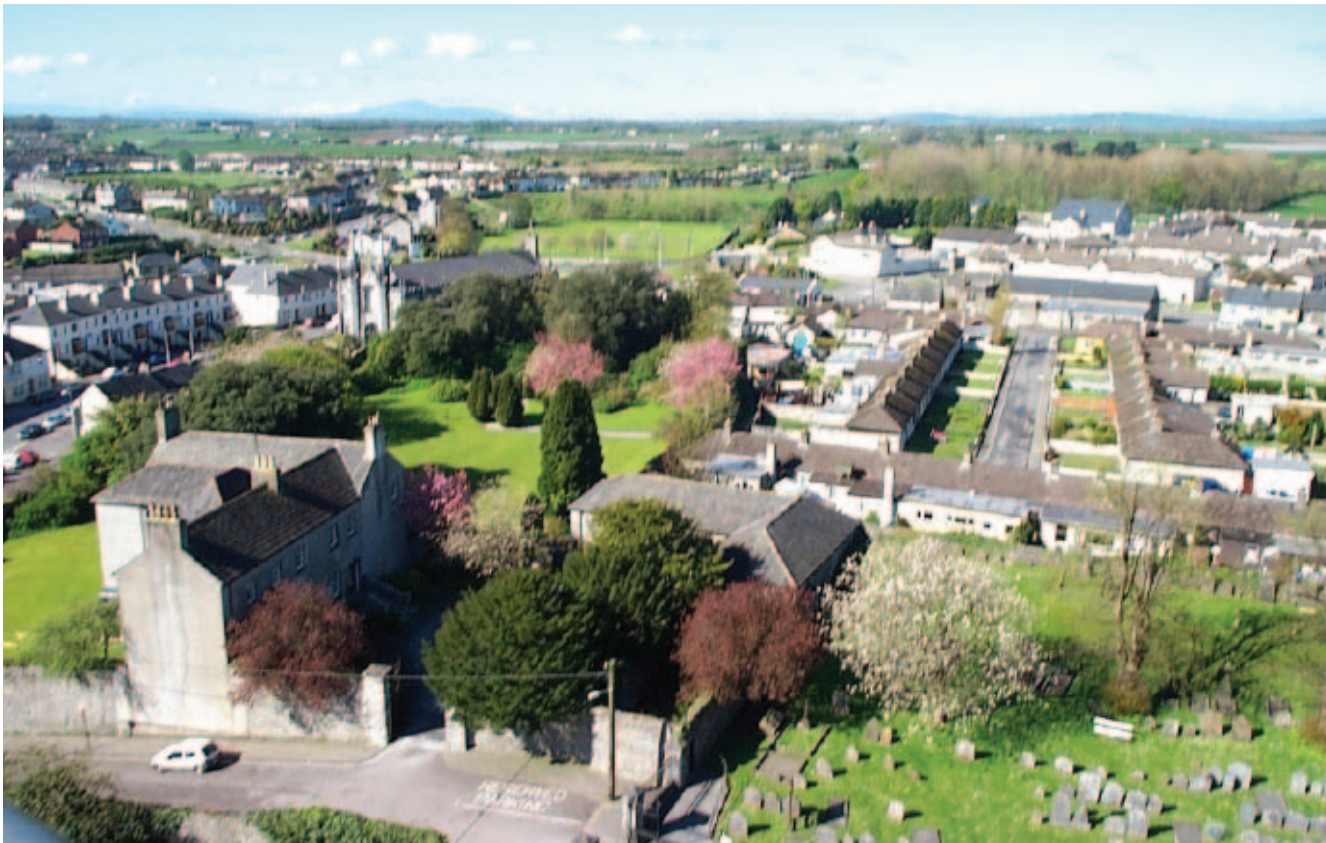
Plate 27: The Deanery and Garden from the top of St Canice's Round Tower (May 2001)

Although the course and history of the walls of Irishtown are not well established, they probably existed from the late 14th century. The line along the west side of the cathedral churchyard probably continued through the Deanery Garden towards Dean's Gate (Plate 27).

The defences of Irishtown are known from a murage grant (to Hightown) in 1377, and a further grant in 1384 (*Liber Primus*, 41, 44). Irishtown is shown as walled (with one tower) on the Down Survey of c. 1655 (Bradley, 2000c, Map 4). The line of defences around the cathedral churchyard seems to have continued and formed the back of the Deanery coach house, though the building of the Georgian Deanery and the creation of its garden (as shown on Rocque's 1758 map) would have removed any traces of the wall.

- Surveys or investigations to determine the extent of any remains of the defences around Irishtown (and not necessarily on the currently assumed alignment). [Policy 15]
- Protection of below-ground remains of the defences. [Policy 6]
- Future development to respect the line of the wall. [Policy 18]

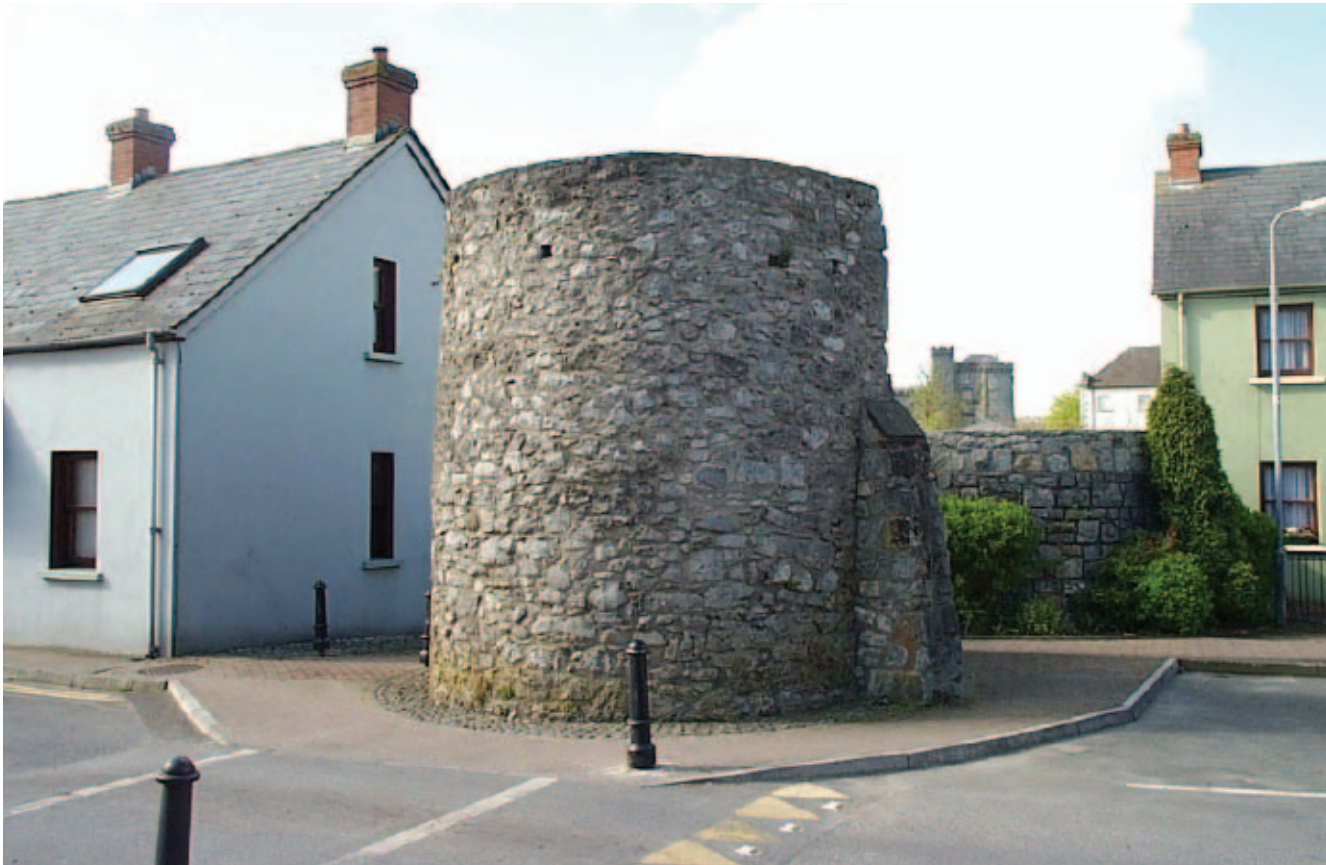
Plate 30: Corner tower from the north-east (May 2001)

Situated on Maudlin Street, this structure was at the outer corner of a garden wall, and would represent the north-east corner of a wall enclosing the lower part of the St John's suburb (Plate 30). Its overall dimensions are about 4m tall, and 2.2m in diameter, with walls 0.3m thick, and an open back towards the former garden (with short lengths of the connecting walls). There is an offset for a 'parapet', with a single row of slots at its base (probably for water run-off). Internally, there are indications of five blocked windows (or perhaps gunports) at 1.7m above ground level, and 0.5 m square. It may well be of 16th-century date.

The tower is in reasonable condition, though it has been repointed in an unsympathetic manner.

- Detailed survey and analysis of surviving fabric. [Policy 14]
- Careful maintenance of vegetation growth on wall (removal of unsuitable woody species). [Policies 9,11]
- Monitoring of condition of fabric to determine any need for repairs. [Policy 11]
- Establishment of maintenance regime. [Policy 11]
- Archaeological record of any alterations or maintenance works. [Policy 15]
- Consideration of display and access. [Policy 19]
- Marking out of lost features in paving. [Policy 20]
