KILKENNY CITY WALLS CONSERVATION PLAN

Oxford Archaeology

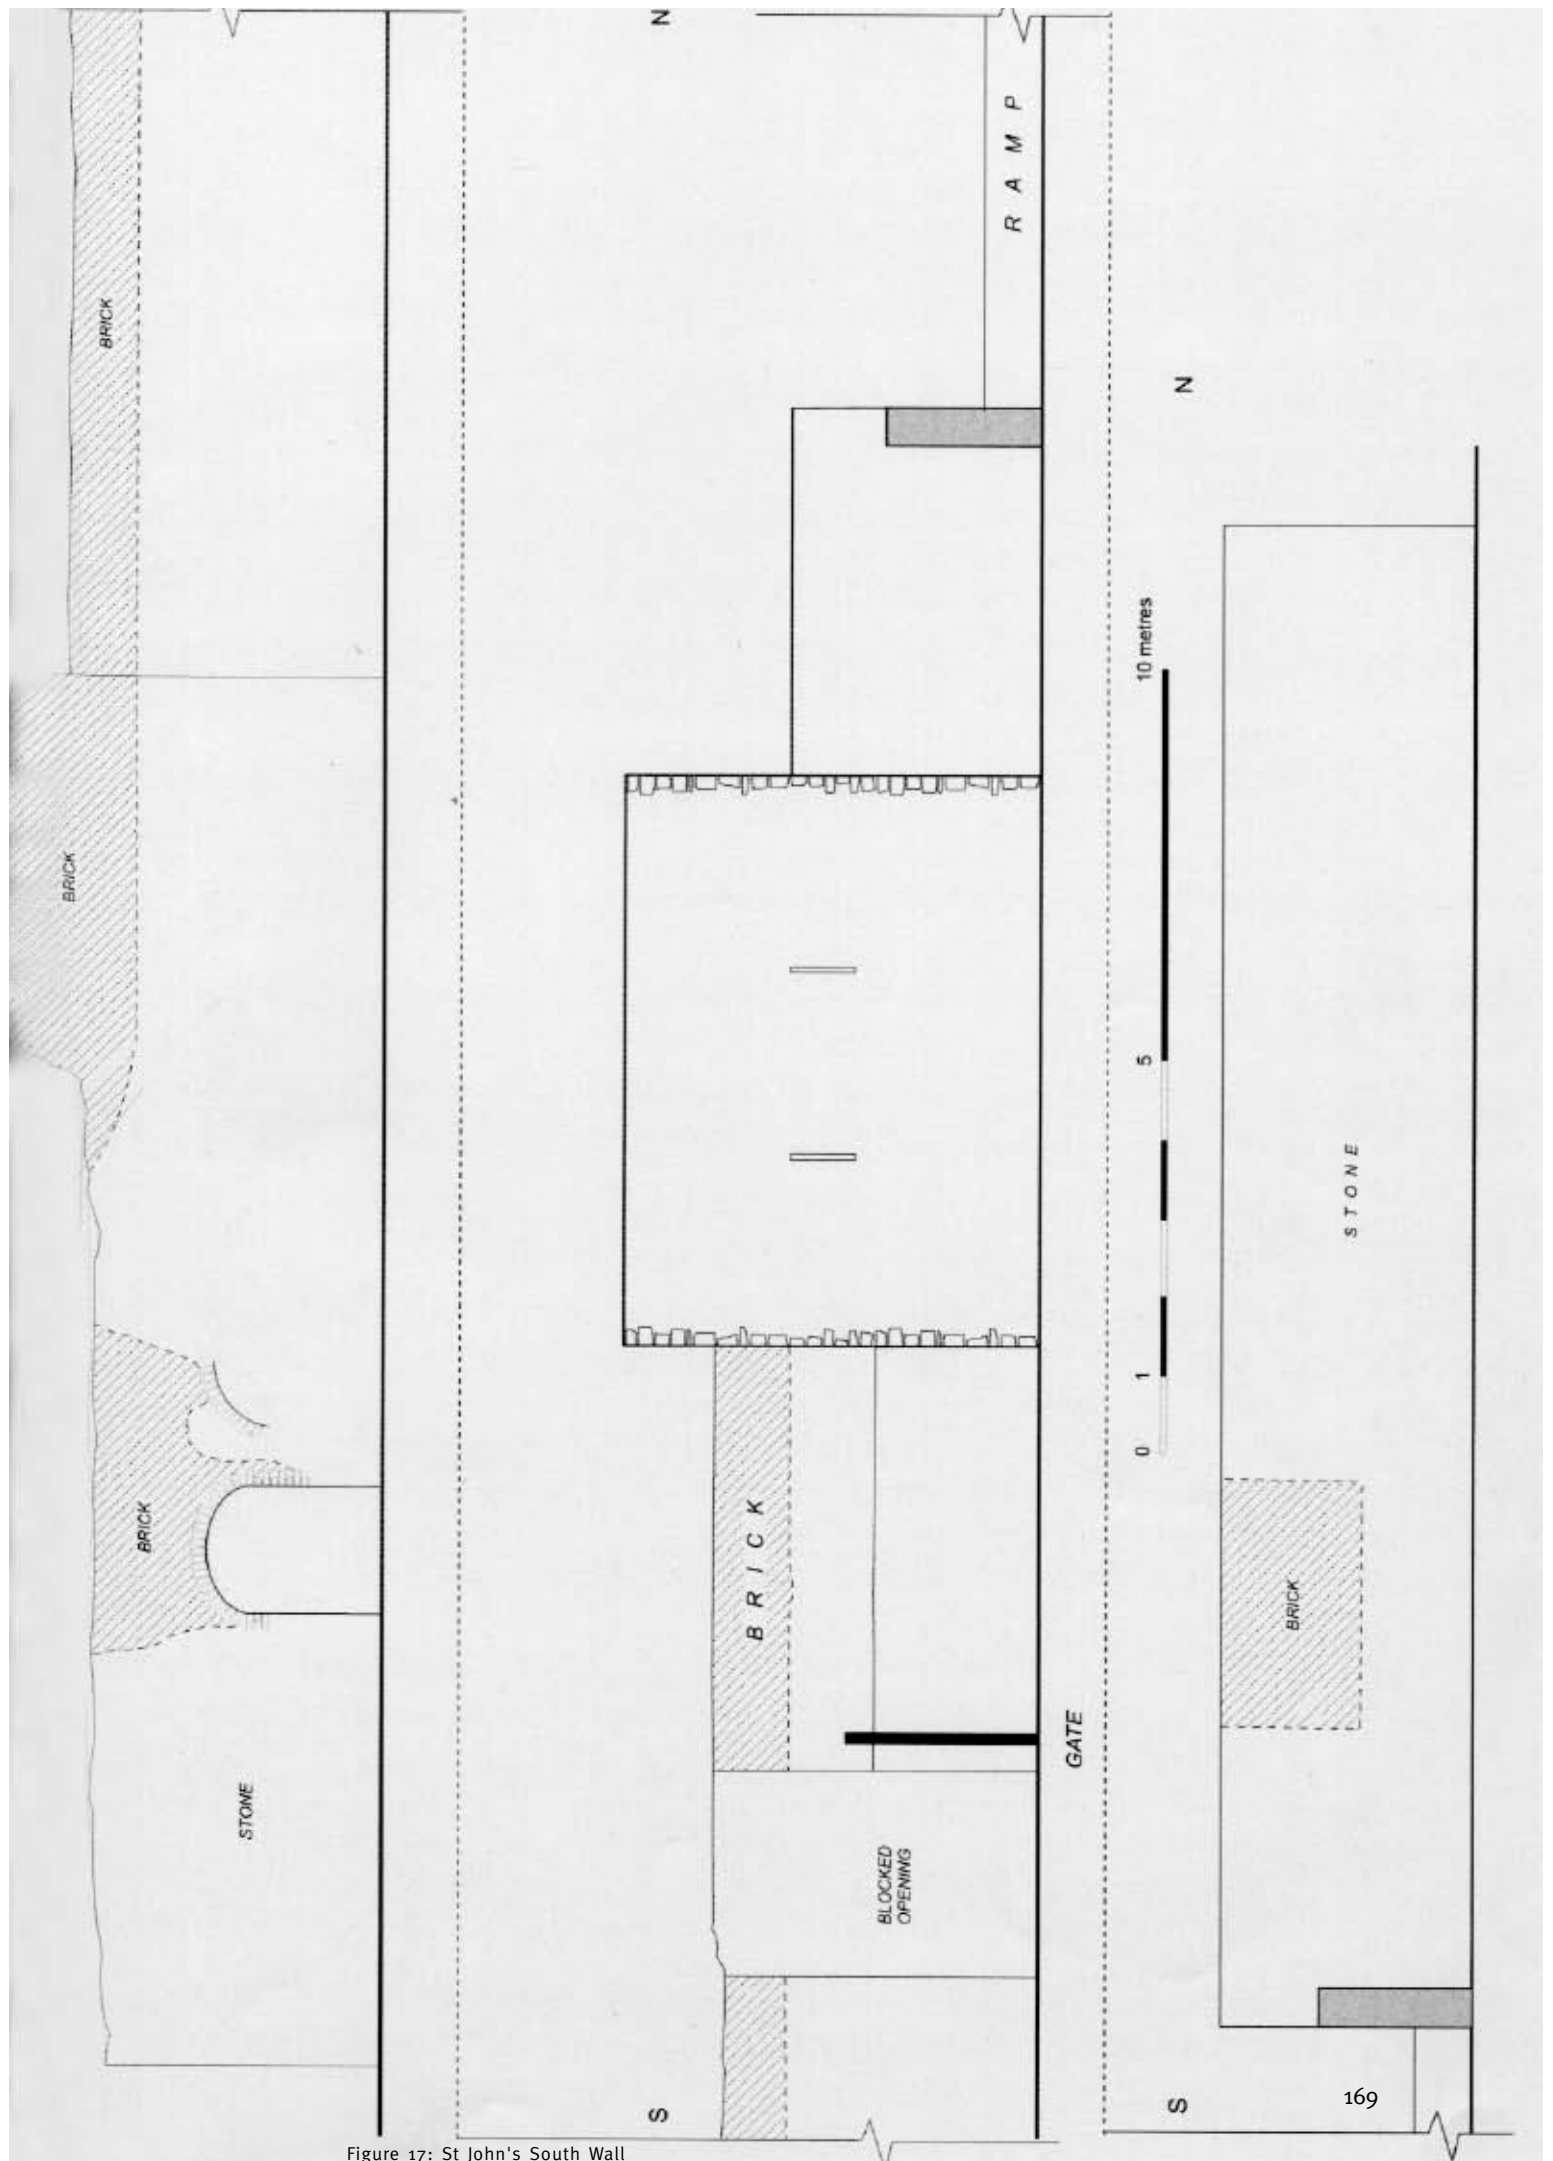
Figure 17: St John's South Wall

There is a continuous rubble stone wall for most of this section. Part survives in the carpark of Langton's Bar, where the ramp across the line of the wall demonstrates the difference in height between the ground inside and outside the wall (Figure 17). To the south of this, a higher length of wall contains two loops, though this has the appearance of being a post-medieval rebuilding of an individual structure (a building inside the wall), perhaps as a garden feature. Further south, the wall is rebuilt with a brick top and has several post-medieval features, but may be medieval at the base.

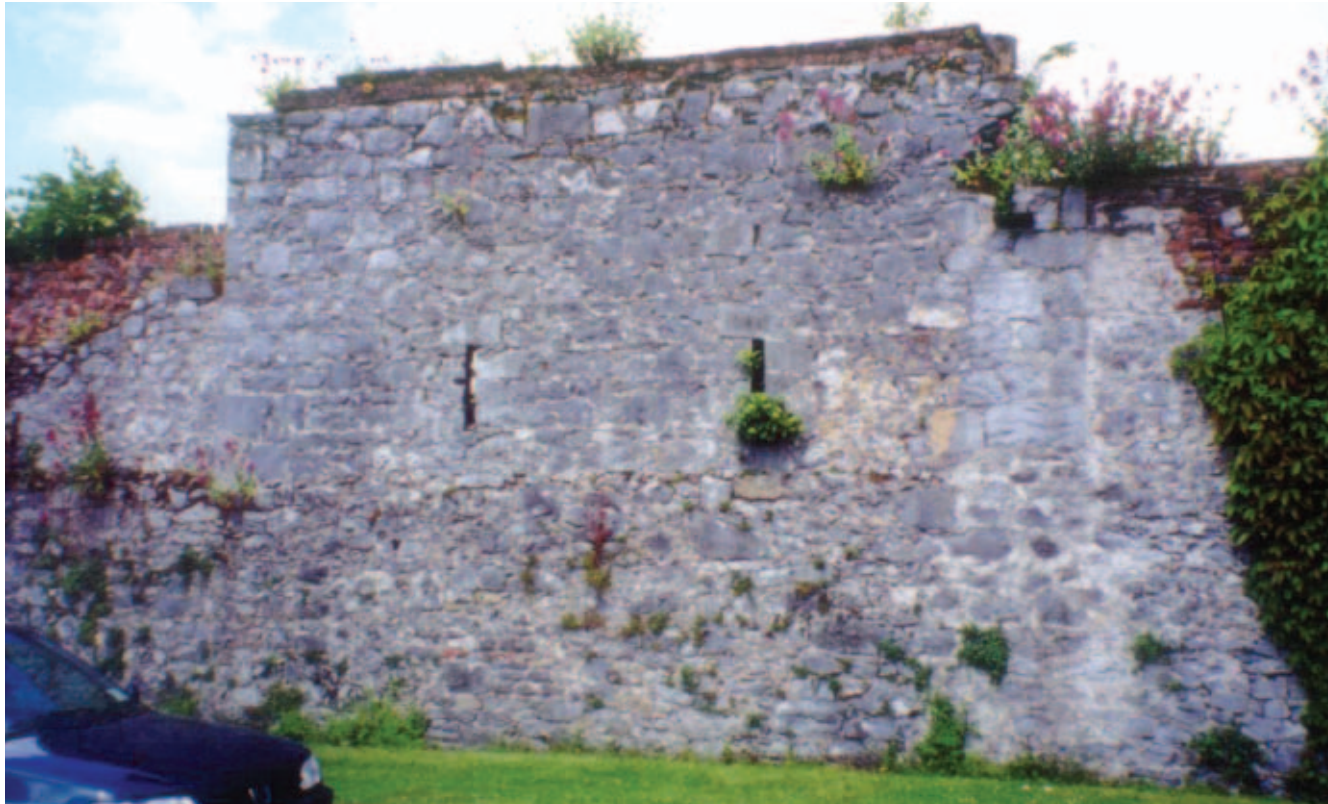
Plate 31: Section of wall displaying two loops, located to south of Langton's Bar (June 2001)

The surviving parts of the wall are in reasonable condition.

- Detailed survey and analysis of surviving fabric. [Policy 14]
- Careful maintenance of vegetation growth on wall (removal of unsuitable woody species). [Policies 9, 11]
- Monitoring of condition of fabric to determine any need for repairs. [Policy 11]
- Establishment of maintenance regime. [Policy 11]
- Archaeological record of any alterations or maintenance works. [Policy 15]
- Consideration of display and access. [Policies 19-21]

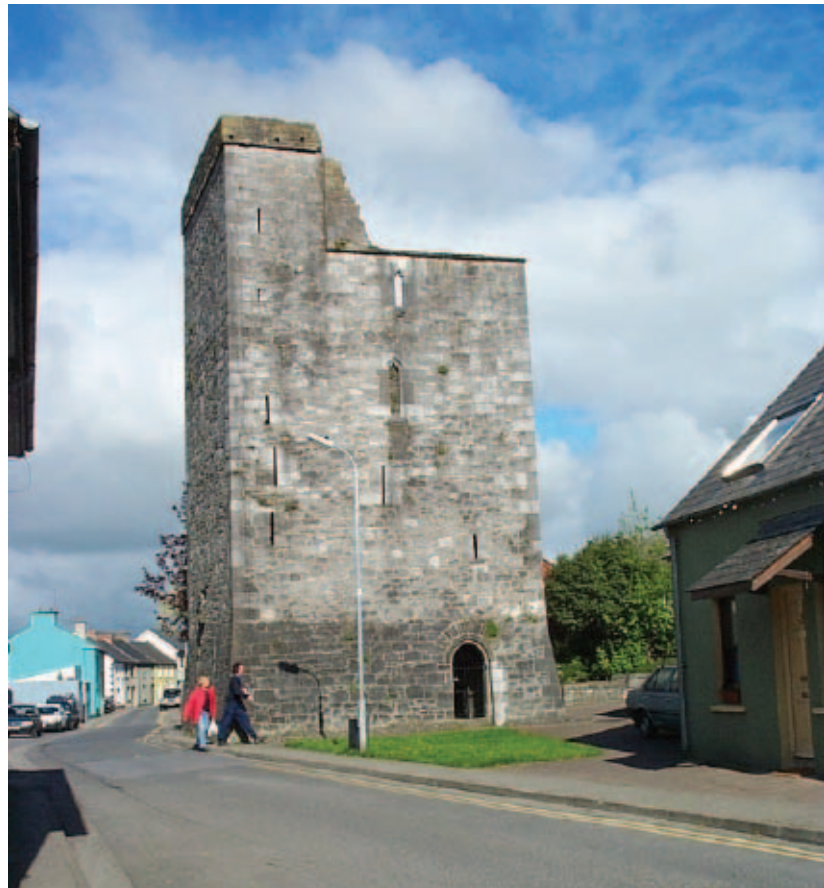
Plate 32: Maudlin Castle from the east (May 2001)

Maudlin Gate, associated with the tower house in Maudlin Street, gave additional protection to the suburb (Plate 32).

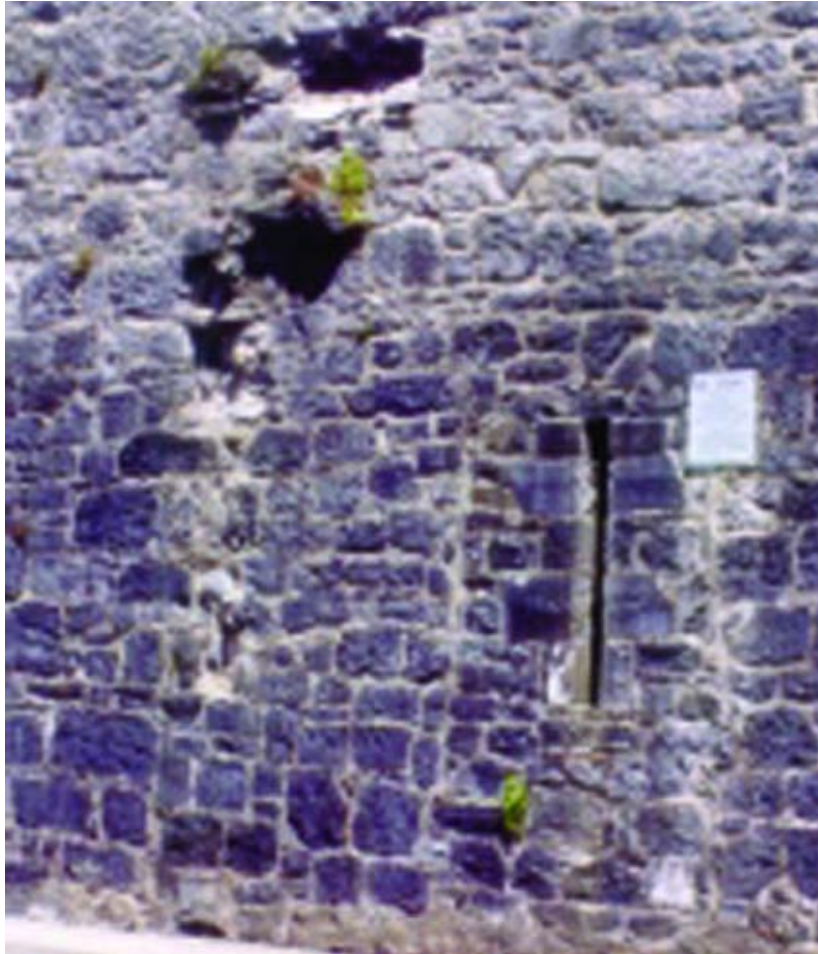
Plate 33: Scar in the south wall of Maudlin Castle, indicating the position of the attached gate (June 2001)

The south wall of the tower has the scar of a wall that formed the side of the gate (Plate 33). The gate, which may have formed the entrance into the hospital enclosure, is shown on Francis Place's view of Kilkenny in *c.* 1698 (Plate 29) and on a similar painting of Kilkenny from the same direction (Bradley 2000c, Pl. 2).
