TALBOT'S TOWER, KILKENNY:

EXCAVATIONS FOR THE CITY WALLS ARCHAEOLOGICAL PARK

Irish Walled Towns Day 22nd August 2010

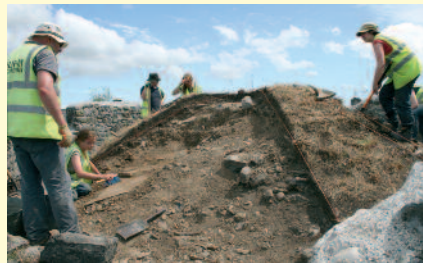
Excavations underway on the top of the roof of the tower

Below: The 'garden mound' on the roof of Talbot's tower before and after excavation

At the top of the tower was a 5m diameter 'pudding' shaped mound of clay which covered the medieval roof of the structure. When excavated it was found to have been put in place in the late eighteenth - early nineteenth century to cover a large gouge that had been made into the structure of the original fifteenth century roof of the tower. The sod layer which covered the mound contained a multitude of artefacts that showed how the top of Talbot's tower was used over the past two hundred years. Finds included fragments of Victorian wine bottles, clay tobacco-pipes, hair pins, lace-chapes and many ladies buttons all attest to the use of the roof as a place for particularly pleasurable types of recreation! Of interest also were a number of .303 bullets and cases, which may have been used by Free State forces against the Republican occupation of Kilkenny castle during the Irish Civil War.

The fifteenth century roof of the tower was basically a dome that was paved with fine stone flags. The flags had been robbed from the central dome of the roof, revealing the stone rubble core beneath. This was constructed using alternating layers of loose stone rubble and mortared masonry, probably to a thickness of c.0.75m – 1m.

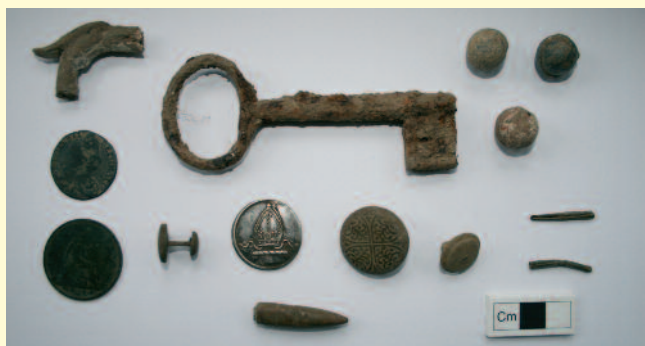
Nearly two-thousand artefacts have been found during the excavations. This is small selection of the finds from the 'garden mound'. Top left to right: birds head terminal, iron key, three musket balls. Middle left to right: Charles II coin, Victorian marble. Bottom left to right: 1868 penny, selection of buttons, lace-chapes, .303 bullet.

Musket shot and early twentieth century bullets from the 'garden mound'.

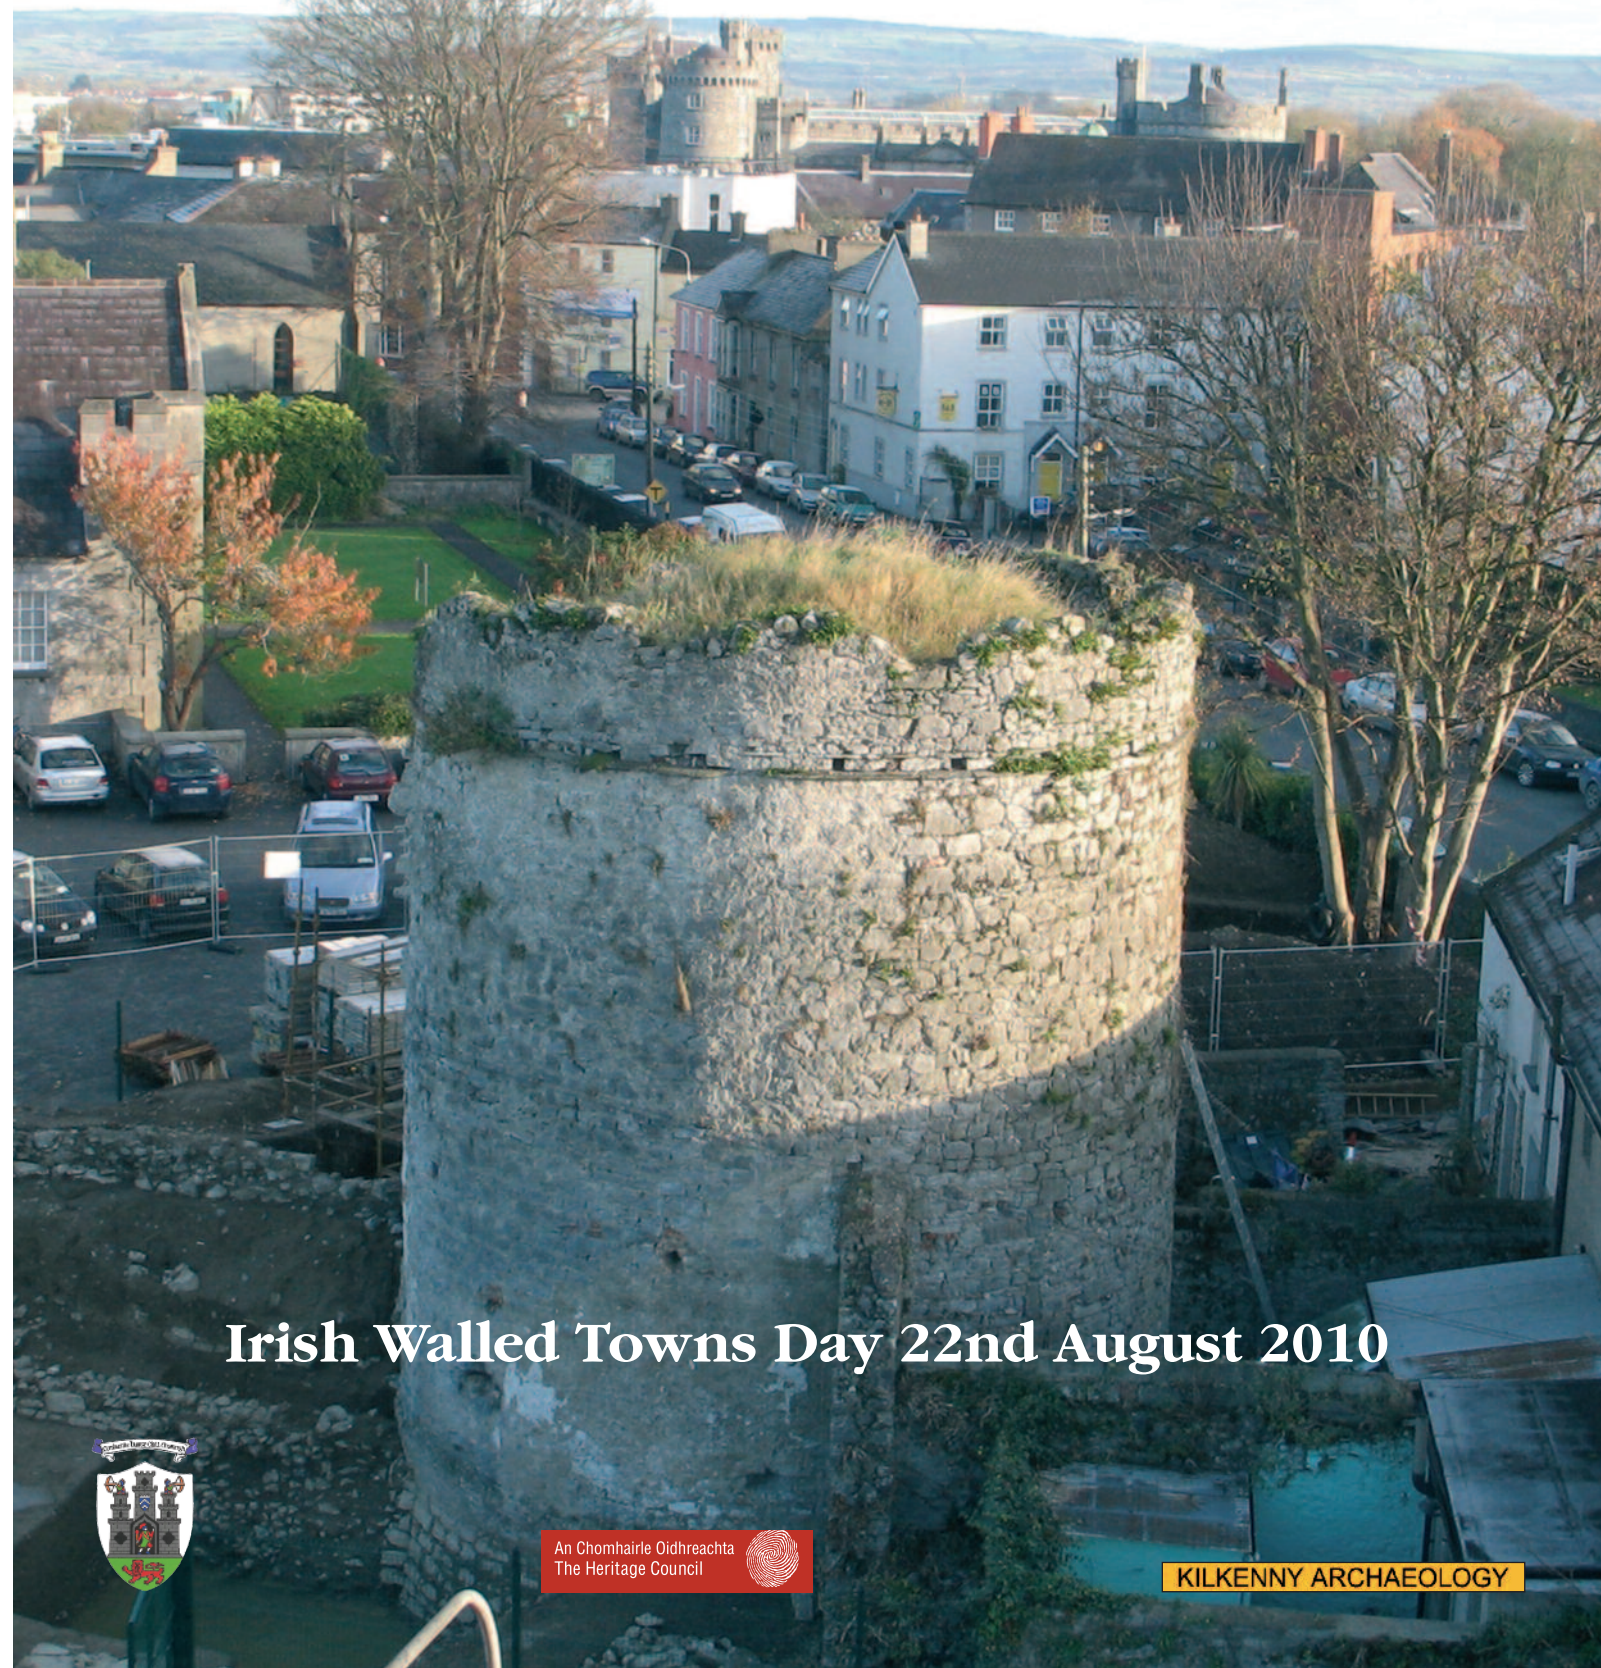
The map shows the town of Kilkenny, Ireland, with the River Nore flowing through it. The town walls are depicted as a series of connected points, with a red circle highlighting the location of Talbot's tower on the walls. The map includes various landmarks such as St. Mary's Church, St. John's Church, and the Talbot Tower. The River Nore flows through the town, with several bridges and gates marked. A legend in the bottom left corner explains the symbols used on the map.

By the year 1300 Kilkenny had reached the zenith of its medieval development and was Ireland's most important inland town. To defend the Anglo-Norman burgesses and protect their market-place walls were built around the town. This walled circuit included the boroughs of Irishtown and Hightown and the suburb of St. John's, and at over two miles in length it was the largest walled town in Ireland, larger than Dublin and comparable in size with York and Chester. A continuous stone wall 2m thick and 8m high encircled the town, seven gatehouses controlled the entry routes and nine look-out towers guarded over the hinterland. One of the most important of these was Talbot's tower.

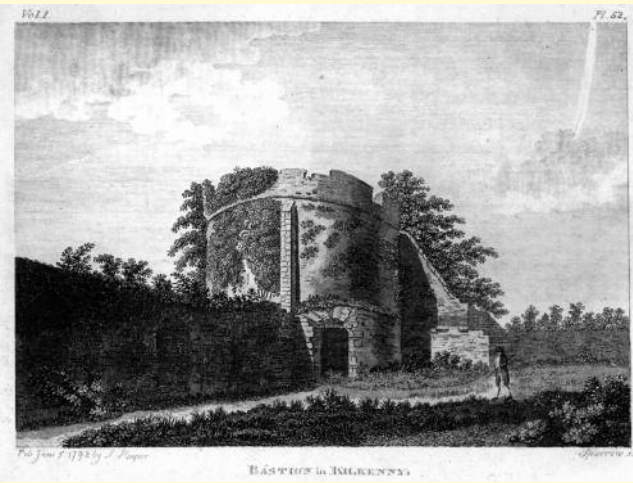
Daniel Grose's illustration of Talbot's tower which was published 1792 shows Talbot's tower from the east

Talbot's tower defended the south-west corner of Kilkenny's Hightown; the wall to the north extends for 850m as far as the river Breaghagh, that to the east for 350m to Kilkenny castle. The tower was strategically sited to take advantage of a low hill and from its parapets there are extensive views in all directions, making it an extremely effective watch-tower.

The tower stands to 9.7m height, is 5.6m diameter internally, and its walls which are 1.65m thick slope to the bottom of the town ditch. The structure that can be seen today is an amalgam of at least three different building episodes.

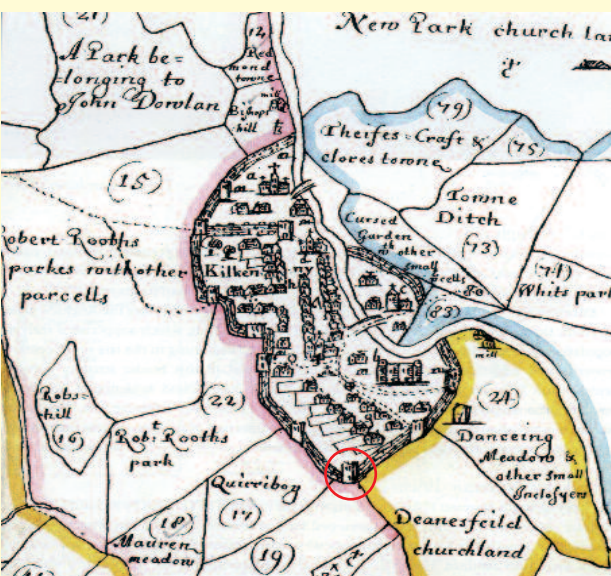
Talbot's tower on the 1654 Down Survey map

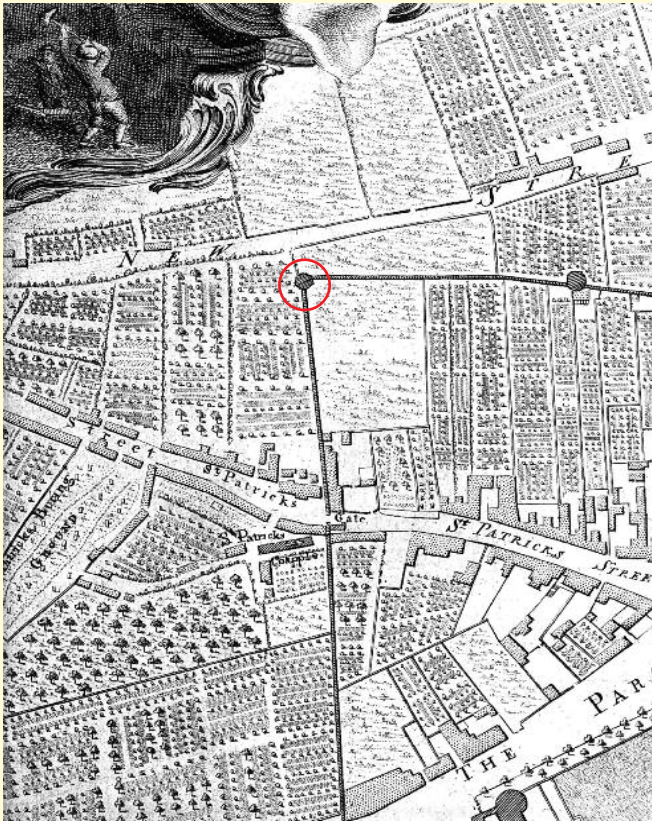
Talbot's tower marked on Rocque's map of Kilkenny 1758

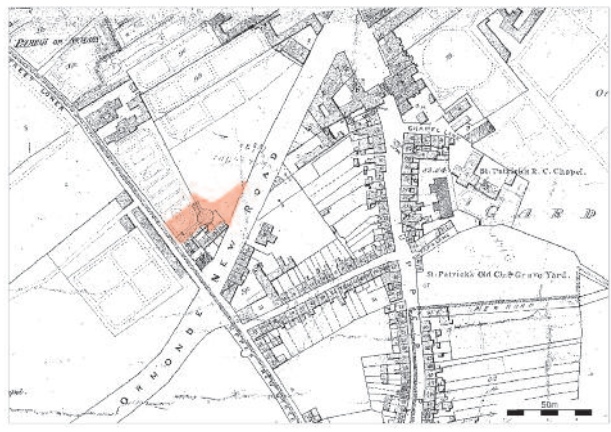
Talbot's tower on the 1872 Ordnance Survey map of Kilkenny

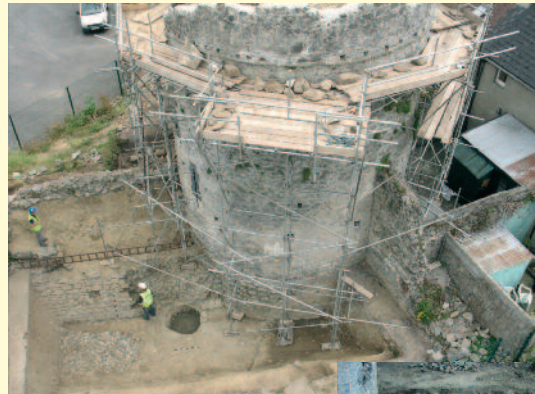
*Excavations in progress on the town ditch and rampart of Talbot's tower
(photo: Airshots Ltd.)*

A 10m long stretch of the town ditch outside the walls was excavated and found to be 5m wide x 1.5m deep. Its inner edge was protected by a sloping stone wall, a 'base batter', that prevented attackers from tunnelling beneath the wall. Excavation of the ditch also uncovered the bottom quarter of Talbot's tower and it too was found to have thick base-batter.

The town ditch was filled with many different layers of soil, some of which had naturally silted into it and some of which had been deliberately dumped. During the medieval period the ditch would have been cleaned out intermittently though it was never completely emptied, which left layers of soil towards the bottom of the ditch that date from the thirteenth century. The ditch would also have been used by the townsfolk as a refuse dump and this is probably where the vast majority of the large quantity of artefacts and animal bones derived from.

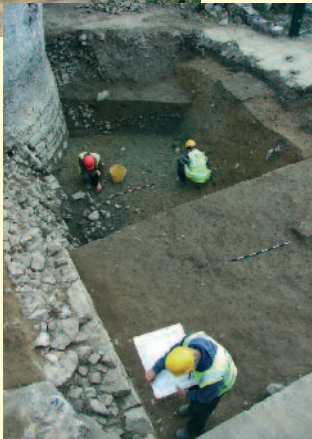
Excavations underway in the town ditch

At the very base of the ditch a rough stone path was found. This was put in place a solid surface that could be worked upon when construction was taking place on the tower. Patches of mortar, chips of stone and nails were all found in amongst the stones of the path.

One layer within the ditch was particularly interesting. This was right up against the wall of the tower and contained numerous pieces of lead musket shot which had been fired at the tower, probably during one of the sixteenth century sieges of Kilkenny.
