# YOUGHAL TOWN WALL

# Conservation and Management Plan

The Integrated Conservation Group,  
The David Kelly Partnership  
and John Cronin & Associates, Planning Consultants

18th May 2008

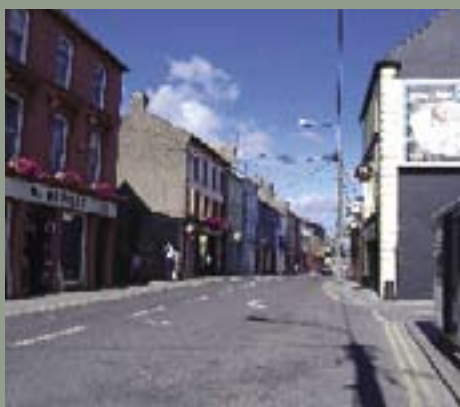
Plate 1. Site of North Gate, North Main Street

The site of North Gate is obvious because of a slight narrowing of North Main Street at this location (Plate 1). Historical records make note of a garrison stationed at Youghal and the *Pacata Hibernia* shows this garrison attached to North Gate. The base of the northern wall of No.160 North Main Street is buttressed (Plate 2), suggesting that this could be the outer garrison wall. No other remains of the gate or garrison survive above ground, but there is potential to identify them during archaeological investigation, should development take place in this area.

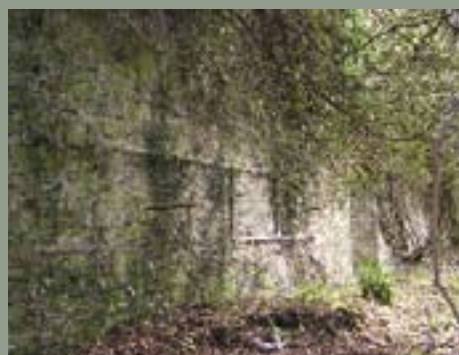
Located within the grounds of Myrtle Grove, Section C is differentiated from the previous sections because of “changes in the texture and pattern” (Kelly 2000:7). A small gate through the wall provides access to other sections of the property. The external face has suffered from extremely heavy vegetation and mortar erosion, which will need to be addressed in order to stabilise the wall (Plate 6). Heavy ivy growth is present on both sides and on top of the wall, including some small trees, which need to be removed.

Plate 6. Section C, Myrtle Grove external face. Note structural inclusions

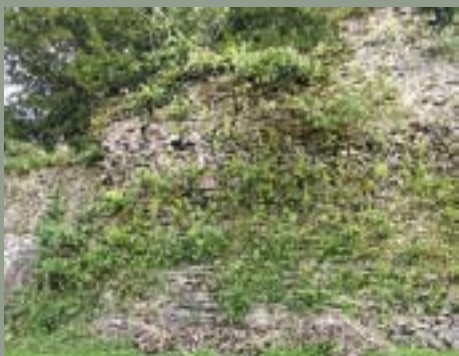
Very little of this section of town wall survives as the circuit has been broken through by a small residential structure, a garden wall and a nineteenth century extension to Myrtle Grove. The internal face appears to be in much better condition than its external counterpart, which suffers from loose masonry and eroded mortar (Plate 8). Again, the wall survives to the height of the wall walk, but Kelly (2000) believes that a small section of the upper parapet remains adjacent to the Myrtle Grove extension (Plates 7 and 8). Anecdotal evidence suggests the flowers growing on the external face of this section of original wall were introduced from the Americas by Sir Walter Raleigh and are therefore of historic interest and require further investigation. The rebuilt garden wall between the residential structure on the external face and the Myrtle Grove extension also dates to the nineteenth century.

Plate 8. Section D external face. Flowers growing on wall are thought to have been introduced from America by Walter Raleigh

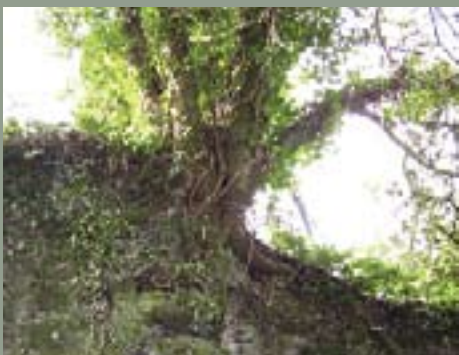
Plate 10. Section E – tree growth from top of wall

Since Section E was originally surveyed in 2000 the dense vegetation has been cleared from the interior face, however the external face of the wall is still inaccessible. The vegetation will also need to be cleared along the external face to assess the condition of the wall. The internal face of the wall appears to be in very good condition and is being well maintained. This section extends from Myrtle Grove house to the St Mary's boundary. The wall includes a modern boarded-up gate at this location, which opens onto a narrow parcel of land external to the wall where two family box tombs are located. This area is very overgrown. This narrow strip of land outside the town wall once provided access from Raheen Road to Myrtle Grove. A gate on Raheen Road possibly marks the right-of-way access, but a number of residential units have since been built over this access. A large sycamore tree growing out of the top of the wall has increased in size in the last seven years and needs to be removed by a qualified arboriculturalist as a matter of urgency (Plate 10).

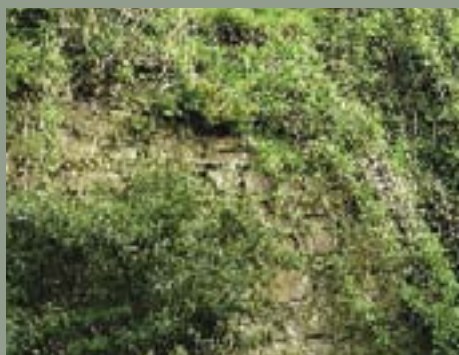
Plate 11. Section E, Myrtle Grove – dense vegetation on external face

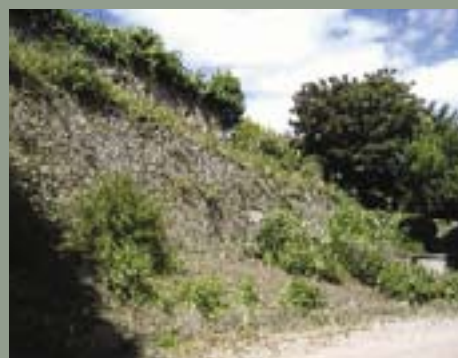
Plate 12. Section F, St Mary's Church – internal face. Note collapse of upper parapet

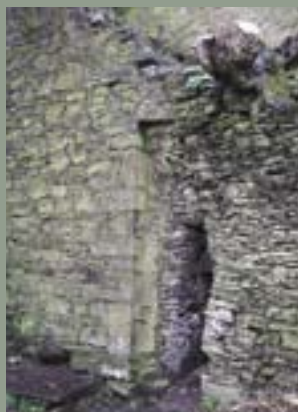
The interior of the wall has had the vegetation removed, although the stump of a sycamore tree that was growing from the wall walk still remains and is not dead. Further along this section two more sycamore trees are growing from the wall – one from the face and one from the top. Because of the substantial tree growth David Kelly has identified this section of wall as requiring immediate and on-going monitoring of structural movement (Fig 2). A monitoring programme should also be set up for the large beech tree beside the wall. It is interesting to note that a small opening created to recess a coffin into the wall exposes the wall's internal structure where at least 3 different phases of construction are identifiable. The later phases of construction actually rest on top of medieval grave slabs (Plate 17).

Plate 17.  
Section G St  
Mary's Church  
– internal  
face with  
tree stump  
and grave  
cut in wall.  
Note later  
extension built  
over medieval  
grave stones

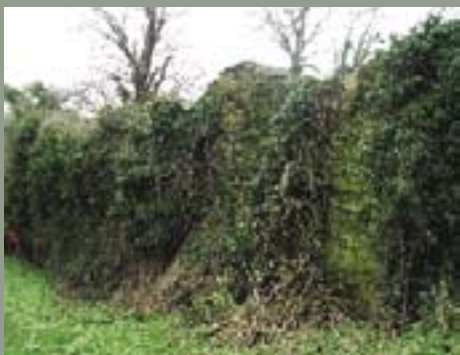
Plate 18. Section G – external face with extensive ivy cover

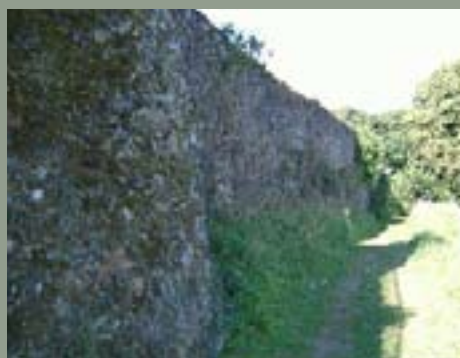
Plate 19. Section H, St Mary's Church – internal face

The town wall is visible within the grounds of St Mary's Church, as the base of the Fever Hospital wall (Plate 19). Trees growing out of the town wall have been cut back, but it is likely that removal of the remaining root system will cause structural damage to this section of the wall, so this can not be done until an appropriate programme of consolidation and repair is in place.

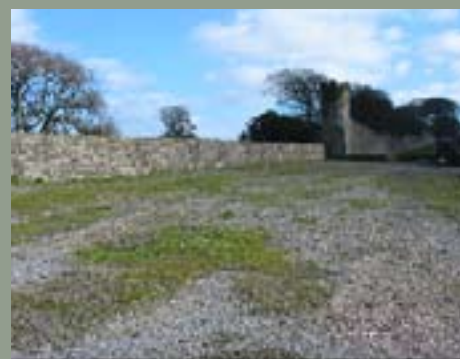
be very under-utilised and currently detracts from the wall experience (Plate 20). The ground level outside the wall has also been raised up and the town wall still exists below the car park level. This section provides an opportunity to improve public presentation and develop the use of the car park facilities, perhaps turning it into a small coach park. Cronin (1994) believes the north-western corner of the car park is the possible location for a former tower. No above ground remains of this tower survive.

Plate 20. Section H, Raheen Road car park – site of former Fever Hospital

- Improve public presentation of the town wall and develop the use of the Council-owned car park facilities on Raheen Road, perhaps turning it into a small coach park. The windows of the former hospital could be re-opened to re-establish the view into the medieval town and down to the river. Security railings or barriers would need to be added to ensure public safety (Fig. 13).
- Develop the College gardens to make the wall more accessible by creating an urban park, encouraging visitors with a small playground area for children and a tree walk with spectacular views, extending from the current wall walk. Access through the gardens via the newly opened gate would heighten the wall experience and provide pedestrian access into the town. Development of this area would require an Action Plan, as there are a number of health and safety issues to be addressed.

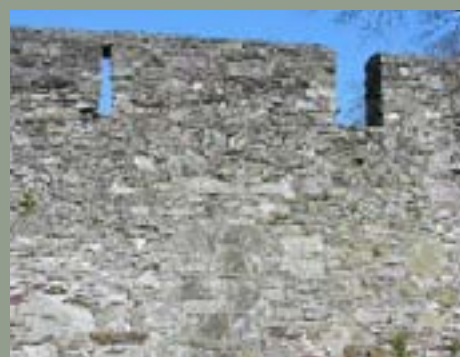
Plate 22. Section I sallyport and 1970s rebuilt upper parapet

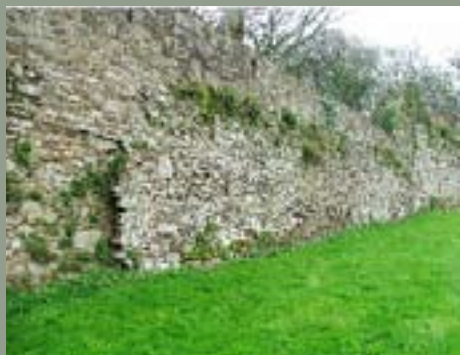
*Plate 24. Section J – external face. Note line of vegetation along old top of wall*

The lower sections of the wall show considerable mortar erosion allowing vegetation growth to creep in. The join between the modern reconstructions is obvious by the line of vegetation that grows along the former top of the wall (Plate 24). There is also membrane between the original wall and rebuilt upper course. The distinctive red sandstone used in the lower, older courses of the wall are weathering more quickly than the other stones used during construction. At one particular section the mortar and stones have been washed out from the base of the external face and stone and mortar replacement work has begun here. Further erosion at this location may lead to the undermining of the wall.

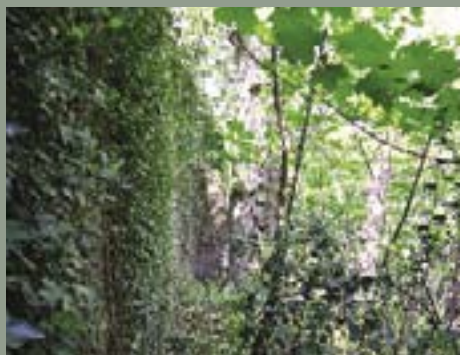
*Plate 26. Section K – town wall interior overgrown with ivy*

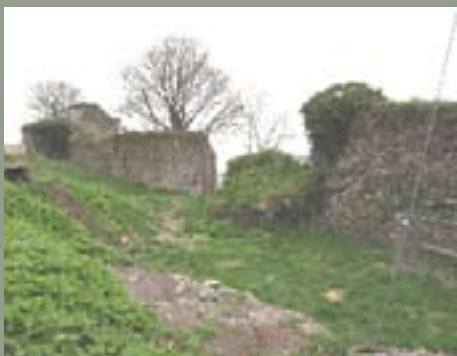
Plate 32. Gate opening and rubble at Section M – external face looking north. Note Montmorenci Tower to the north

Section M continues south from Montmorenci Tower, and there is evidence of recent repair and reconstructive work (Plate 33). The wall is high, but less than 1m thick. Vegetation growth is a huge problem along this section, and there are two openings in the wall at this location (Plates 32-3). Facing on to Raheen Road is the remains of a now un-used kiosk. This building should be purchased by the Council and removed to allow better presentation of the town wall.

A section of the wall was removed in the nineteenth century to provide access to Montmorenci House, which was constructed at that time (Plate 32). Despite the height of the wall at this location the public is regularly climbing the wall here and cutting across

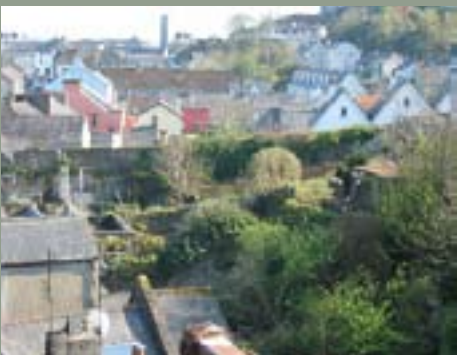
In 1999 two test trenches were excavated at the rear of 16 South Main Street by the Archaeological Services Unit, UCC (Licence No. 99E0300). The site is located within Base Town and the town wall forms the property boundary on both the south and west sides. A large section of the southern wall still survives (Plate 42). Neither test trench revealed any archaeological material (McClatchie 2000).

Plate 42. Section Q – internal face (taken from Clock Gate)

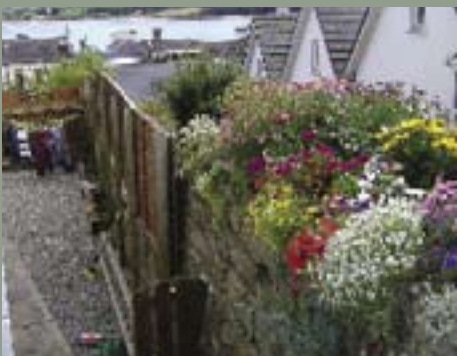
Plate 43. Section Q – vegetation growth on top of town wall. Note close proximity of recent developments

Along Tailor's Lane there is a new development of houses (Nos. 1-4) against the external face of the wall, which survives better than the internal face of the wall, although both the exterior face and the top of the wall of Section Q have substantial vegetative growth (Plate 43).

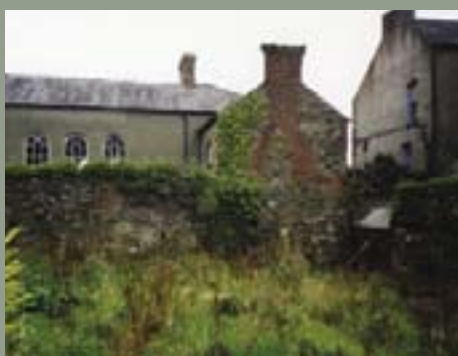
Plate 47. Possible section of town wall to rear of Courthouse. Note Water Gate on right

The rear wall of the Courthouse yard is not directly aligned with the Water Gate but is of similar form and fabric to the town wall and is now believed to be part of the identified circuit. The wall is possibly linked to the Water Gate to form part of the total gate structure (Plate 47). Kelly has also suggested that "parts of the gate structure are incorporated into the buildings on the southern side" of the arch (*ibid*: 23).

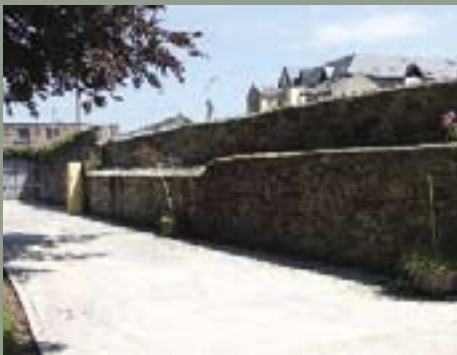
Plate 50. Section U – internal face with concrete capping of top of wall and wall walk

Internally the east-west wall can be viewed from the rear garden of No. 138 North Main Street and shows some open joints, and concrete capping of the wall walk and the parapet (Plate 50). The quayside face, now in the car park, is more difficult to read because parts of the wall have been plastered over and partially covered by two concrete columns, which were associated with a former industrial building (Plate 51).

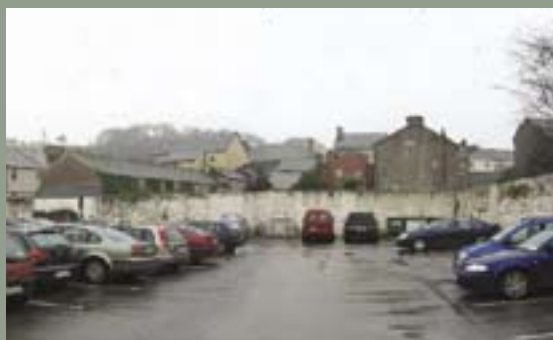
Plate 51. Section U – external face at Catherine Street car park

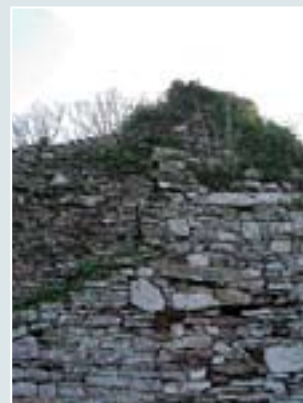
*Bowing of external face of section J, note the open joints and heavy growth to wall*

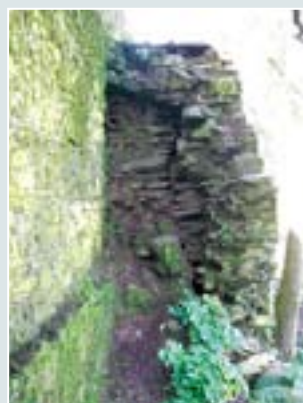
*Loss of wall walk and exposed core to Section J*

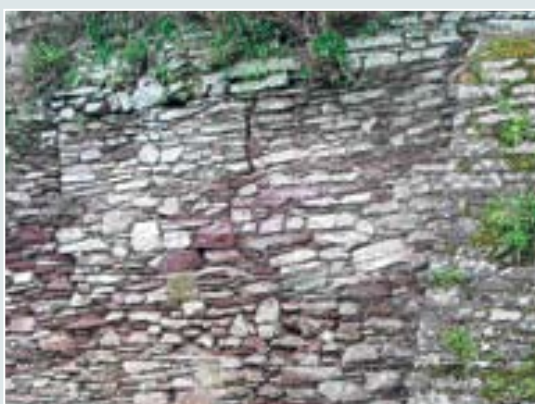
*Open joints to external face of section K*

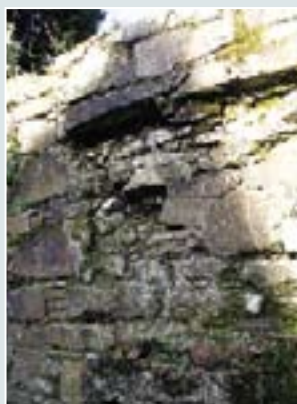
*Voids to internal face of section F, where vegetation has been removed in recent times.*

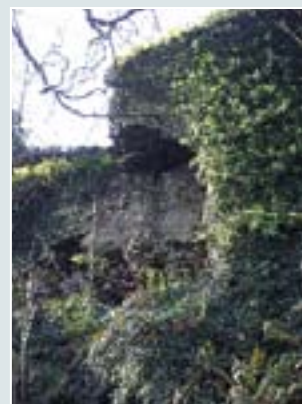
*Significant loss of material to the internal face of section J*

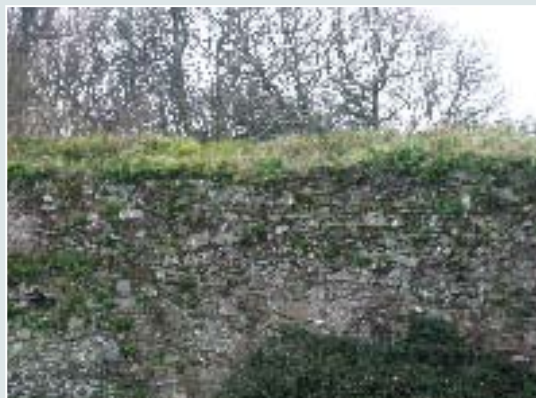
*Plant life to cap of Section L.*

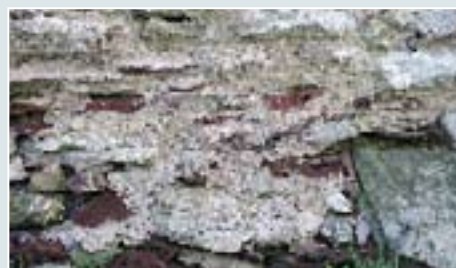
*Poorly pointed stonework to external face of section J.*

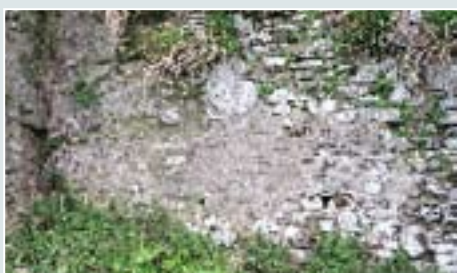
*Cementitious pointing to external face of section K, note the poor pointing technique*

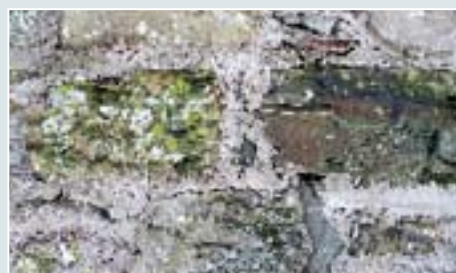
*Stonework buttered with pointing material to external face of section J..*

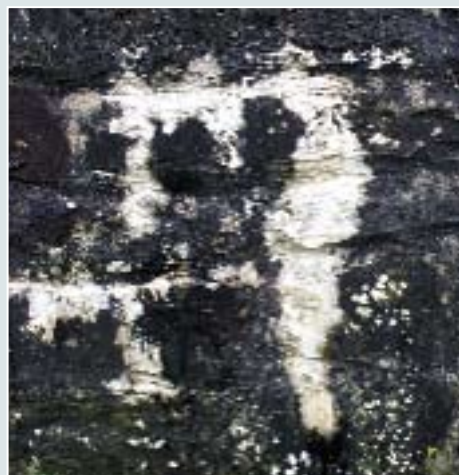
Areas of lime leaching were recorded on the external face of section K and the internal face of section I, where excessive water penetration is washing the lime mortar from the joints. Lime leaching occurs when calcium in the form of soluble lime leaches from mortars, forming encrustations on the stone surface .

*Lime leaching from internal face of section I.*

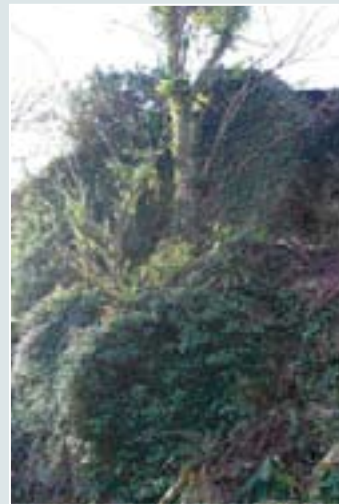
*Tree life and higher order plant life to internal face of Section J.*

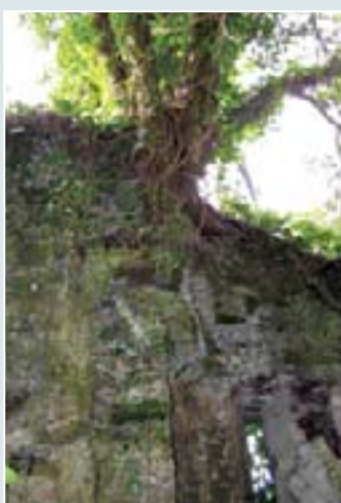
*Mature tree growing from the wall head at section E.*

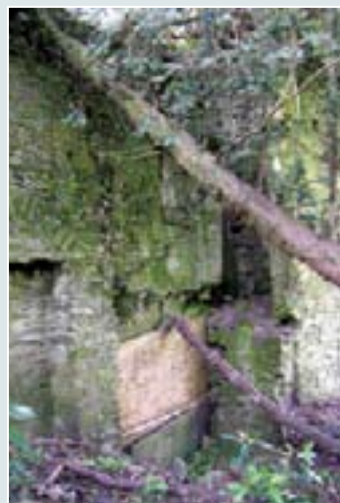
*Fallen tree resting on head of wall at section E*

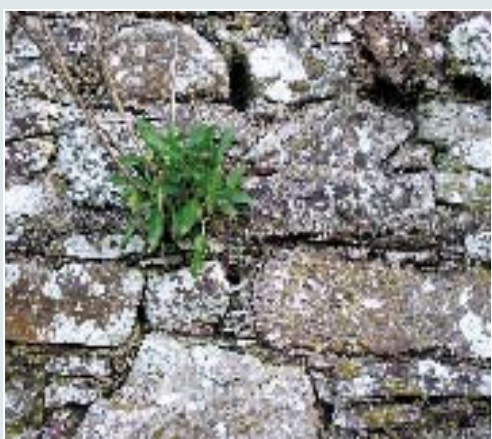
*Lichen to stonework on external face of section J, note plant life to wall.*

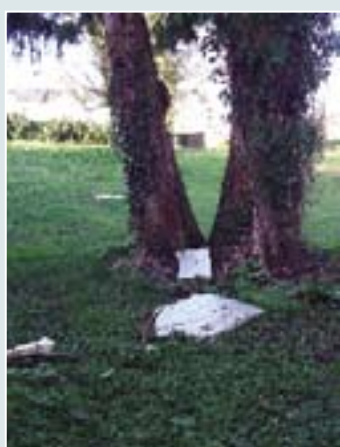
*Dumping adjacent to external face of Section G*

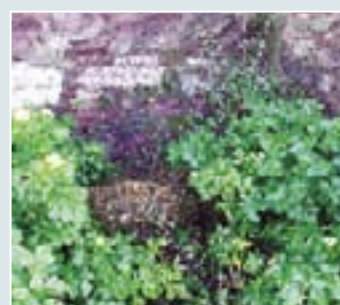
*Dumping adjacent to external face of Section K.*

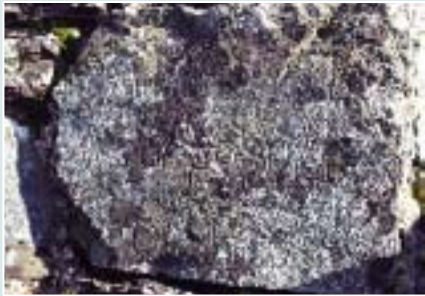
*Graffiti to stone on inside of tower to section I*

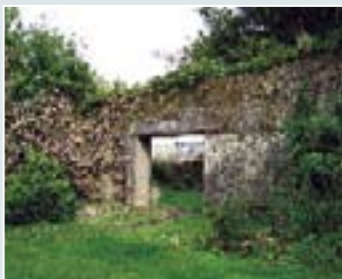
*Opening at section D.*

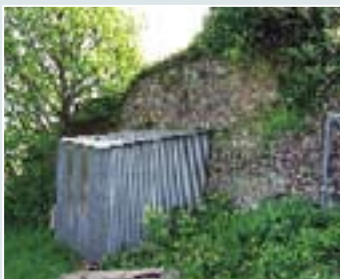
*Outbuilding abutting internal face of Section M.*

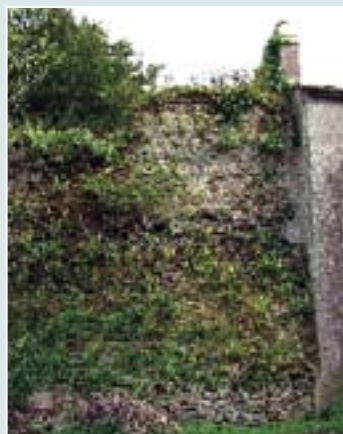
*Myrtle Grove built up to the historic town wall at section D.*

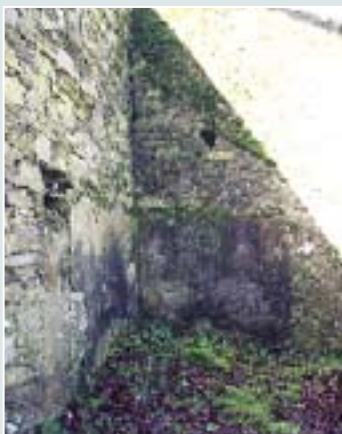
*Scarring from former structure to internal face of Section J.*
